**Historic Landmark Commission  
October 24, 2011  
Permits in National Register Historic Districts  
NRD-2011-0080  
Pease Park  
1100 Kingsbury Street**

**SUBJECT: Update: Back-up Information for National Register Permit:  
Pease Park Improvements**

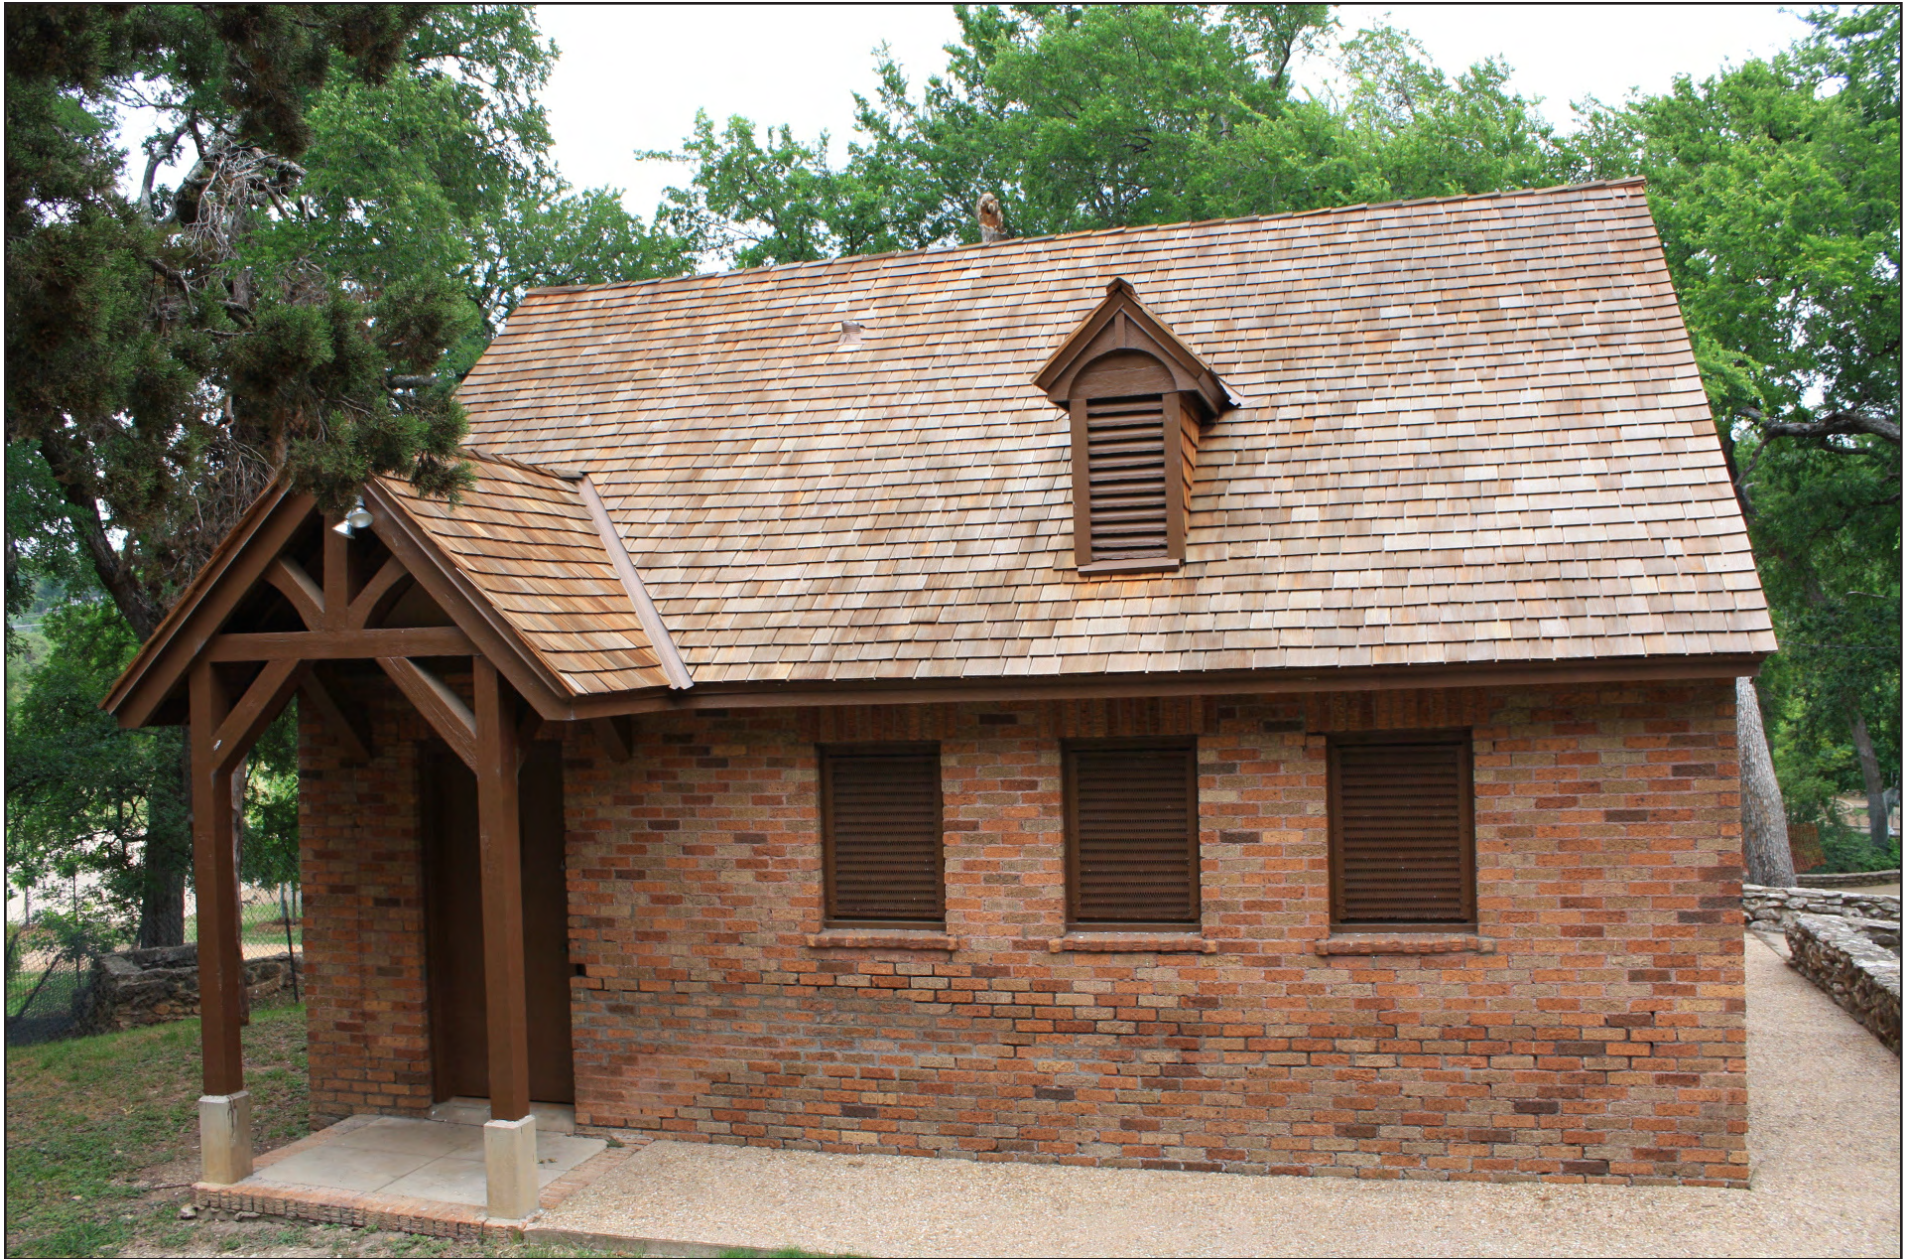
The Tudor Cottage Restrooms building (Fig. 1) in Pease Park is one of the earliest buildings constructed in Austin as a park facility. The restrooms were designed in the mid-1920s. While the link is not yet fully substantiated, it is widely thought that Hugo Kuehne, a prominent architect, designed the restrooms. Kuehne designed the Oakwood Annex restrooms, the Zilker Caretaker Cottage, and several early park shelter houses. Kuehne was very active in the early development of Austin's park system.

Figure 1: Pease Park Historic Tudor Cottage Restrooms constructed in the mid-1920s and attributed to architect Hugo Kuehne.

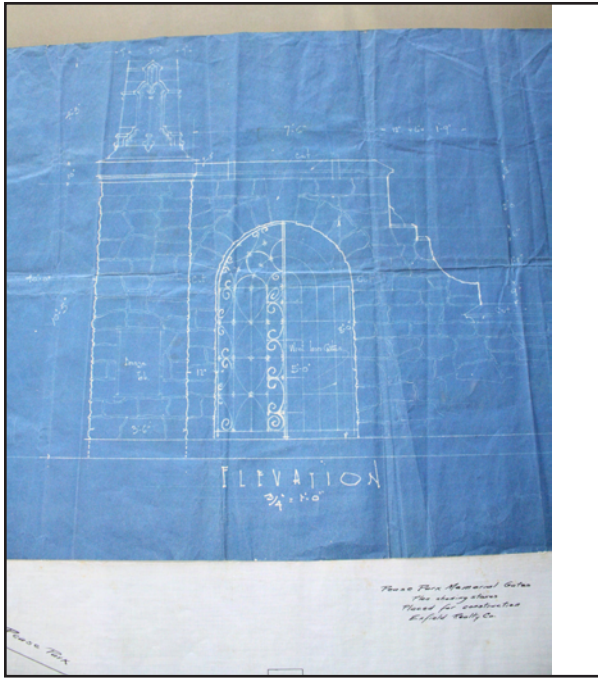
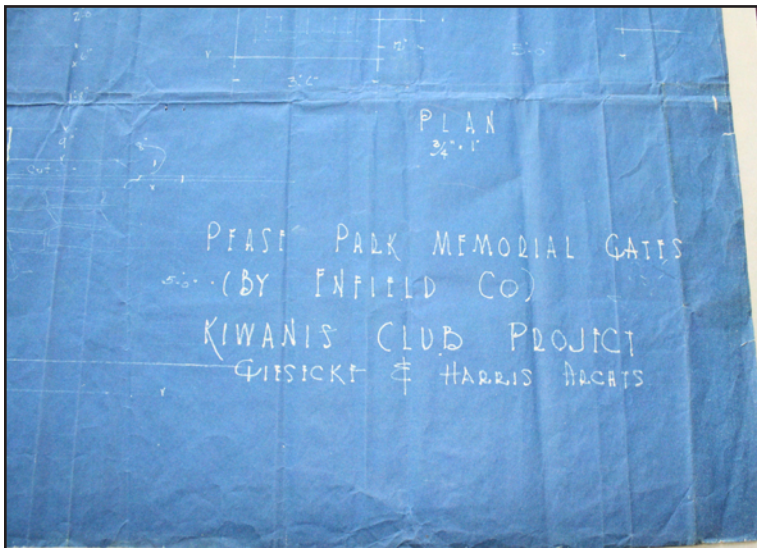
At the intersection of Parkway and Kingbury Street are two archways constructed of limestone in a random rubble configuration. These archways serve as the original entry gates to Pease Park and were constructed in 1926-27. Designed by the prominent architecture firm of Giesecke & Harris, the original design of the gates specified decorative wrought iron, bronze plaques, and lanterns atop each archway. The project was financed by Niles Graham, the grandson of Texas Governor Elisha Pease who donated the land to the city for the purpose of a public park in 1875. Graham also led the Enfield Company, a firm that was involved in the development of the surrounding neighborhood. The Kiwanis Club was also involved with the project as evidenced by a citation on the blueprints, which are archived at the Austin History Center (Fig. 8).

Figure 8: Original construction drawings for Pease Park Memorial Gates (Austin History Center).

1. Final review of repointing and graffiti removal specifications on restrooms, and concrete repair treatment specifications for tables and benches should be presented to CHPO staff for administrative review.
2. Replacement plaque should be fabricated in bronze as is specified in the original construction documents.

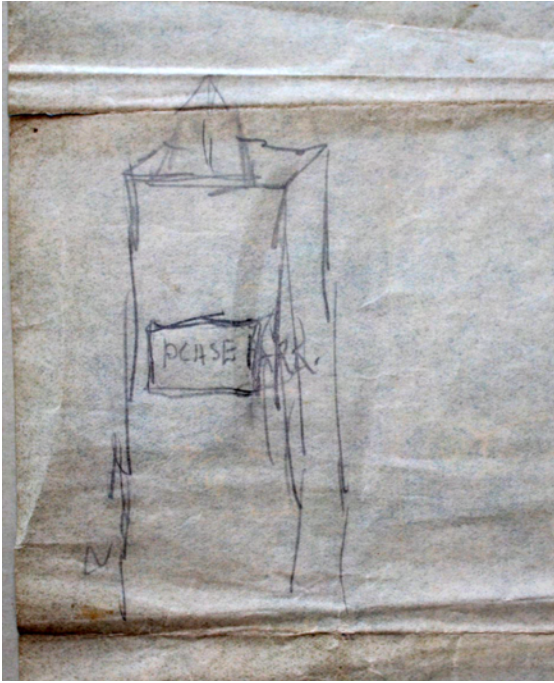
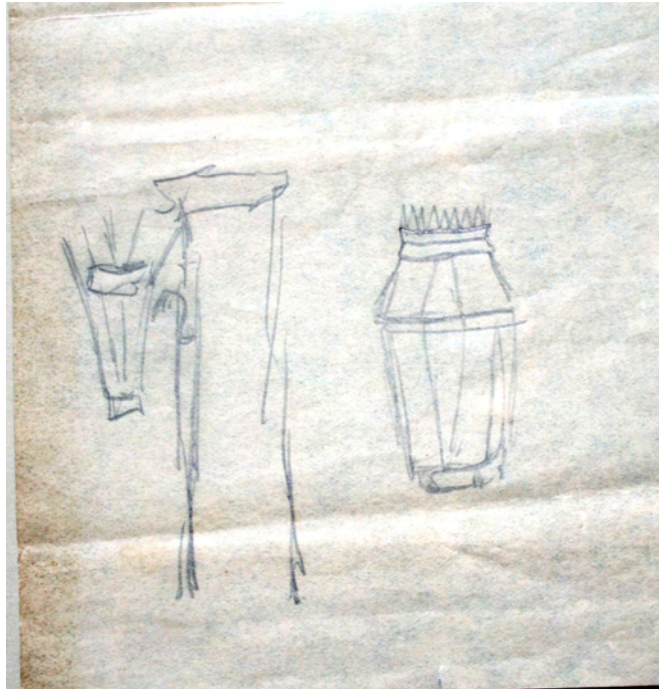
Figure 10: Sketches found on the back of original construction drawings for Pease Park Memorial Gates (Austin History Center).

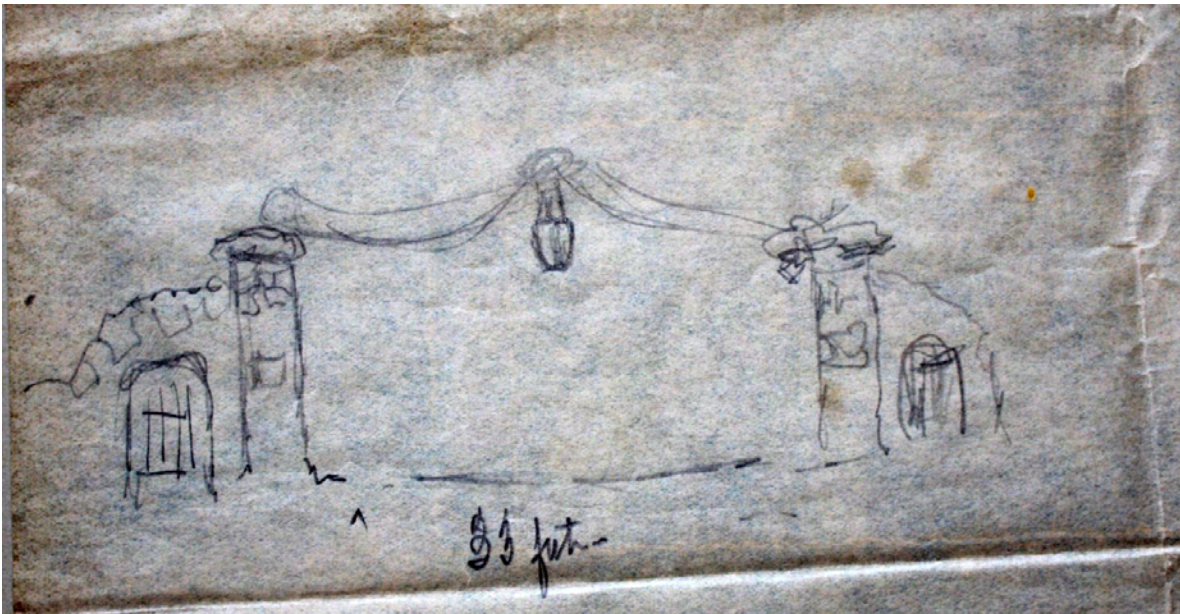
Figure 11: Notation found on the back of original construction drawings for Pease Park Memorial Gates (Austin History Center).

Proposed & started  
By L.T.G. & M.G.C.  
Pease Park gates.  
Entrance at Park Hwy.  
R. Tib. Graham.

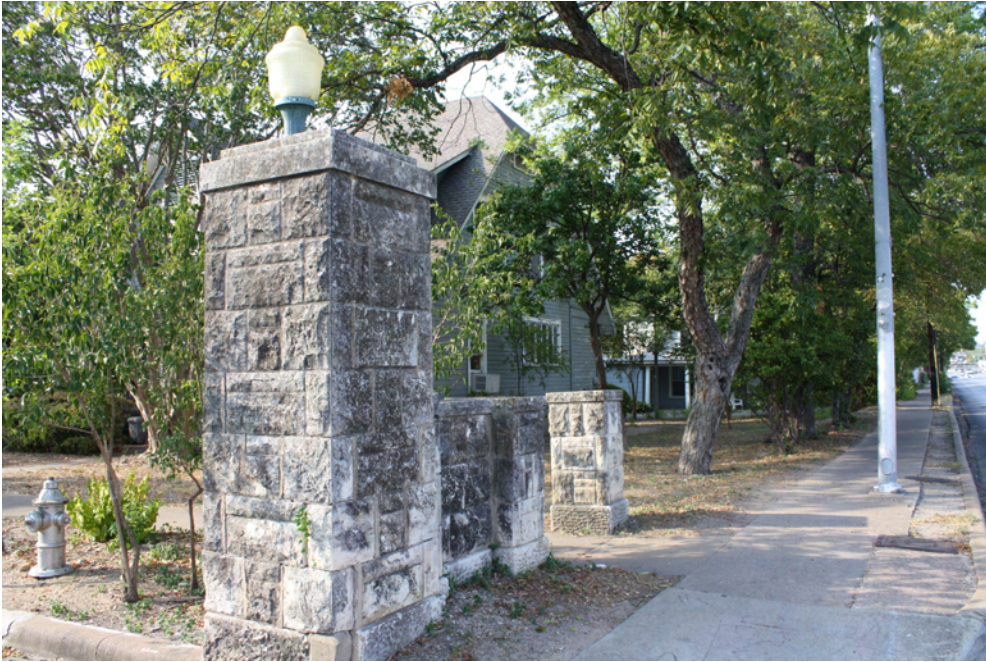
Figure 13: Entry column into Aldridge Place Neighborhood at Guadalupe Street and 33rd Street.

- b. Replace missing stone at corner and stone cap with matching material.
  - c. Replace missing plaques with sandstone plaques. Font to be block lettering similar to that used on the Aldredge Place entrance columns. Date on plaques will be "1926" - the date gates were constructed.

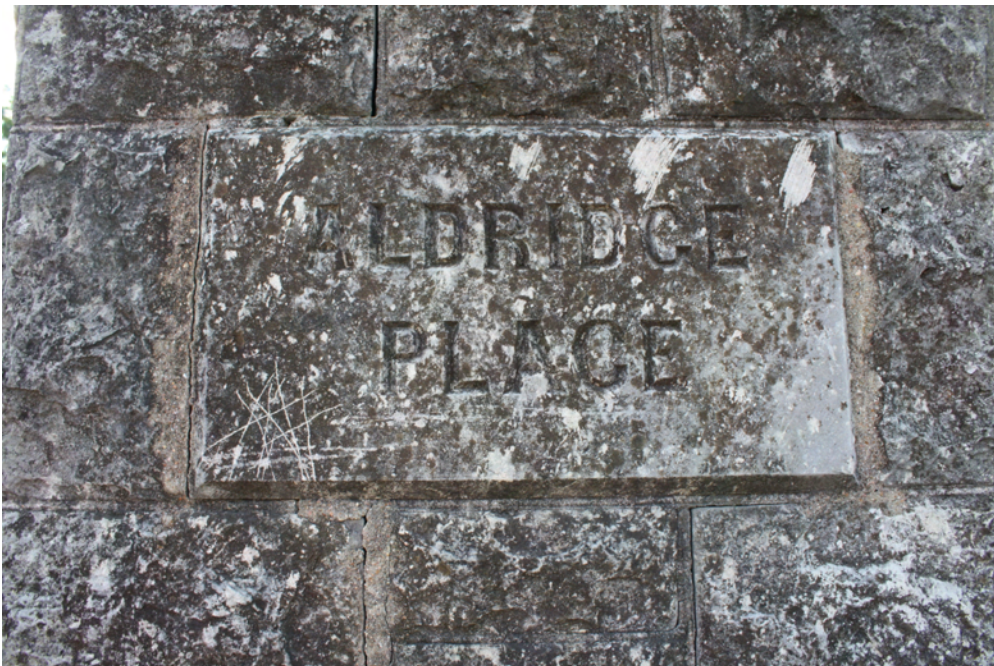
Figure 14: Detail of limestone sign with lettering carved into stone.

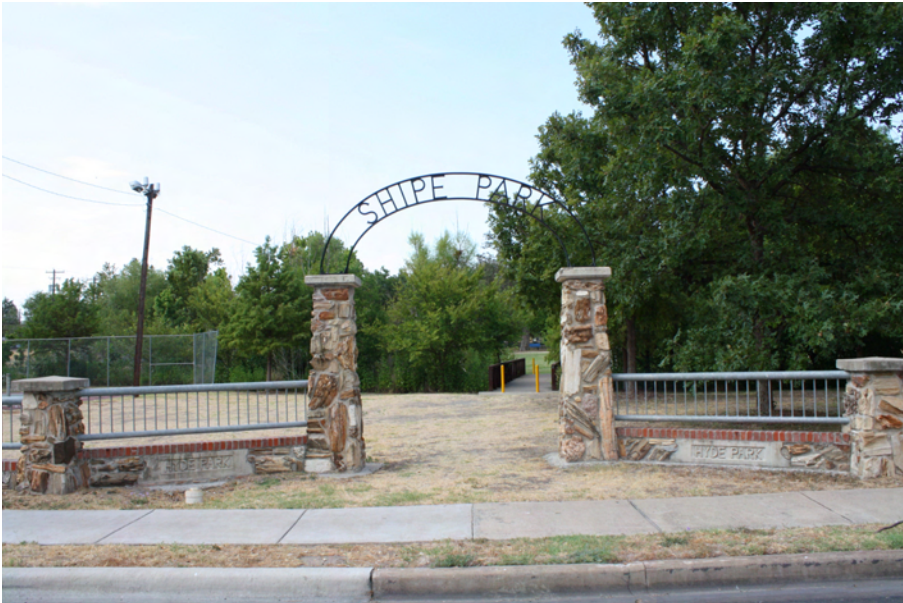
Figure 15: Recently constructed entry arch into Shipe Park. The petrified stone was taken from a nearby building that was demolished. Original neighborhood signage was incorporated into the design. Note that entryway pays homage to historic nature of park and neighborhood yet is clearly new construction.

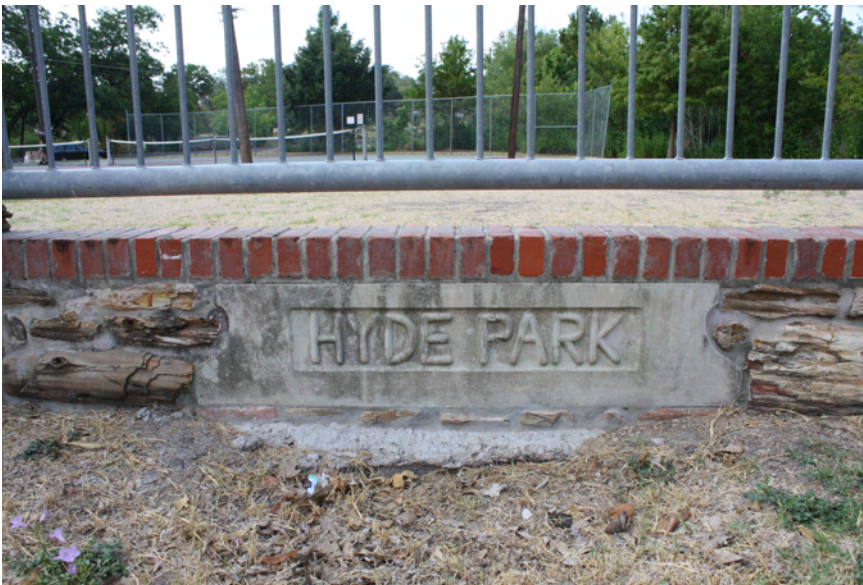
Figure 16: Detail of historic Hyde Park neighborhood signage. Notice that lettering is embossed rather than carved.

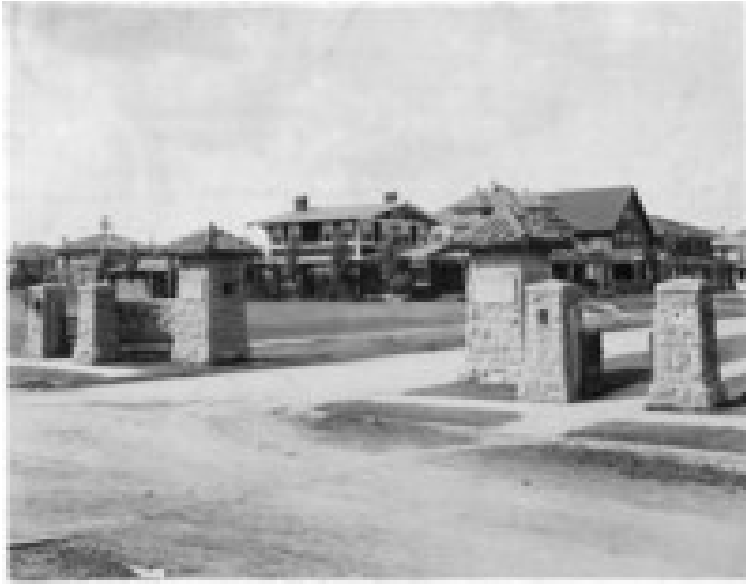
Figure 17: Historic photograph of entry gates to the Swiss Avenue Historic District in Dallas, Texas. (<http://eastdallasblog.dallasnews.com/archives/swiss-avenue/>)

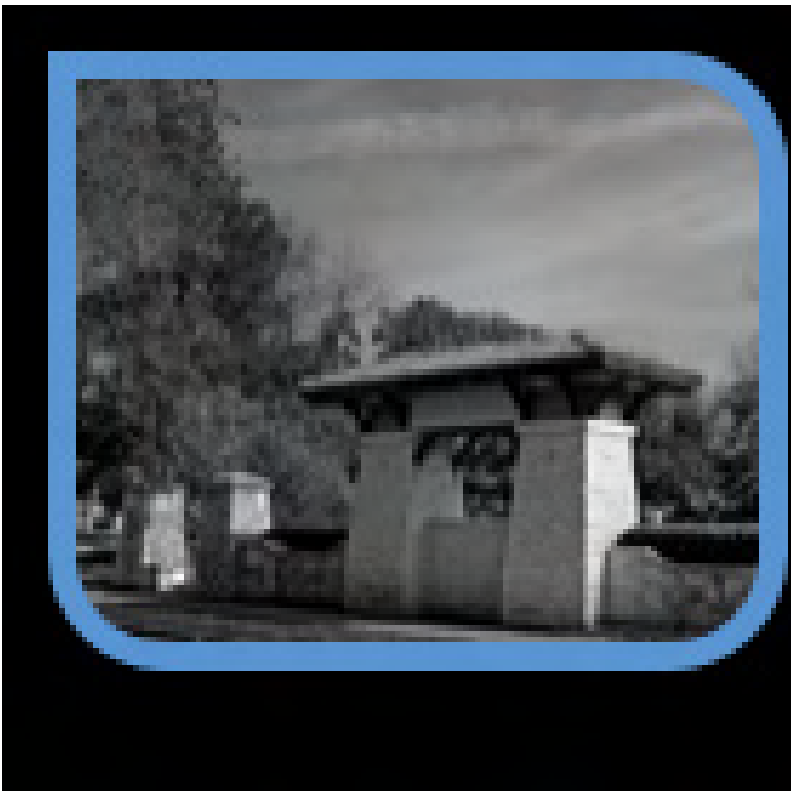
Figure 18: Current photograph of restored entry gates to the Swiss Avenue Historic District in Dallas, Texas. (<http://www.swissavenueproject.com/neighborhoods/>)
