Address of Property: 1101 E 10th Street

Building Name or LHD: Metropolitan AME Church

# PROPERTY INSPECTION REPORT

**Concerning:** 1101 E. 10th Street, Austin, TX 78703

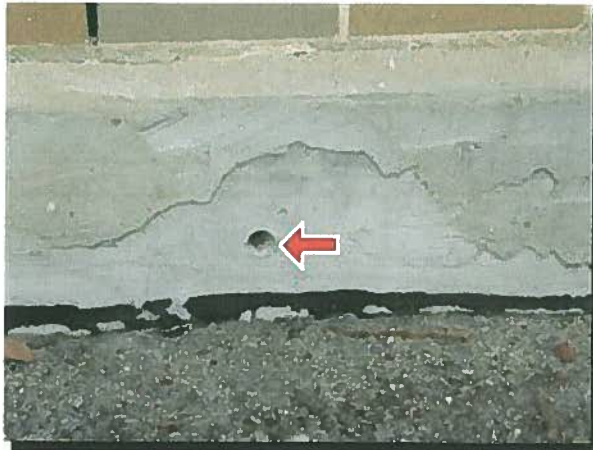
A. Picture 5

☒ Seal all exposed post tension cable ends at foundation walls.

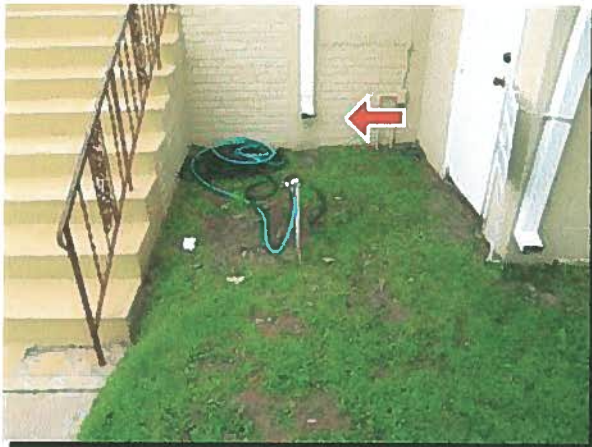
B. Picture 7

☒ Downspouts deposit large amounts of runoff near the base of the structure, and appear to be contributing to the moisture content in the basement. Gutter downspouts that terminate at or near foundation should be extended away from foundation to reduce/prevent moisture intrusion.

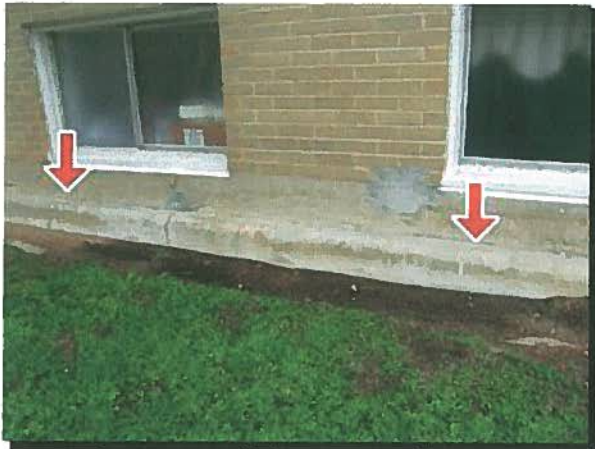
B. Picture 12

☒ Cement barrier at base of structure, adjoining basement walls is sloped towards structure. This barrier should slope away from the structure.

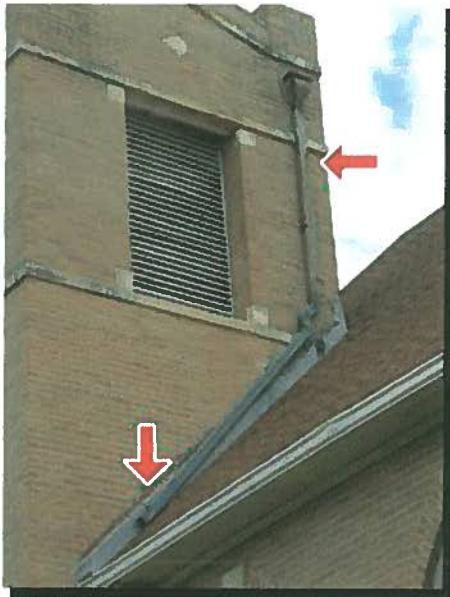
B. Picture 15

☒ Downspouts that extend from scuppers at third/fourth story to lower gutters should actually extend all way down to grade, as the gutters do not appear able to accommodate the excess runoff.

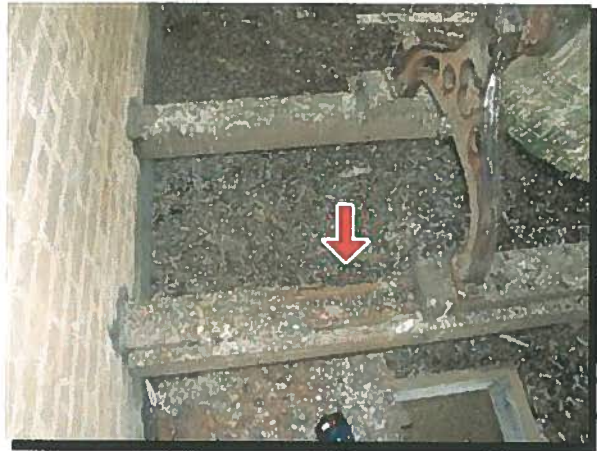
D. Picture 4 Rotted nearly half-through.

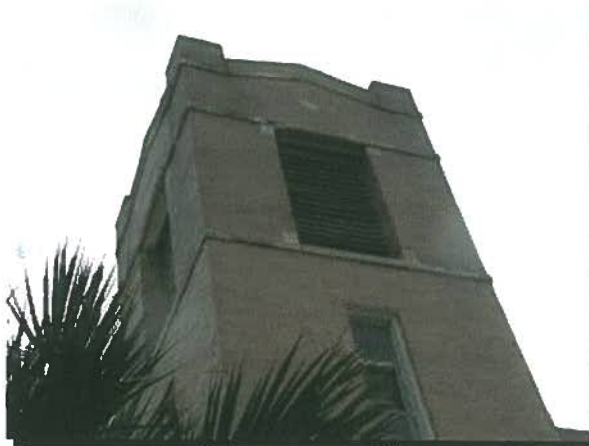
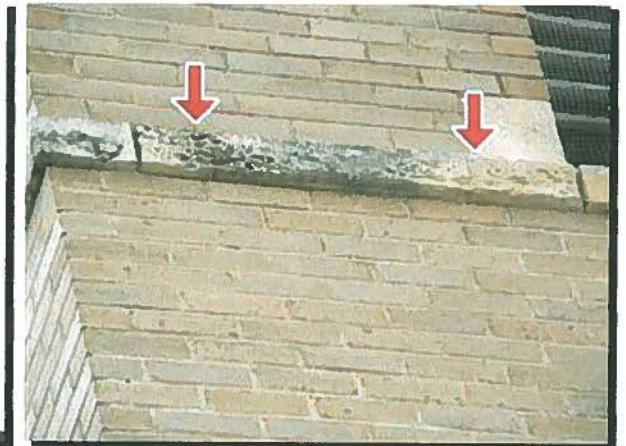
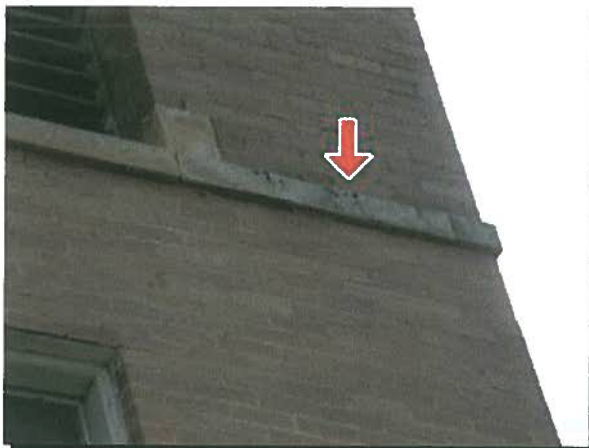
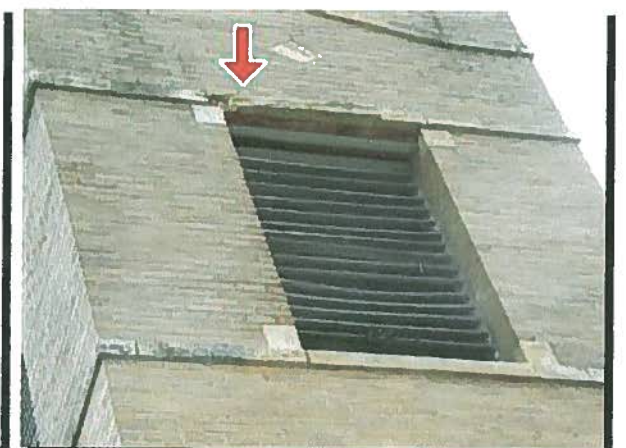
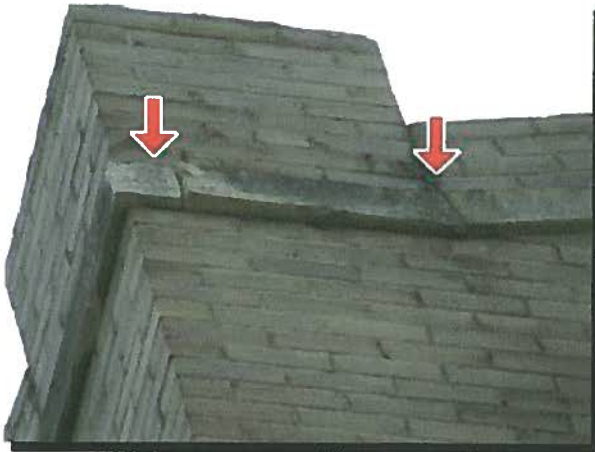
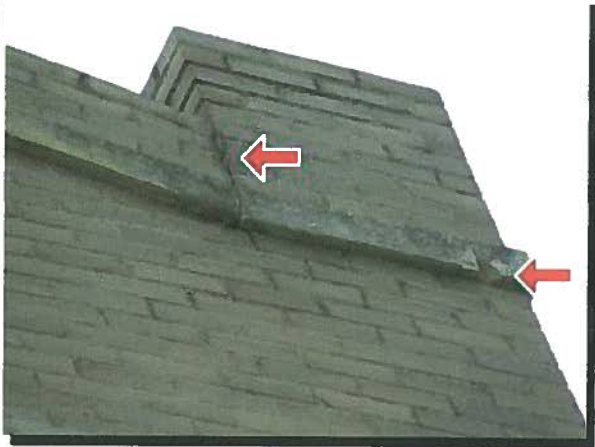
☒ Exterior of walls are decaying in areas, particularly where (what appears to be limestone) is deteriorating. There are several cracks in the brick and stone structure that indicate structural shift, and will require repair.

Where there is decay and weather damage, these areas should be repaired and stone replaced. Some areas appear to require nothing more than a cleaning and weather seal application. a masonary should evaluate these areas for method of replacement, as additional support may be needed to prevent shift.

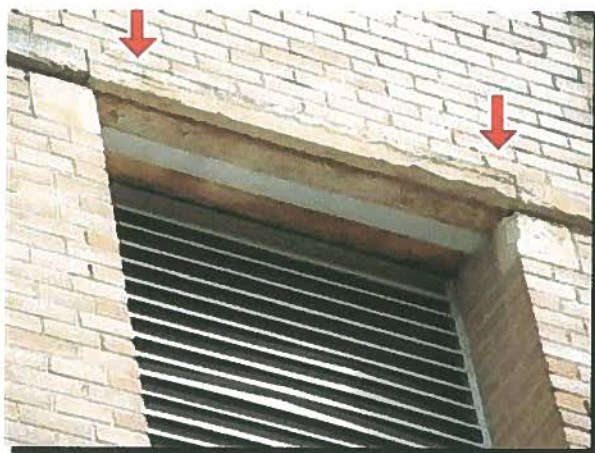
E. Picture 19

☒ Lintels are deteriorating and shifting outwards from wall applications. Some of the stonework is protruding and near falling out of wall, creating a safety hazard. The stonework in these areas will require replacement, and structural enhancements to these areas is recommended. A qualified mason should repair.

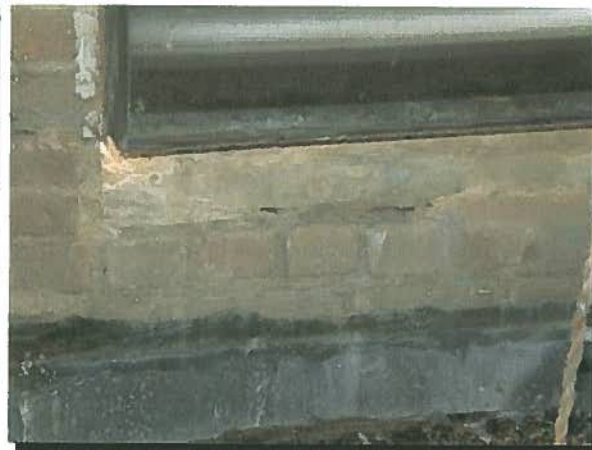
E. Picture 22

☒ Interior walls of towers have decaying brick mortar, there are signs of structural shift and there is no horizontal support present. An licensed structural engineer should evaluate these towers for structural integrity, and determine if structural upgrades are necessary. Internal wood or steel truss systems and/or lattice work may be recommended, but cannot be determined by an inspector.

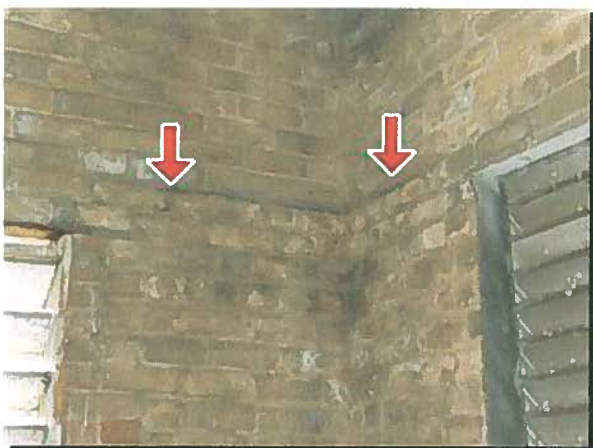
E. Picture 27 Structural shift.

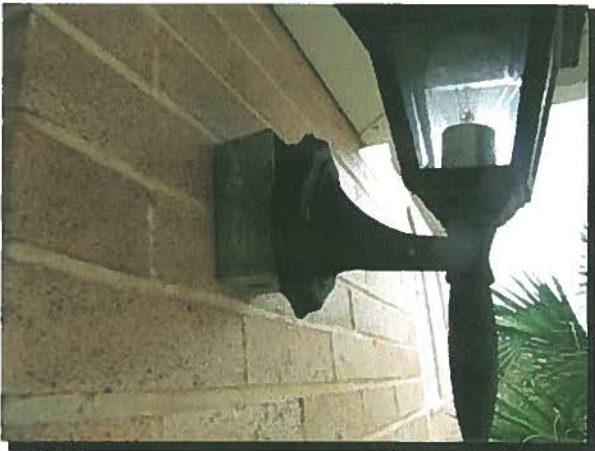
E. Picture 36

- ⊠ There are areas of the exterior wood siding, trim, Fascia, Drip edge, door jambs, etc. that have sustained varying levels of water (rot) damage and is in need of repair
- ⊠ It is recommended that all protrusions through the exterior siding and fixtures mounted on the exterior be sealed in order to prevent moisture incursion. Using a quality exterior caulk type sealant around pipes, wires, light fixtures etc. can prevent moisture related failure of electrical components and siding materials.

- ⊠ Seal (paint) all exposed wood surfaces around the exterior of the home to include any bare wood, joints in siding and trim, etc.
