# **JOLLYVILLE TRANSMISSION MAIN: Environmental Commissioning Monthly Report**

Presented to the Austin Environmental Board  
April 4, 2012

# Jollyville Transmission Main Project Status

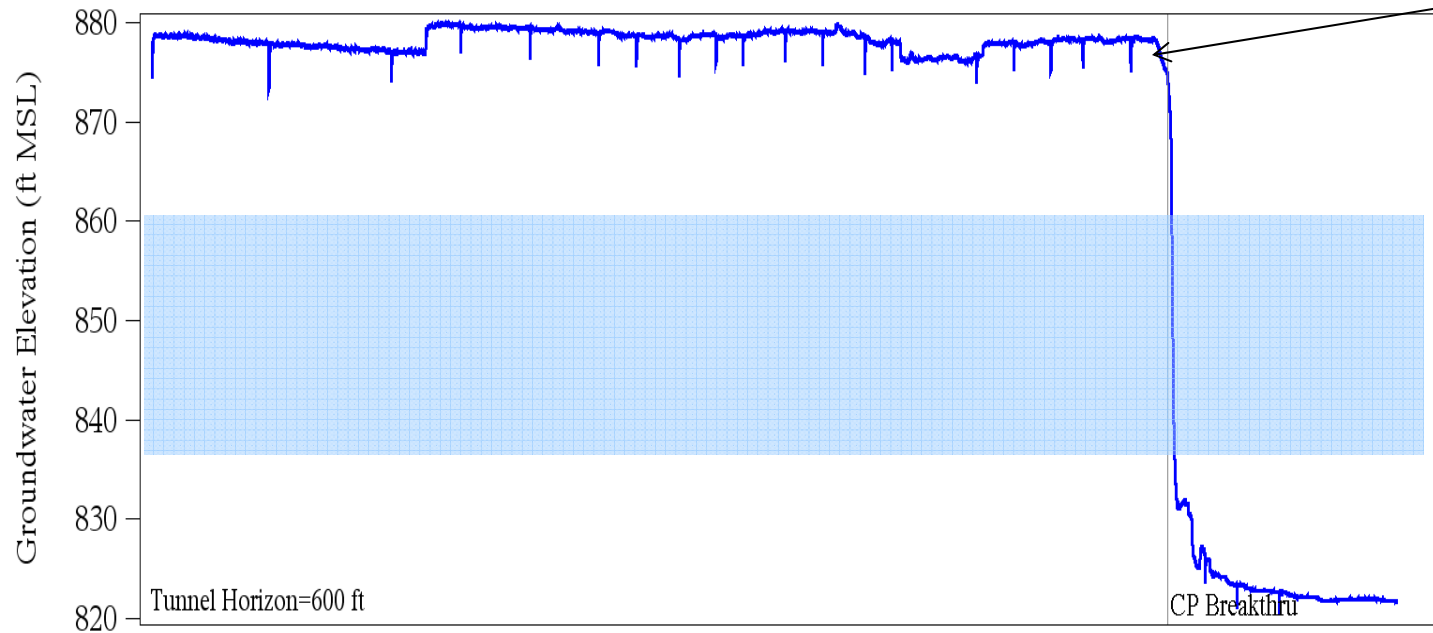
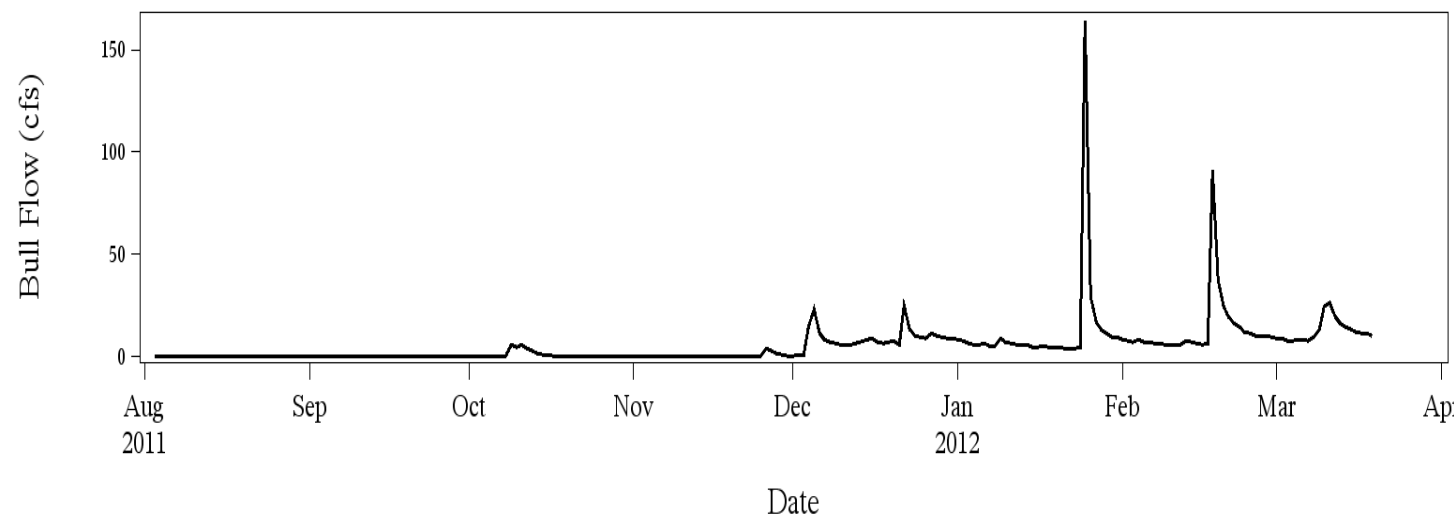
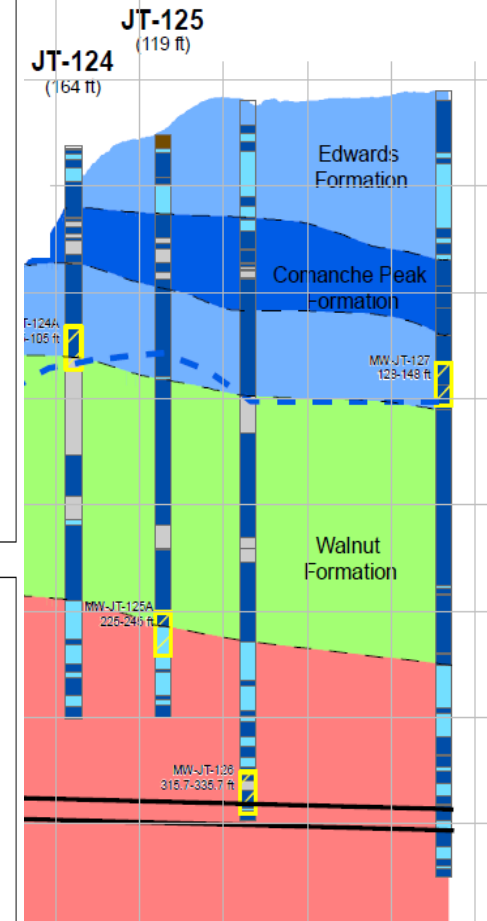
## Well JT127, Troll

Comanche Peak/ Edwards  
contact breached in  
Jollyville Reservoir shaft

Issue	Resolution
Rapid drop in JT-127 groundwater level	Analysis underway. Possible explanations include Comanche Peak formation operating as a confining layer, resulting in pressure drop when Comanche-Edwards contact mined through.

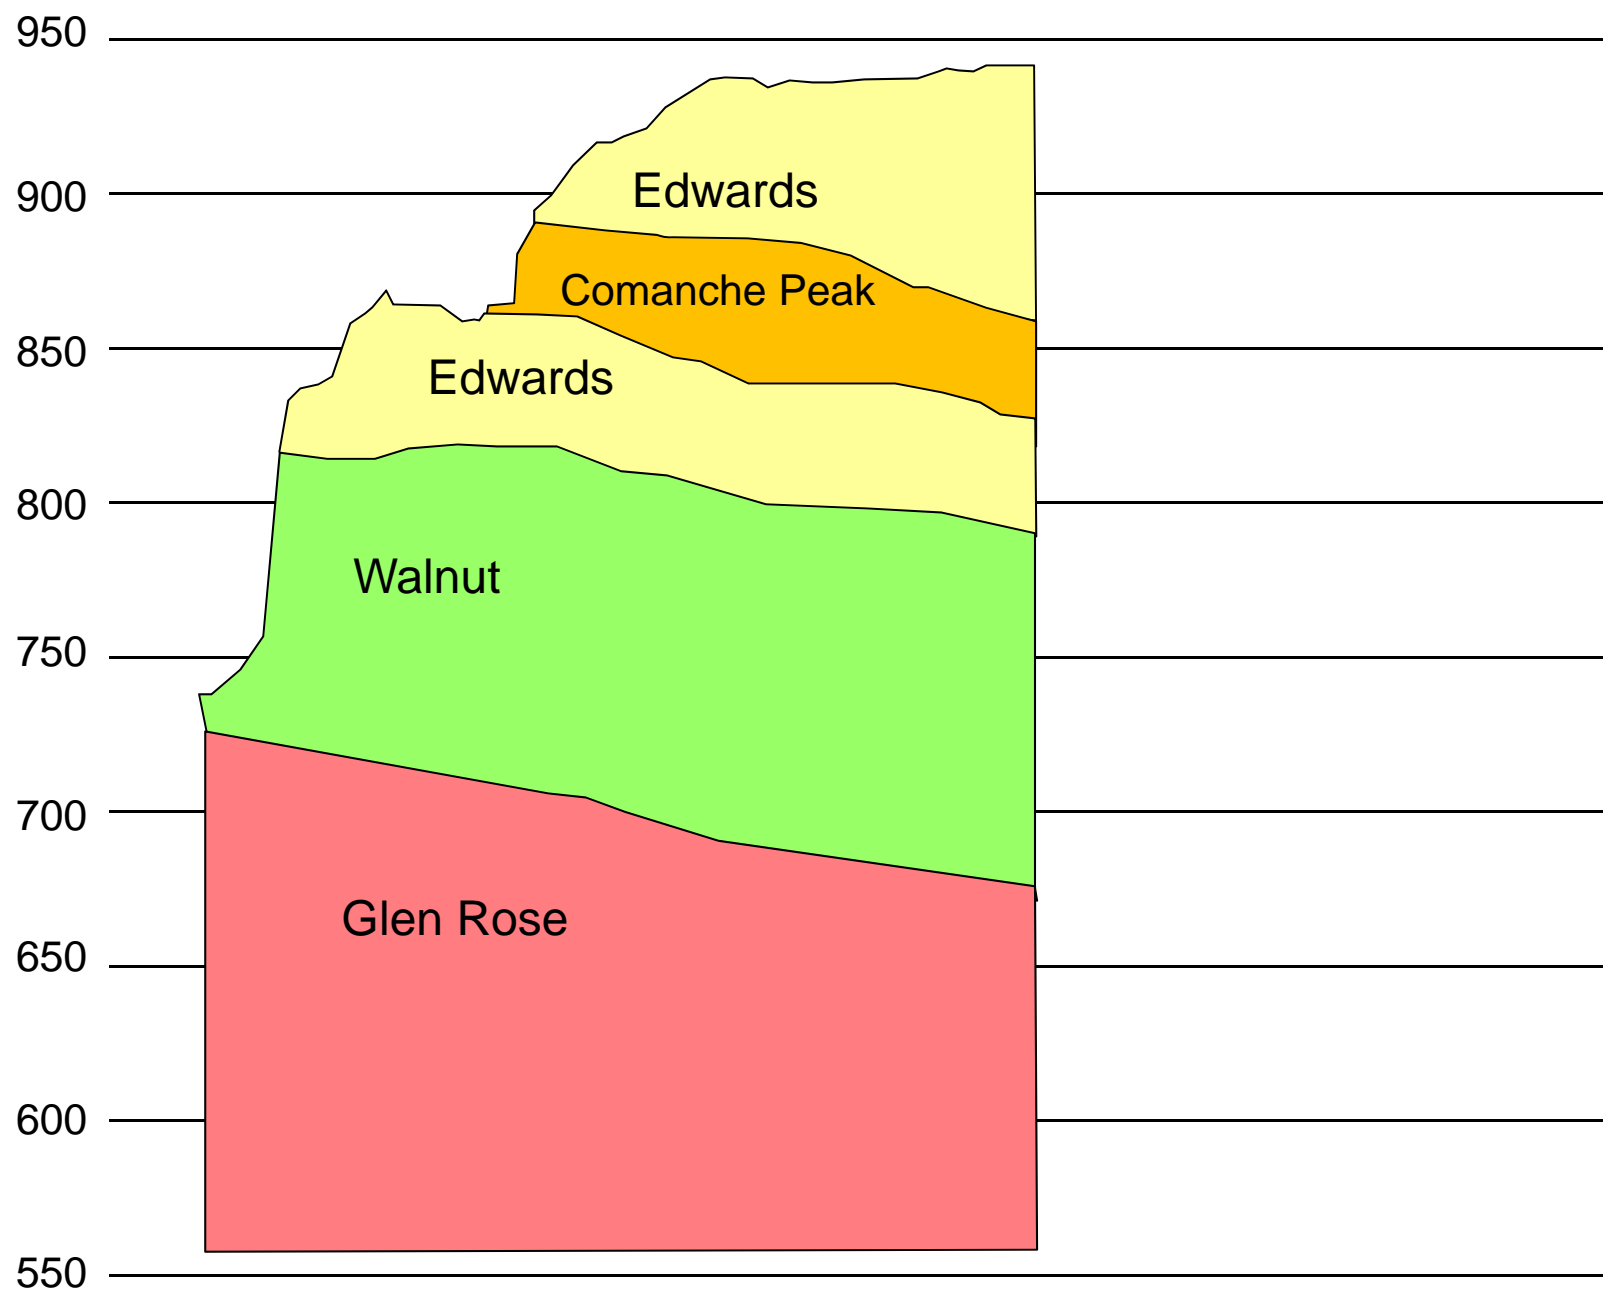
# JT-127 well

Issue	Resolution
Lack of recovery in Four Points monitoring wells	Both wells at Four Points shaft showing signs of recovery at this time.
Possible leaching of di-n-butyl phthalate in grout compound into groundwater	Monitoring for organic compounds proceeding weekly at JT-112 and Gaas Spring. 5 samples so far; none detected.
Shaft water outflow measurements	Meters at Four Points and Jollyville Reservoir now recording daily inflow/outflow. EC working with Project Team to fine-tune recordkeeping in preparation for tunneling operations.
Rapid water level rise in JT128 after storms on 1/25 and 2/18 and modest rise after 3/10 and 3/20 rains	EC working with Project Team to prevent further flooding of well. EC recommending adding water to nearby karst feature to document possible connection to the well. Well will be repaired by licensed driller contracted through B&V.

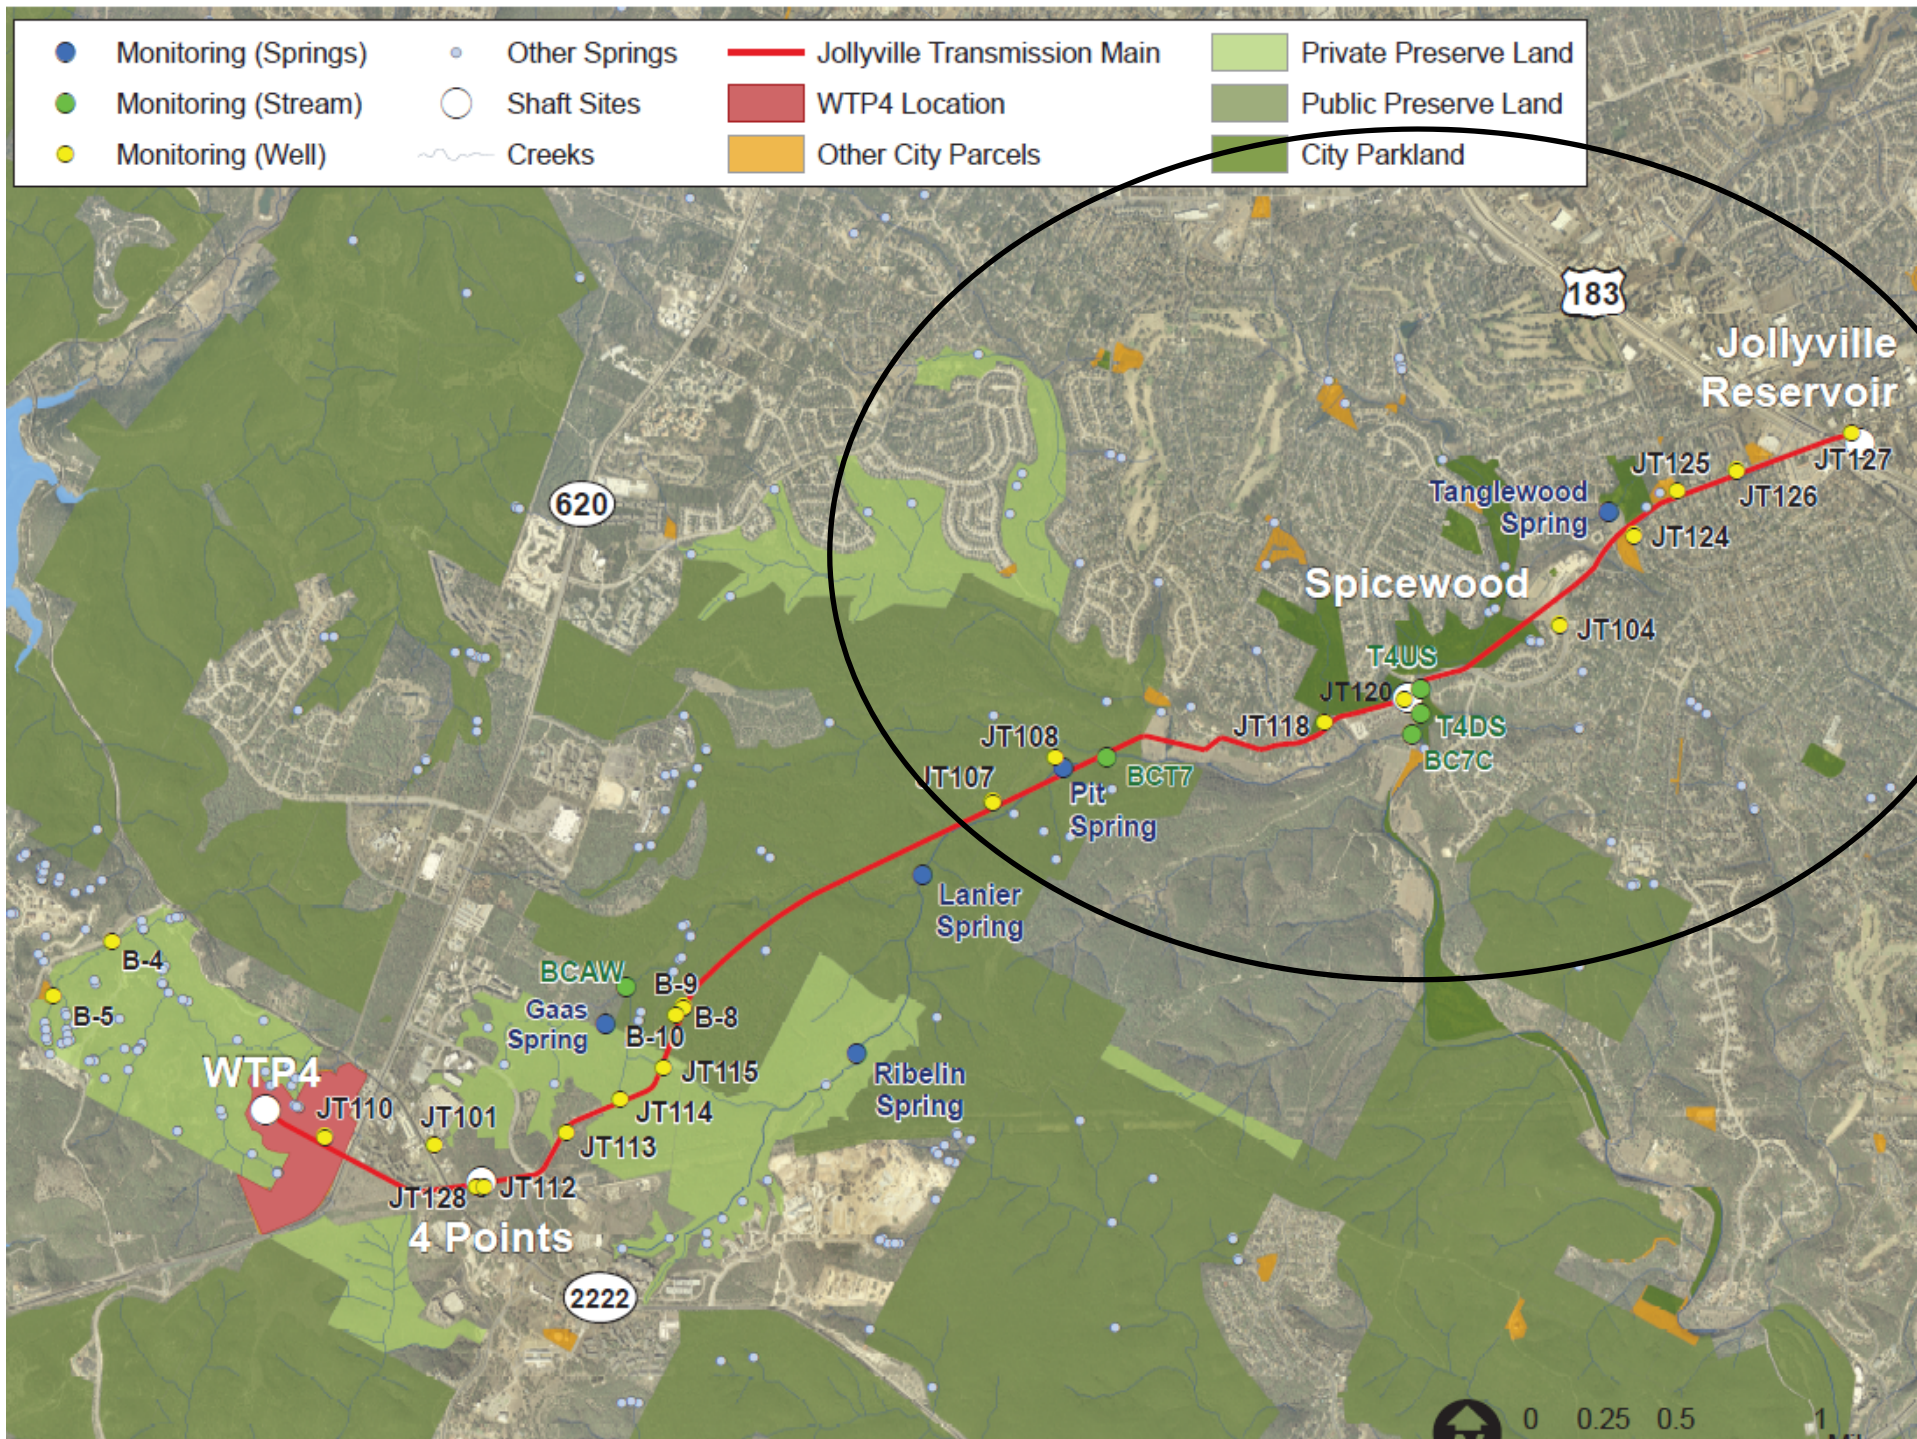
# Hydrographs for Eastern Area

- The water-level recoveries observed in Glen Rose wells JT-125A and JT-126 are not a result of recharge from precipitation events in late 2011 and early 2012 through the Edwards.

- The water-level changes of several feet observed in Glen Rose wells within and immediately east of the BCP could not have transmitted through the Glen Rose to produce the much larger (greater than 20 ft) water-level changes observed in Glen Rose wells JT-125A and JT-126.

- The water-level declines and recoveries observed in Glen Rose wells JT-125A and JT-126 do not indicate greater hydraulic conductivity in the Glen Rose than was measured using packer tests.

- The observed differences in water-level elevation and magnitude of change during 2011 and early 2012 between the Edwards and Glen Rose wells indicate relatively poor hydrologic connection between the Edwards and the Glen Rose.

- The pumping of irrigation wells at golf courses in the vicinity of the eastern end of JVTM appears to be a plausible cause for the water-level declines observed in Glen Rose wells JT-125A and JT-126 in summer 2011 and the subsequent recoveries after pumping cessation.
