HISTORIC LANDMARK COMMISSION
APRIL 22, 2013
CERTIFICATE OF APPROPRIATENESS
LHD-2013-0004
3805 Avenue H
Hyde Park Local Historic District

PROPOSAL

Reroof a contributing house using asphalt dimensional shingles.

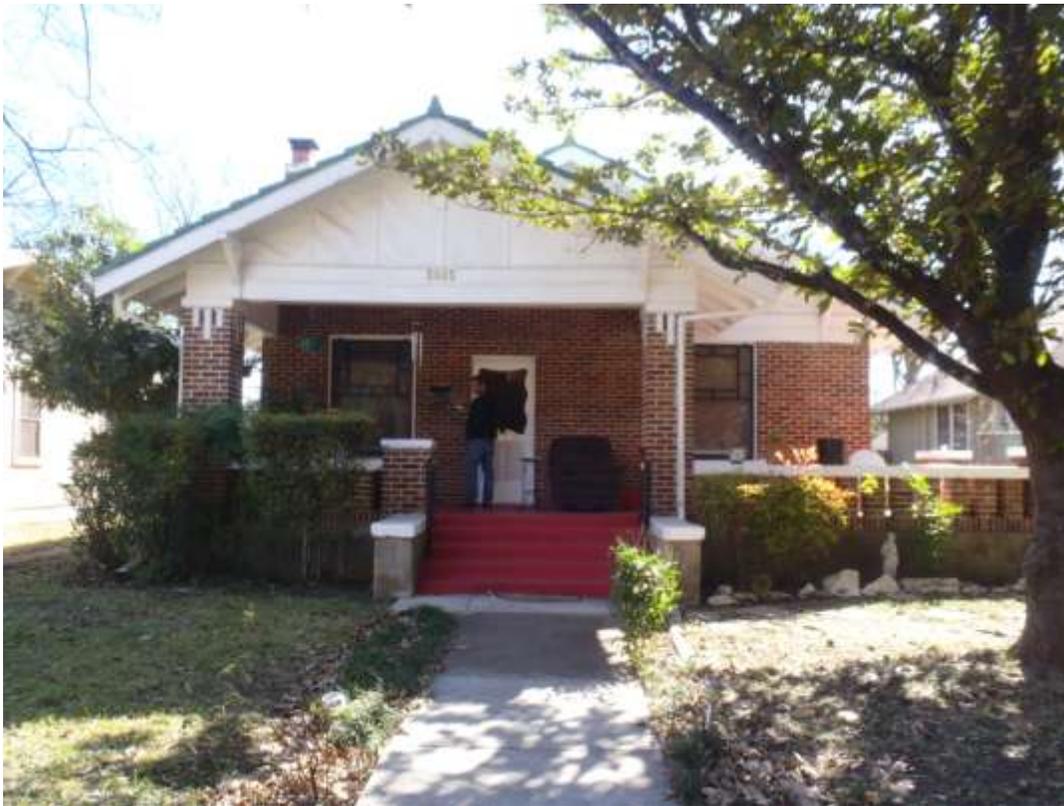
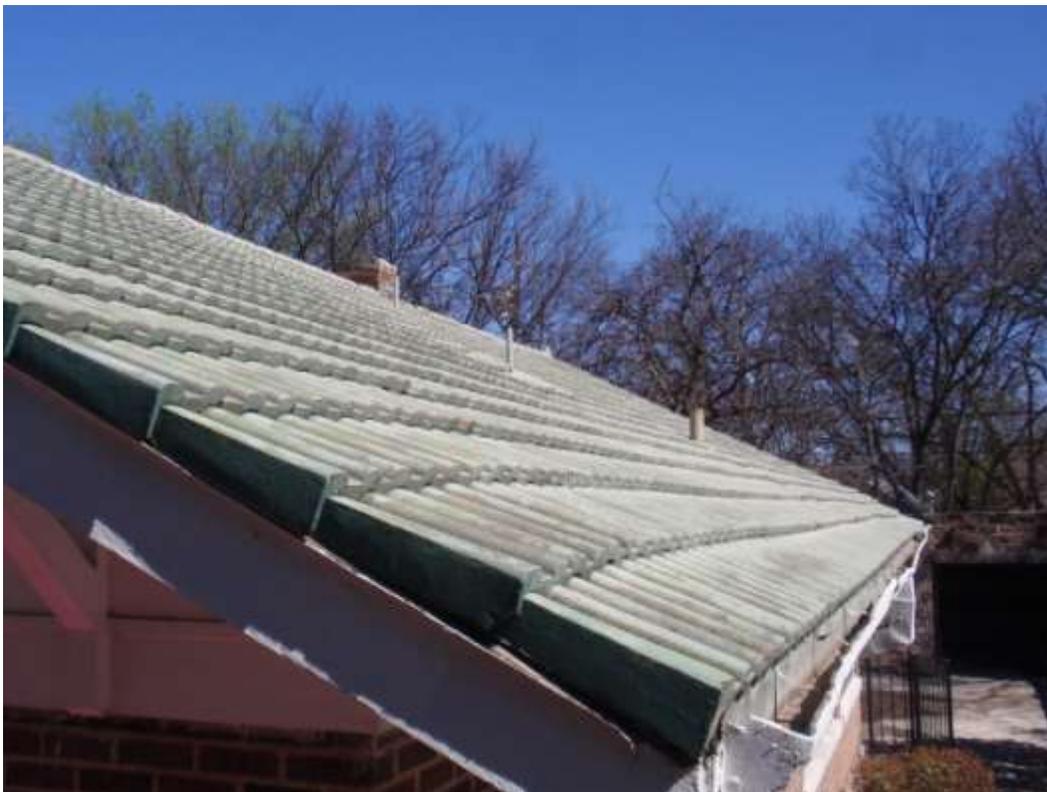
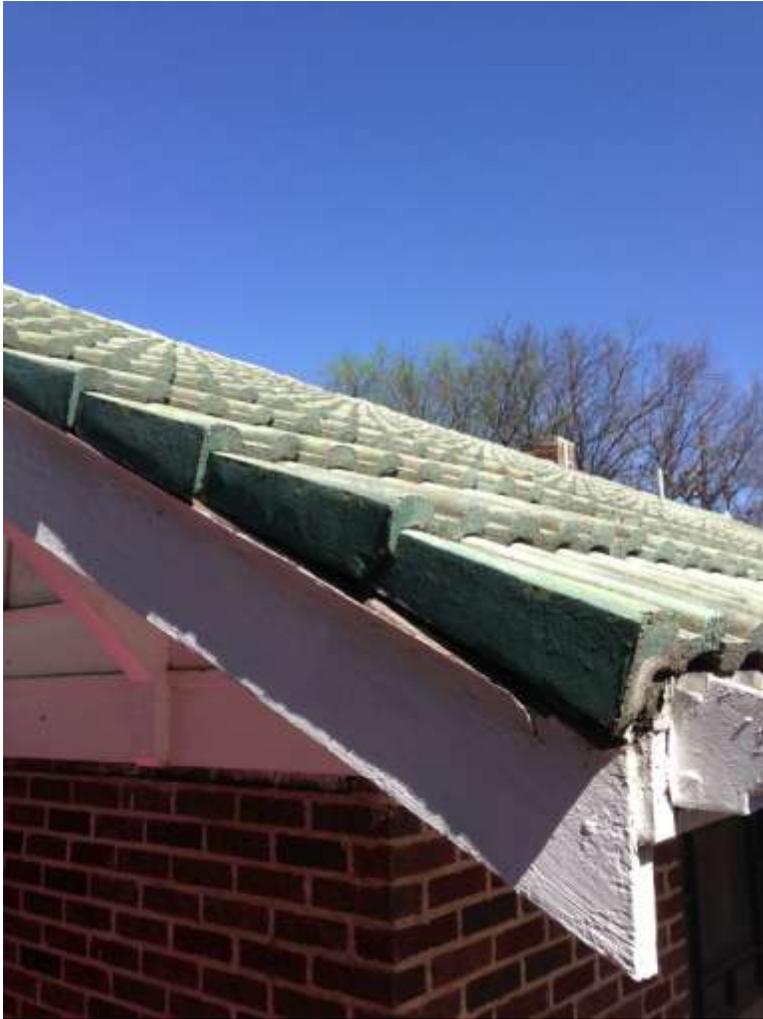
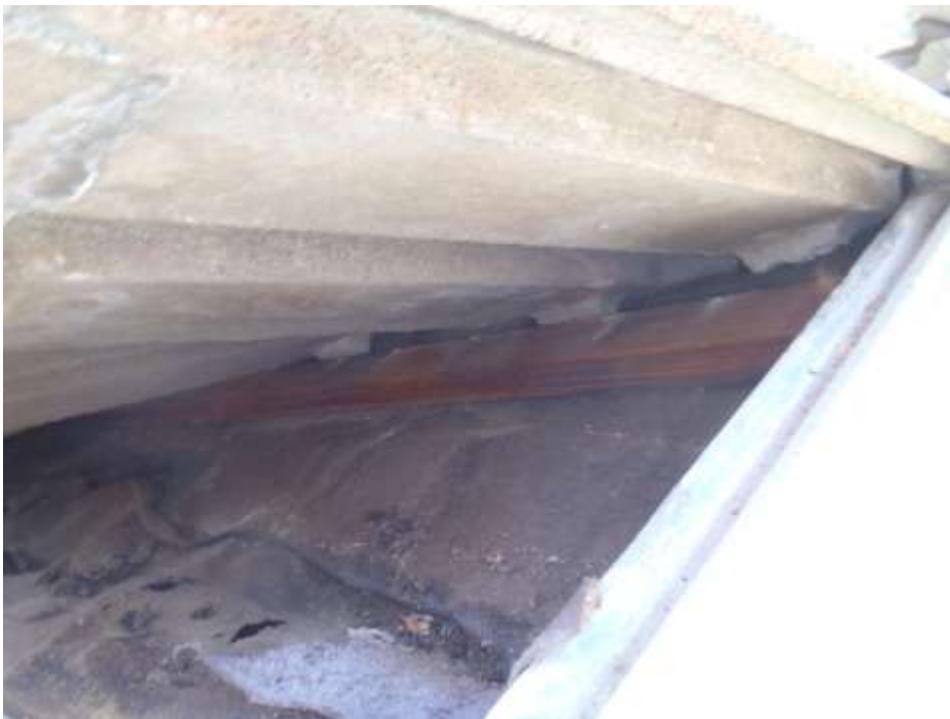
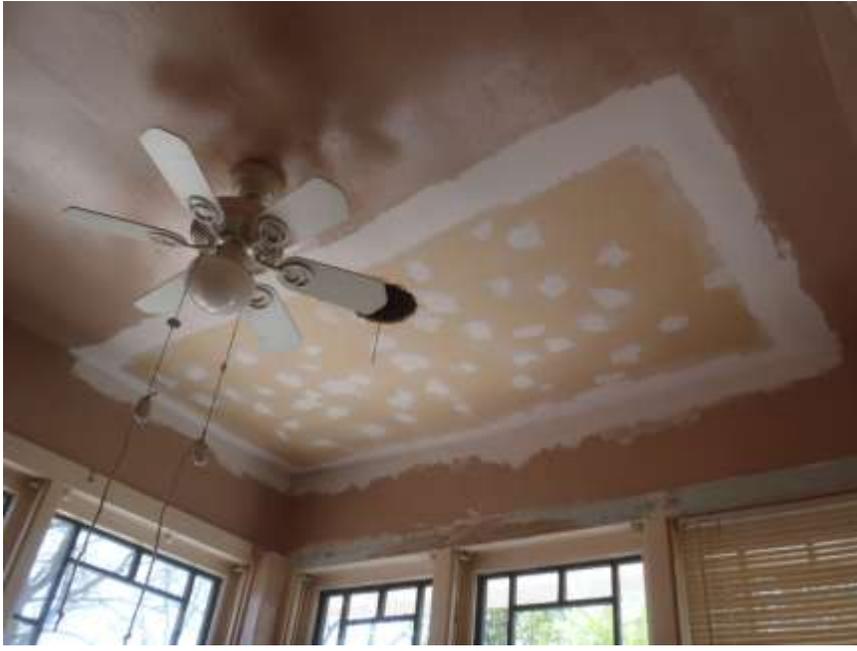
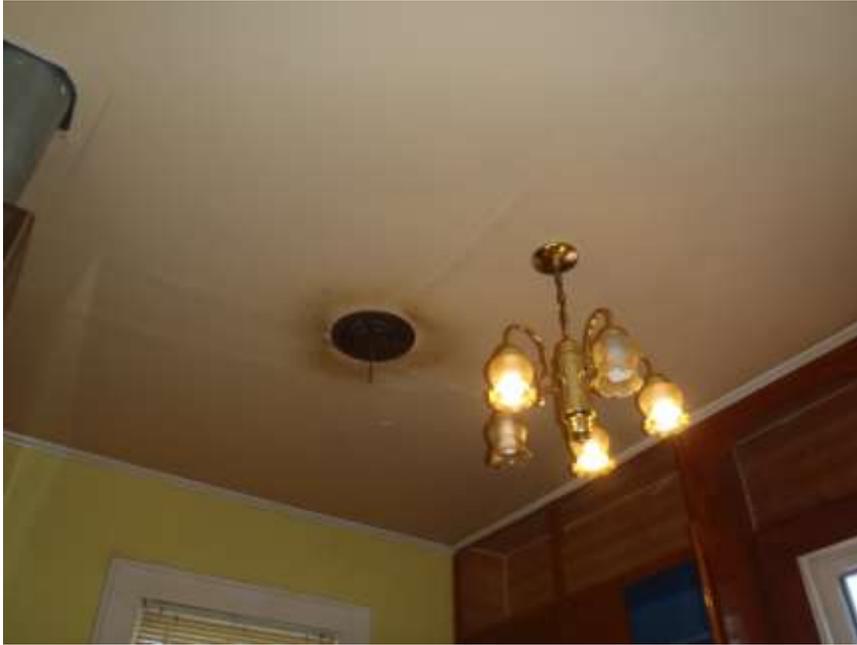
PHOTOS

The applicant proposes to remove the existing concrete tile roof and replace it with asphalt dimensional shingles. The existing concrete tiles are in poor condition with damaged and missing units and lack of integration between the tiles and vertical surfaces. These conditions allow water infiltration, which is impacting interior conditions.
