Application for Certificate of Appropriateness for a City Landmark or Local Historic District

Mayfield Park
Erosion Control &
Wall Stabilization
Plan Overview

Mayfield Park
Erosion Control &
Wall Stabilization
Plan Sketch

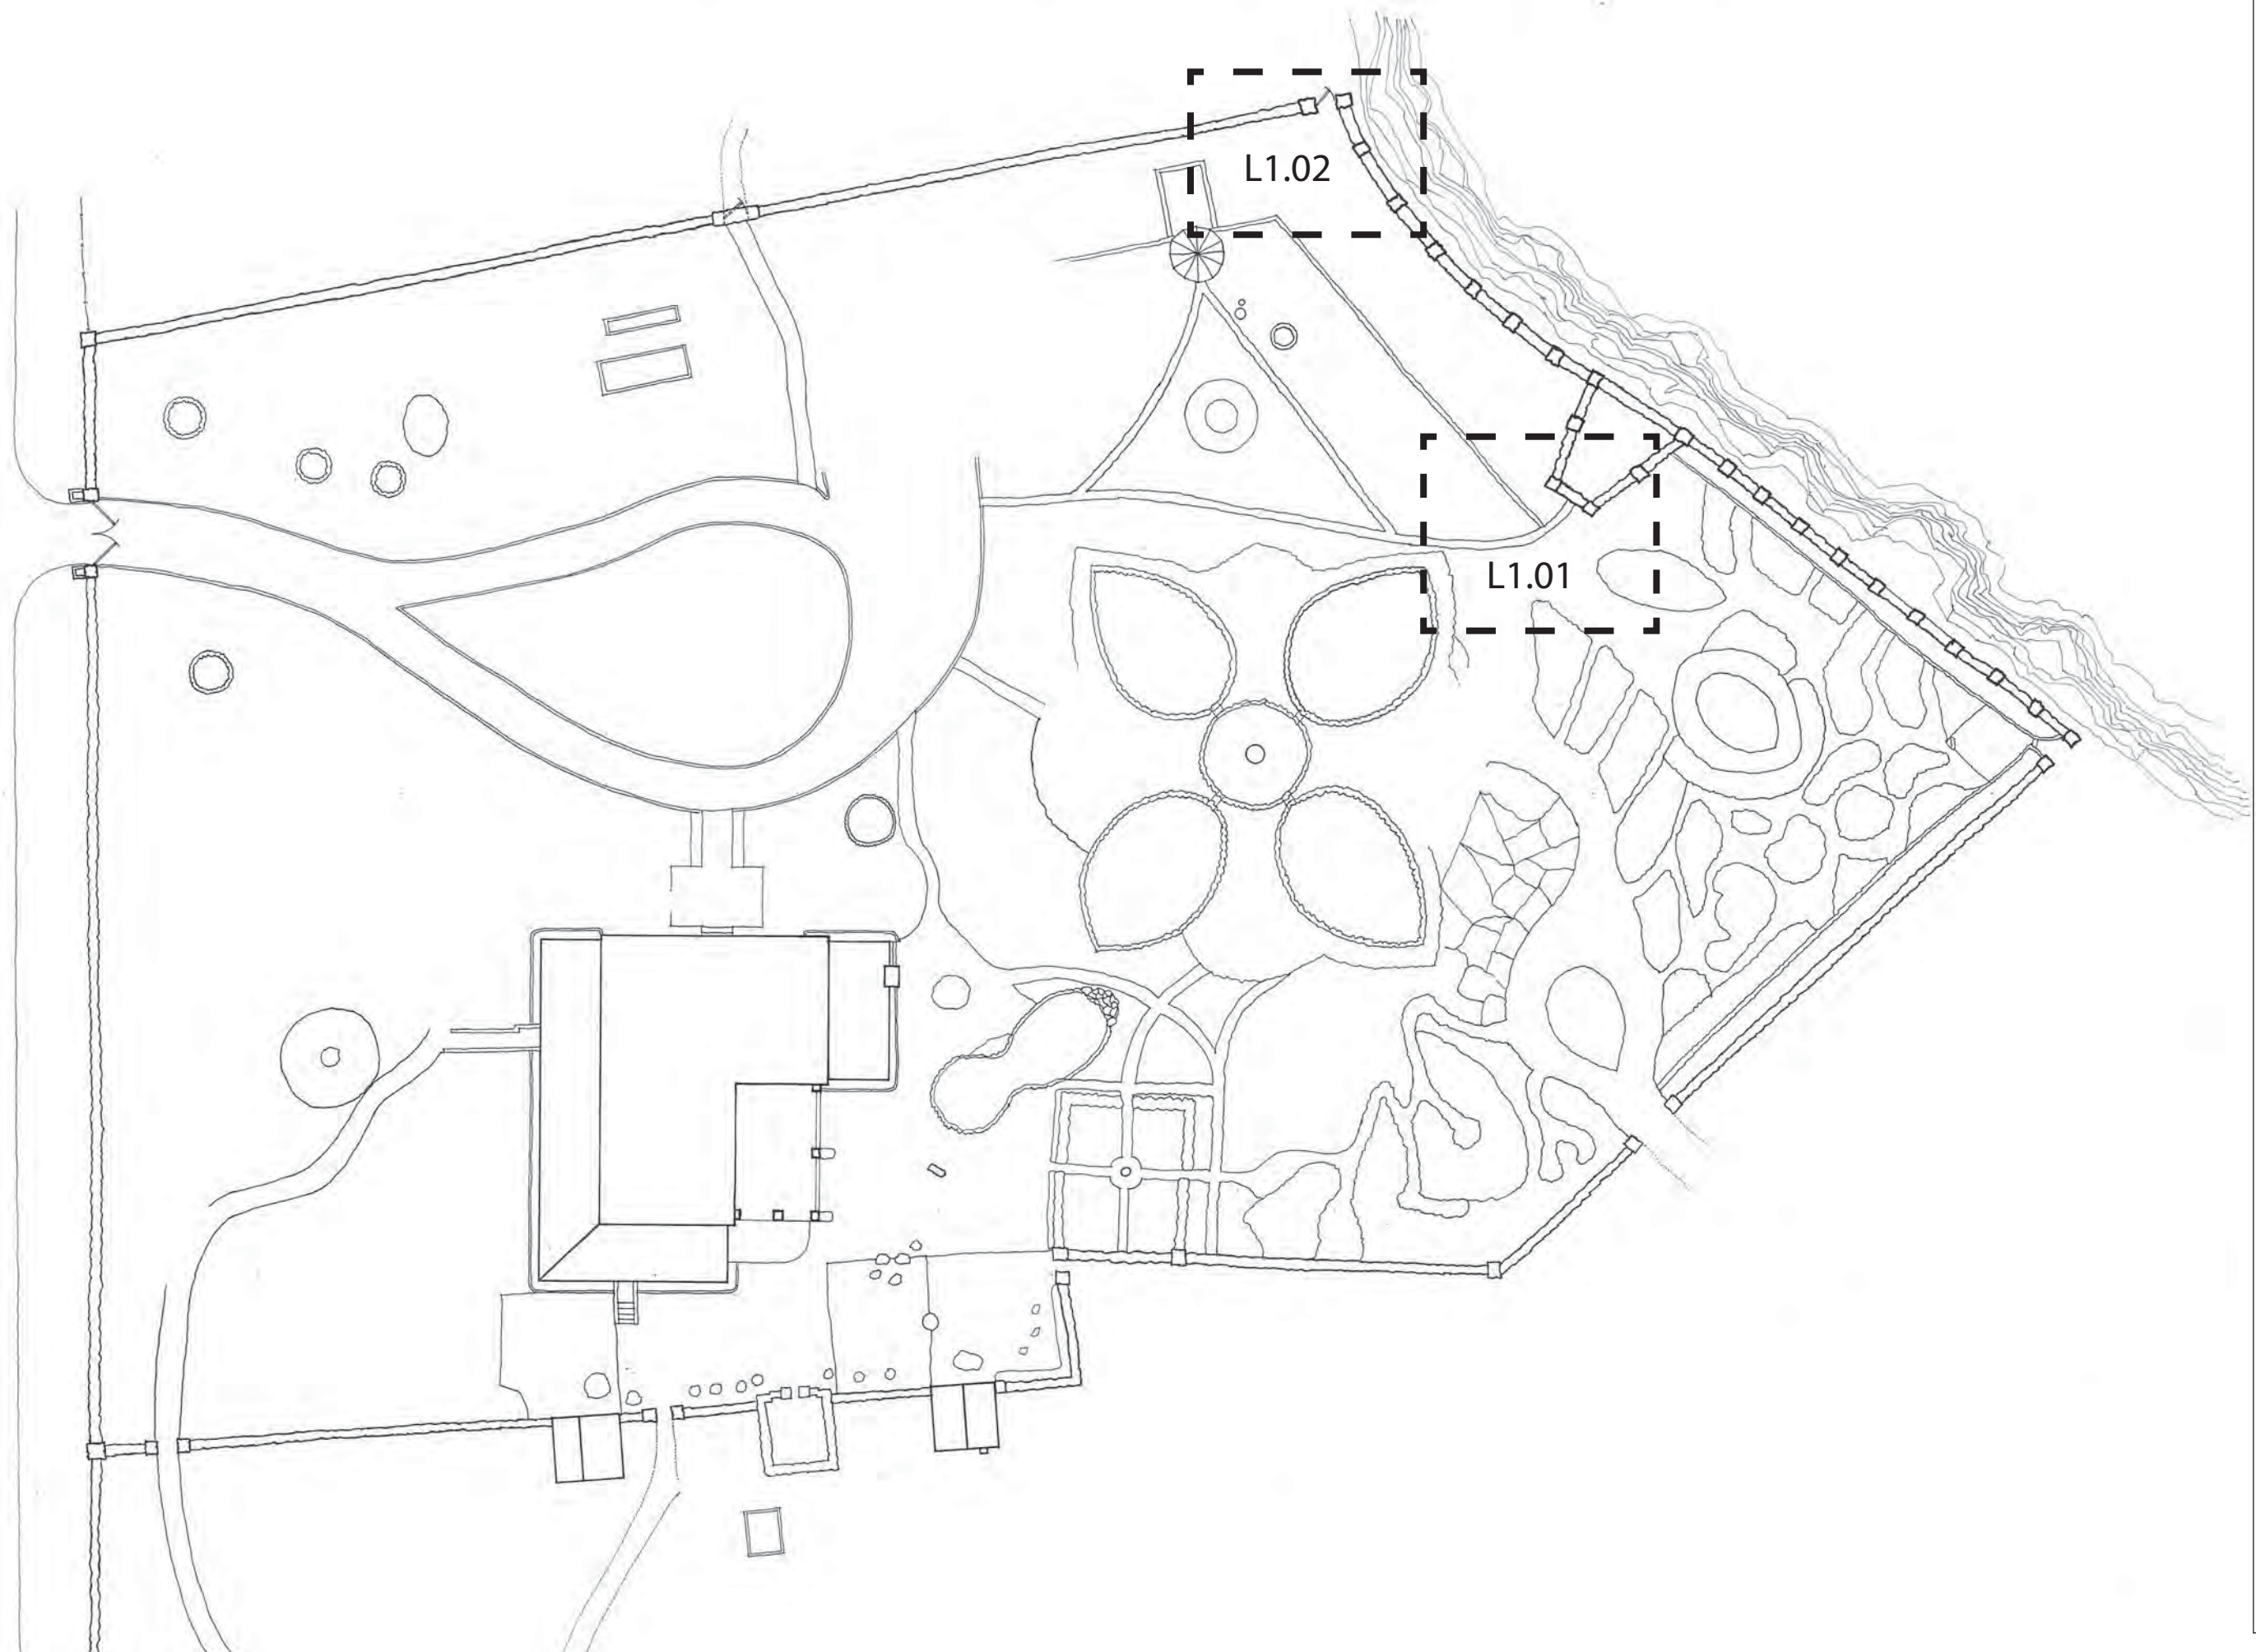
L1.00

Existing wall to be repaired to match historic condition. (approximately 47' of wall at 9"-15" height). Verify extent of work and wall heights in field with Landscape Architect. Contractor to provide stone and mortar samples for Landscapes Architects review prior to installation.

Steel edge step with 6" riser, 1/4" thick plate steel, primed and painted black; stake in place with 15" stakes at 2'-0" o.c. or as needed to secure steel. If tree roots are encountered consult with Landscape Architect for steel layout adjustments prior to installation.

Limestone flagstone stepping stones, 2-3" thick, sawn top and bottom, ranging in dimension from 2'-3'. No pieces smaller than 2' in any dimension. Remove existing field stones to provide for 1" sand setting bed for flagstone. Stone color should be a gray similar to existing stone on site.

Note: Use excavated field stones removed to install flagstone to repair wall.
