Cottonwood Tree Removal at Barton Springs Pool

Joint Committee Notification Ar

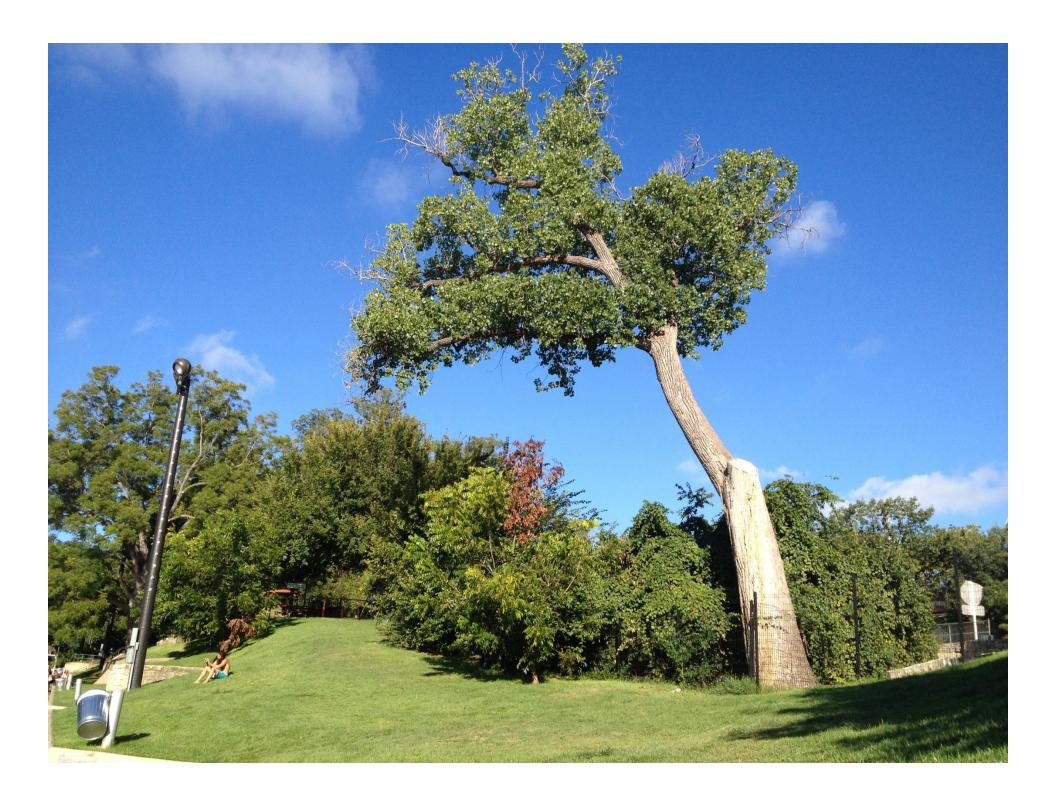
Cottonwood, Populus deltoides

Risk Rating: 8

Size: 48" DBH, 45-60' Height

Age Class: Over-mature

Notes: codom at 30 ft near drainage large shallow roots beyond

Root Summary: good ratio near trunk, fair@dripline, bigger roots near dripline

Soil/Foliage Summary: sandy & clay; minor dieback in crown

Radar Summary: Lowest percent average solid wood: 49% at 1 foot,

overall average Mattheck score: 0.638

- Tree scheduled for removal in 2015 as part of Eliza Springs project
- This is a declining over-mature tree whose condition has deteriorated rapidly over the last 5 years
- Removal options will be limited as tree continues to deteriorate
- Removal is recommended and chosen option

Maintenance Recommendation: Prune – Crown Clean, possible removal.
