**HISTORIC LANDMARK COMMISSION  
JANUARY 25, 2016  
DEMOLITION AND RELOCATION PERMITS  
HDP-2015-1037  
3108 GRANDVIEW STREET**

Re: 3108 Grandview / TK # 15215

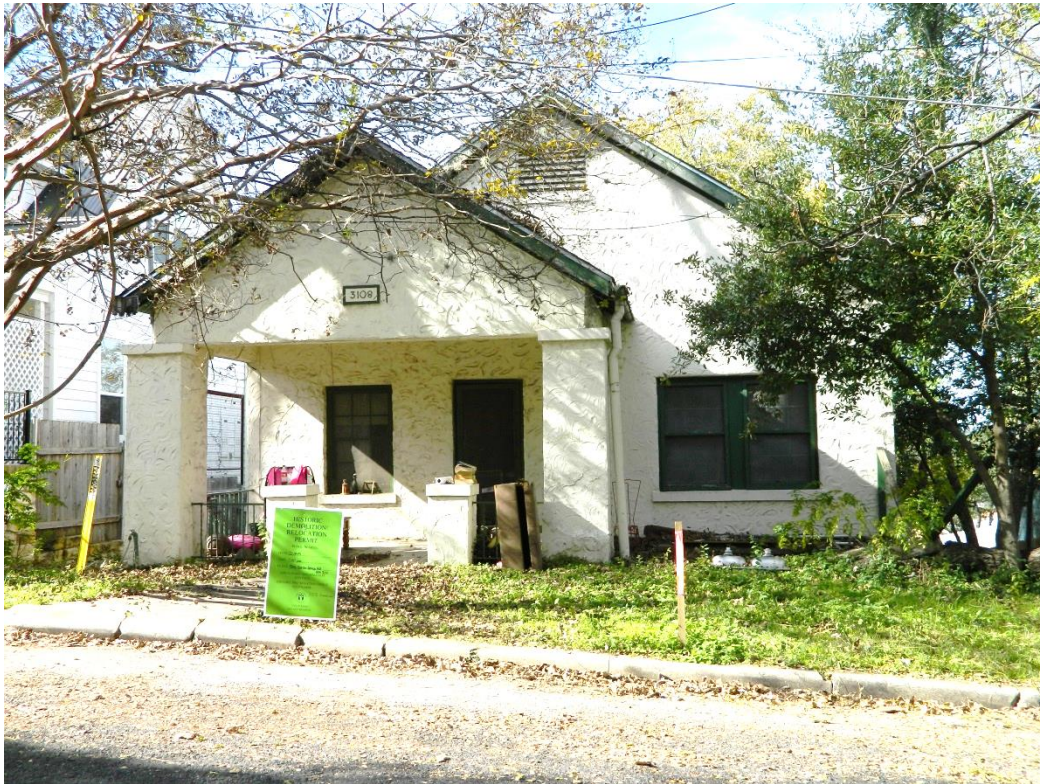
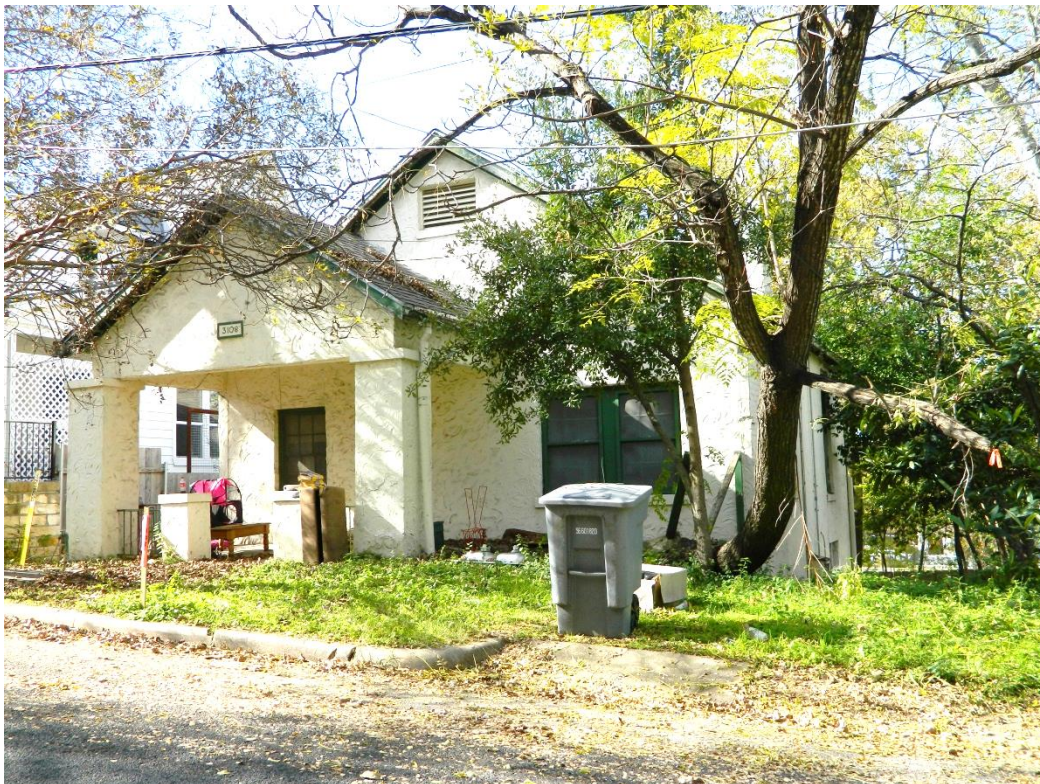
Details of the palm-plastered exterior of the house

The exterior wall finish is a cement based stucco with numerous cracks which have allowed water to infiltrate the perimeter walls. The presence of mold growth within the exterior walls is high.
