Table of Contents for Carpenter Hall Site Plan
Heritage Tree Variance Package

ITEM FOR ENVIRONMENTAL COMMISSION AGENDA

SITE PLAN #: SP-2016-0073

Tree Risk Assessment Report

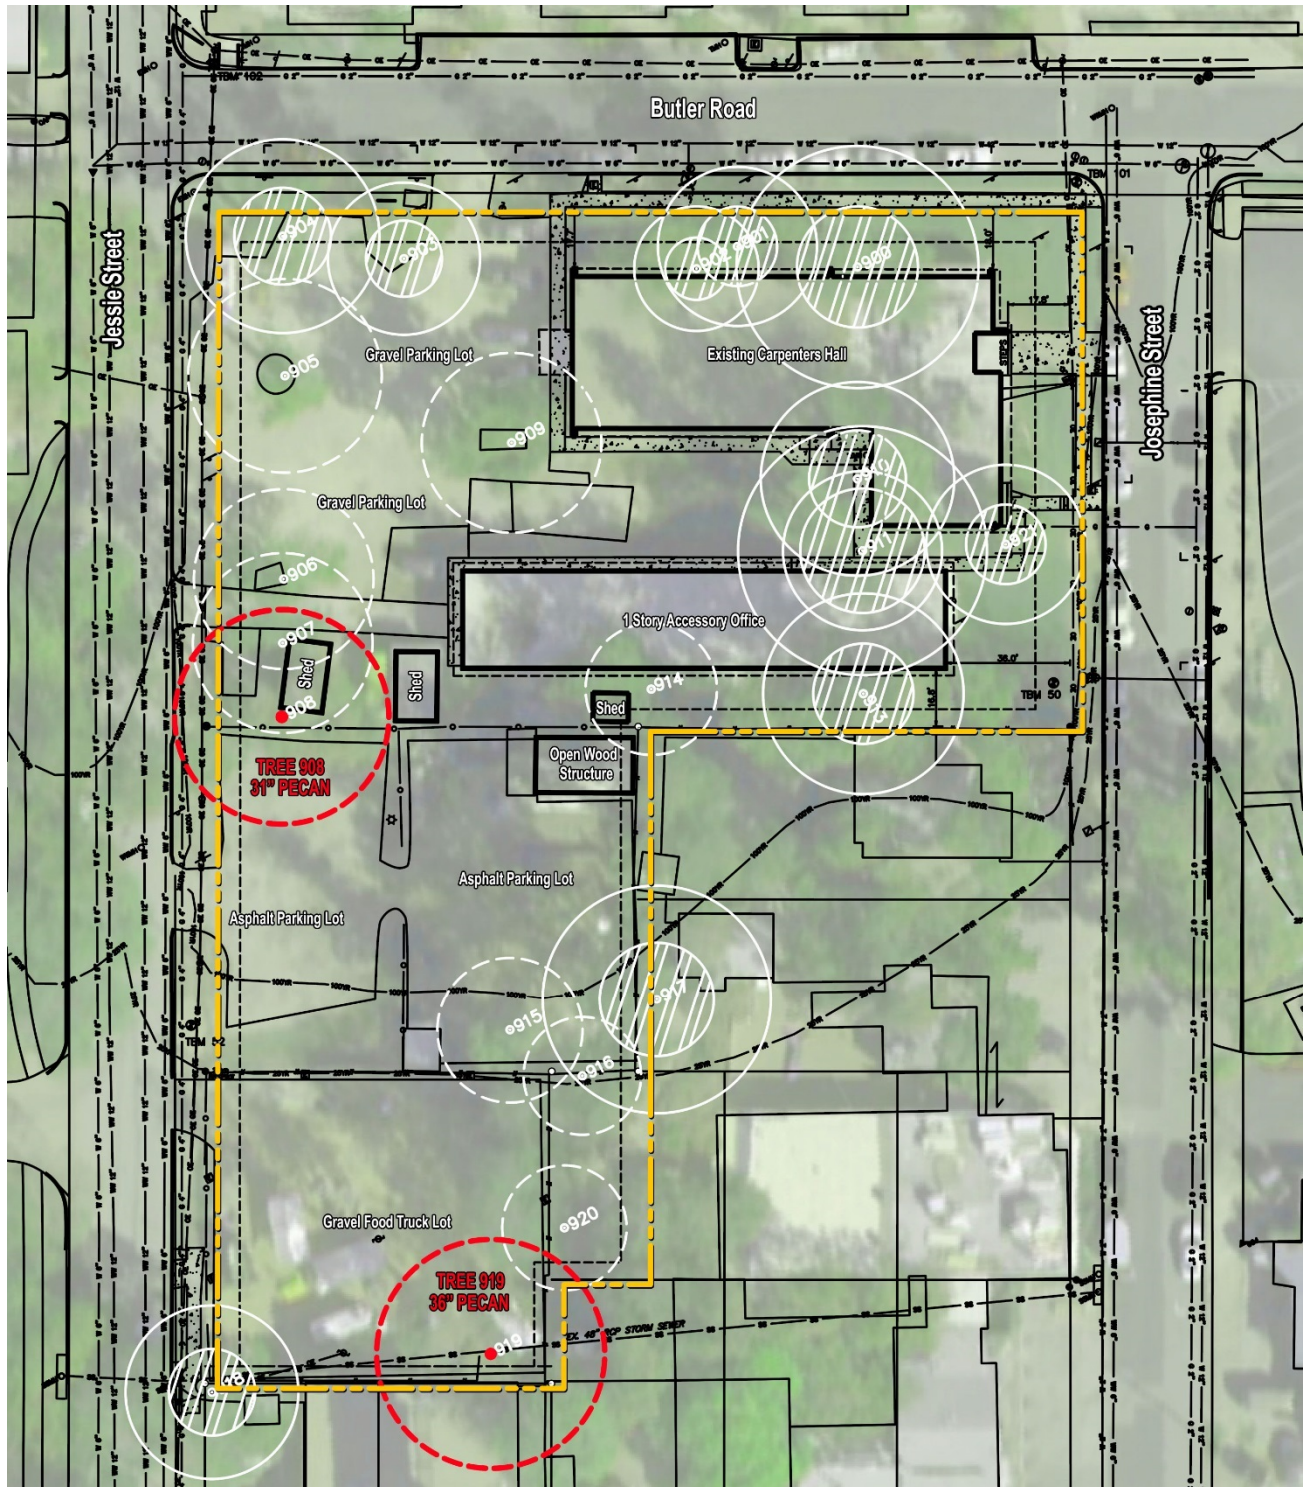
EXHIBIT A EXISTING CONDITIONS

There are currently two heritage trees on the site being requested for removal, (1) 31" Pecan and (1) 36" Pecan (EXHIBIT A).

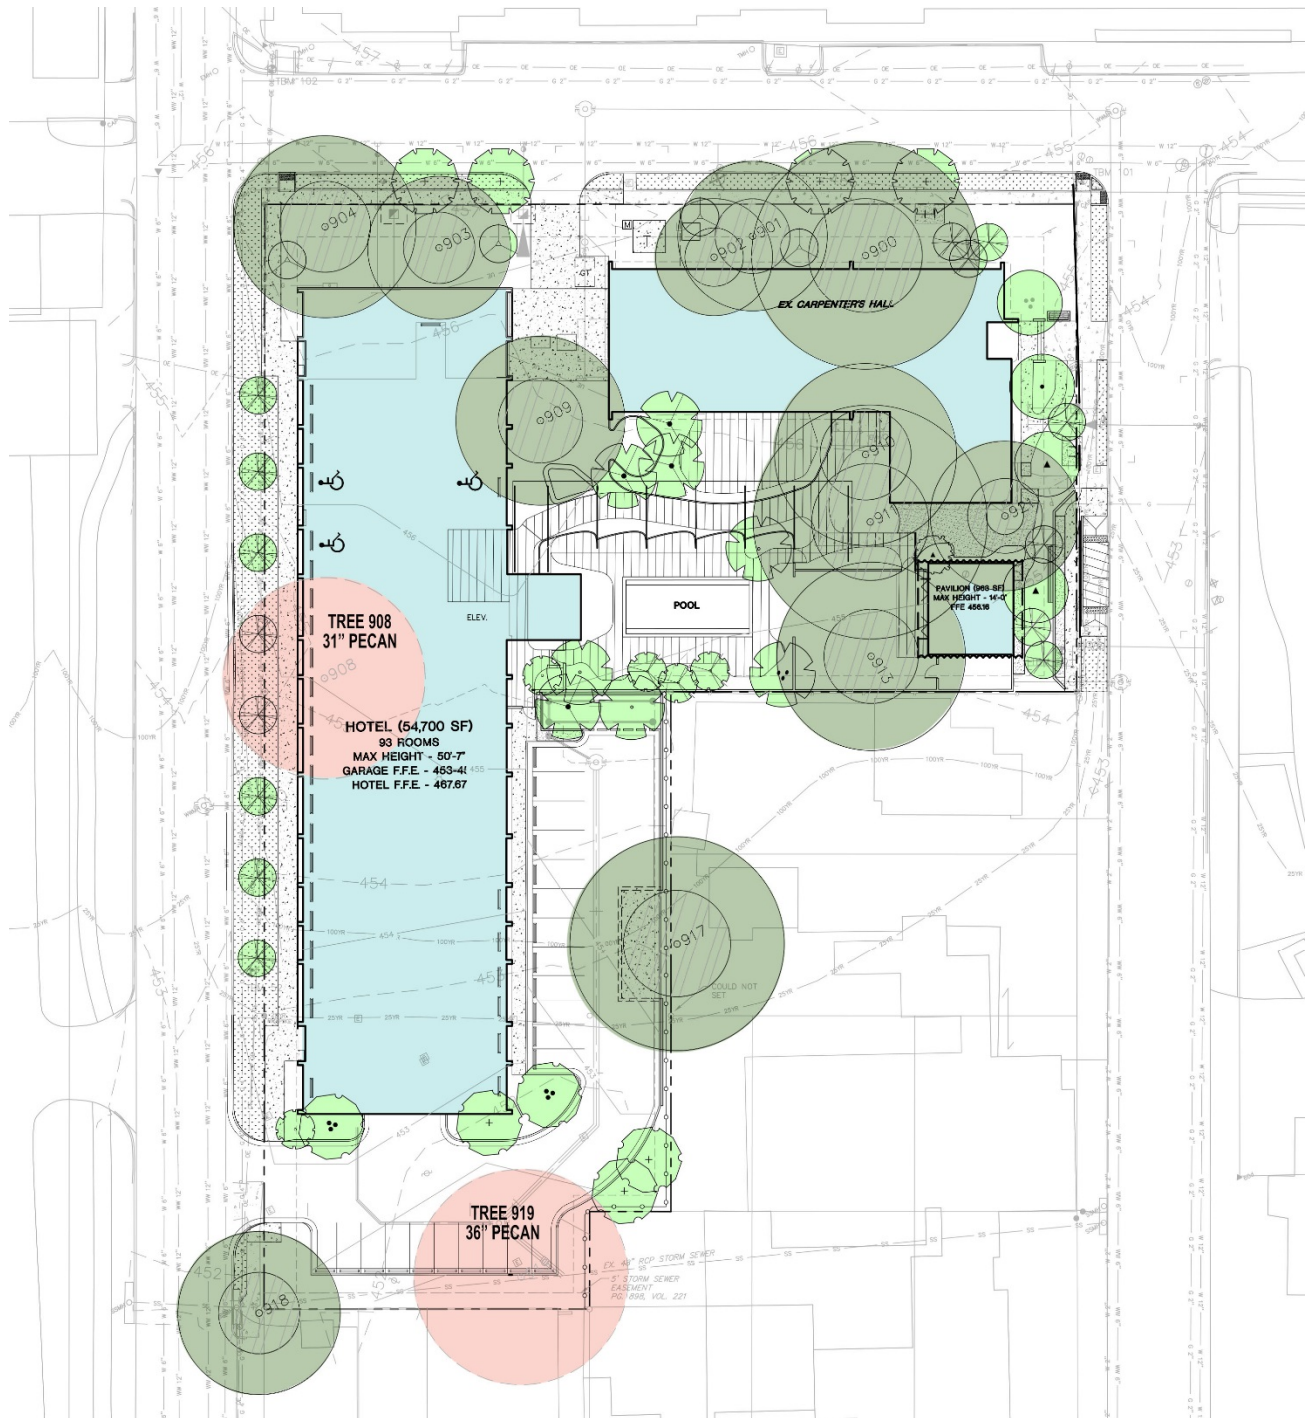
EXHIBIT B PRELIMINARY SITE PLAN

Tree 919, a 36" Pecan, depicted on (EXHIBIT B), is being requested for removal based on the condition of the tree, and its potential risk of causing personal injury, property damage, or both.
