Table of Contents for Block 36 Site Plan
Heritage Tree Variance Package

SITE PLAN #: SP-2018-0015C

SITE PLAN: Block 36 (SP-2018-0015C)

REQUEST: The applicant is requesting to remove two heritage trees, each with a single-stem greater than 30 inches as allowed under LDC 25-8-643

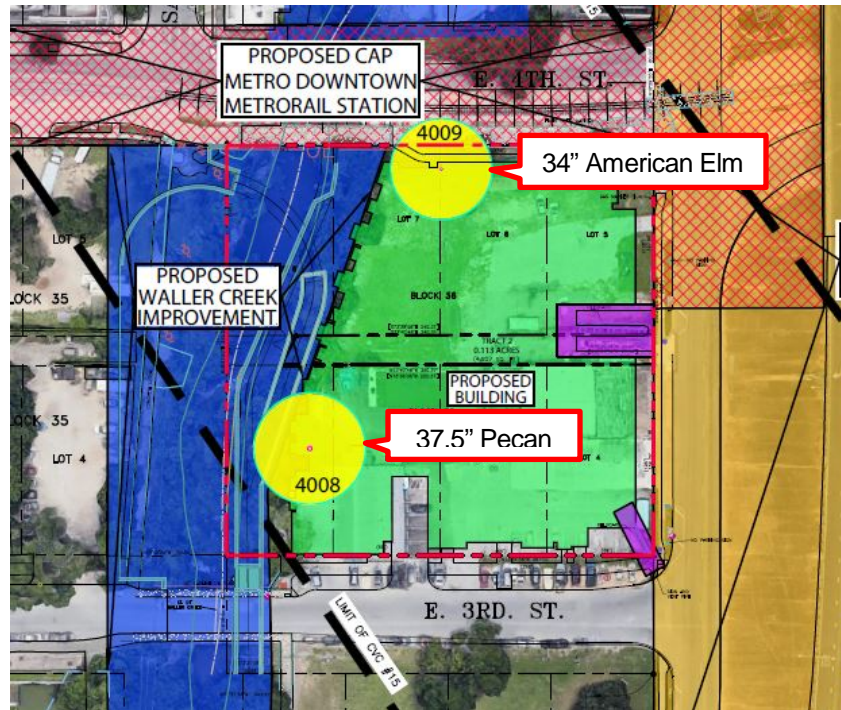
EXHIBIT A: Site Constraints Exhibit with 37.5" Pecan and 34" American Elm Tree Locations

REQUEST: There are two heritage trees on the site that are being requested for removal: a 37.5" Pecan located at the southwestern corner of the property, and a 34" American Elm located along the northern edge of the property along East 4th Street. See Exhibit A for tree locations.
