703 Oakland Avenue

Inspection Report : Exterior Walls

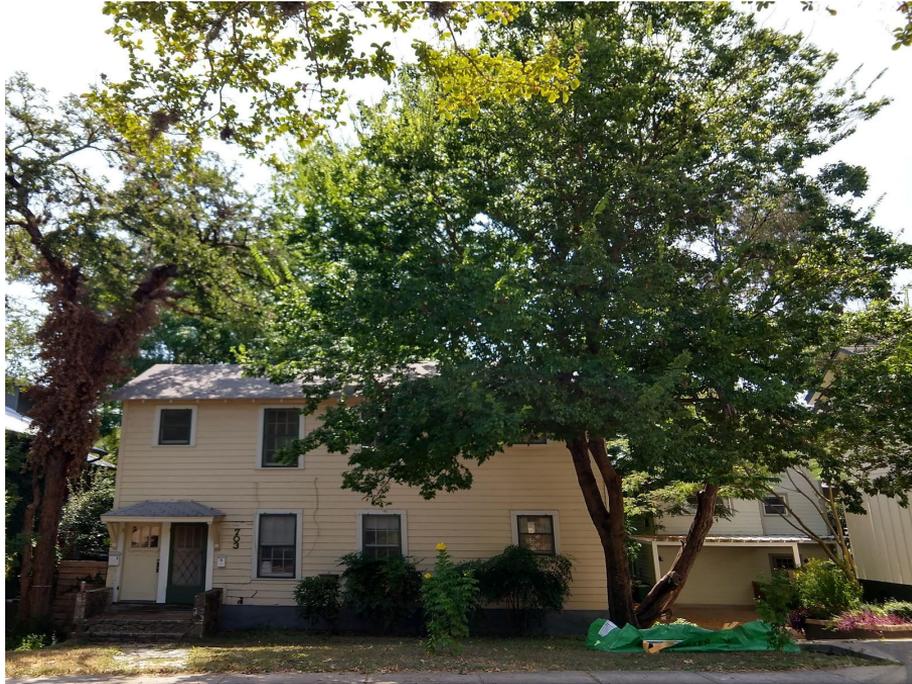
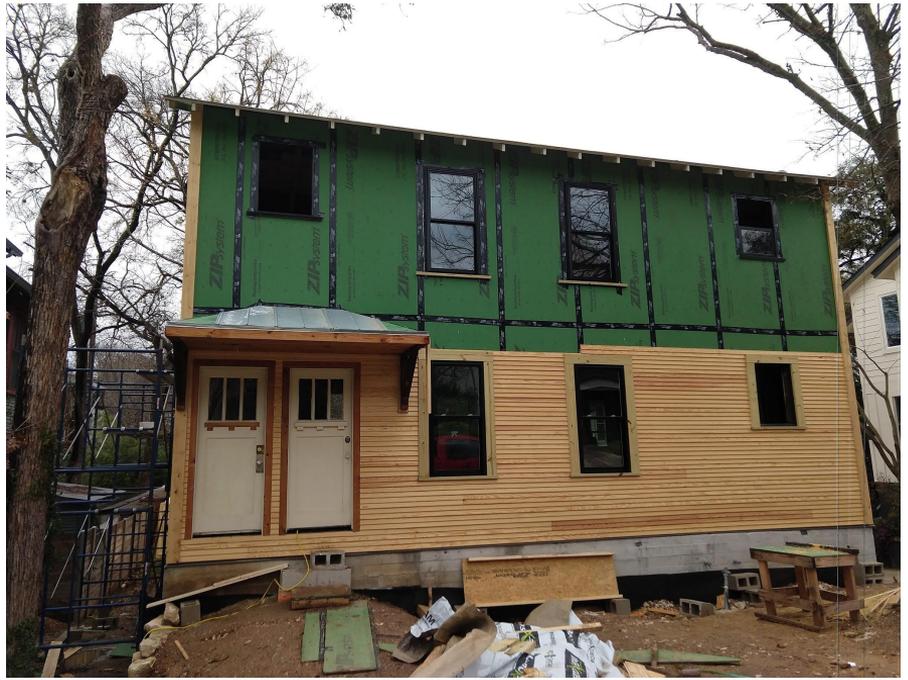
Deficient: Significant and detrimental water damage observed at wall assemblies. Condition is most severe at east wall and "garage" transition. Other locations included around all wall openings (doors, windows, etc.). As repairs are conducted, additional areas are expected to be discovered. The water damage is correlated with deferred maintenance, missing flashing and weatherization details and poor construction practices. **If ignored, condition will progress.**

(3) **Deficient:** End-of-life conditions observed at siding veneer. Defects included: wood rot, deterioration, water damage, loose boards, damaged boards.

Installed flashing and water barrier (zip board)
for long term preservation.

Replaced window molding with pressure-treated wood
for long term preservation but maintaining same
architectural
design from 1938.

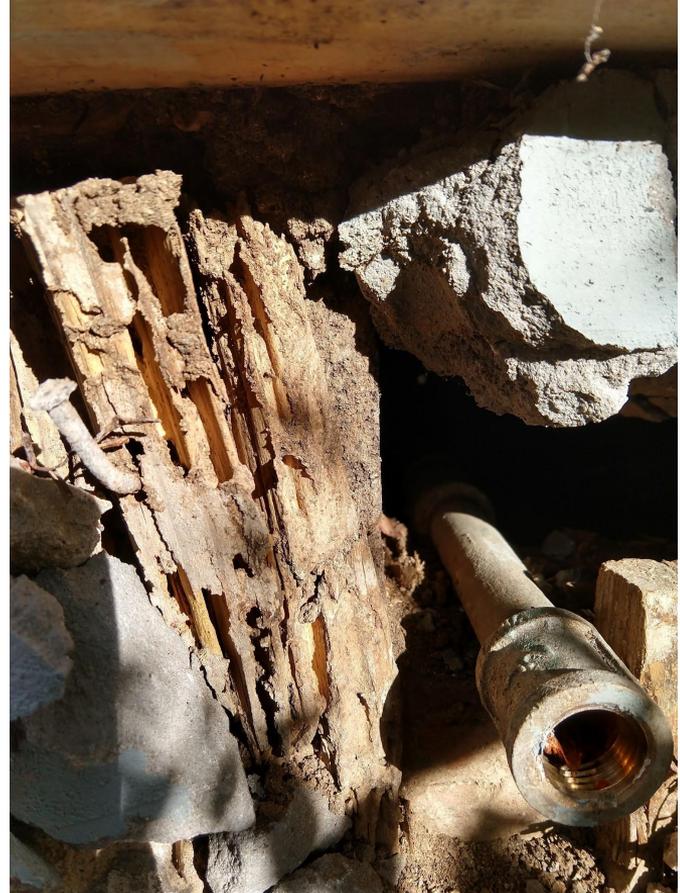
8G. Visible evidence of active sub-termites has been observed in the following areas: various areas under structure.

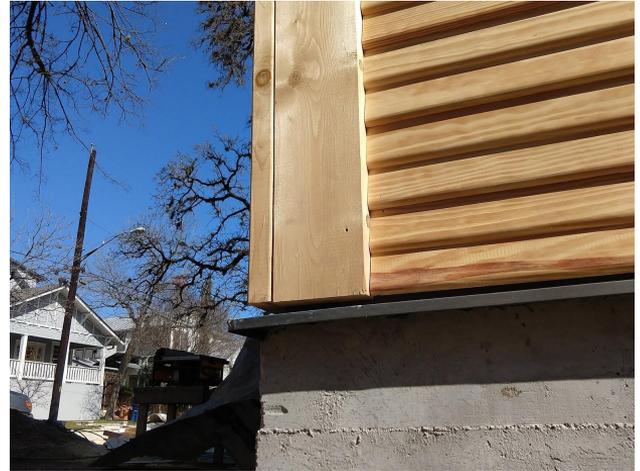
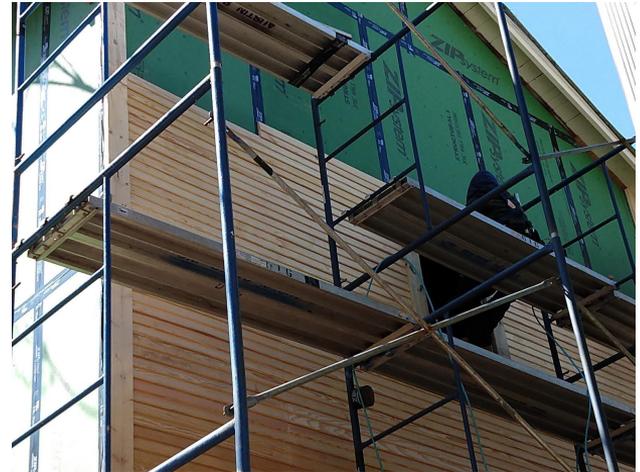
Deficient: The windows are in over-all very poor condition. The majority of windows observed with water penetrations issues, air infiltration issues, deteriorated glazing, cracked panes and damaged/missing counter balance springs, impeded egress (can not escape during emergency - windows do not open).

1. Did not enlarge or relocate any window openings with the exception two rear kitchen windows (south wall - facing backyard)
2. Retained and repaired all possible historic windows by mixing and matching components which were salvageable.
3. For necessary replacement of historic windows, used windows that are the same size and match the dimensions, profile, and configuration of historic windows
4. Substituted materials are appropriate to the profile and finish appearance of the historic window.
5. Replacement windows were installed so that they maintain the same planar relationships and joint patterns as existed historically relative to window frames, exterior wall planes, and other exterior features.

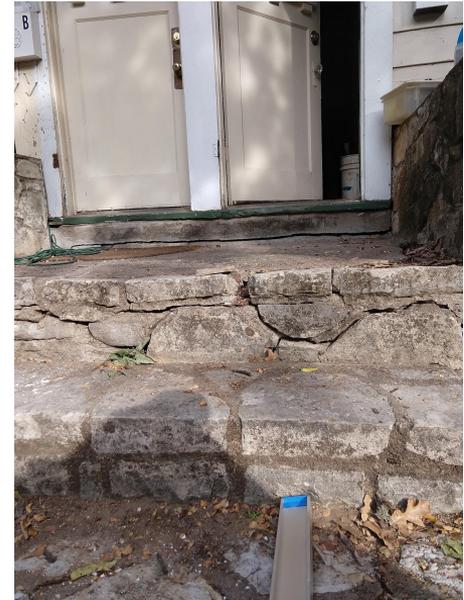
(1) **Deficient:** Porch shows cracking, loose stones, out-of-level appearance, in-adequate riser and tread dimensions.

Kept all historical stones to rebuild a safe and code compliant set of stairs leading to front doors. Remaining stones can be used for landscaping around front of house. Stairs must be code-compliant.

Requesting that the stairs be built for the safety of an 87 year-old man with wider threads for a walker, all risers the same height and no tripping hazard.
