PROPERTY INSPECTION REPORT

703 & 705 Oakland Avenue, Austin, TX 78703

By: Nathan W. Vick (TREC#20219), Professional Inspector, TREC #20219, 5/12/2019

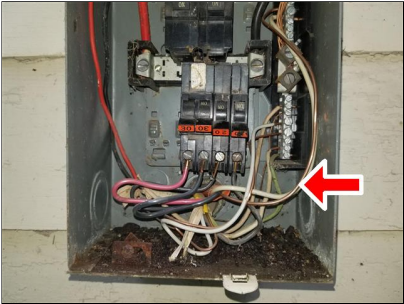
A. Item 4(Picture)

**Deficient:** Electrical Panels are in very poor condition. Defects included: FPE Panel present (known fire hazard), old fuse boxes (known fire hazard), rusted enclosures, no ground electrode observed, no bond conductor observed, no labeling, wire size/breaker size, missing breaker cover plates, missing conduit. Current adverse conditions at electrical panels represent fire and shock hazards.

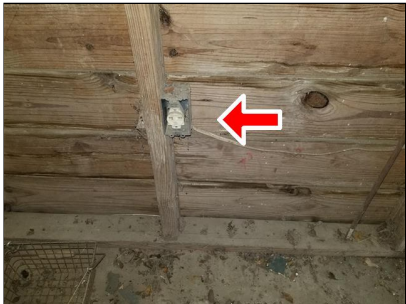
B. Item 2(Picture)

**Deficient:** Electrical wiring is in very poor condition. Defects included: exposed splices, exposed wires, unsecured wires, open ground (majority of outlets and fixtures), reversed polarity, under-sized wires, damaged face plates, missing face plates, non-functional fixtures, non-functional outlets, non-functional

switches, in-adequate number of outlets, arching at outlets, missing exterior rated outlet and switch covers, missing/defective smoke detectors, missing GFCI protection, and missing AFCI protection. Current adverse conditions at electrical branch circuits (connected devices and fixtures) represent fire and shock hazards.

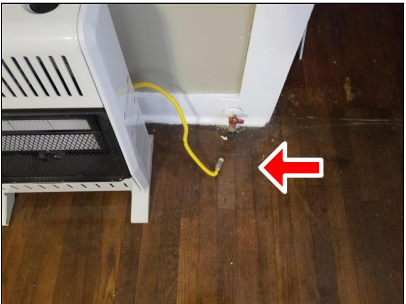
A. Item 1(Picture)

**Notes:** Gas lines were dis-connected time of inspection. Gas heaters were not inspected or tested.

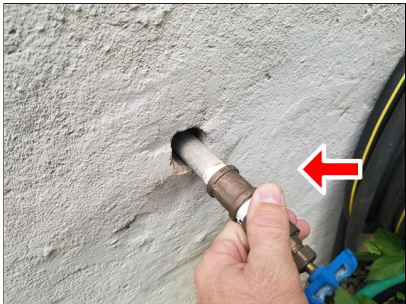
A. Item 2(Picture)

**Deficient:** Water supply systems and fixtures are in very poor condition. Defects included: rusted old galvanized steel piping, leaking old galvanized steel piping, very weak water flow at plumbing fixtures (trickle - upper unit), unprotected pipes at crawlspace, un-secured pipes at crawlspace, leaks at pipe joints and connections at crawlspace, leaks at fixtures, poorly functioning fixtures, loose toilets, rusted steel sinks, high water pressure, missing cut-off valves, rusted cut-off valves, missing Pressure Regulating Valve, missing Back-flow Preventer, missing anti-siphon valves, missing main shut-off valve.

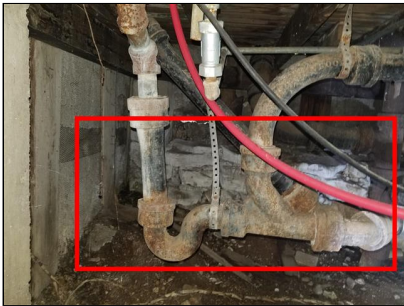
B. Item 1(Picture)

**Deficient:** Drains, waste and vents in very poor condition. Defects included: rusted old cast iron piping/joints/connections/fittings, leaks at old cast iron piping/joints/connections/fittings, unable to test upper unit

drain function due to poor water flow, unable to inspect vents due to inaccessible attic space, flex-drain pipes.

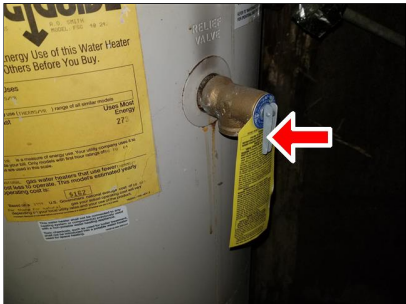
C. Item 2(Picture)

(1) **Deficient:** Upper unit water heater is in very poor condition. Defects included: leakage, diaphragm has likely failed, excess rust formation observed at multiple locations at water heater (flue, tank, connections/fittings), anode rod is fully deteriorated, missing T&P drain pipe, missing Thermal Expansion Tank.

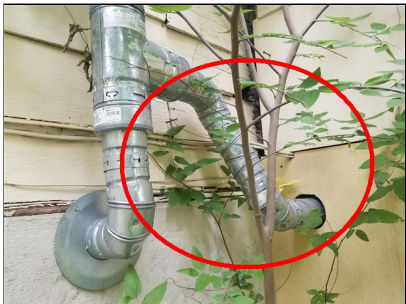
C. Item 5(Picture)

(3) **Deficient:** Vegetation in close proximity to metal flue pipes. This could pose a fire hazard.

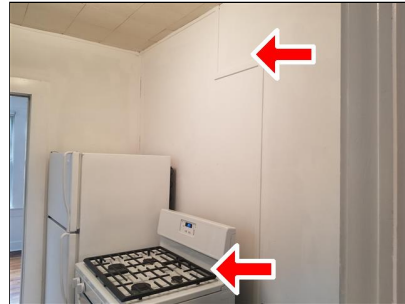
C. Item 2(Picture)

Deficient: Missing ducted exhaust for gas ranges. Current building standards require range hoods to discharge to the outdoors through a single-wall duct. The duct serving the hood shall have a smooth interior surface, shall be air tight and shall be equipped with a backdraft damper. Ducts serving range hoods shall not terminate in an attic or crawlspace or areas inside the building. Code Reference: IRC (M1503)

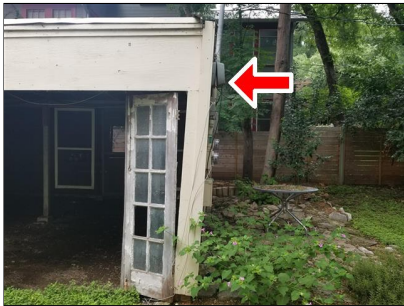
C. Item 2(Picture)

**Deficient:** Garage is in very poor condition. Defects included: under-sized supporting members, over-spanned supporting members, damaged through-out support members, out-of-plane appearance, appears very unstable, high soil elevation, expired roof covering, in-adequate flashing details, water penetration, poor weatherization. Structure will likely be condemned if inspected by City.

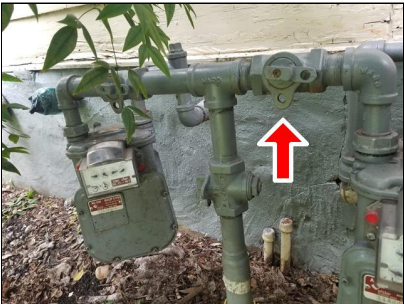
I. Item 1(Picture)

(1) Gas shut-off and entrance located at west wall of home.
