BPG Inspection, LLC

**2609 San Pedro Street
Austin TX 78705**

Client(s): Joseph
Inspection Date: 9/15/2020
Inspector: Randal Pitts , 9911

Style of Home: Two Story, Duplex	Age Of Home: 1918	Home Faces: West
Vacant or Occupied: Occupied	Utilities Active: All	Client(s) Present: Buyer's Agent
Weather: Partly Cloudy, Hot and Humid	Temperature: Over 80	Rain in last 3 days: No
Ground/Soil Condition: Damp	Ancillary Services: Wood destroying insect	Recommended Professionals: Structural Engineer, Roofer, Licensed Electrician, Licensed HVAC, Licensed Plumber, Licensed Pest Control, Door, Window, Chimney Sweep

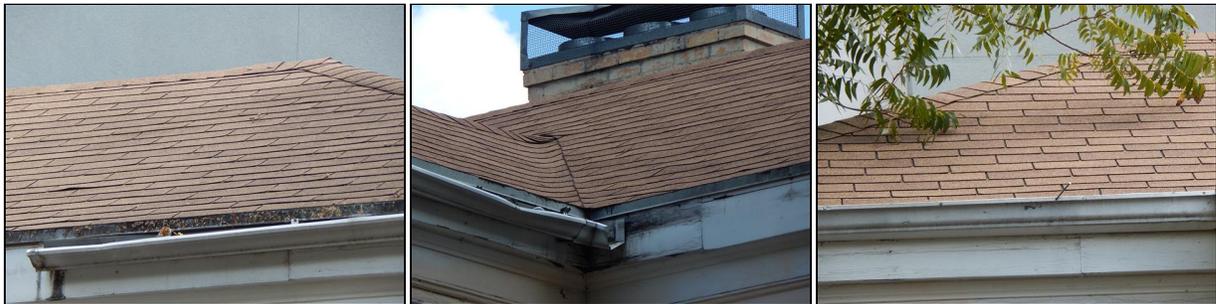
The roof covering appeared in fair condition. The covering appeared to be properly fastened.

I recommend increasing the ventilation to promote the life expectancy of roof covering. 1 sqft ventilation per 150 sqft attic space.

Remove all debris from roof slopes and valleys. Leaf debris may hide possible defects and damage to roofing materials. Debris may also cause water to dam up under shingle tabs.

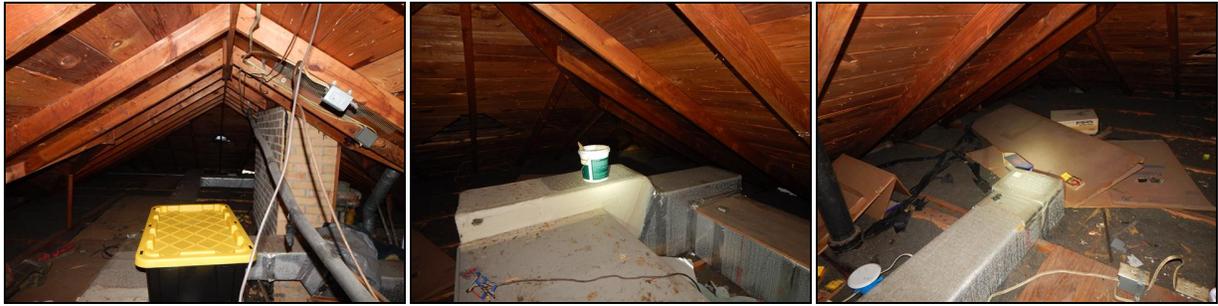
There was evidence of leaks in areas of the attic (flue pipe penetrations, chimney, valleys etc.). Some areas of the deck may require repair. Replacement of flashings, jackboots or possibly parts of the covering at these areas may be necessary to ensure it is leak free. A roofer should further evaluate roof covering, deck and exterior flashing systems for need of repair or replacement.

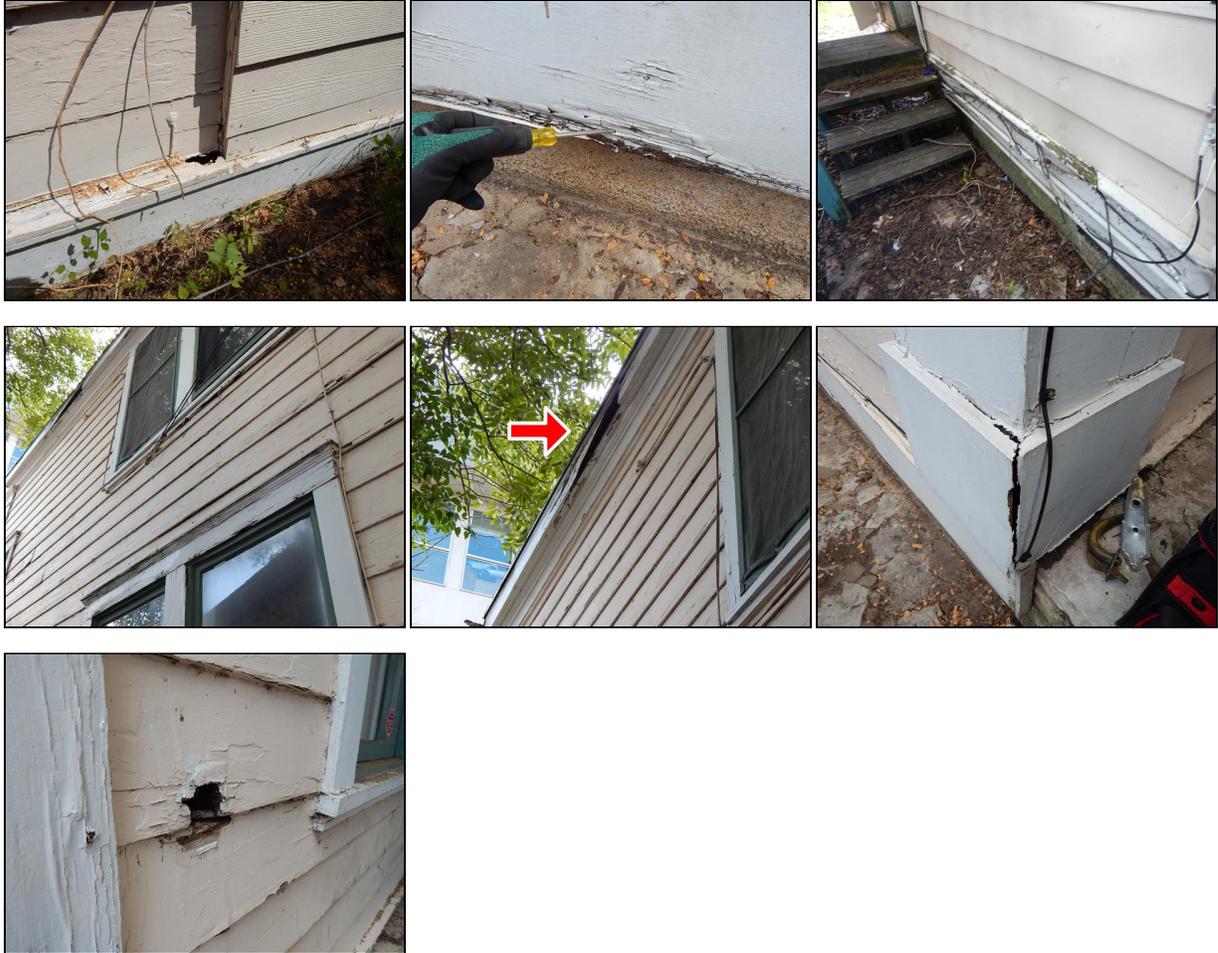
Trim all hedges, ivy and trees away from exterior wall surfaces. Heavy foliage against walls may be conducive to insect, rub or moisture damage. (Limited view of surfaces in these locations)

All exterior siding butt & transitional joints that are separated more than 1/8" should be re-sealed (caulk and paint) to prevent moisture incursion.

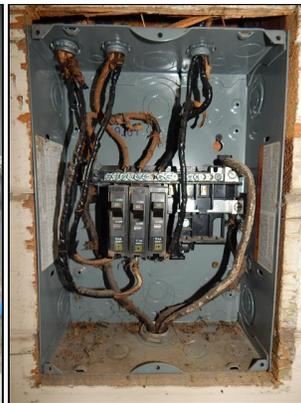
Sub panel.

There are remnant panels that should be removed.

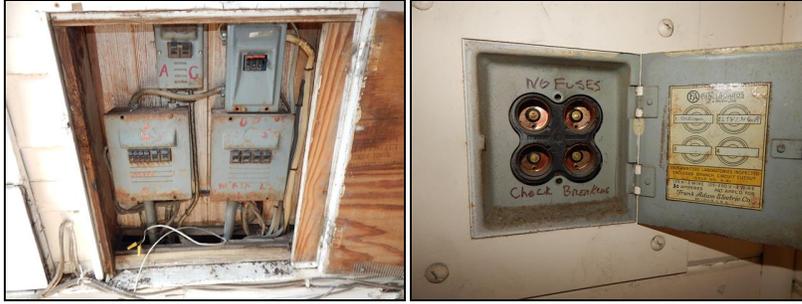
The sub panel and A/C disconnect are manufactured by FPE (Federal Pacific Electric). These panels have documented trip hazards and are no longer manufactured. Further evaluation of the panel for repairs or replacement is required by a licensed electrician.

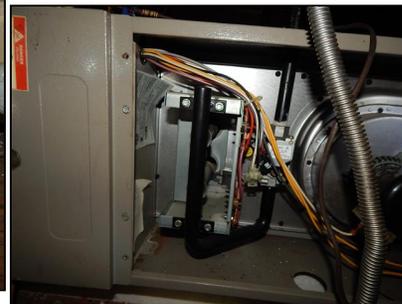
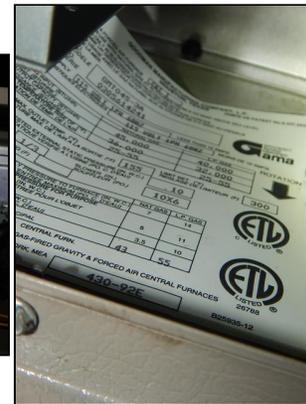
The downstairs heating system flue is in contact with building materials. Gas flues should have 1.5" of clearance surrounding the flue pipe. A heat shield should also be installed at the penetration.

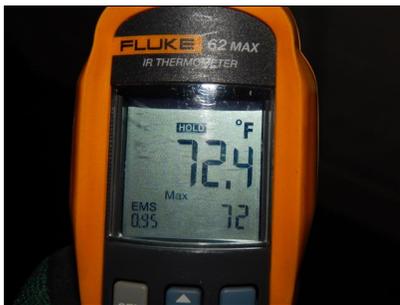
Return air temp.

☒ The downstairs A/C cooling system did not pass the temperature differentials tests. Normal supply and return temperature drops should be between 14 to 22 degrees. The system registered 12 degree temperature differential. Both interior and exterior units were operating during this test.

Further evaluation for service, repairs or component replacement by a professional HVAC company is recommended to return unit to functioning as intended from factory.

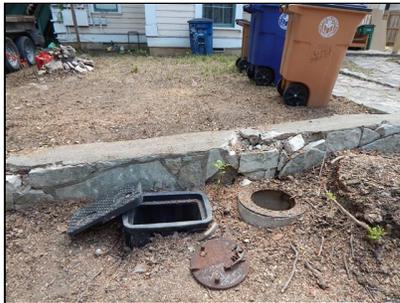
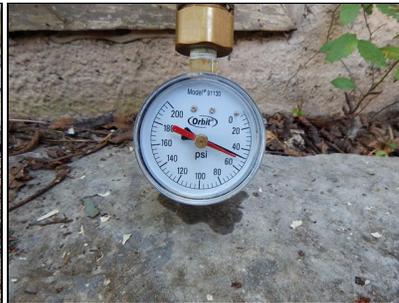
The hot water pressure did not pass a "functional flow" test. Acceptable flow is determined by running water in the sink and tub/shower while a toilet is flushed. Shower/tub pressure did drop to an unacceptable level in the upstairs bath. Further evaluation is needed by a plumber for correction or repair.

The controls are reversed in the downstairs bath. The position of the hot and cold water controls on all plumbing fixtures should meet accepted industry standards. These standards dictate that hot water controls are always located on the left and cold controls are located on the right. With single handle faucets, turning the handle to the left should increase the flow of hot water, while turning the handle to the right should increase the flow of cold water. Fore and aft action fixtures should have the hot to the rear.

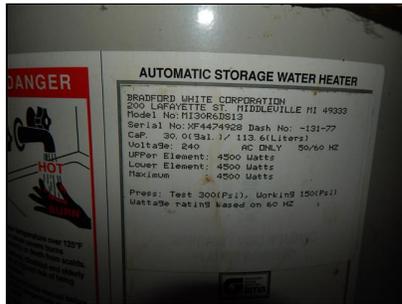
Upstairs unit: 30 gal, 4500 watt unit.

The water heaters do not have an electrical service disconnect means located within site of the unit as now called for by today's standards.

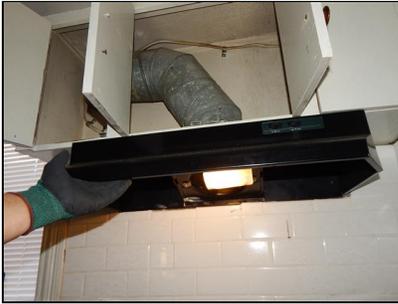
The downstairs hood vent fan and light were not functional.

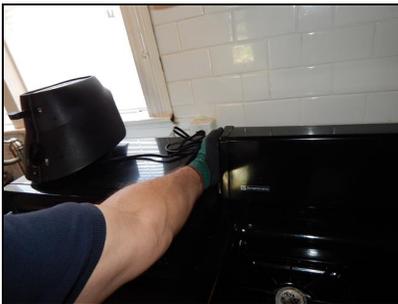
There is no child protection anti-tip device installed. Anti-tip brackets prevent the stove from accidentally tipping over if weight is placed on the oven door
