For Historic Landmark Commission Hearing
Regarding: 1208 W.22nd St., Austin
October 20, 2020

1208 West 22nd St. Austin

Re: Structural Assessment: 1208 W 22nd Street, Austin, Texas

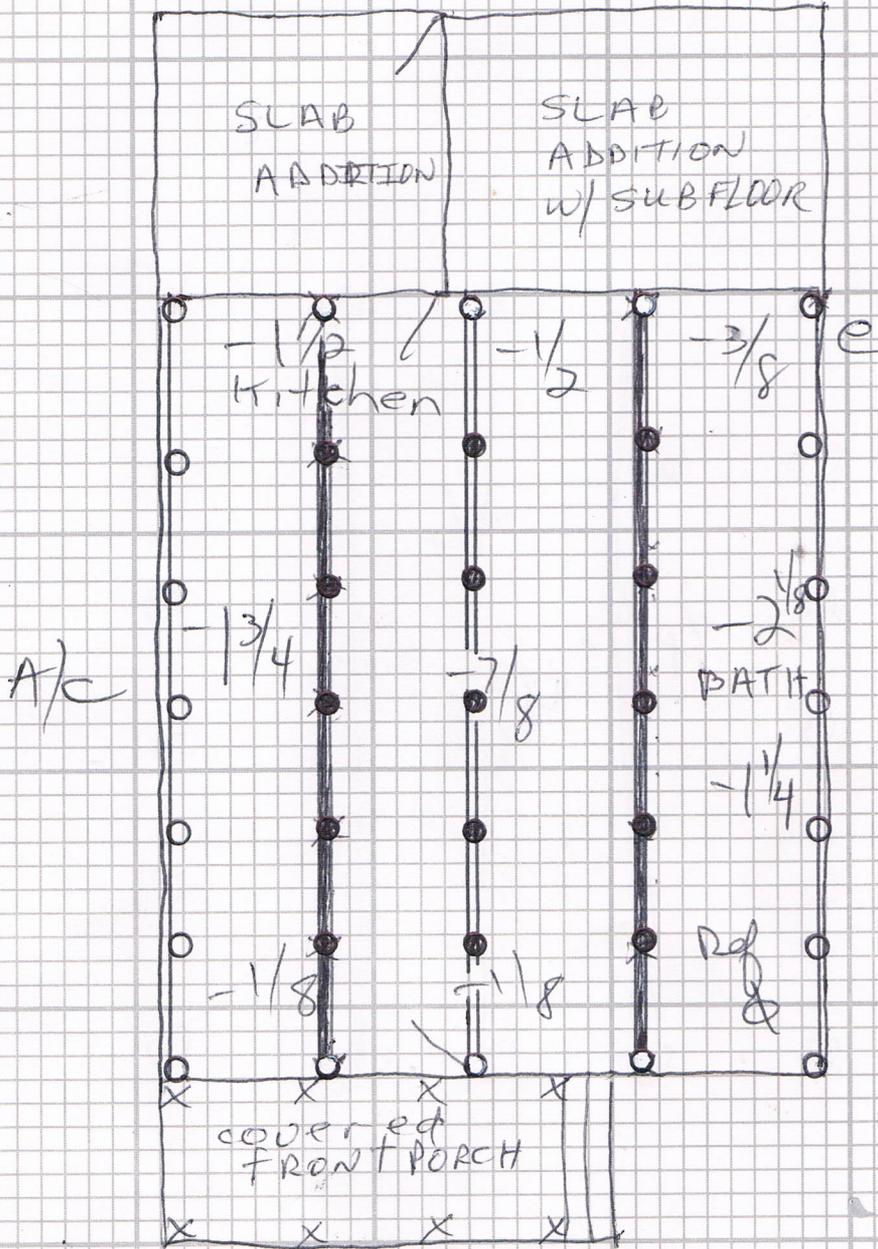
LEVEL BEST FOUNDATION REPAIR

Contractor to install or replace approximately 66 ft. of 4x6 sill beam below structure for support. Contractor will install 15 spread footing piers with 10" sonotube. New piers to be installed with 2'X2' footing 2' deep, or less if sitting on rock. Contractor will install approximately 0 ft. of 0 joist. After installation, Contractor to raise structure to as near as possible to level to the limits of the structure, unless otherwise stated. Newly installed piers to be shimmed as necessary to retain newly attained height. Existing piers to be shimmed as necessary. All shim material to be steel plates. It is understood and agreed that in order to perform the above mentioned work: it is possible that sheetrock, wallpaper, or other rigid materials may crack. Therefore the below figures do not include any redecorating, painting, repairing, plumbing or electrical work, or replacing any materials not called for in this agreement.

Additional Work To Be Performed: Includes (8) spread footing piers for the front porch. Post engineer report provided after final payment received. City permit included.
Any needed beam replaced @ \$25/L.F.; joists replaced @ \$20/L.F.
