## **3003 E 18th Street Condition**

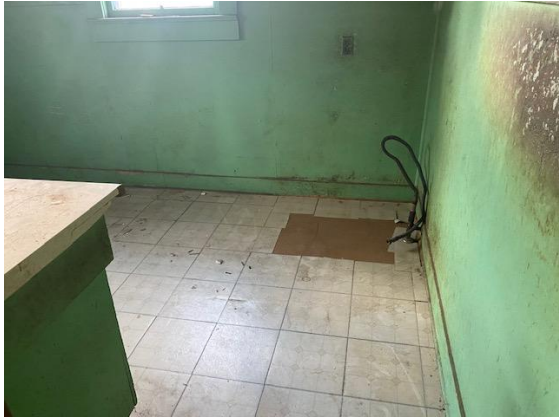
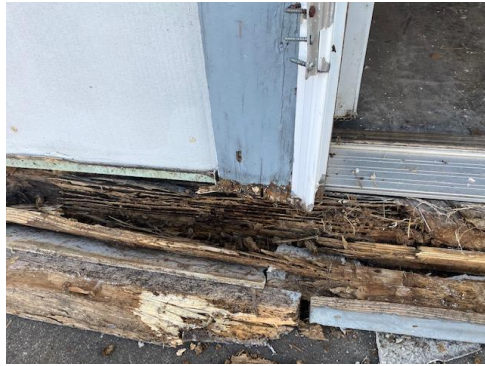
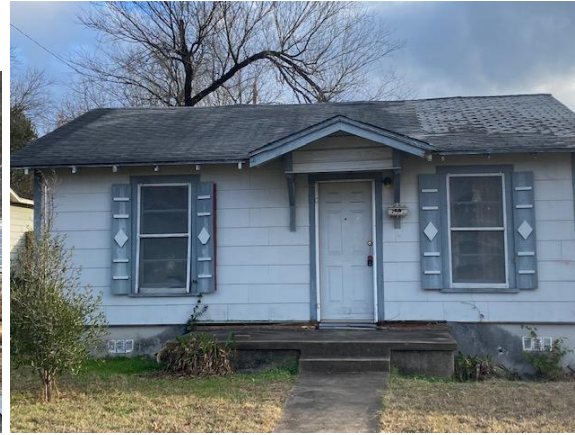
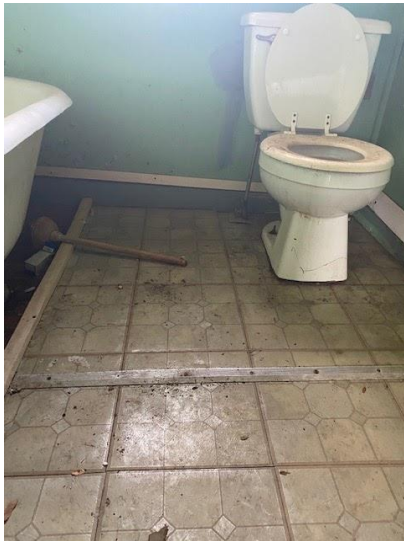
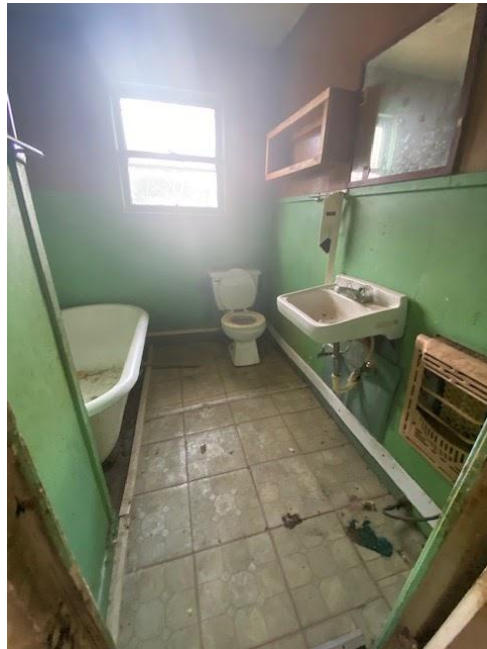
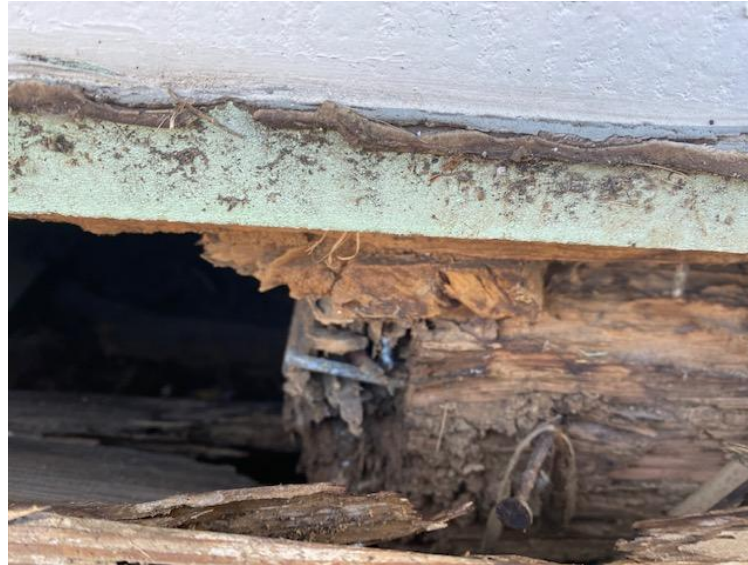
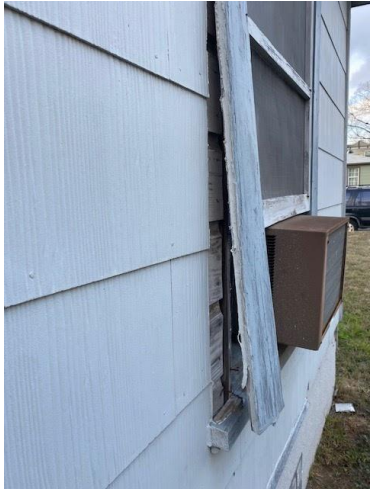
Roof deteriorated with water leaking through to the interior of the house

Rotted / carpenter ant damage to beams

Uneven floors inside of house due to damaged beams
