Structural Investigations & Geotech Report

Summary Report
Structural Floor System Capacity Assessment – Austin Fire Department
Fire Station No. 3 – 201 W. 30th St., Austin, TX
Fire Station No. 22 – 5309 E. Riverside Dr., Austin, TX
CTLGroup Project No. 231701

**GEOTECHNICAL ENGINEERING STUDY
FIRE STATION #3 AND #22 BAY REPLACEMENT
201 W. 30TH STREET / 5309 EAST RIVERSIDE DRIVE
AUSTIN, TEXAS**

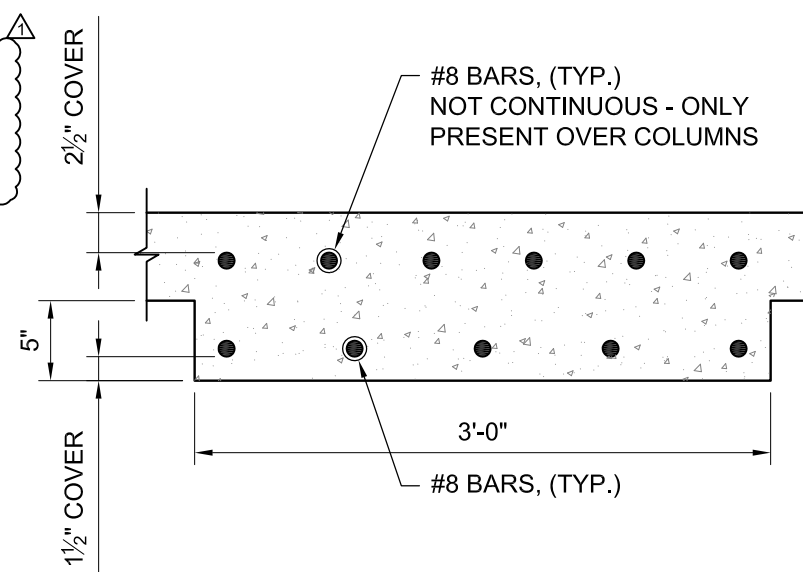
4 DETAIL D
1" = 1'-0"

NOTE:
1. NO SHEAR REINFORCEMENT DETECTED
IN MIDDLE BEAMS.

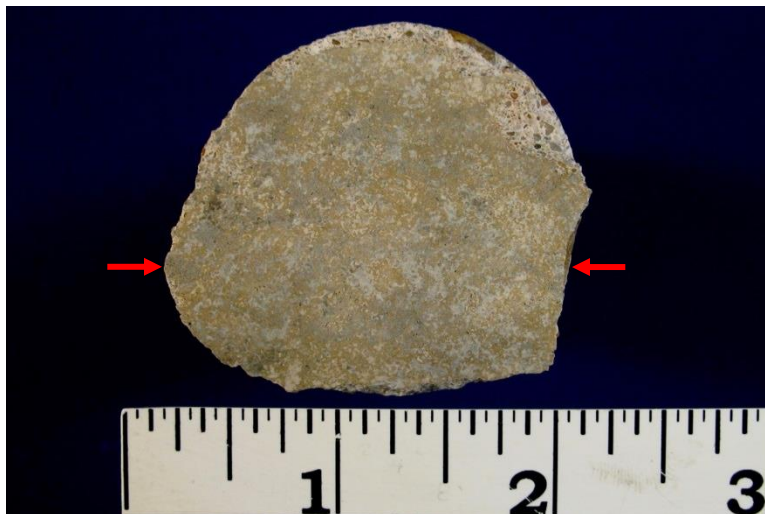
1c. Core bottom surface. The surface is a formed wavy shape. Red arrows point to corrugated ridge.

Fig. 1 Core FS #3 C15, as received in the Petrographic Laboratory for testing.

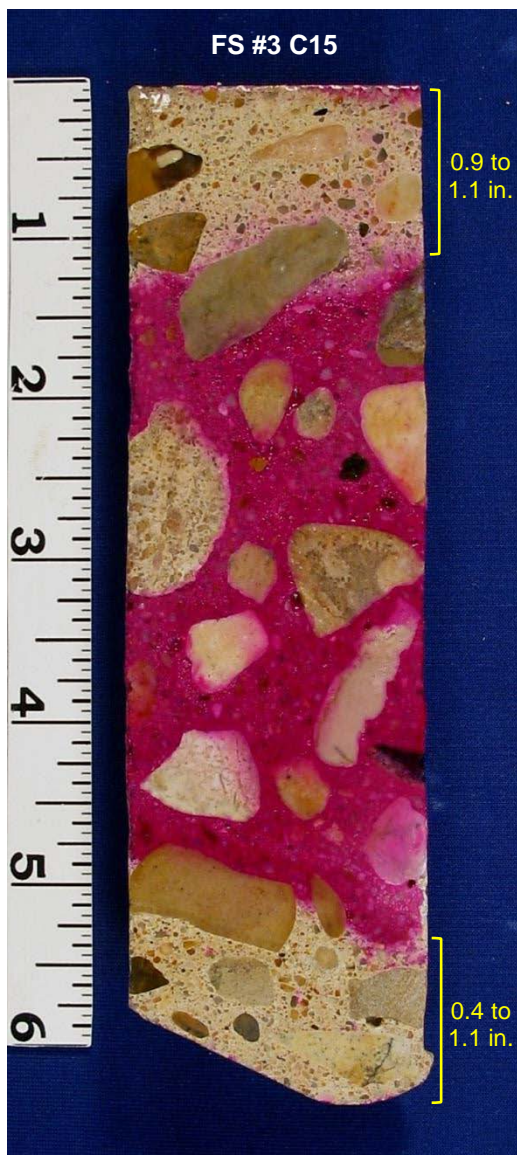
3a. Core FS #3 C15

Core FS #3 C15 does not contain rebar. Paste carbonation is present in both the top and bottom portions of the concrete core (Fig. 3a). From the top surface, the paste is carbonated to

Fig. 3 Saw-cut, cross-sectional concrete surfaces of Cores FS #3 C15 and FS #3 C16. Phenolphthalein (a pH indicator solution) was applied to the surface to determine paste carbonation levels. Non-carbonated paste is deep magenta; carbonated paste did not change color. Yellow bars and text designate depth into the concrete from the nearest surface. Scale is in inches.

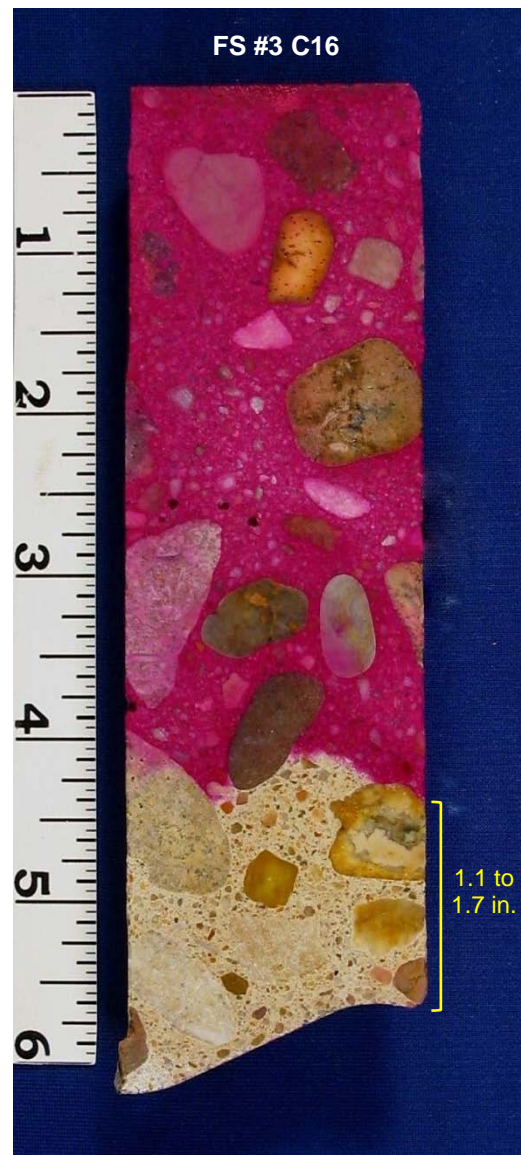
3b. Core FS #3 C16

Core FS #3 C16 does not contain rebar. Paste carbonation is observed only in the bottom portion of the concrete core (Fig. 3b). From the bottom surface, the paste is carbonated to depths of 29 to 44 mm (1.1 to 1.7 in.) into the concrete.

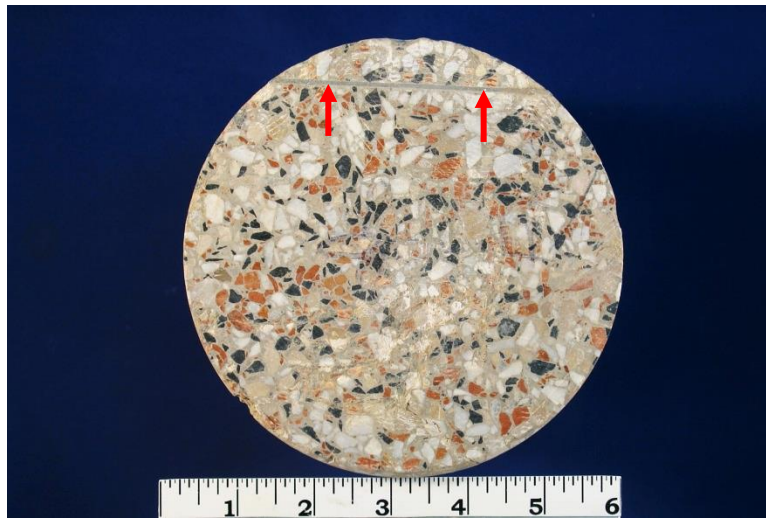
1a. Top surface. Surface is a terrazzo-like concrete material. Red arrows point to a thin reinforcement plate.

Fig. 1 Core No. 3-Big Core, as received in the Petrographic Laboratory for testing.

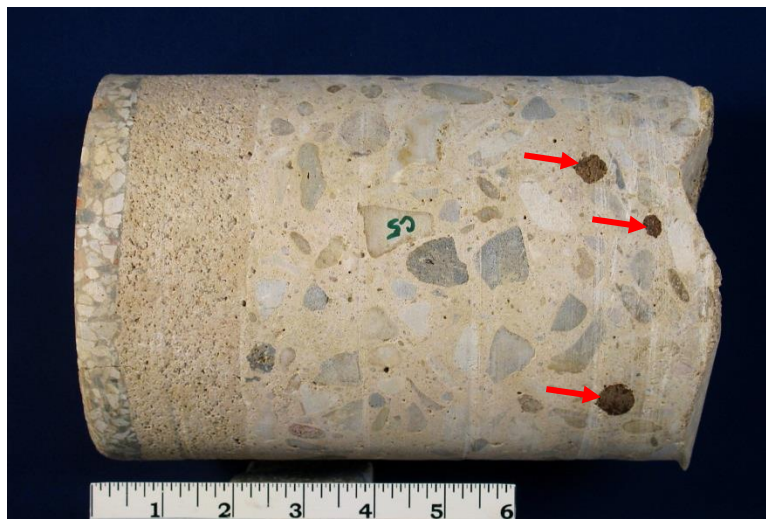
1b. Side view of core. Core consists of a terrazzo-like concrete topping, with an underlying mortar-like layer, then the underlying substrate concrete. Three rebar segments (red arrows) are present in the bottom portion of the concrete. The concrete bottom surface is a formed, wavy corrugated shape.

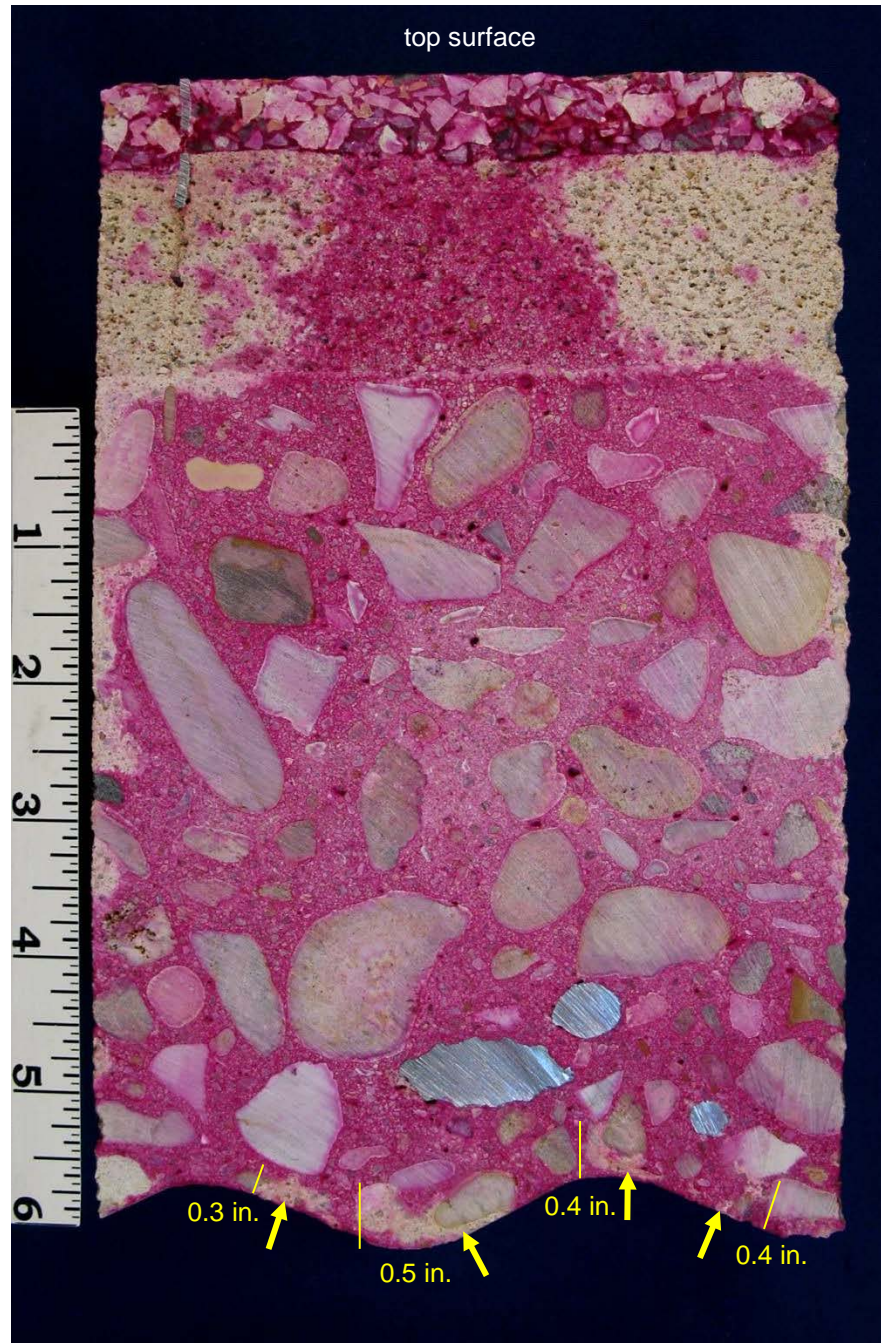
Carbonation in Core No. 3-Big Core is minimal and does not reach any of the four rebar segments present within the concrete (Fig. 3). The rebar segments have concrete cover ranging from 0.5 to 1 in. from the bottom surface. Four small, local regions of carbonation extend from the bottom surface to depths of 0.3 to 0.5 in. into the concrete. The carbonated region which extends 0.5 in. into the concrete is relatively far away from the rebar segments. The closest rebar segment to this carbonated region has 1 in. of concrete cover; the rebar is not comprised.

Fig. 3 Saw-cut, cross-sectional concrete surface of Core No. 3-Big Core. Phenolphthalein (a pH indicator solution) was applied to the surface to aid in carbonation assessment. Non-carbonated paste is deep magenta; carbonated paste did not change color. Four local regions of carbonated paste are present along the bottom surface; yellow arrows point to these regions and yellow bars and text designate depth into the concrete from the nearest bottom surface. Scale is in inches.

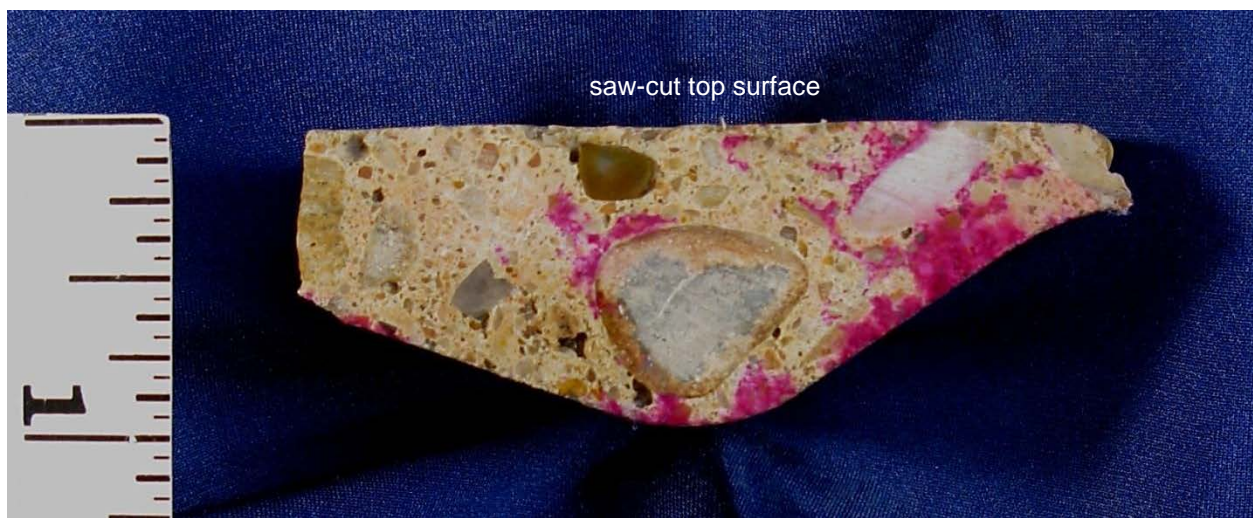
Carbonation in No. 3-C14 is substantial. The majority of the paste is carbonated throughout the full depth of the core sample, with small amounts of noncarbonated paste along the bottom surface (Fig. 4). The non-carbonated paste appears to extend upwardly into the concrete in a relatively random nature. Due to the amount of carbonation, it is likely that the carbonated paste is present beyond the 0.9 in. portion of the core evaluated in this examination.

Fig. 4 Saw-cut, cross-sectional concrete surface of Core No. 3-C14. Phenolphthalein (a pH indicator solution) was applied to the surface to aid in carbonation assessment. Non-carbonated paste is deep magenta; carbonated paste did not change color. The majority of the paste is carbonated throughout the full depth of the concrete sample. A small amount of non-carbonated paste is present along the bottom surface and mottled upwardly into the concrete. Scale is in inches.

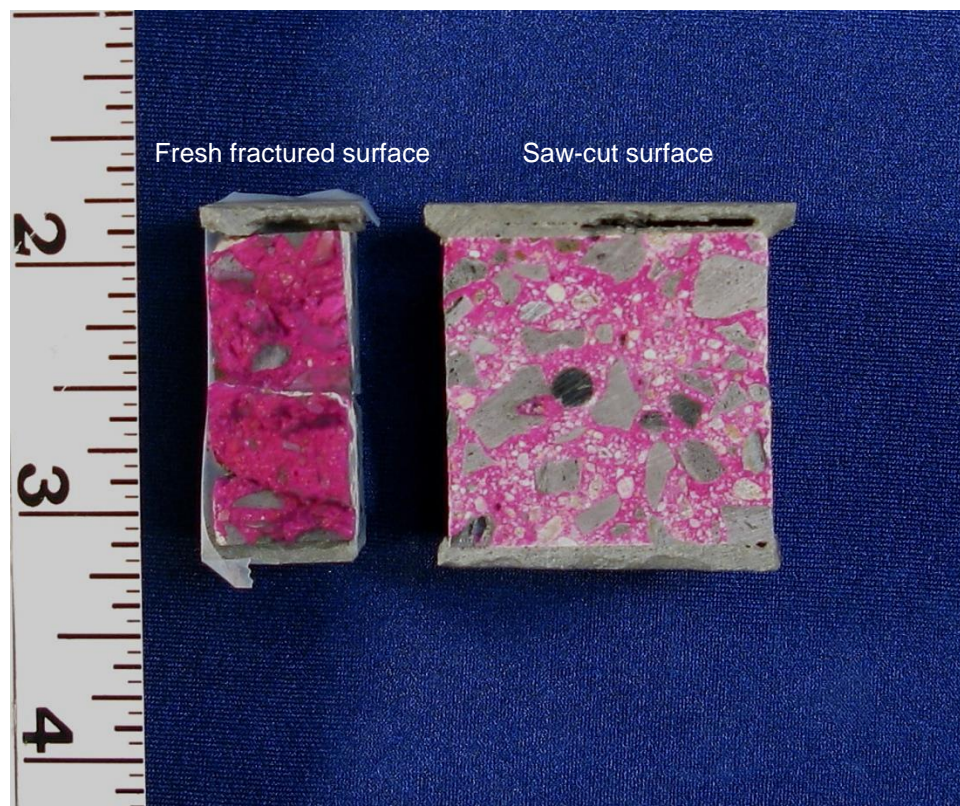
No paste carbonation is observed in the concrete of Core FS#22-C12 (Fig. 1). The sample contains one 4-mm-diameter (0.2-in.-dia.) wire mesh segment. All information obtained in the examination is presented in the laboratory data form at the end of this report.

Fig. 1 Core FS#22-C12, after being saw-cut longitudinally in the Petrographic Laboratory. One resultant longitudinal saw-cut surface is shown on the right. The other longitudinal saw-cut surface was freshly fractured in the laboratory (left). Phenolphthalein (a pH indicator solution) was applied to these surfaces to determine localities of paste carbonation in the concrete. Non-carbonated paste is deep magenta; carbonated paste does not change color. In the core specimen, no carbonation is observed. Scale is in inches.

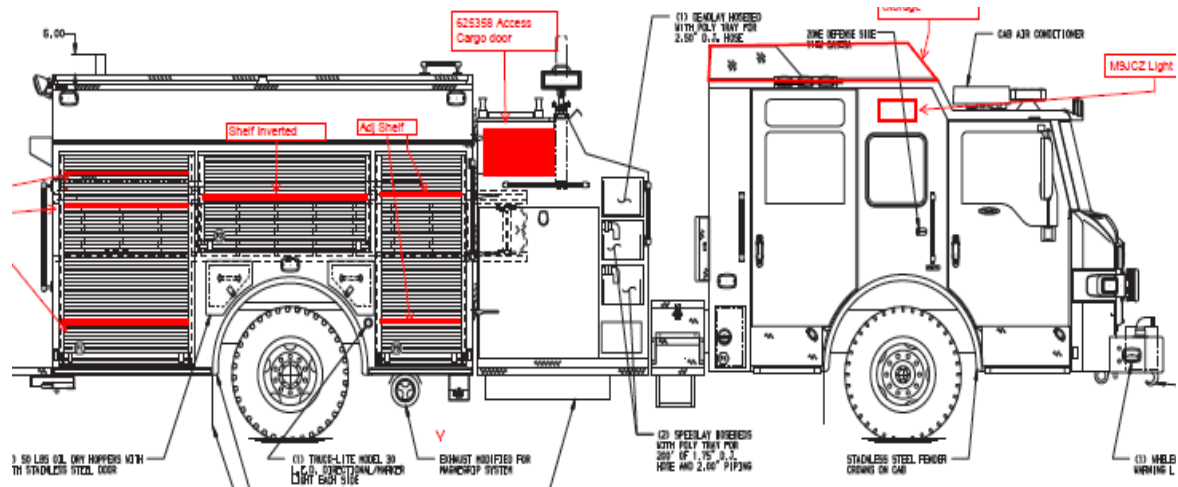
Figure 8: Ladder truck

Gravity live load includes a ladder truck in one bay and an engine truck in the other bay. The ladder truck weight and wheel footprint calculations are shown in Figure 8. The engine truck weight and wheel footprint calculations are shown in Figure 9.

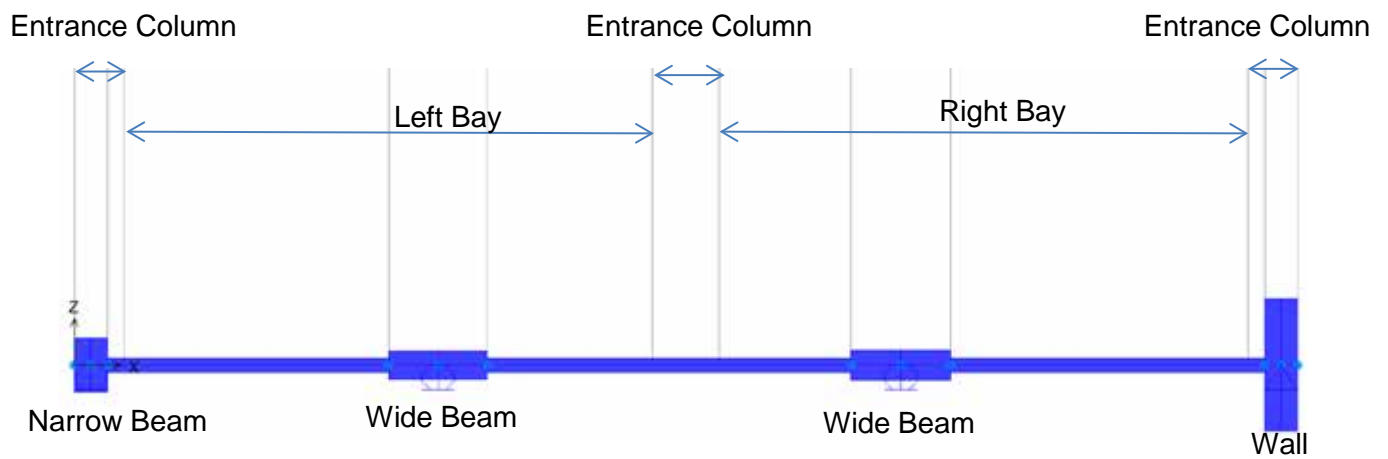
Figure 10: Continuous 1-ft strip model of slab

A three-span strip of the floor slab is analyzed under dead and live loads. The analysis model is shown in Figures 10 and 11. The effective width of one-way slab is calculated per AASHTO LRFD 2010 as shown in Table 3. Based on these results, an effective width of 99 in. is assumed for a single axle and an effective width of 151 in. is assumed for a tandem axle with 52 in. spacing between the parallel axles.

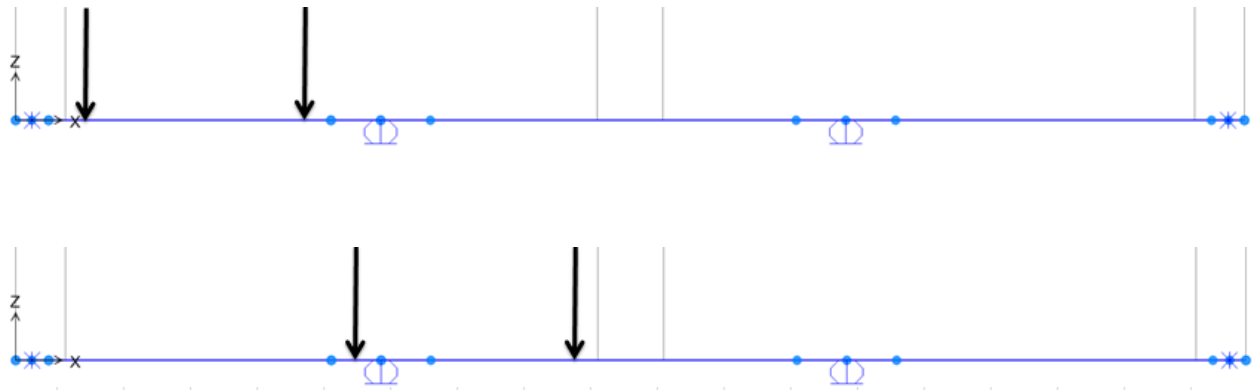
Figure 12: 27-kip axle extreme positions in the left bay

An analysis of the slab strip is conducted under a 27-kip axle load in the left bay and a 27-kip axle load in the right bay as shown in Figures 12 and 13. In this analysis, possible truck/axle positions are considered to be anywhere between a far left position and a far right position within the bay.

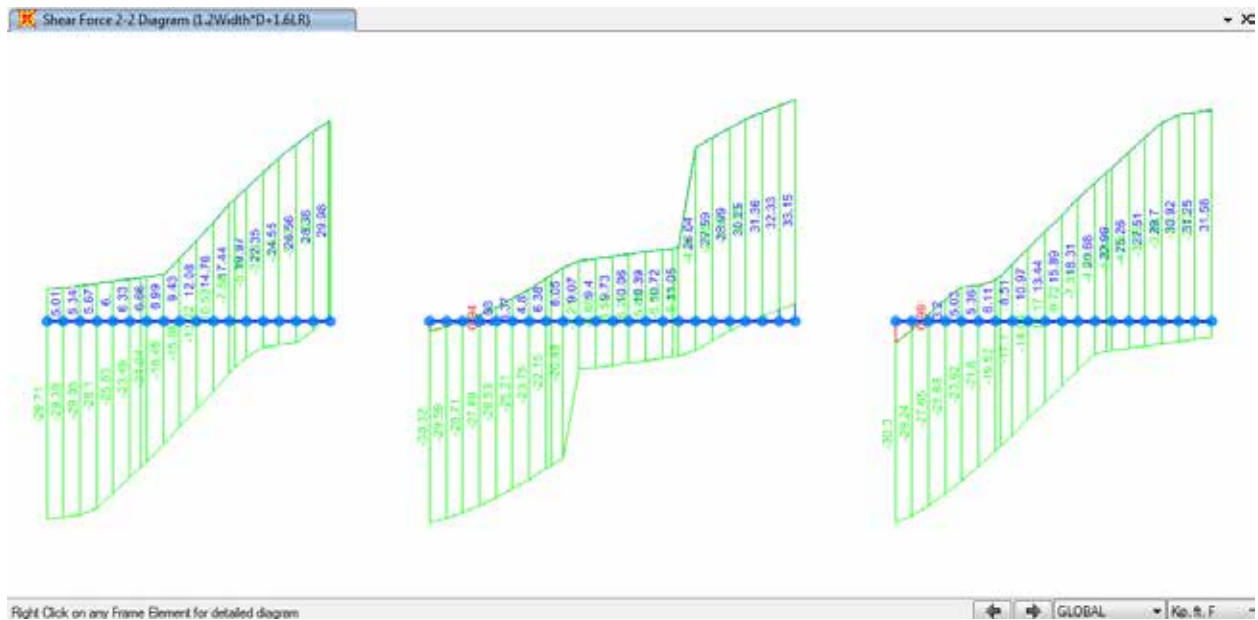
Figure 14: Shear force envelope due to factored self-weight of 99-in. strip plus factored truck loads in left and right bays

The shear force and bending moment envelopes are shown in Figures 14 and 15. The maximum shear force, positive bending moment, and negative bending moment from these envelope diagrams constitute the maximum demand (D) on the slab.

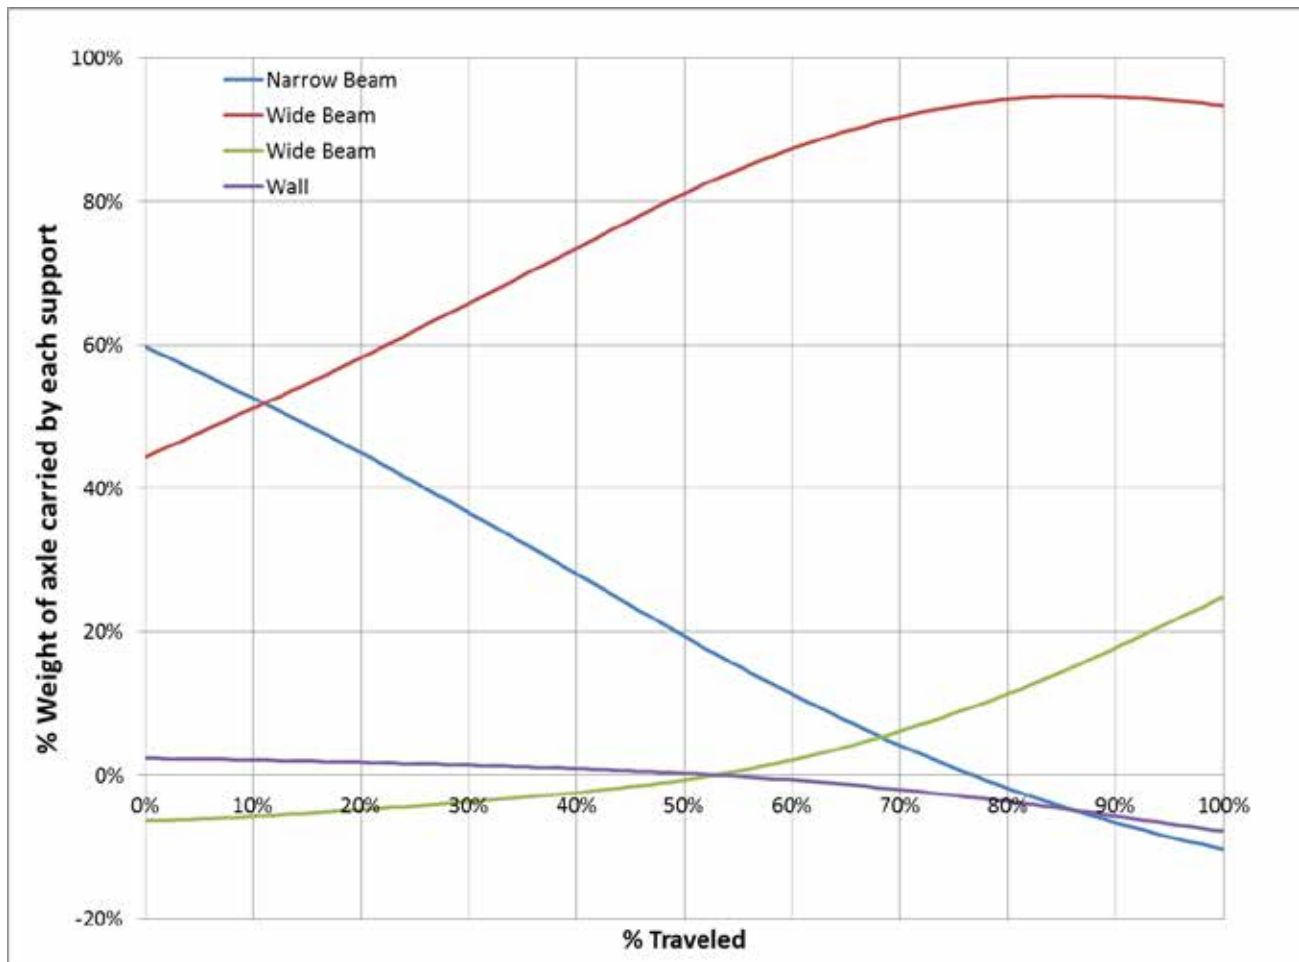
Figure 16: Reactions due to 27-kip axle positions in the transverse direction in left bay

Figure 16 shows the slab reactions as the axle is positioned from one side of the left bay to the other side of the left bay. Figure 17 shows the slab reactions as the axle is positioned from one side of the right bay to the other side of the right bay. These reactions are used to calculate the percentage of the axle load that is carried by each support as shown in Table 6.

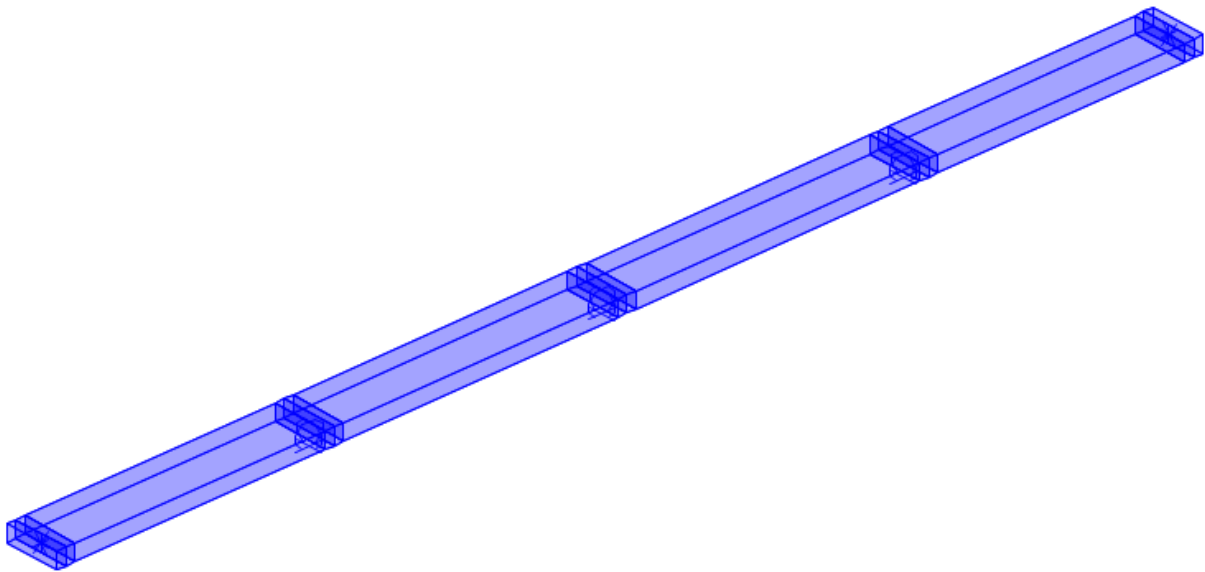
Figure 19: Model of wide beam showing member cross section

A four-span continuous beam model of the wide beam is analyzed under dead and live loads. The analysis model is shown in Figures 18 and 19.

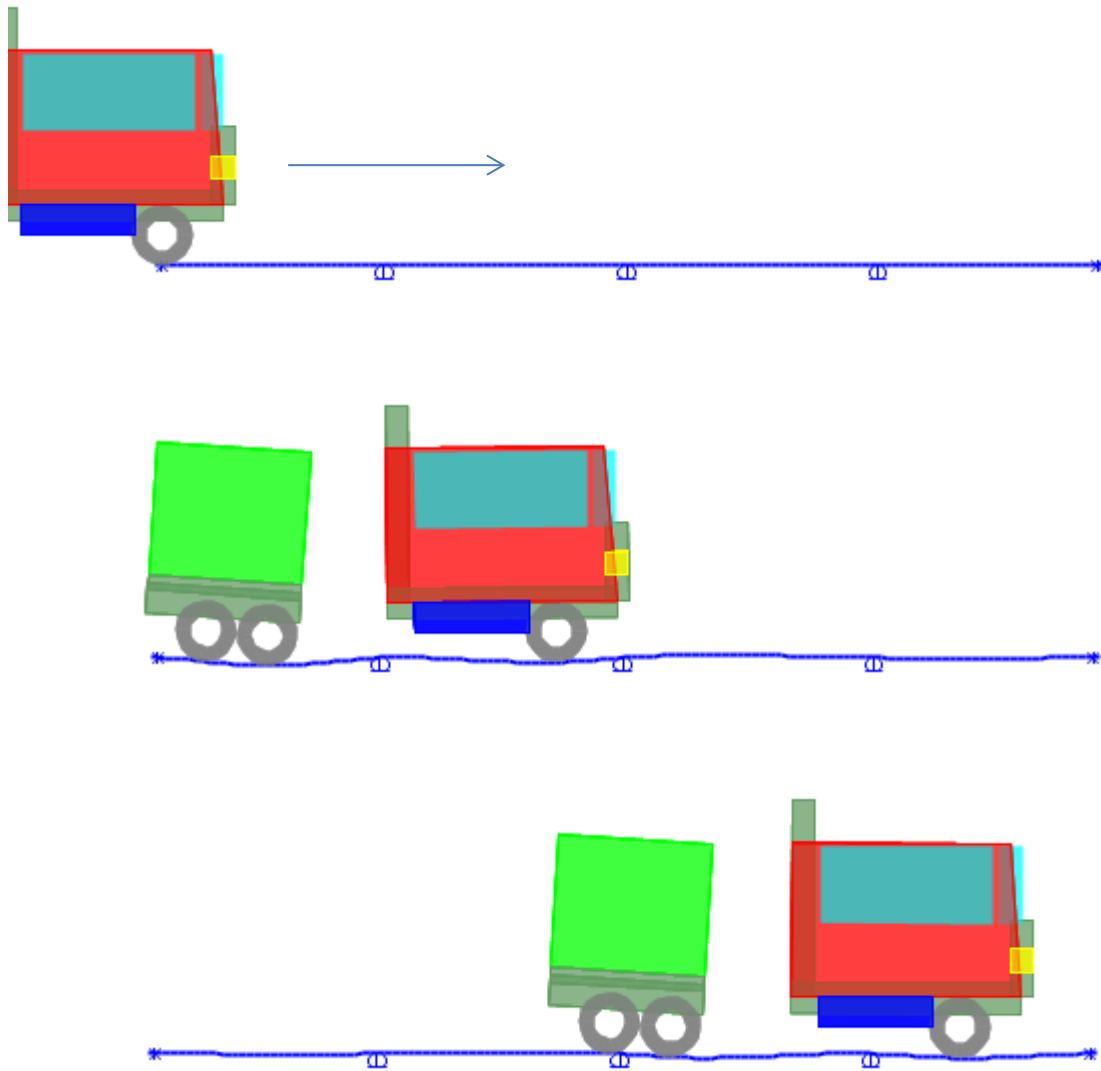
Figure 20: Ladder truck moving inside

Moving load analyses of the wide beam are conducted under a ladder truck and an engine truck as shown in Figures 20 to 23. The results of these analyses are scaled by the percentages shown in Table 5 and combined.

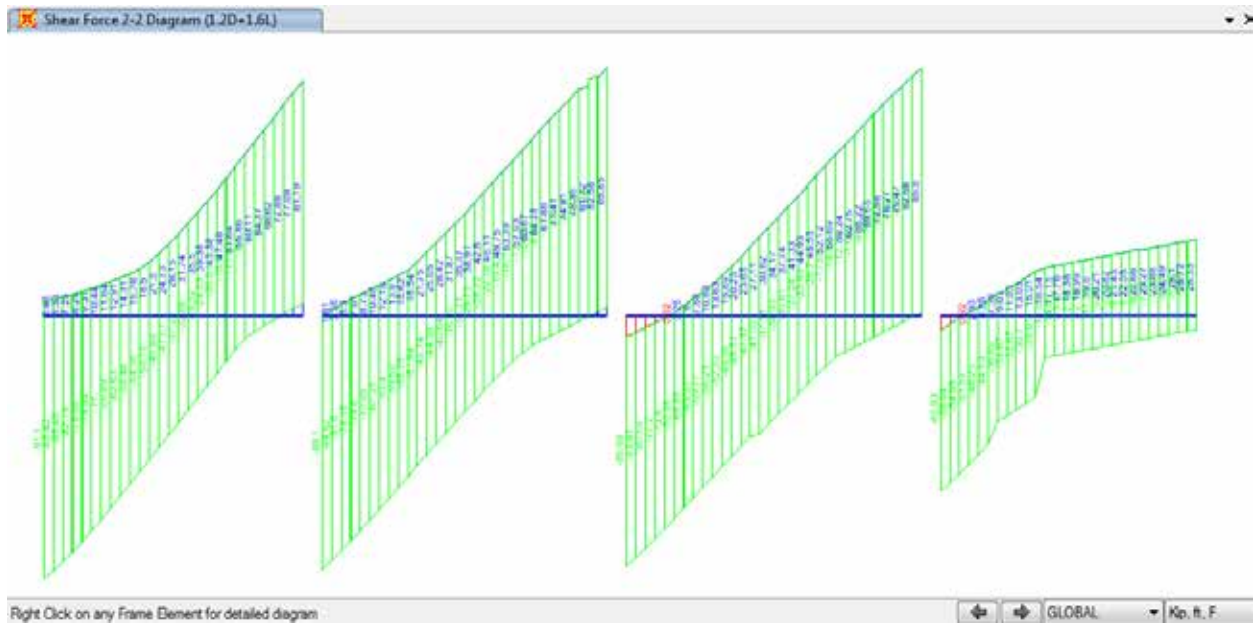
Figure 24: Wide beam shear envelope due to factored self-weight plus factored truck loads

The shear force and bending moment envelopes are shown in Figures 24 and 25. The maximum shear force, positive bending moment, and negative moment from these envelope diagrams constitute the maximum demand (D) on the wide beam.

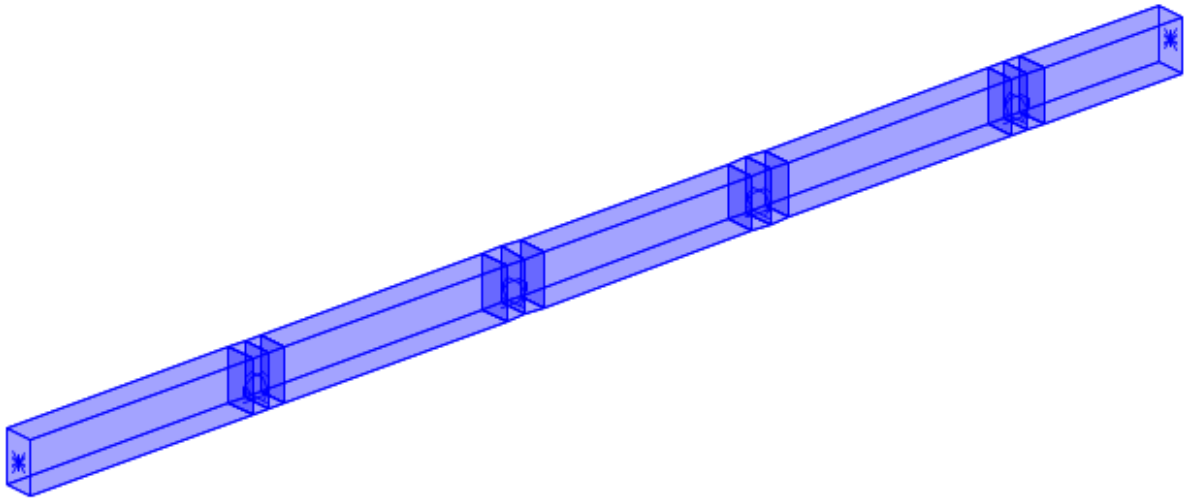
Figure 27: Model of narrow beam showing member cross section

A four-span continuous beam model of the wide beam is analyzed under dead and live loads. The analysis model is shown in Figures 26 and 27.

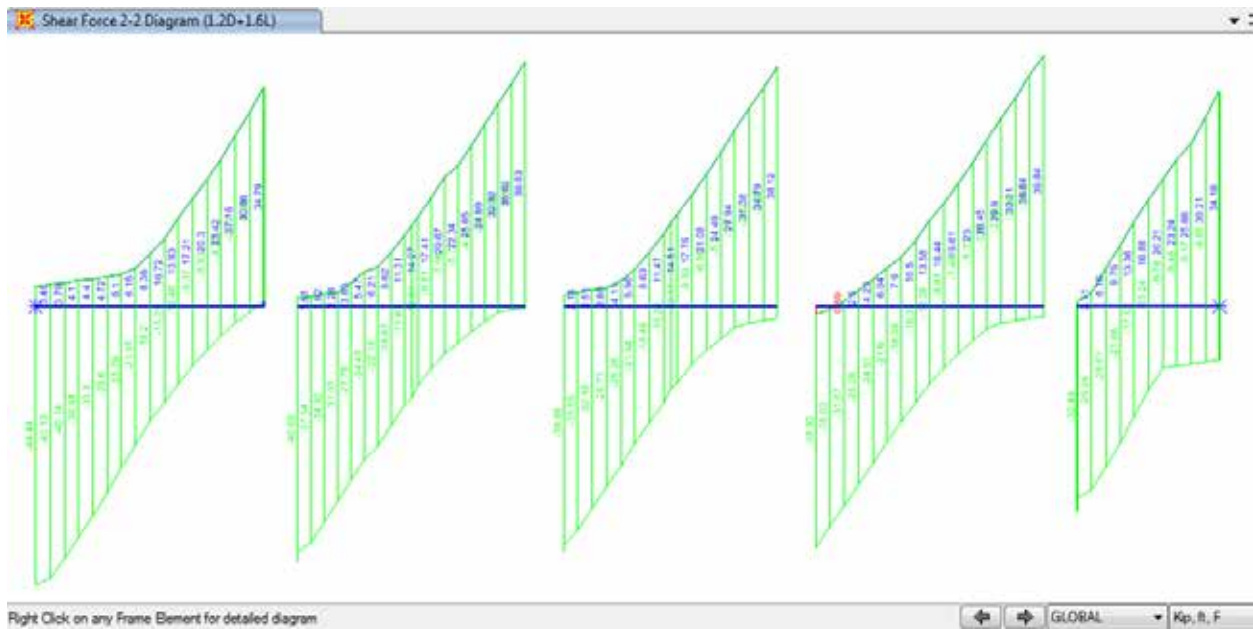
Figure 28: Narrow beam shear envelope due to factored self-weight plus factored truck loads

The shear force and bending moment envelopes are shown in Figures 28 and 29. The maximum shear force, positive bending moment, and negative moment from these envelope diagrams constitute the maximum demand (D) on the wide beam.
