911-09-07 Congress Avenue

Grandberry Building and Mitchell-Robertson Building,
911 Congress Avenue Historic District

May 24, 2021

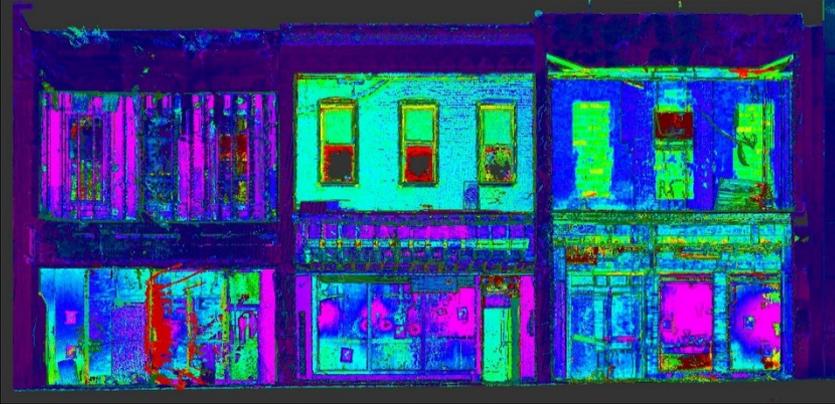
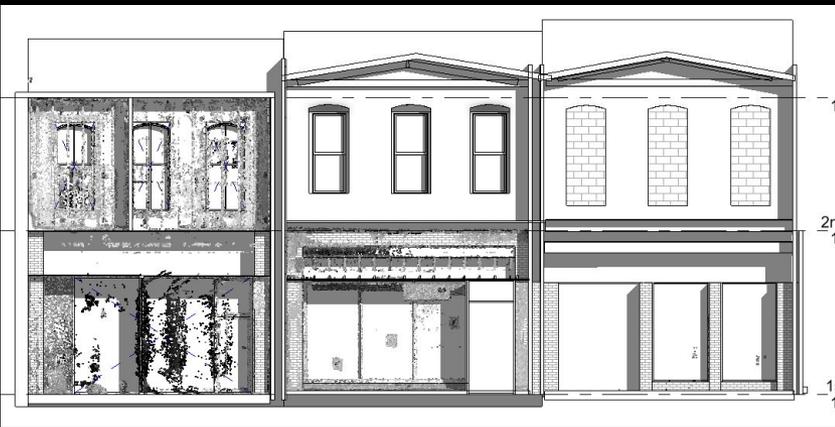
Initial Laser Scan Assessment

- Initial scanning of the buildings was completed last week and draft of rectified 3D model is underway.
- Additional scans required of front facades.
- Further investigation of the data is required to determine extent of damage.
- Scan and model are basis for deconstruction and reconstruction permit documents.
