ITEM FOR ENVIRONMENTAL COMMISSION AGENDA

NAME & NUMBER OF PROJECT: Rainey Tower
SPC-2021-0129C

MEMORANDUM

CASE FOLDER: SPC-2021-0129C

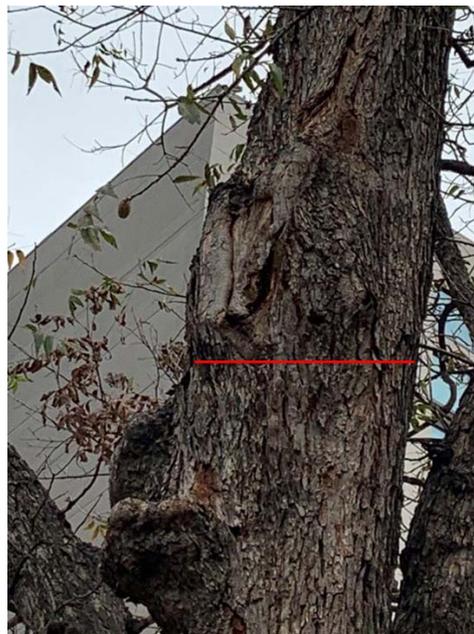
Scan at 625 cm

The orange and red suggest cracks or pockets of decay where the sound moved very slowly between the sensors.

This scan shows less sound wood in the center and extending outwards through the shell wall between sensors 3-8, and between 8-1. This scan was taken below an old, exposed pruning wound, and above branch nubs. Failure of this portion of the tree would result in the loss of a significant part of the tree canopy (Image 2). Eight sensors were used in this scan. The scan at this level is structurally compromised.
