2002 SCENIC DRIVE RESIDENCE, EXISTING CONDITIONS | JUNE 28, 2022

2002 SCENIC DRIVE
EXISTING CONDITIONS

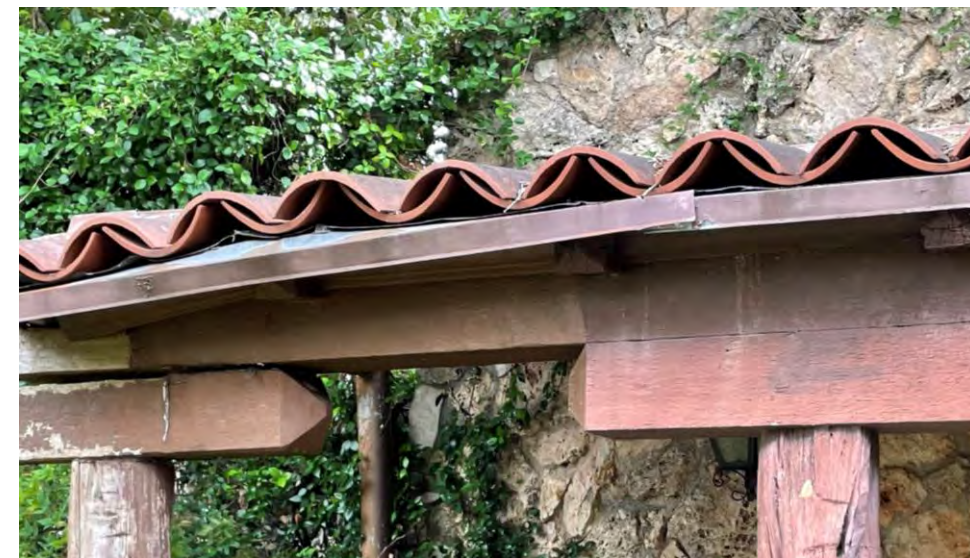
1. THE ROOF IS FALLING APART AND IS SHOWING SIGNS OF WATER DAMAGE.
2. THE ROOF IS SLANTING, WHICH IS A SIGN OF STRUCTURAL FAILURE AND MATERIAL DETERIORATION.

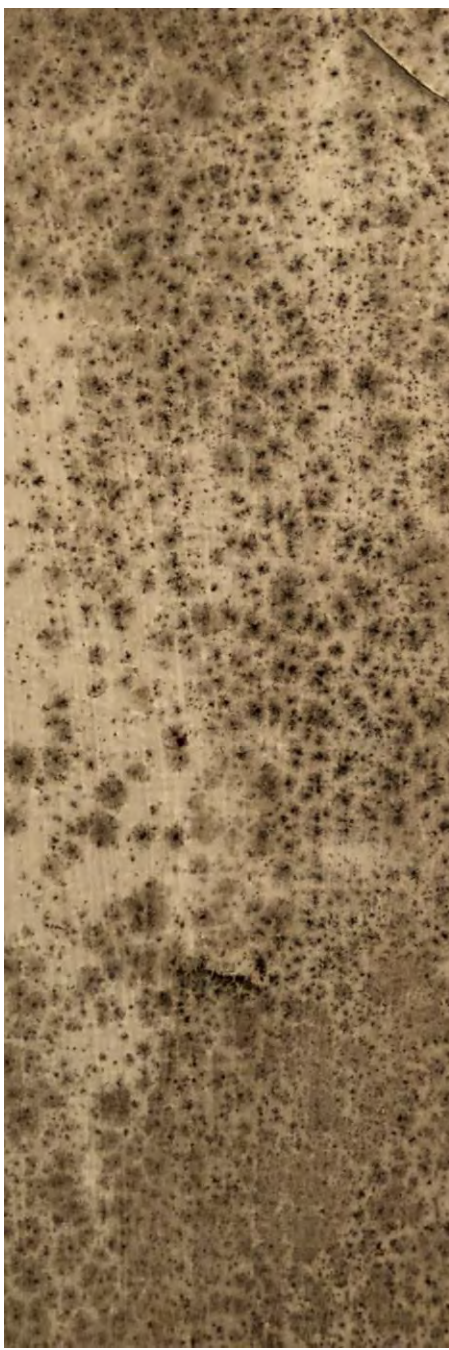
1. DEBRIS HAS COLLECTED INSIDE THE BATHTUB, SHOWING WATER DAMAGE AND CEILING FAILURE.
2. THE CEILING HAS MOLD GROWING ON THE SURFACE OF THE WOOD, WHICH IS CAUSING FAILURE AND COMPROMISING THE MATERIAL.

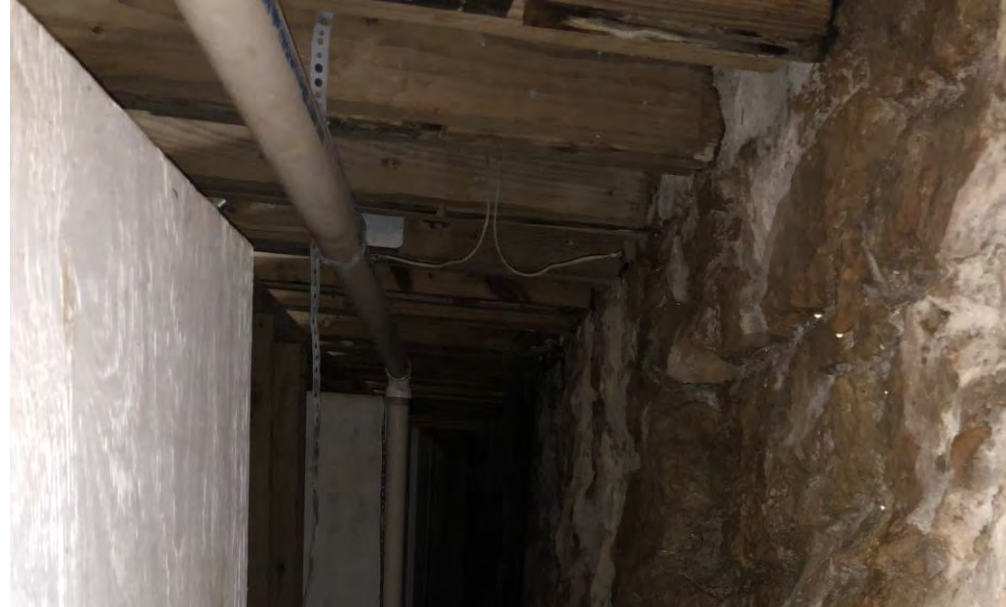
1. WATER IS LEAKING THROUGH THE RETAINING WALL AND INTO THE APARTMENT. WATER CAN ACTIVELY BE SEEN DRIPPING DOWN THE ROCK WALL.
2. IN ORDER TO HOLD UP THE SECOND FLOOR, RAILWAY TIES ARE USED AS STEEL BEAMS.
3. WATER IS DRIPPING DOWN THE ROCK AND FINDS ITS WAY TO THE STRUCTURE'S CONCRETE BASE.

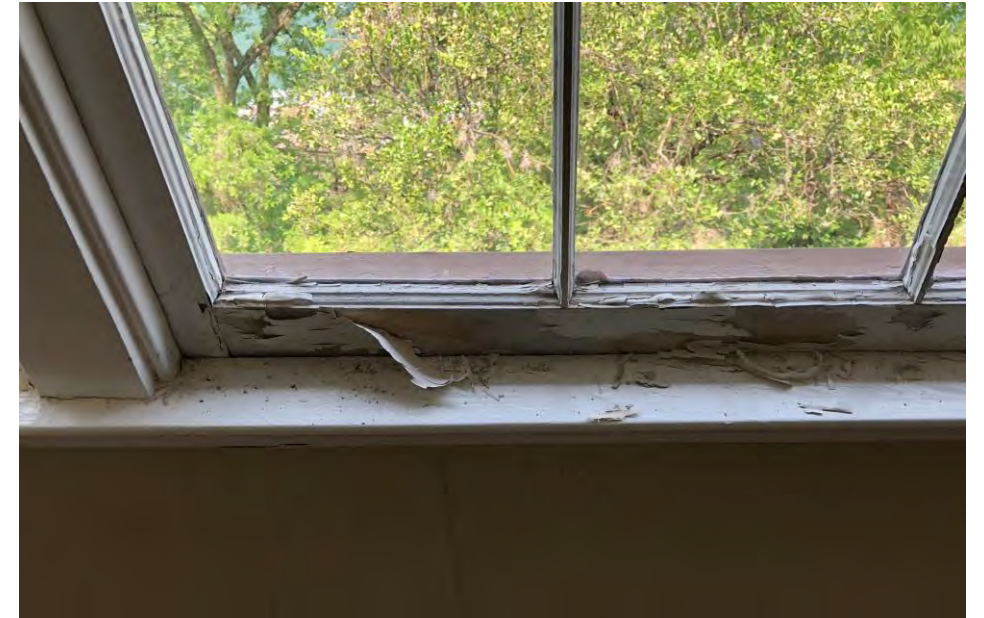
1. THE WINDOWSILL IS FALLING APART AND IS DROPPING DEBRIS ONTO THE WINDOW SILL AND FLOOR.
2. THE FLOOR IS BOWING DUE TO THE LACK OF STRUCTURAL SUPPORT BELOW.

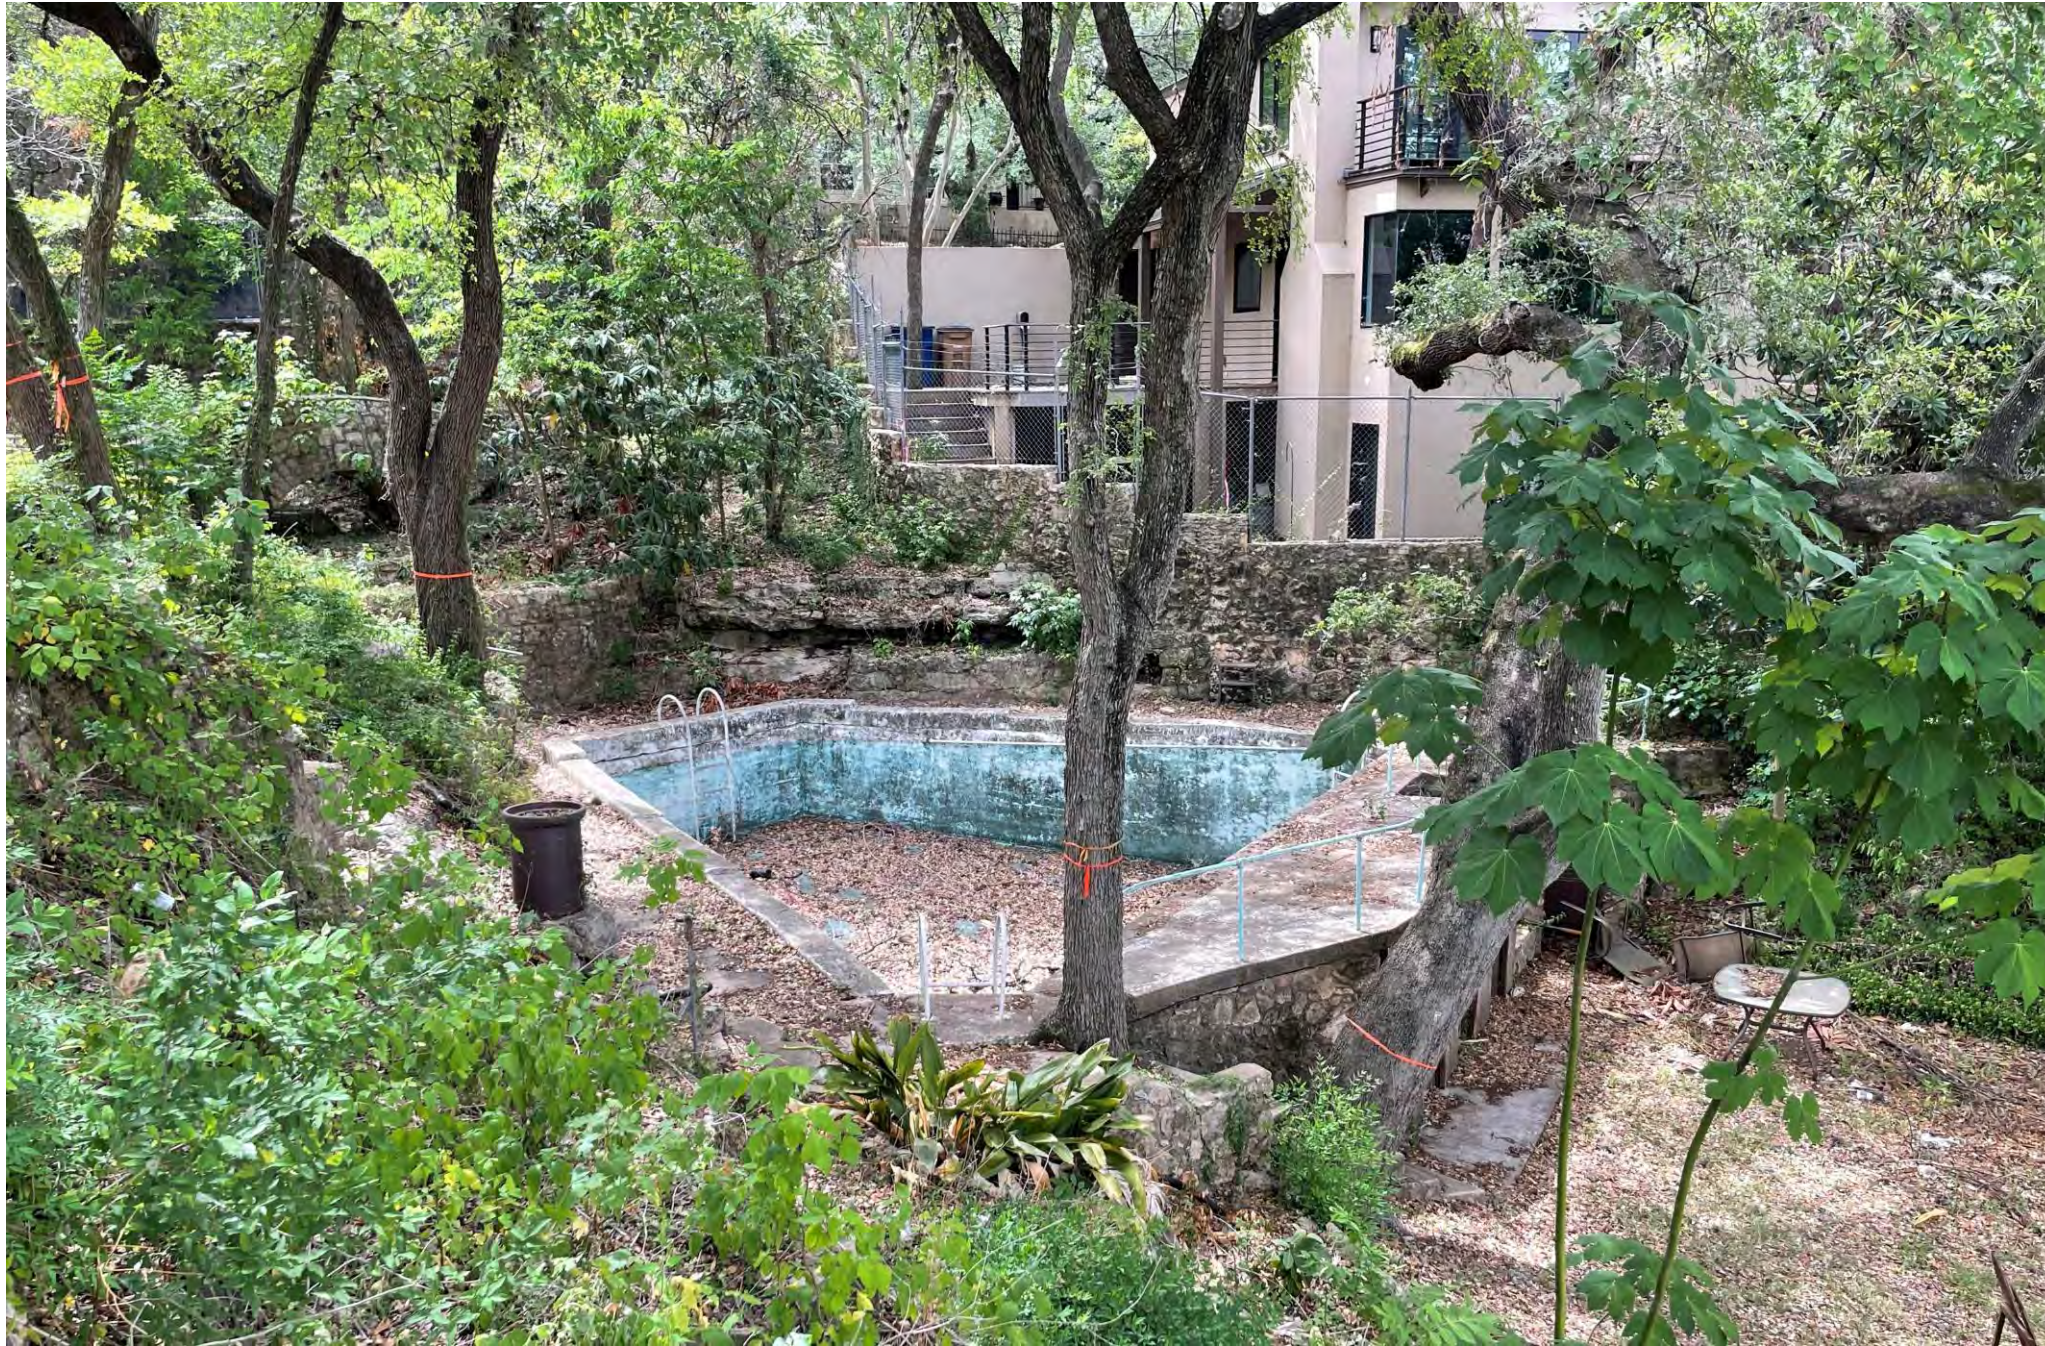
1. THE POOL'S STONE AND CONCRETE ARE SPLITTING APART AND CRACKING.
