# Engineer's Report

Assessment of structural conditions  
2002 Scenic Drive, Austin, Texas

21206.01

June 20, 2022

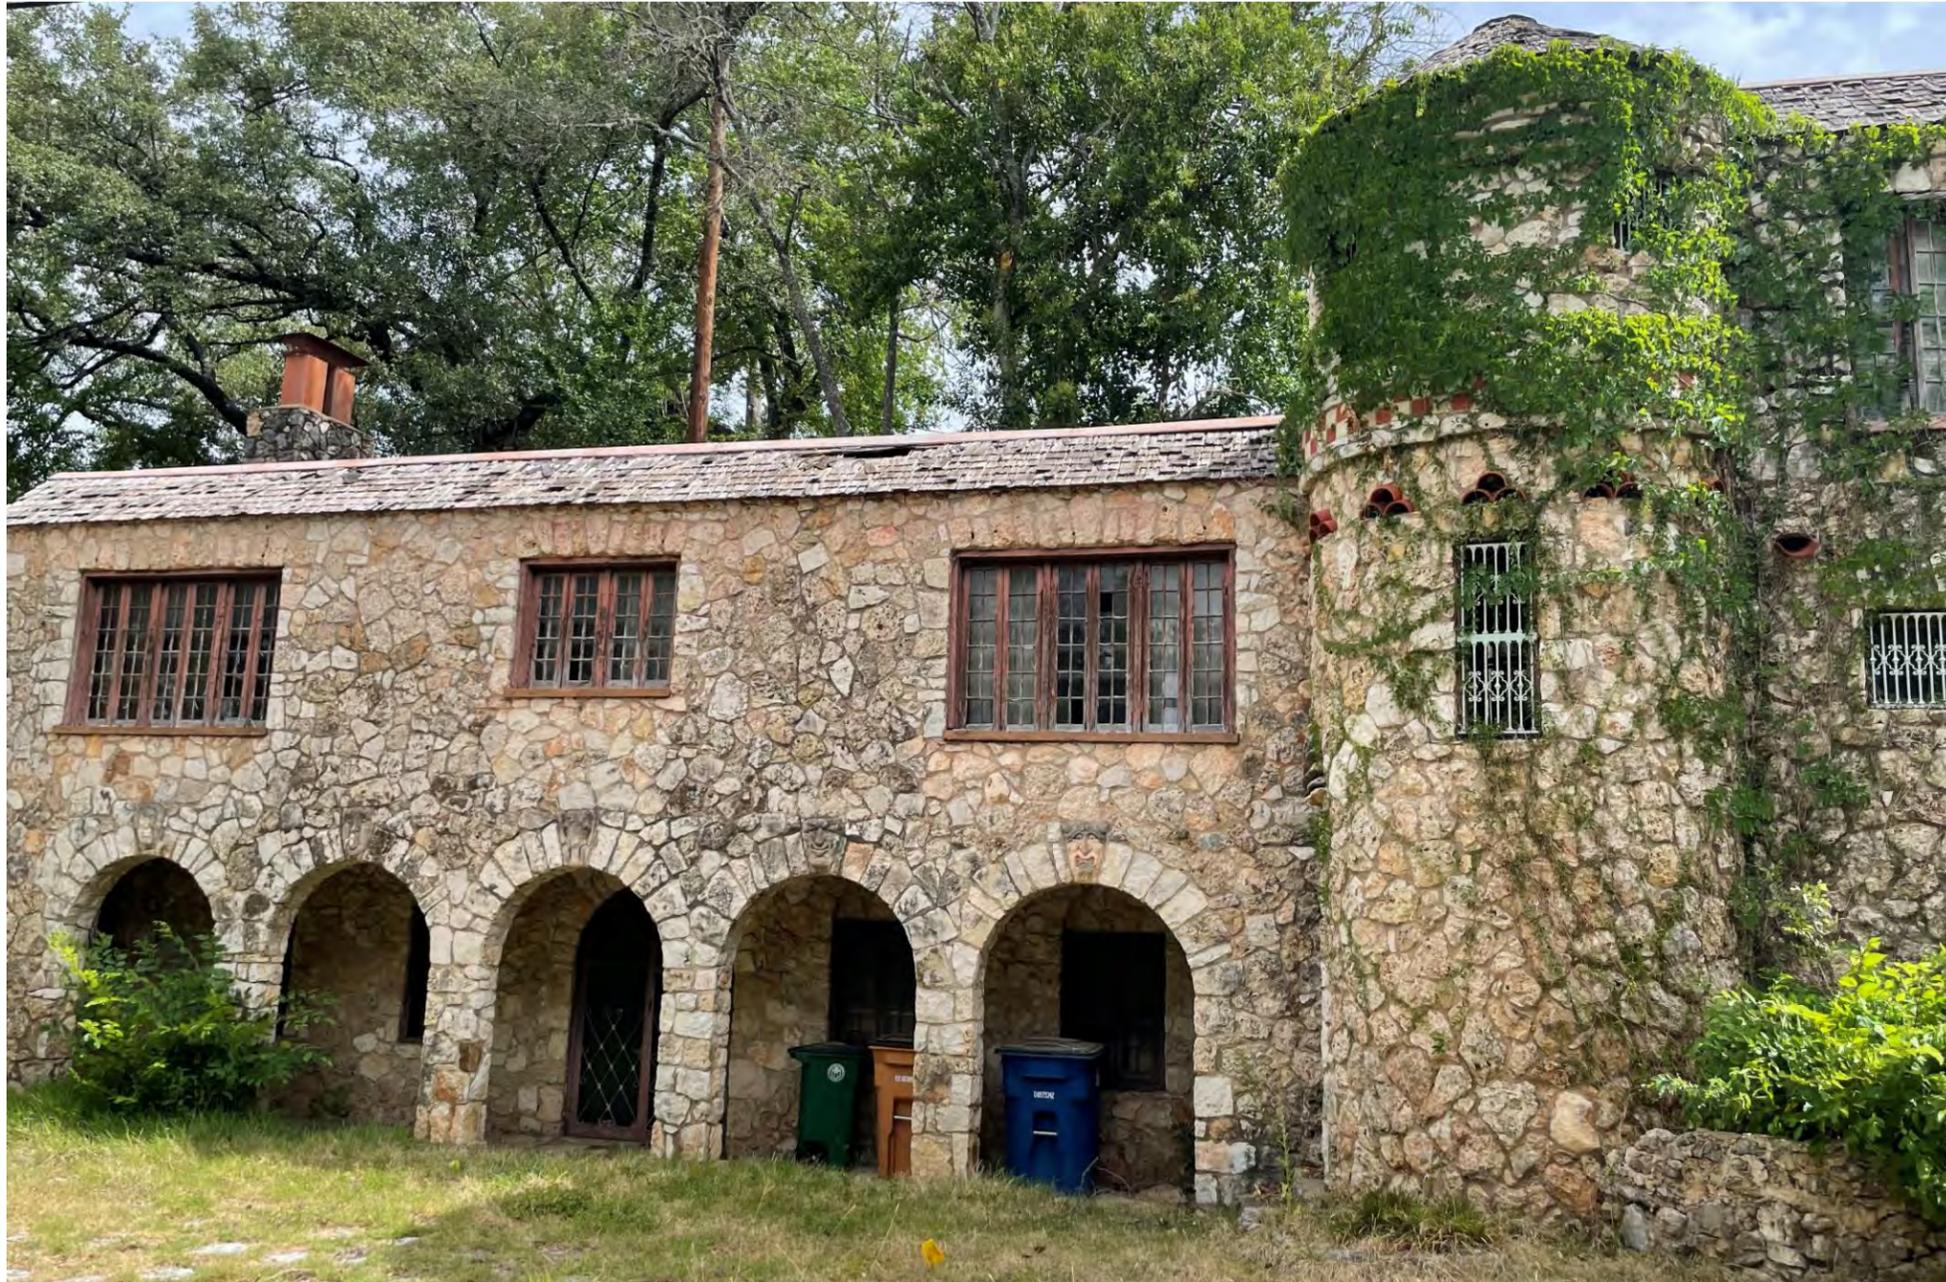
APARTMENT EXTERIOR

1. ROOF DAMAGE INDICATED BY DISPLACED, DAMAGAGED AND MISSING SHINGLES. HOLES IN THE ROOF POINT TO BROAD WATER DAMAGE WITHIN AND POTENTIAL DAMAGE TO STRUCTURE.
2. WOOD WINDOWS - JAMBS, SILLS, AND FRAME ARE ROTTED. BROKEN PANES THROUGHOUT.

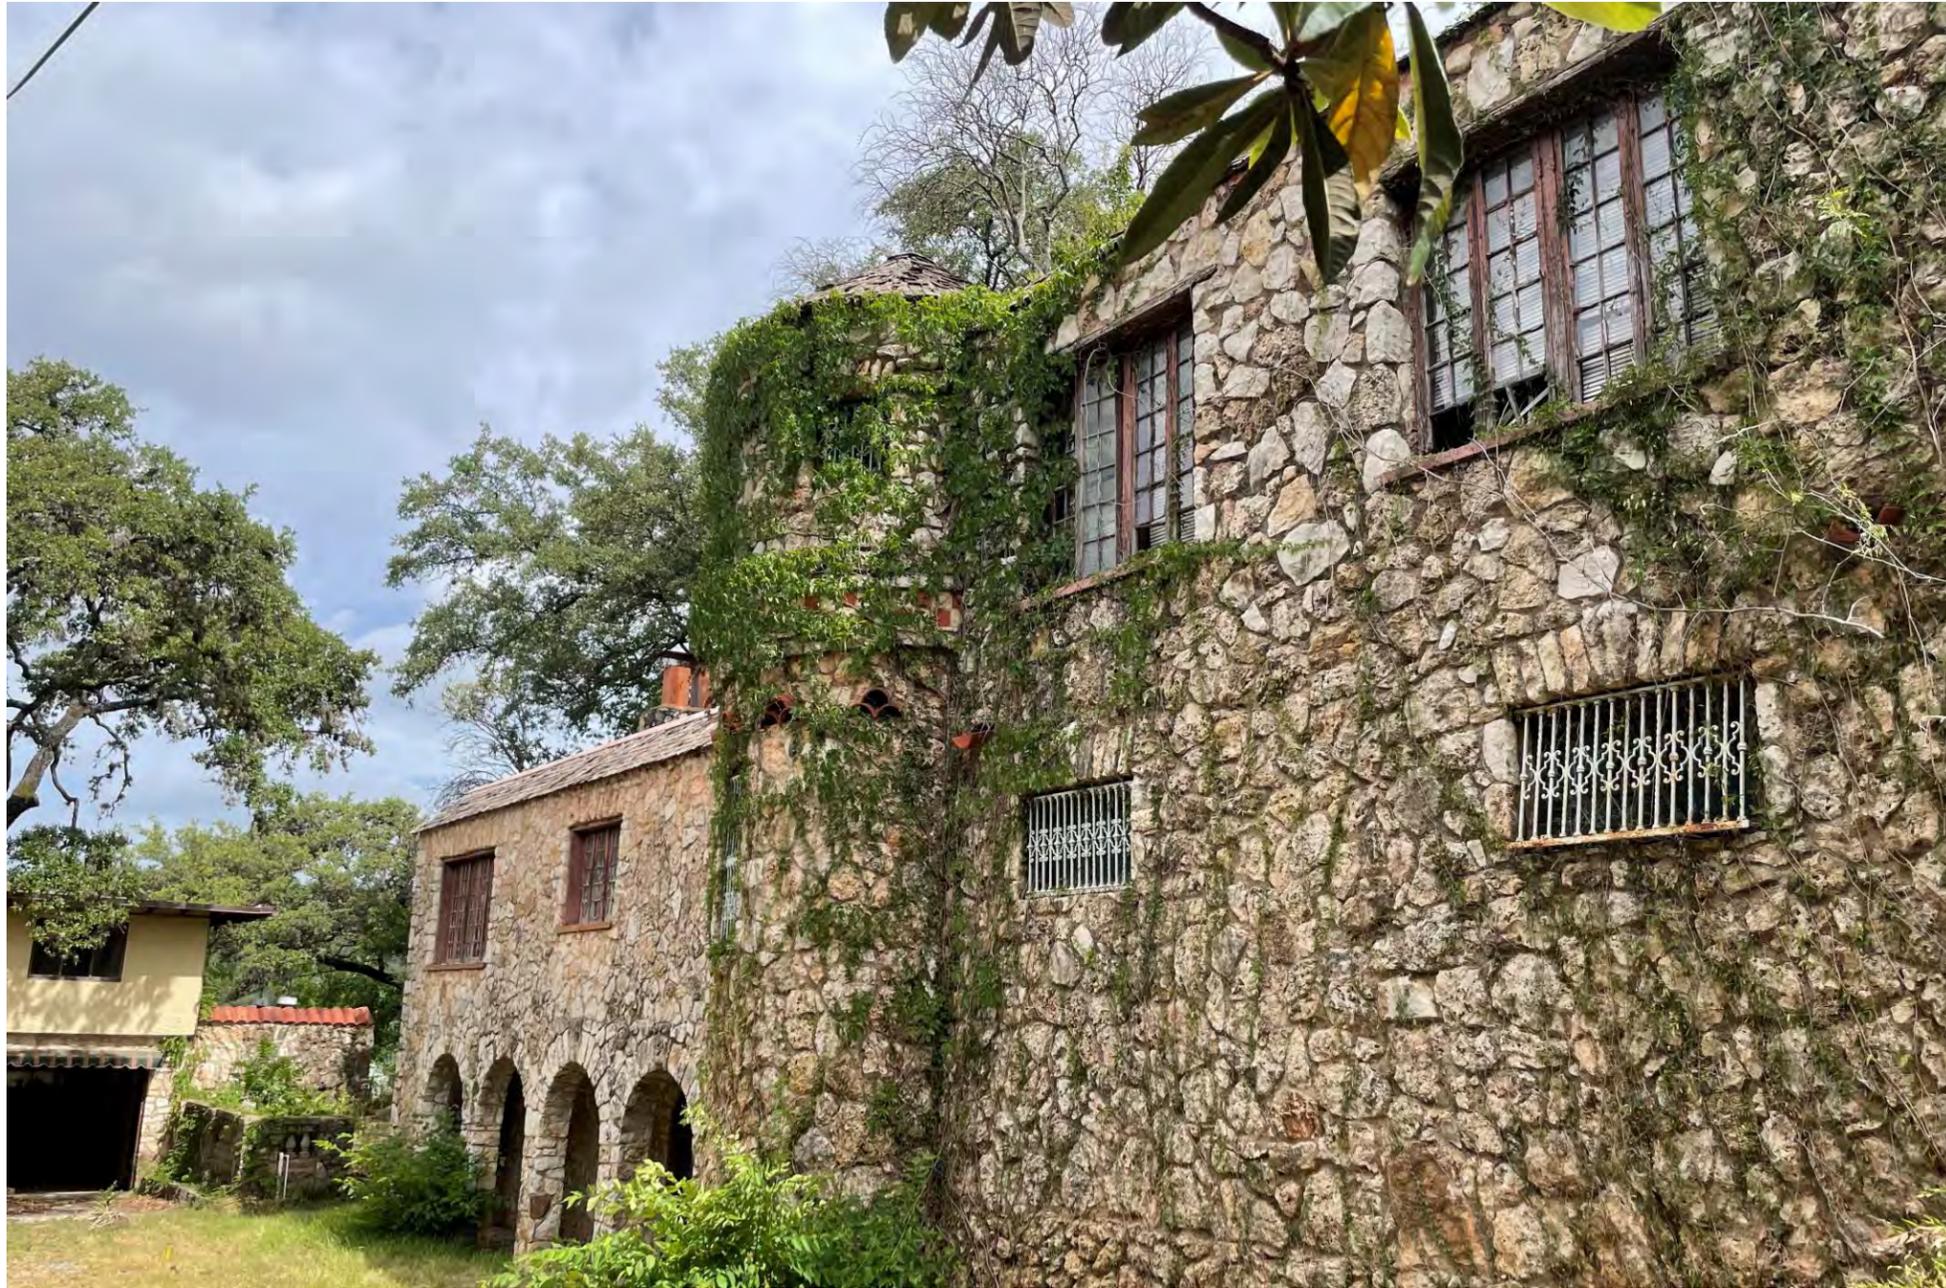
APARTMENT EXTERIOR

1. METAL IS RUSTED AND VINES ARE ENTERING INTO APARTMENT.
2. WOOD WINDOWS - JAMBS, SILLS, AND FRAME ARE ROTTED. BROKEN PANES THROUGHOUT. VINES ARE OVERGROWN AND ARE ENTERING INTO THE INTERIOR.

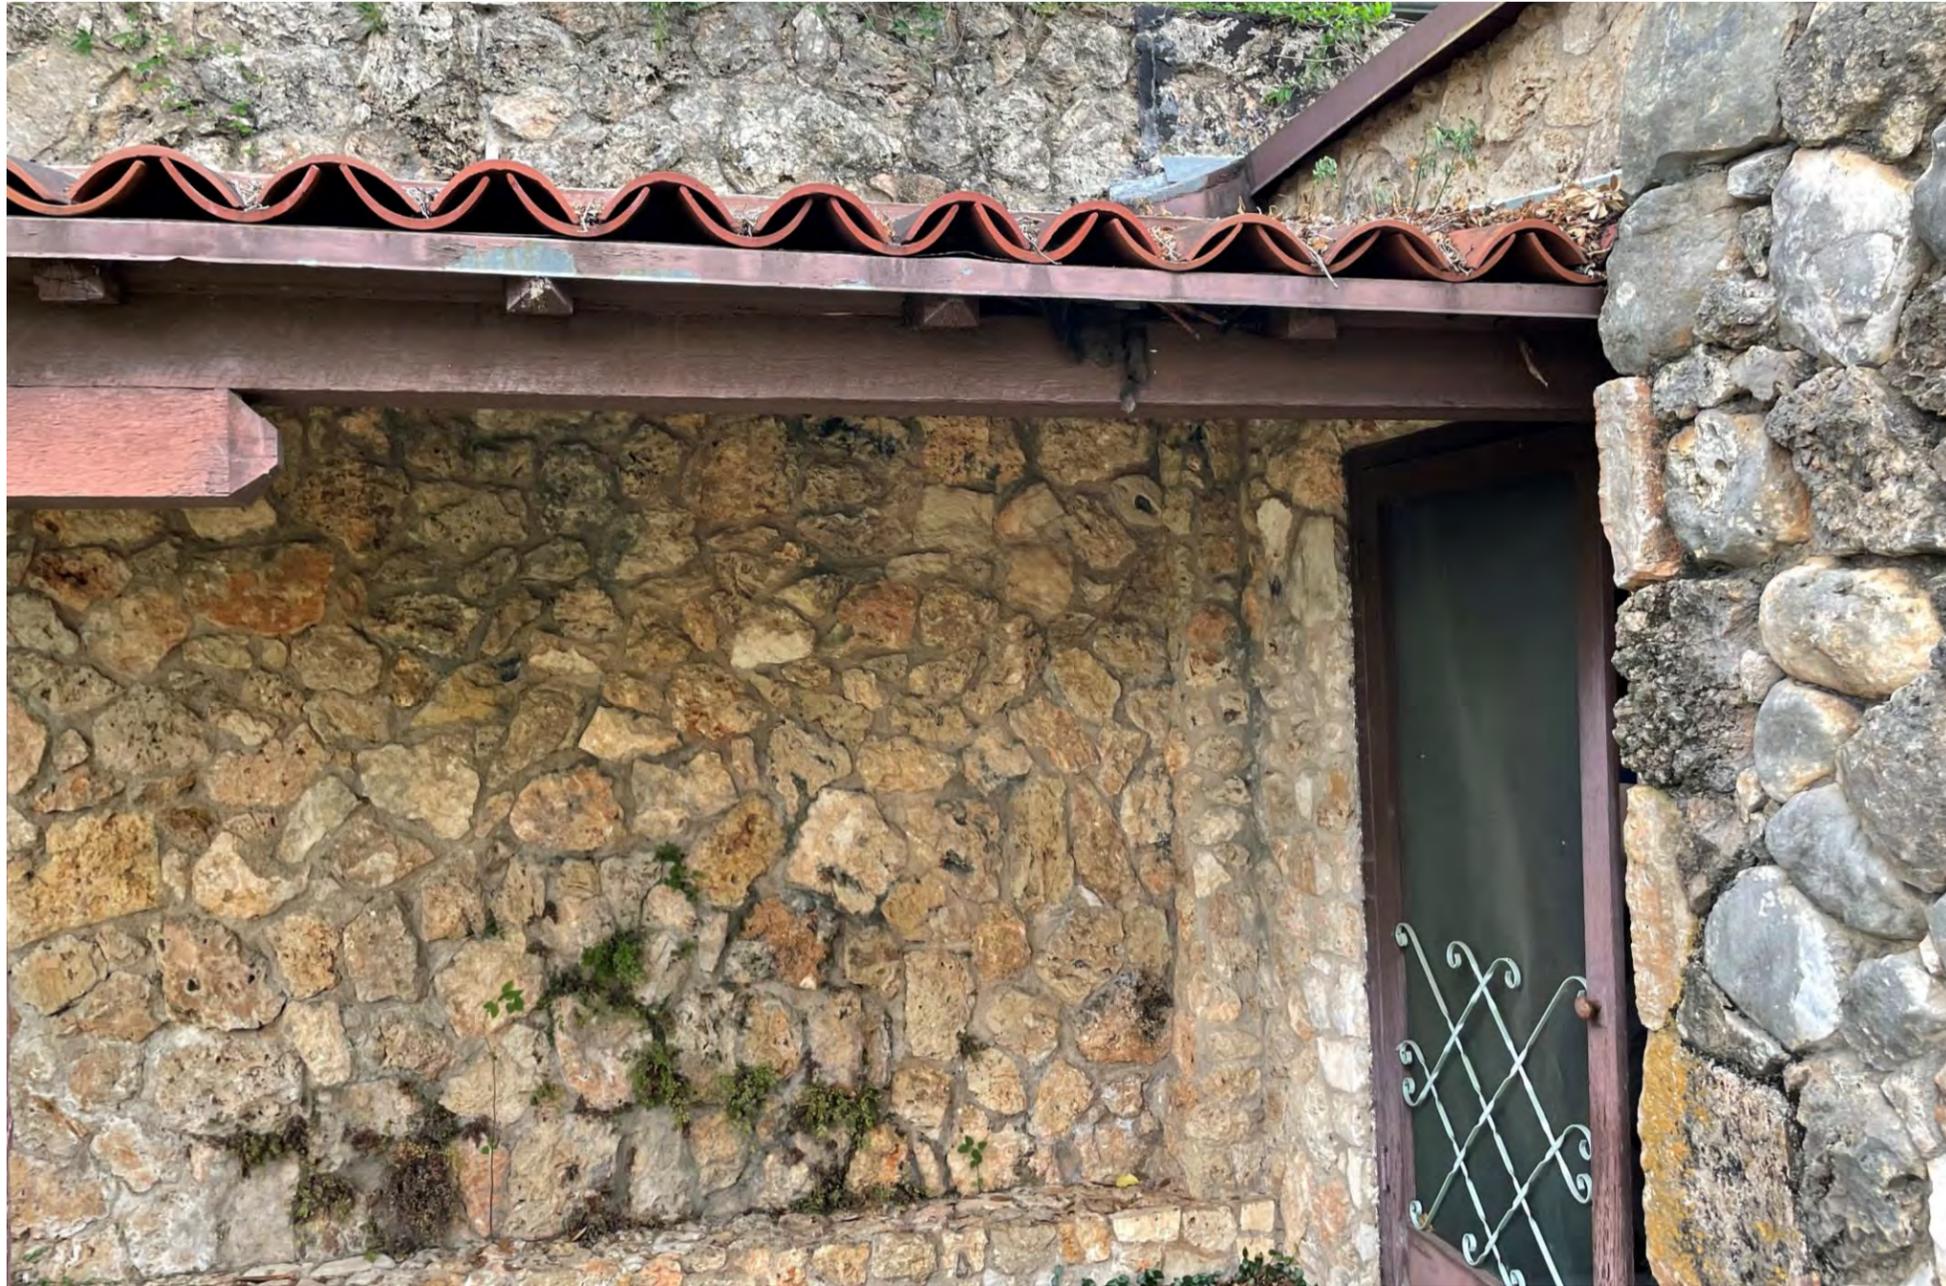
APARTMENT EXTERIOR

1. THE ROOF IS FALLING APART AND IS SHOWING SIGNS OF WATER DAMAGE.
2. THE ROOF IS SLANTING, WHICH IS A SIGN OF STRUCTURAL FAILURE AND MATERIAL DETERIORATION.

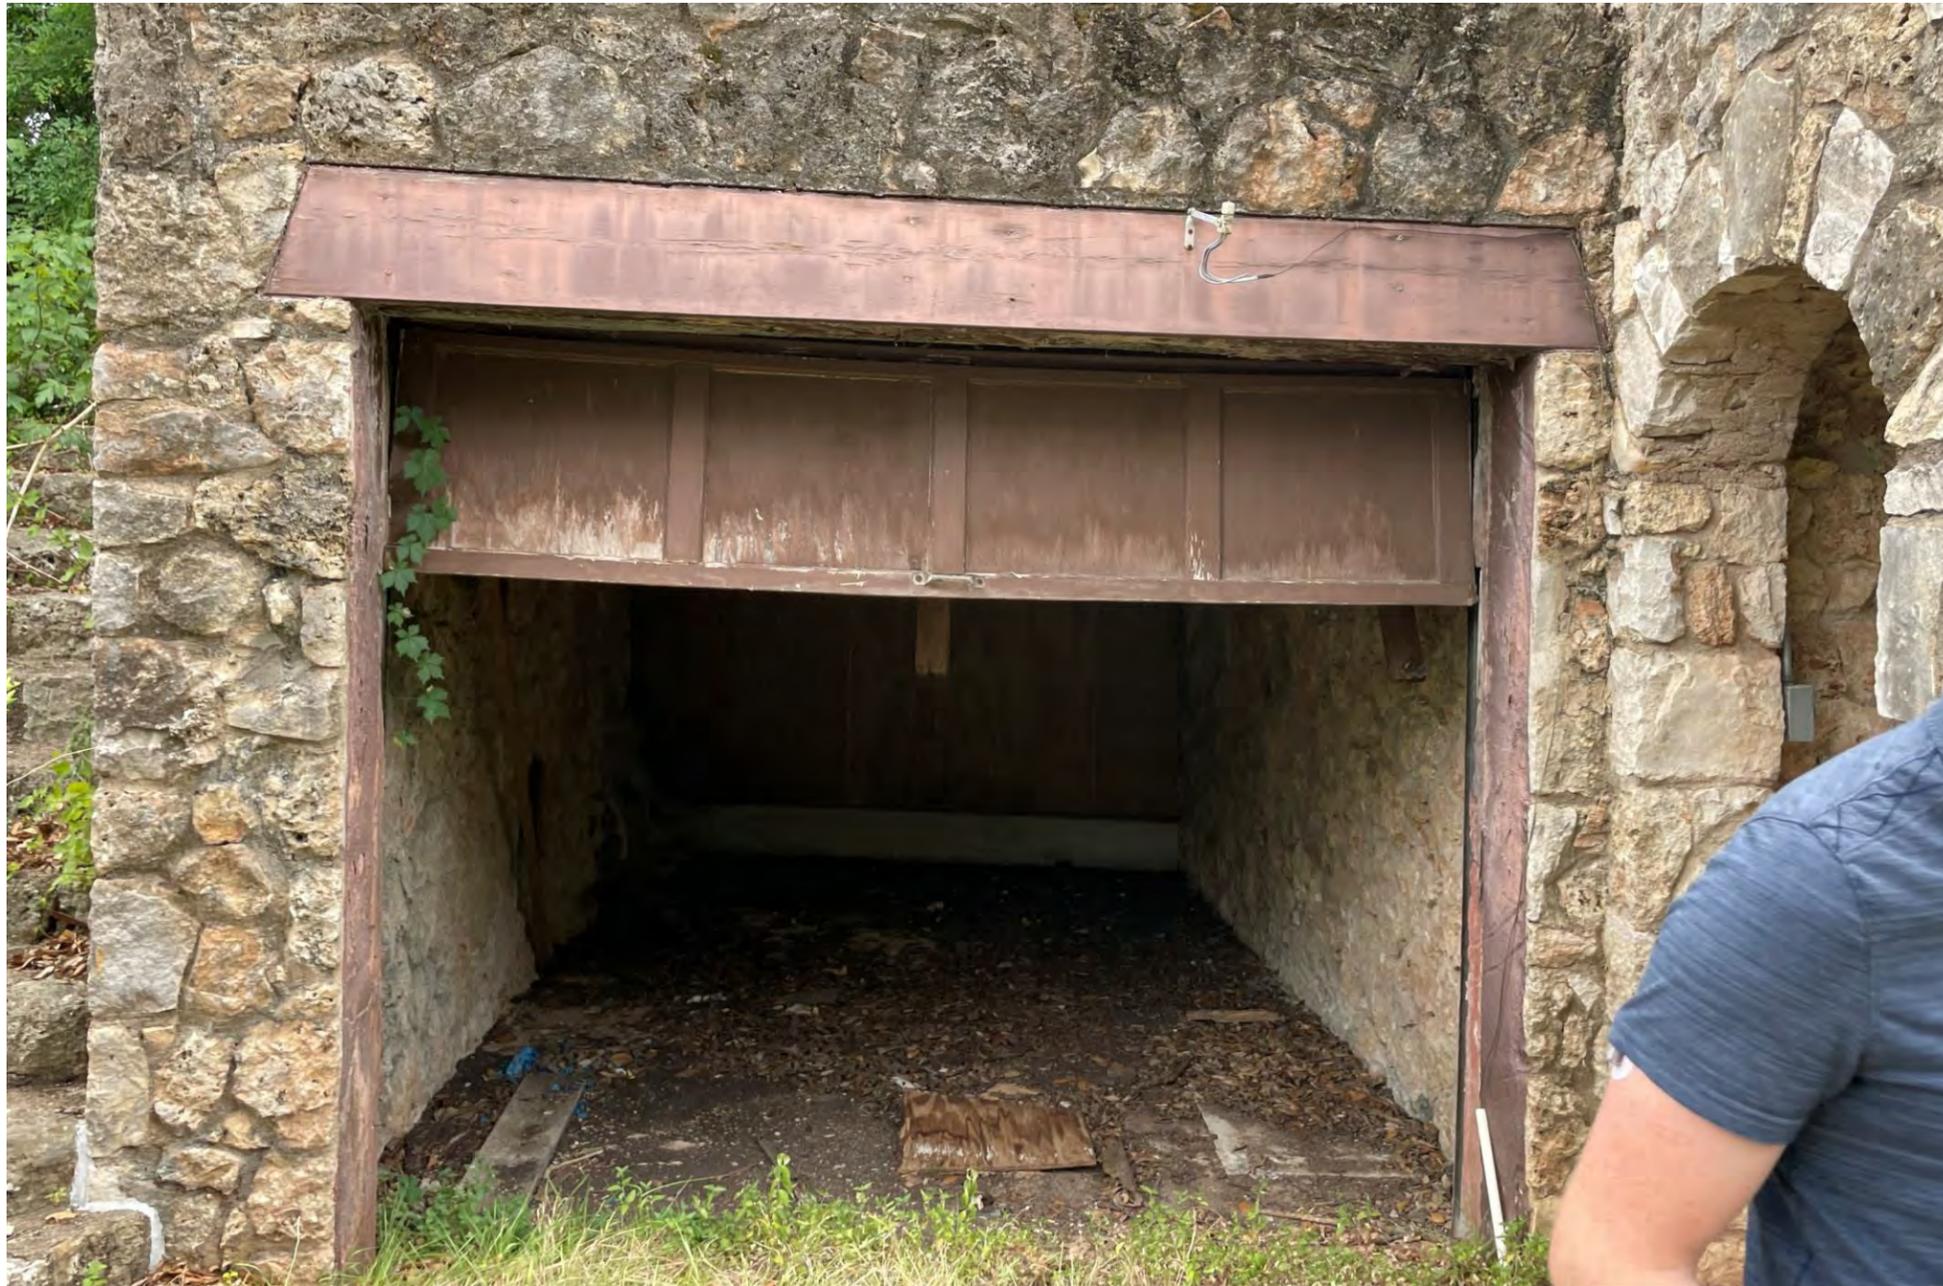
APARTMENT EXTERIOR

1. THE UNDERSIDE OF THE GARAGE ROCK WALL IS SHOWING SIGNS OF MOLDING.
2. THE ROOF OF THE GARAGE IS MOLDING AND HAS WATER DAMAGE.

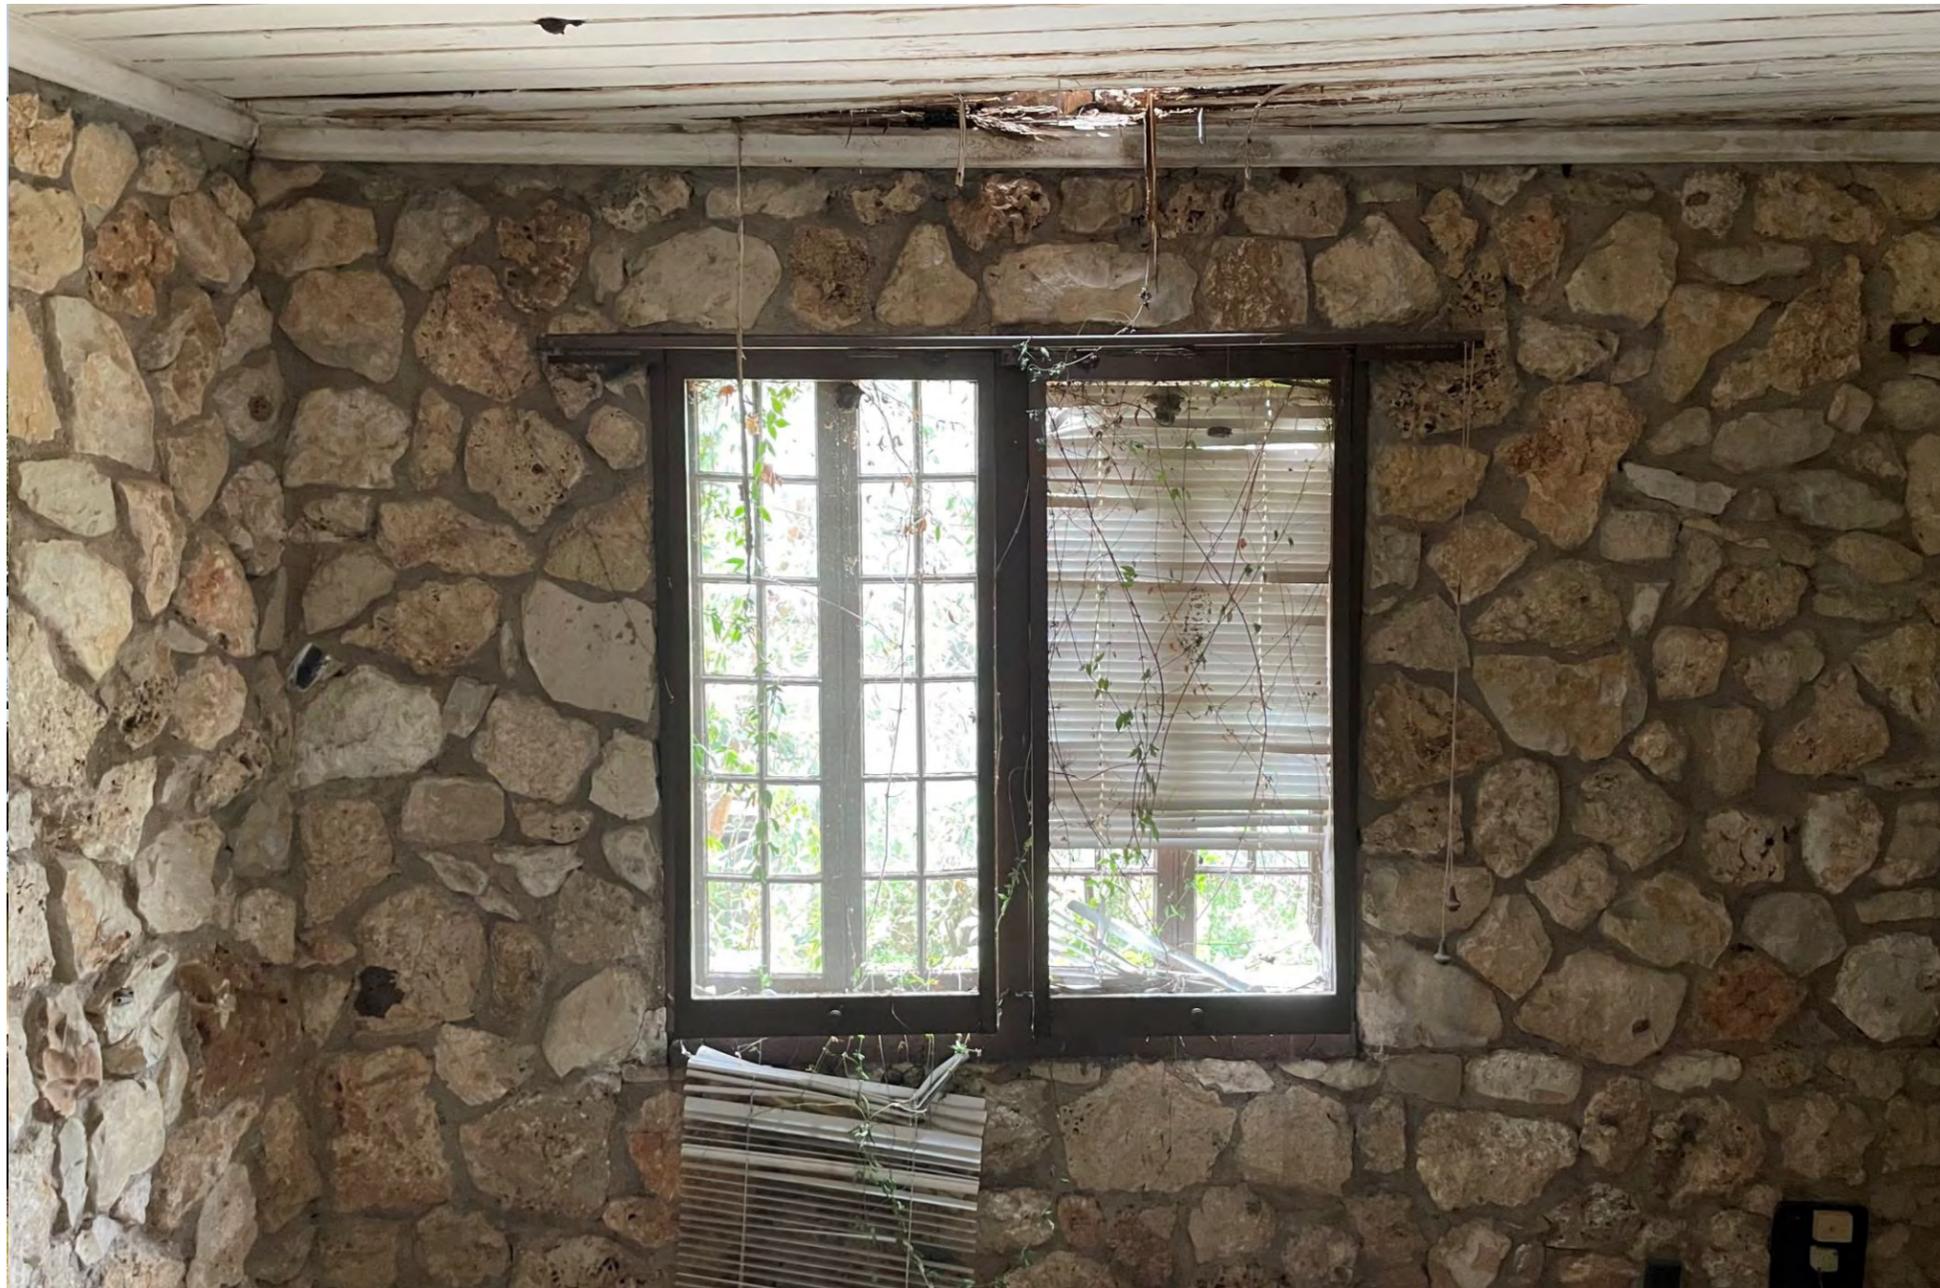
APARTMENT INTERIOR

1. HOLES IN CEILING AND ROOF - SKY VISIBLE THROUGH INTERIOR CEILINGS AND ROOF. VINES HAVE INVADDED STRUCTURE THROUGH BOTH ROOF AND BROKEN WINDOWS.
2. WATER DAMAGE - EVIDENCE OF LONG-TERM WATER DAMAGE APPARENT ON CEILINGS, WALLS, AND FLOORS.

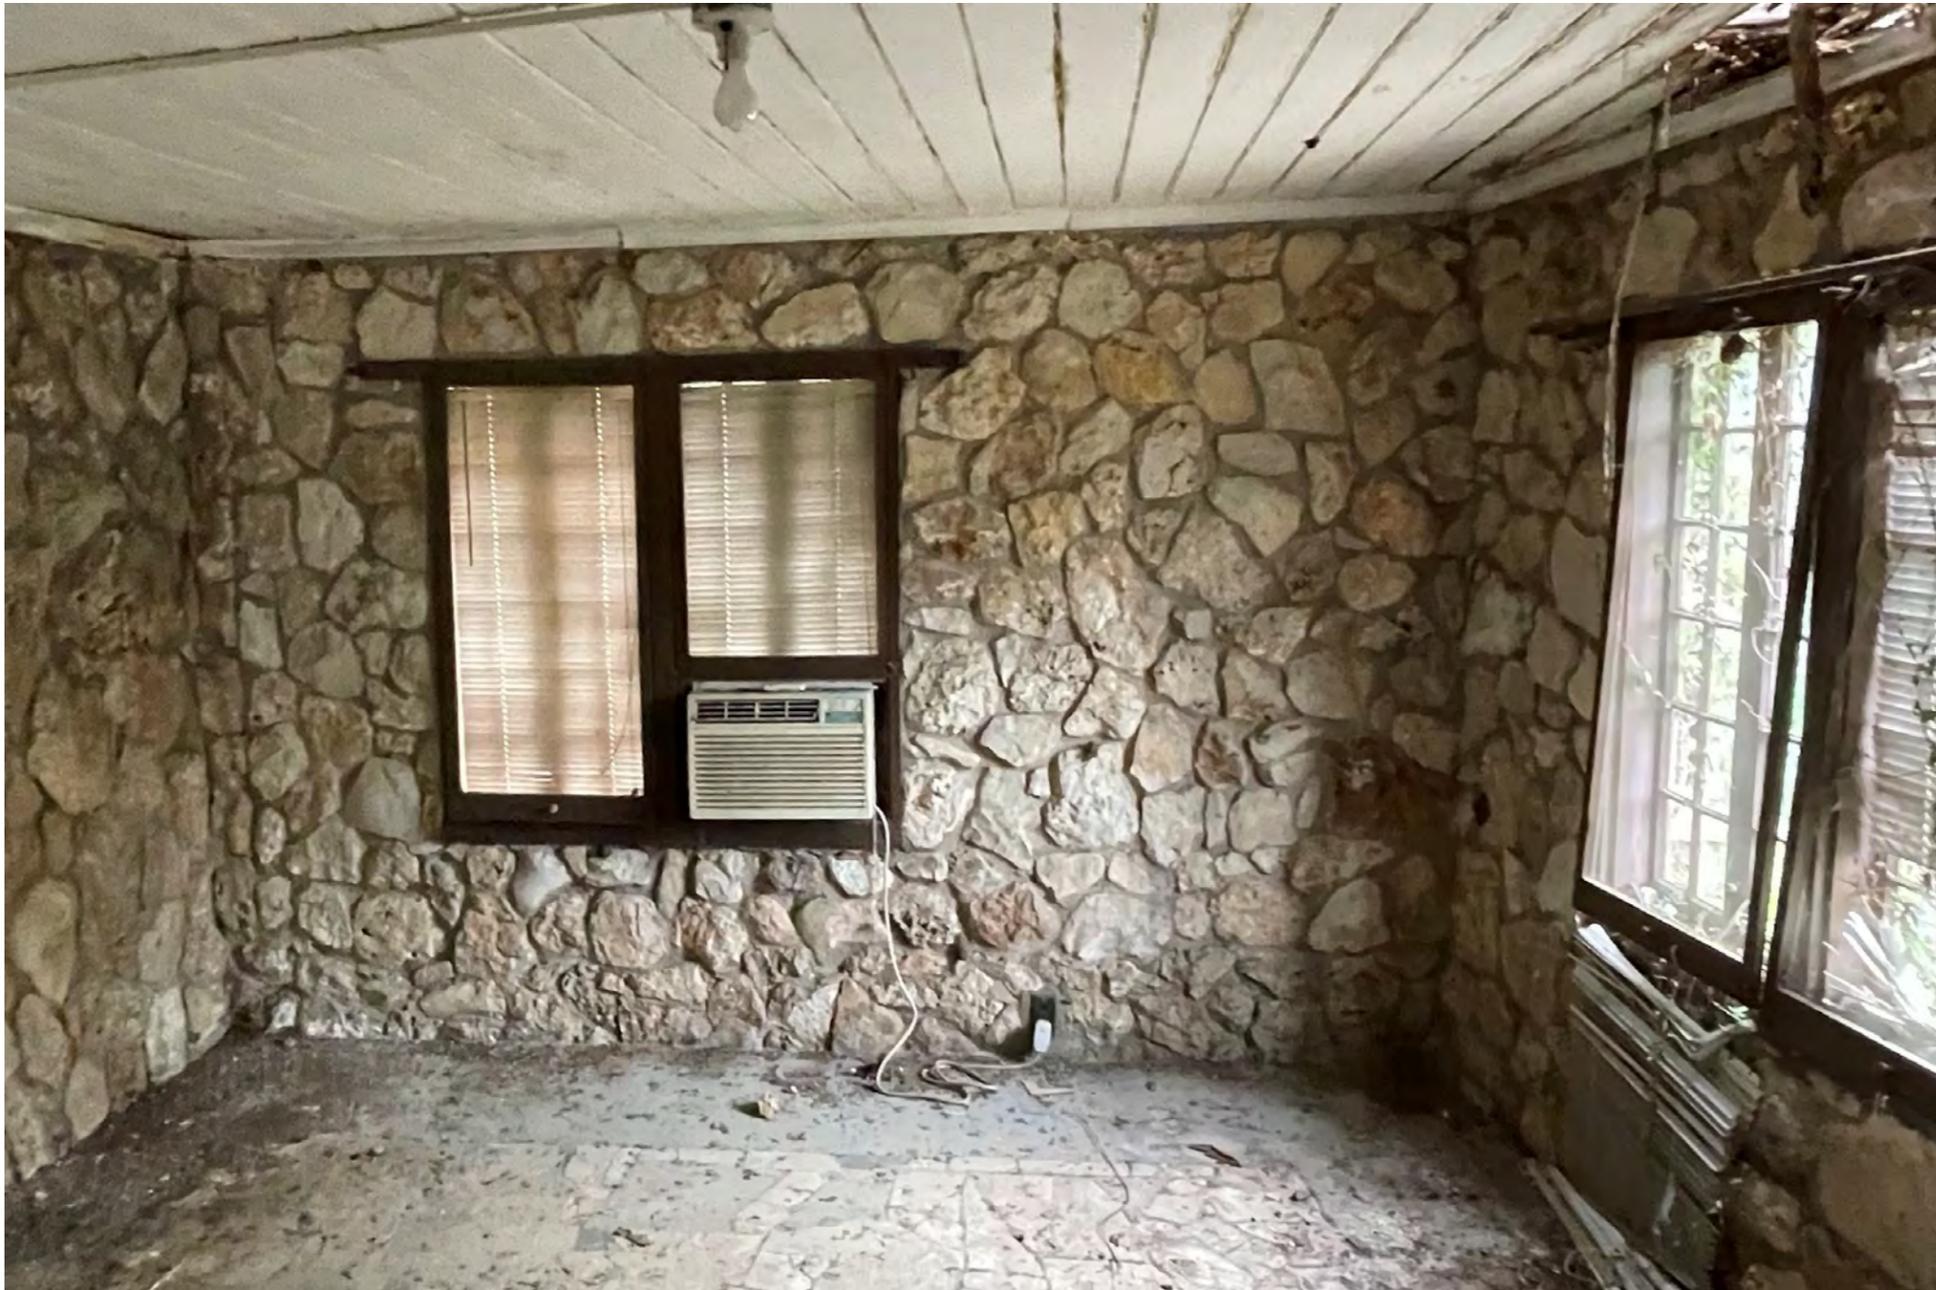
APARTMENT INTERIOR

1. DISCOLORATION AND ROT SHOWS SIGNS OF WATER DAMAGE.
2. WATER DAMAGE - DISCOLORATION AND DEBRIS INDICATE LONG-TERM WATER DAMAGE ON CEILINGS, WALLS, AND FLOORS.

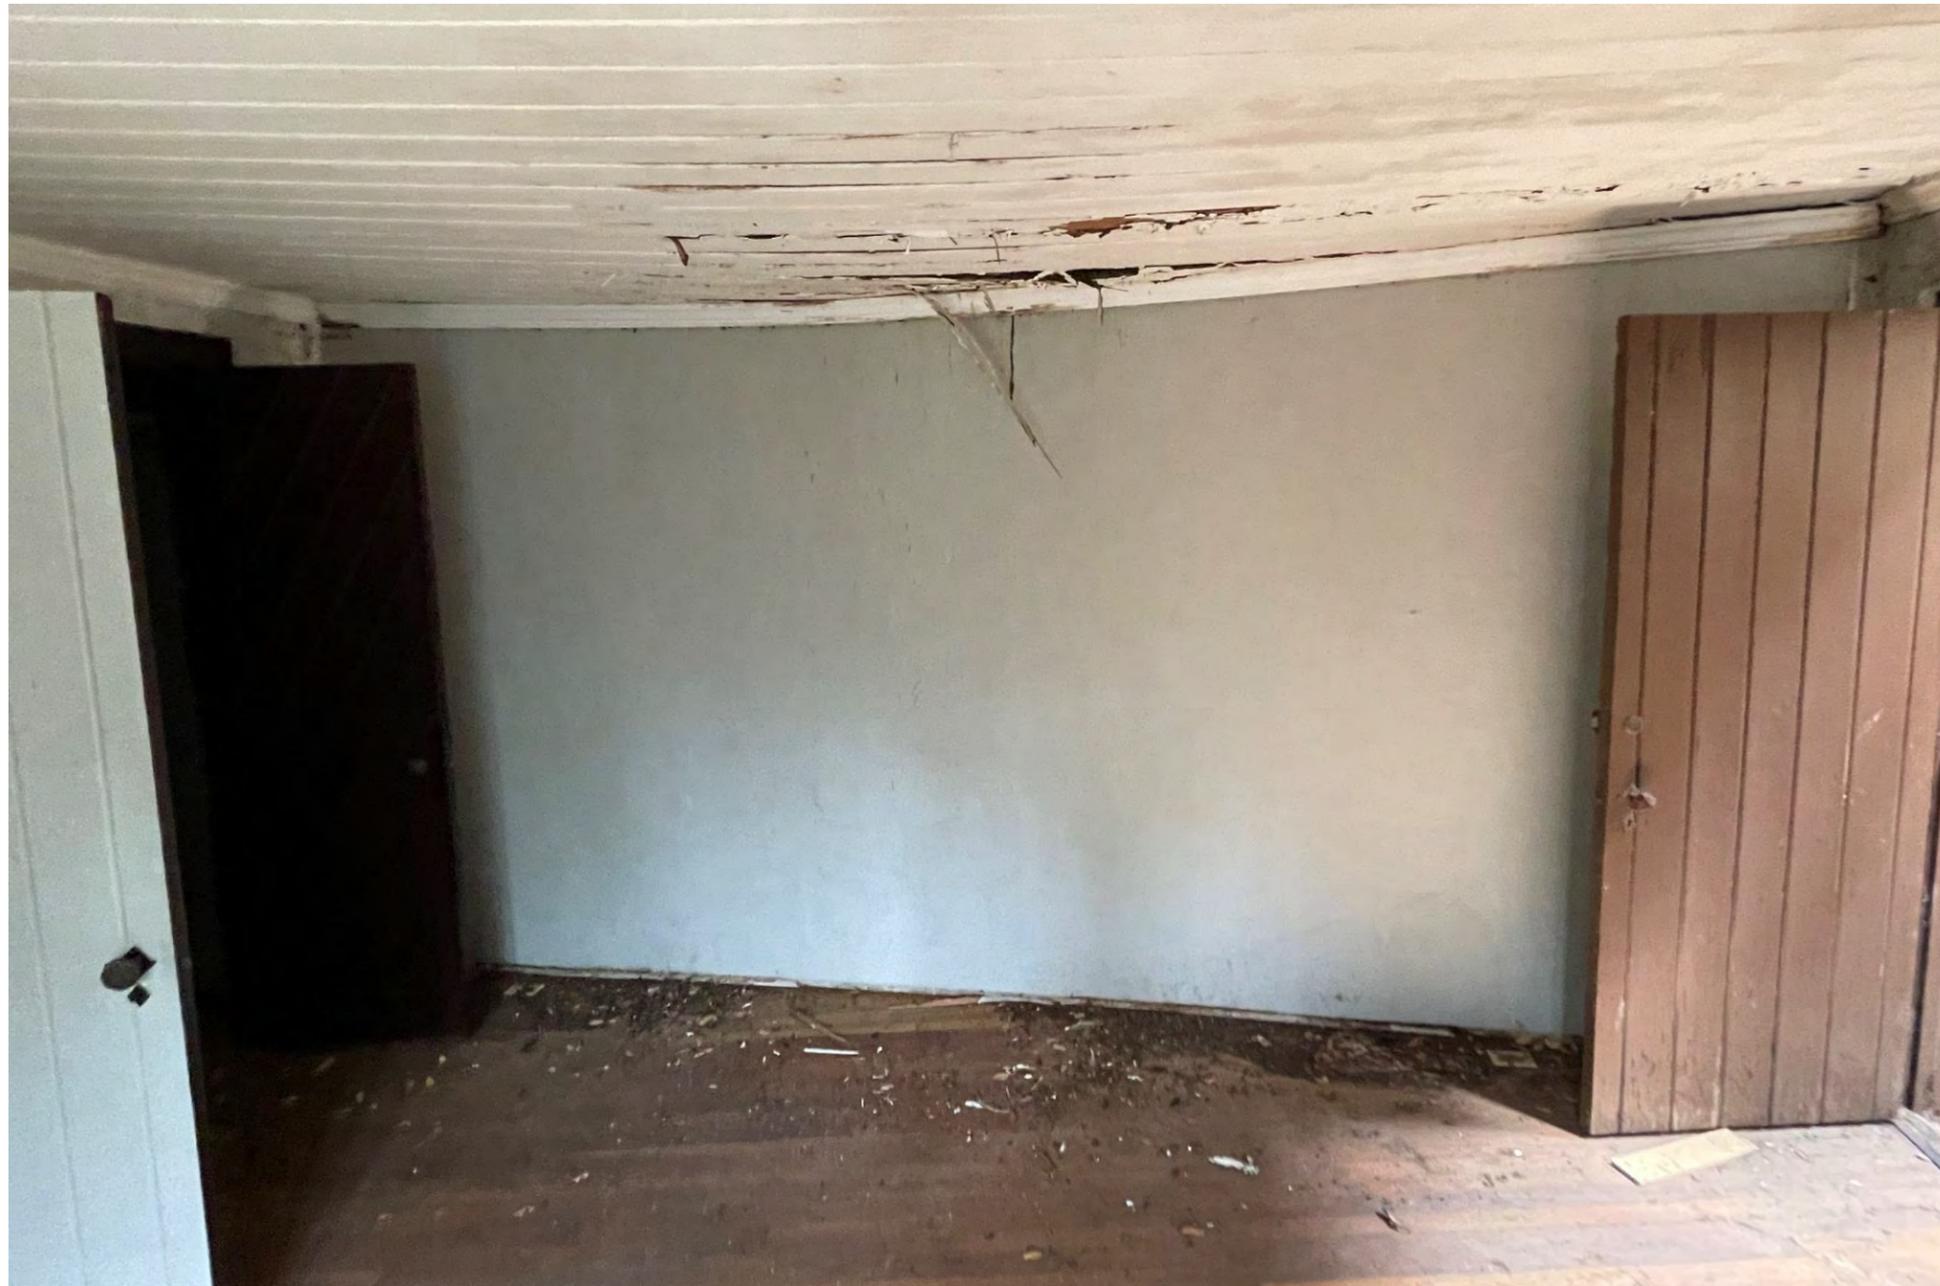
APARTMENT INTERIOR

1. THE CEILING IS BOWED AND SHOWS SIGNS OF WATER DAMAGE AND DETERIORATION.
2. DUE TO THE CEILING FAILURE, DIRT AND DEBRIS ARE COLLECTING ON THE FLOOR BELOW.

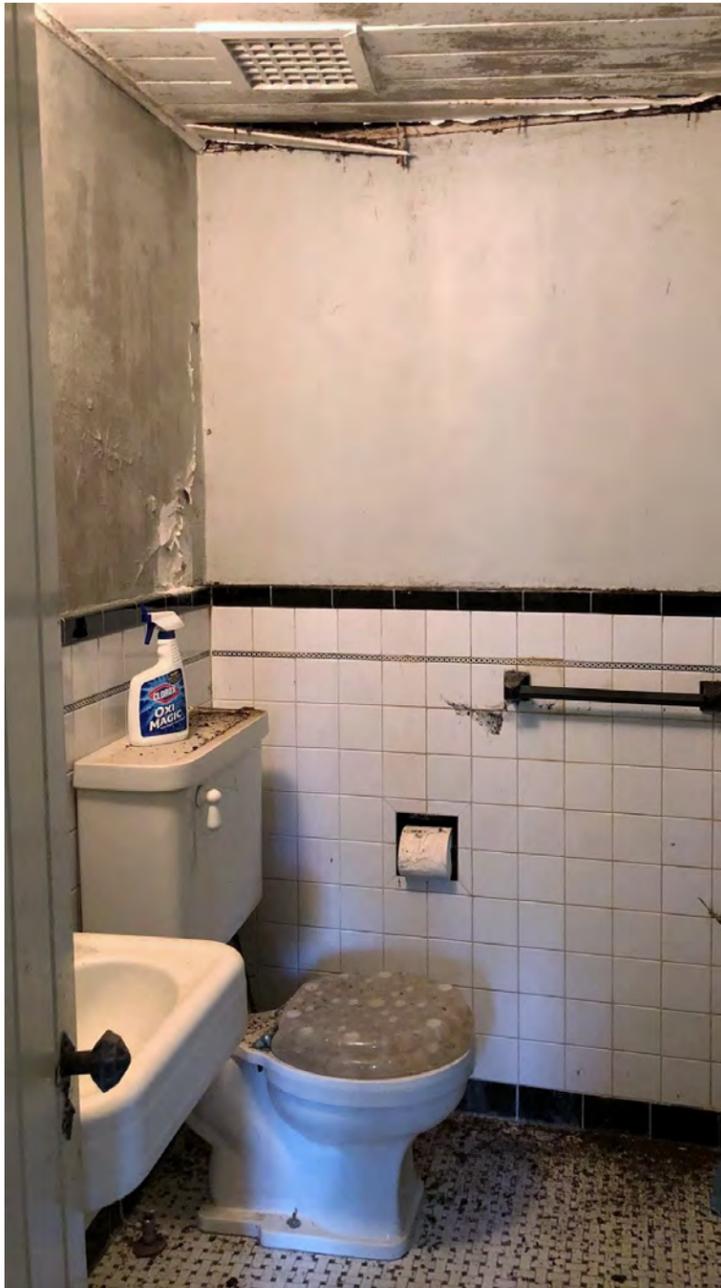
APARTMENT INTERIOR

1. DEBRIS HAS COLLECTED INSIDE THE BATHTUB, SHOWING WATER DAMAGE AND CEILING FAILURE.
2. THE CEILING HAS MOLD GROWING ON THE SURFACE OF THE WOOD, WHICH IS CAUSING FAILURE AND COMPROMISING THE MATERIAL.

3. THE CEILING IN THE BATHROOM IS DETERIORATING AND MOLDING.

4. THE CEILING OVER THE BATHTUB IS DETERIORATING AND ALLOWING DEBRIS TO COLLECT IN THE TUB.

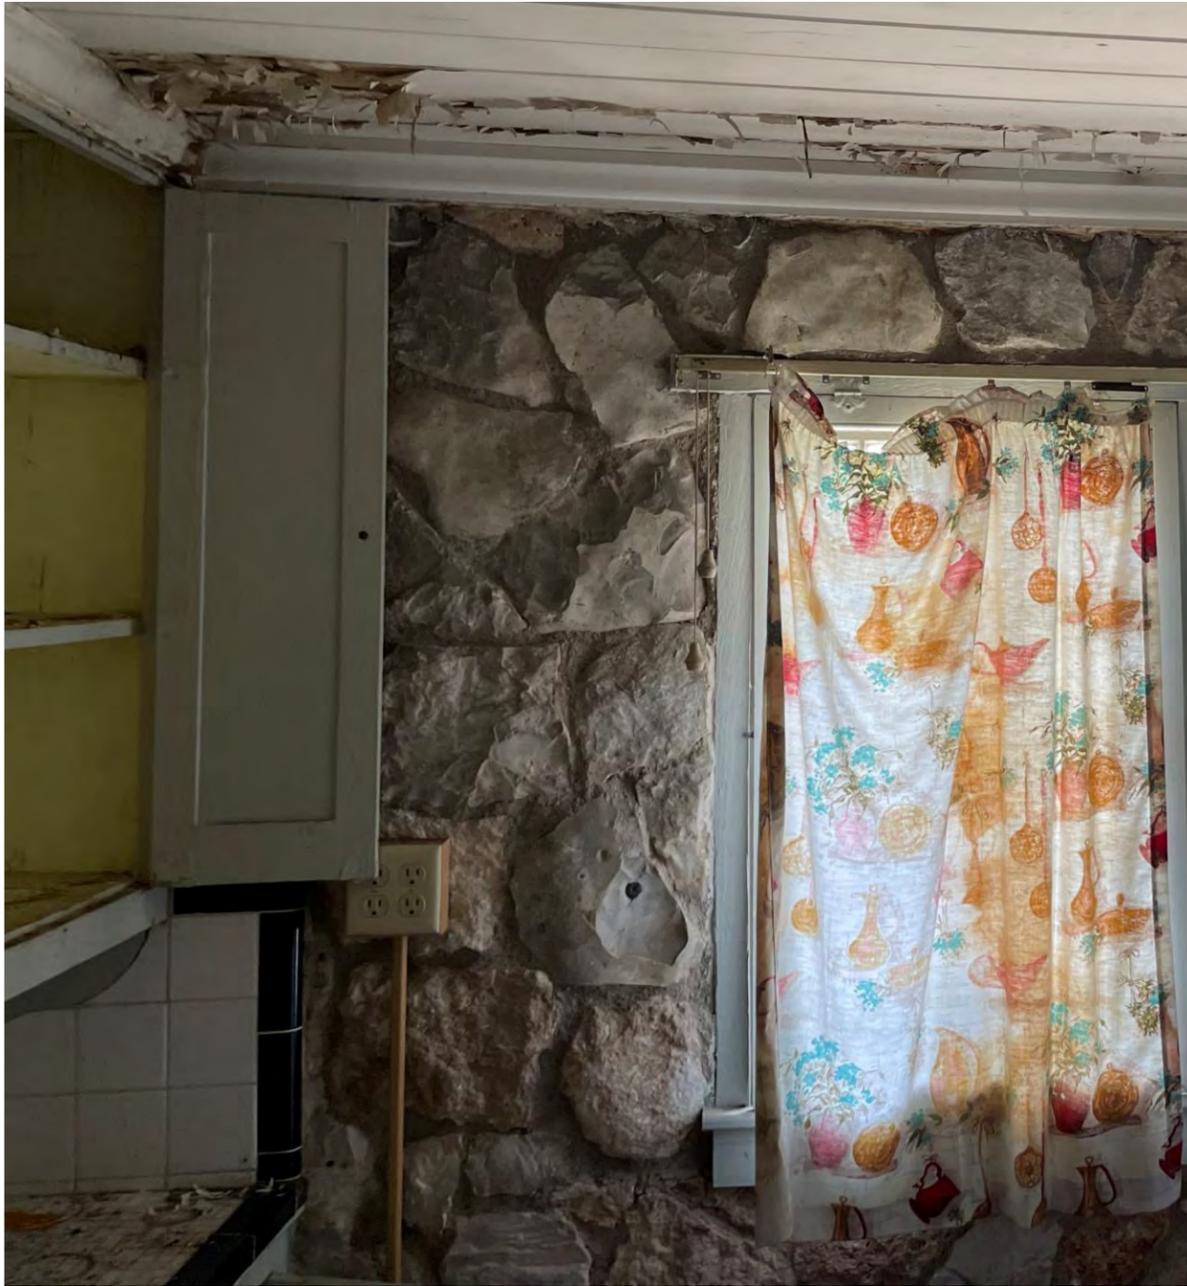
APARTMENT INTERIOR

1. WOOD CEILING IS ROTTED, FALLING APART, AND SEPERATING.
2. CEILING FAILURE HAS OPENED THE INTERIOR UP TO EXTERIOR LIGHT, WATER, AND AIR. WATER DAMAGE CAN BE SEEN ON THE WALL AND CEILING.
3. THE KITCHEN CEILING AND STRUCTURE HAS DETERIORATED AND IS FALLING APART.

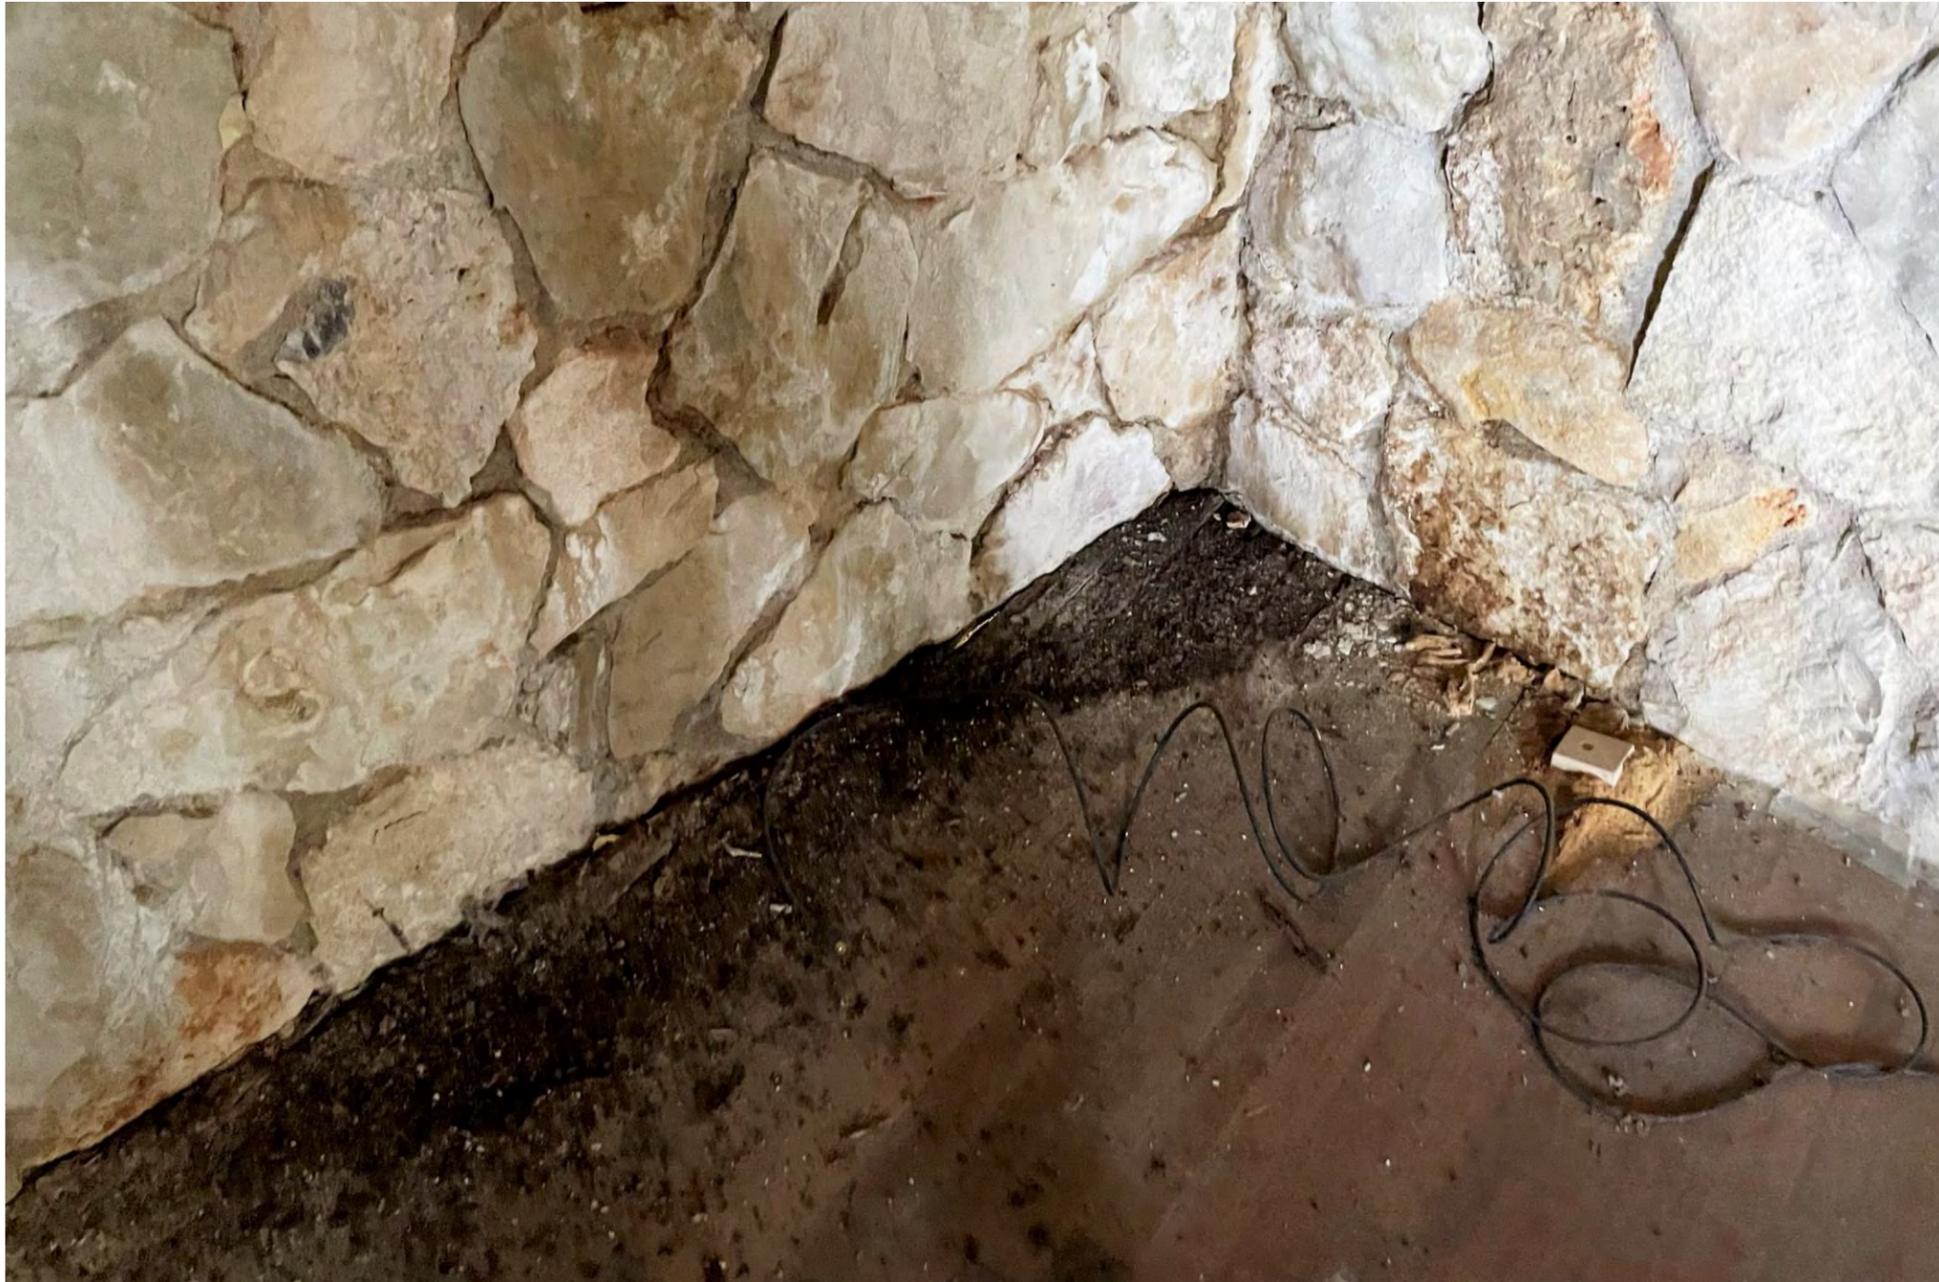
#### APARTMENT INTERIOR

1. CEILING FAILURE HAS ALLOWED DEBRIS AND DIRT TO COLLECT INSIDE THE APARTMENT. THE WOODEN FLOOR IS CRACKING AND DETERIORATING FROM WATER DAMAGE.
2. THE WOODEN FLOOR IS FALLING APART AND SEPERATING FROM THE WALL.
