# Engineer's Report

Assessment of structural conditions  
2002 Scenic Drive, Austin, Texas

21206.01

June 20, 2022

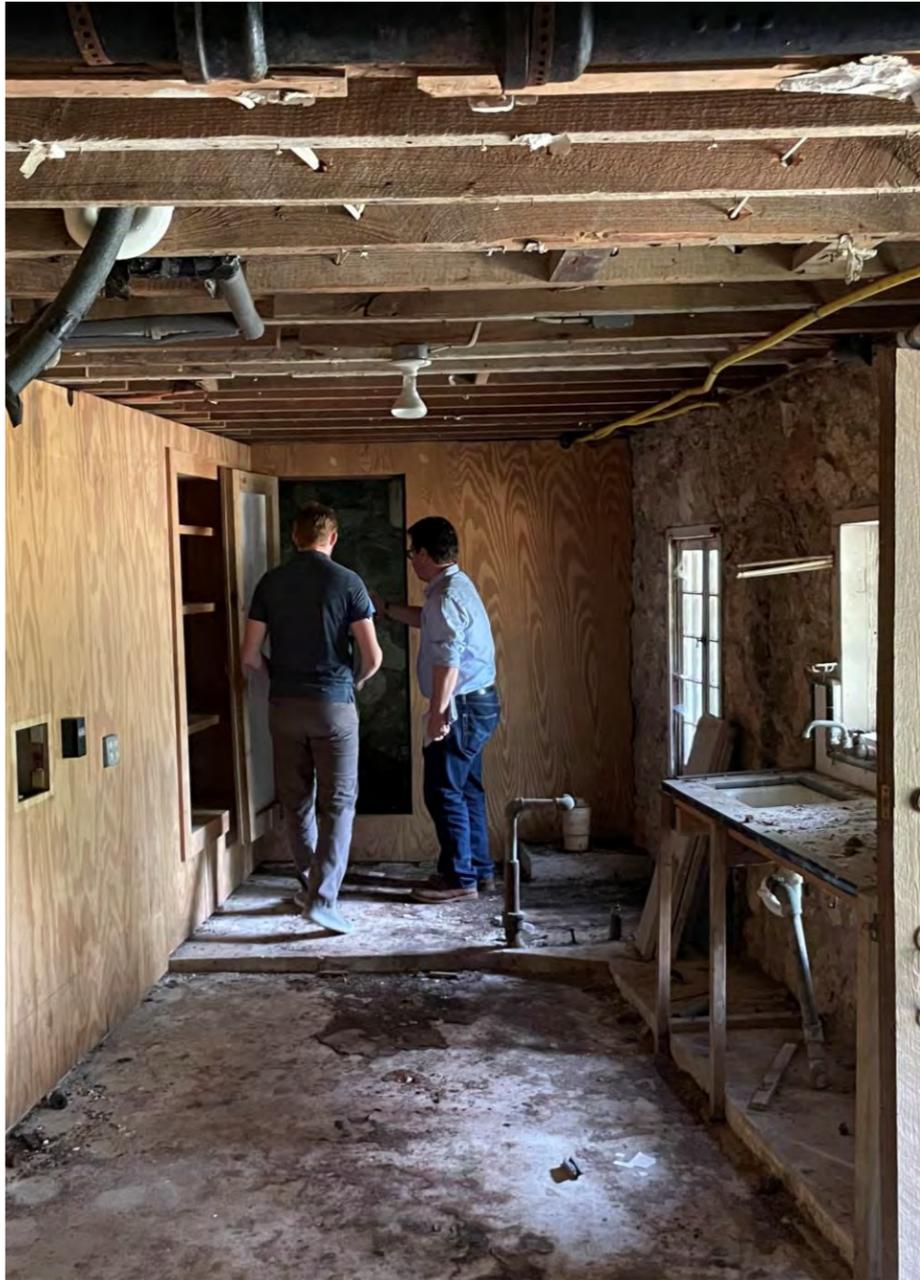
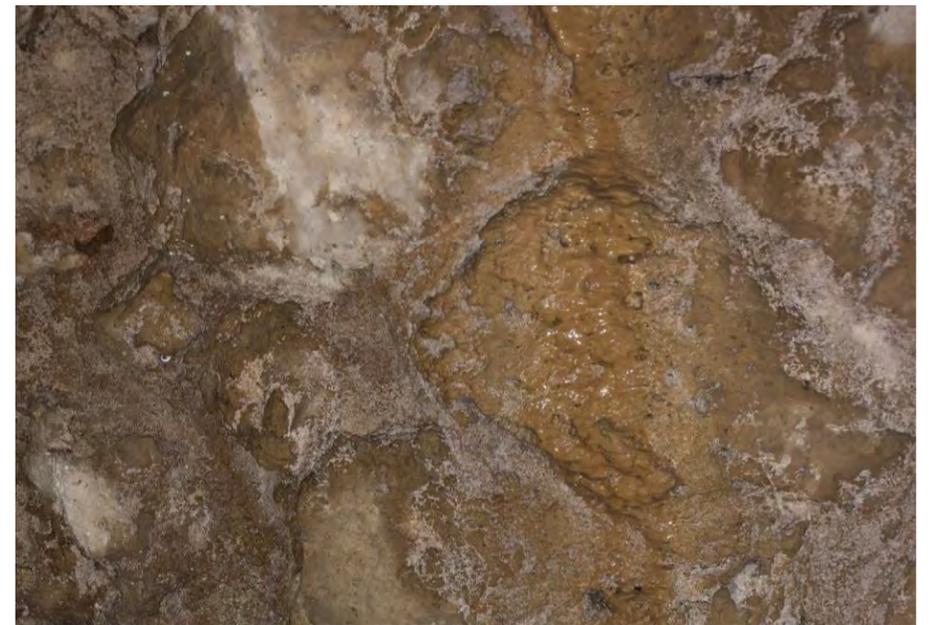
The existing floor joists are supported in slots gouged into the face of the exposed limestone cut (photo 1, page 16), which was leaching water (photo 3, page 16) during my visits despite no antecedent rainfall. The ends of the joists are spliced onto the original joists as part of a previous repair which was undoubtedly caused by previous similar rot. The splices are not adequate and show clear signs of deflection and distress. The repair ends are now showing signs of rot. These structural connections are inadequate and dangerous.

The stone wall on the second floor is supported on an inverted steel railroad rail, which is not properly supported at points of bearing or against rotation. The elevated concrete slab over the garage also appears to use steel railroad rails as reinforcement, and the steel shows severe corrosion. Again, I recommend caution under and on this slab until it can be properly shored.

#### APARTMENT INTERIOR

1. WATER IS LEAKING THROUGH THE RETAINING WALL AND INTO THE APARTMENT. WATER CAN ACTIVELY BE SEEN DRIPPING DOWN THE ROCK WALL.
2. IN ORDER TO HOLD UP THE SECOND FLOOR, RAILWAY TIES ARE USED AS STEEL BEAMS.
3. WATER IS DRIPPING DOWN THE ROCK AND FINDS ITS WAY TO THE STRUCTURE'S CONCRETE BASE.

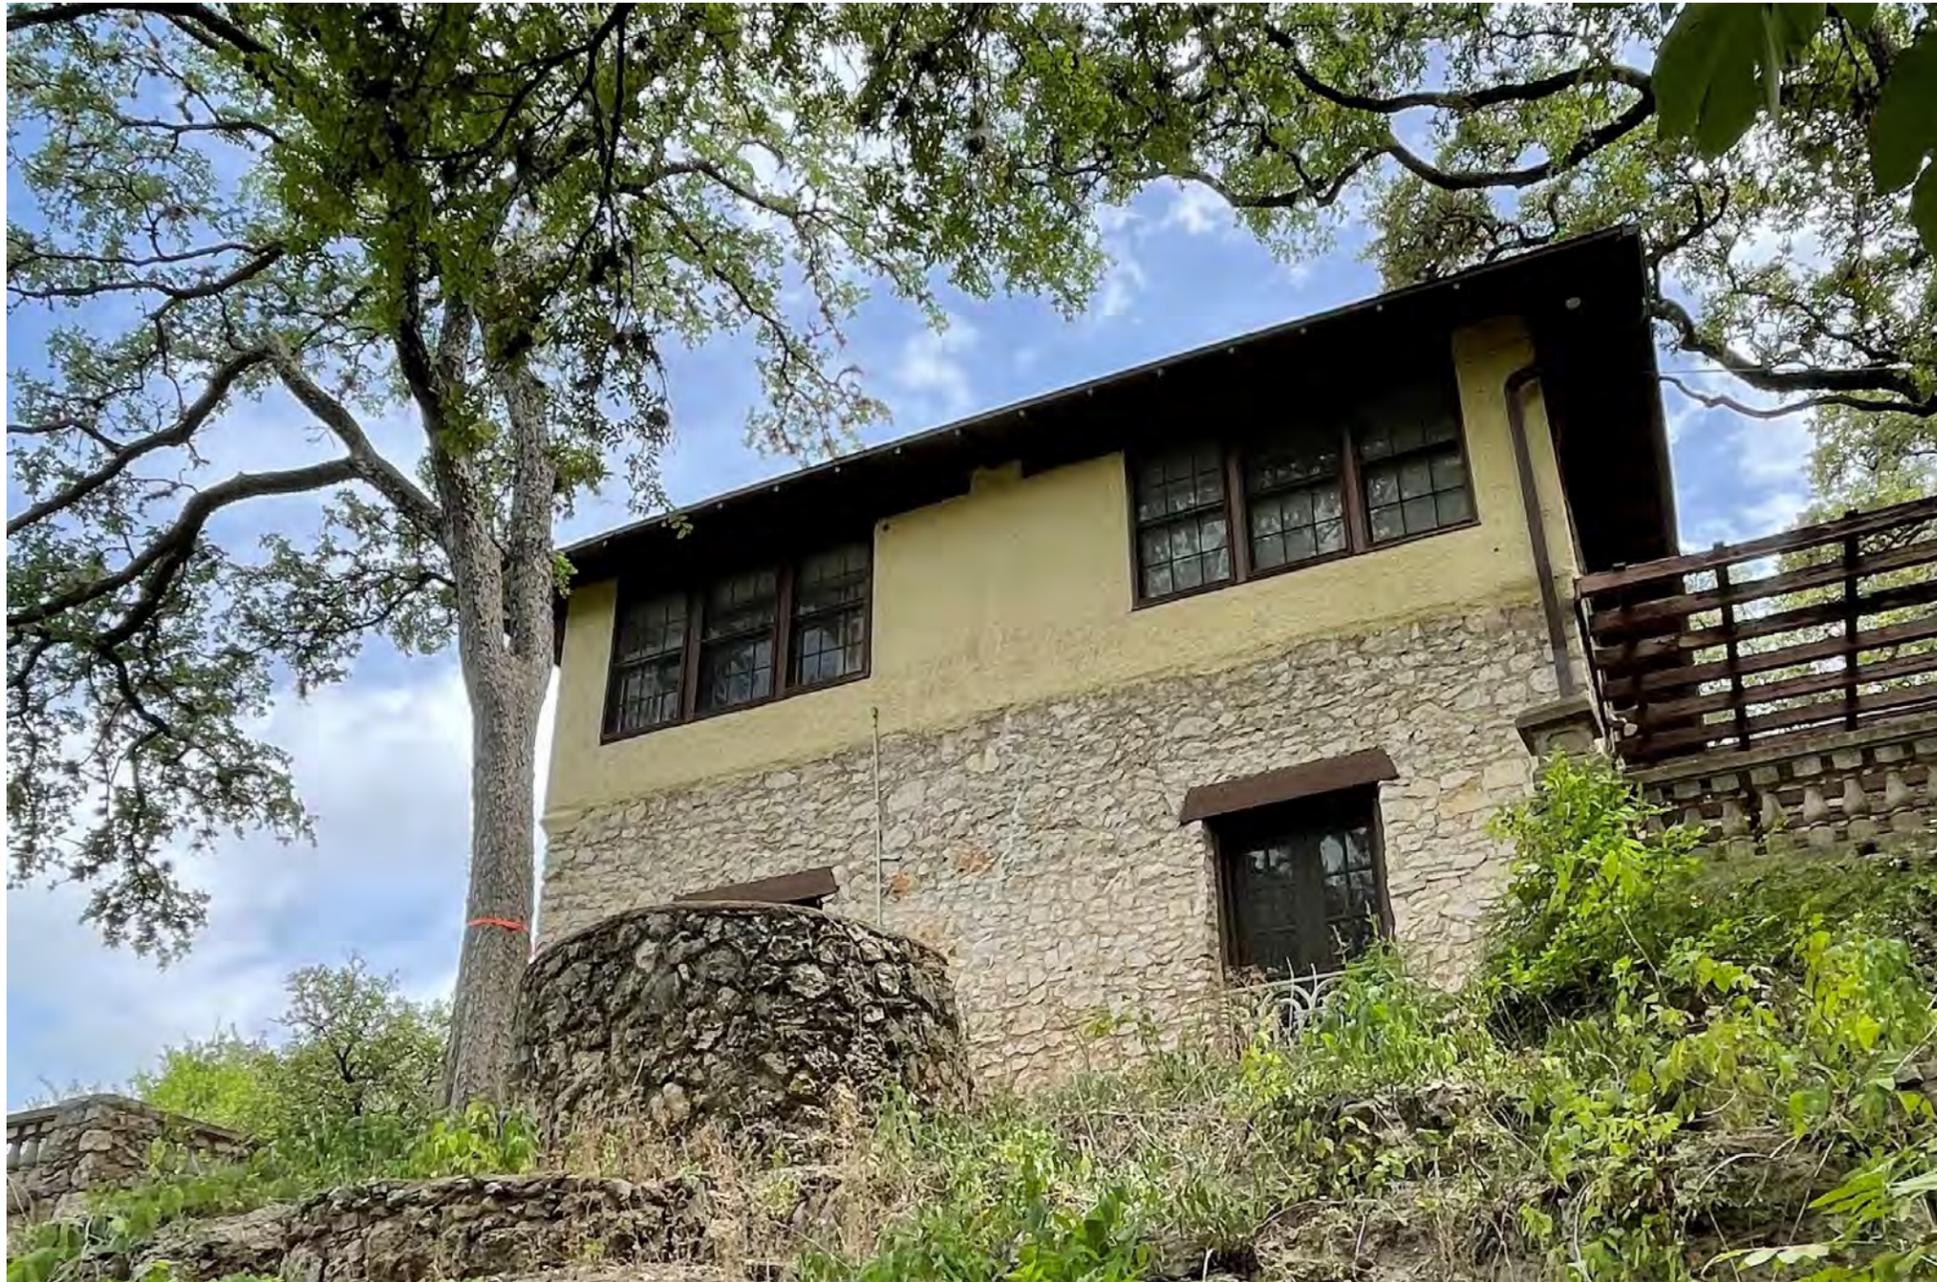
Additionally, the reuse of the existing masonry walls as non-load-bearing is not possible. The south wall has a significant crack (photo on page 19) that was previously patched and continues to move. This wall is noticeably out-of-square and out-of-plumb. Foundation movement is likely occurring. Further investigation will be required, but if the foundation is rubble, which is typical for the era, less invasive stabilization techniques will not be possible. The masonry walls will need to be removed so that the foundation can be rebuilt with reinforced concrete.

TWO STORY HOUSE EXTERIOR

1. THERE IS A CRACK THAT STARTS AT THE ROOF, GOES THROUGH THE STUCCO SECOND FLOOR, AND CONTINUES THROUGH THE STONE WALL TO THE GROUND. IT HAS BEEN FILLED AND COVERED WITH PLASTER. THE BOTTOM OF THE STONE WALL SHOWS WATER DAMAGE.

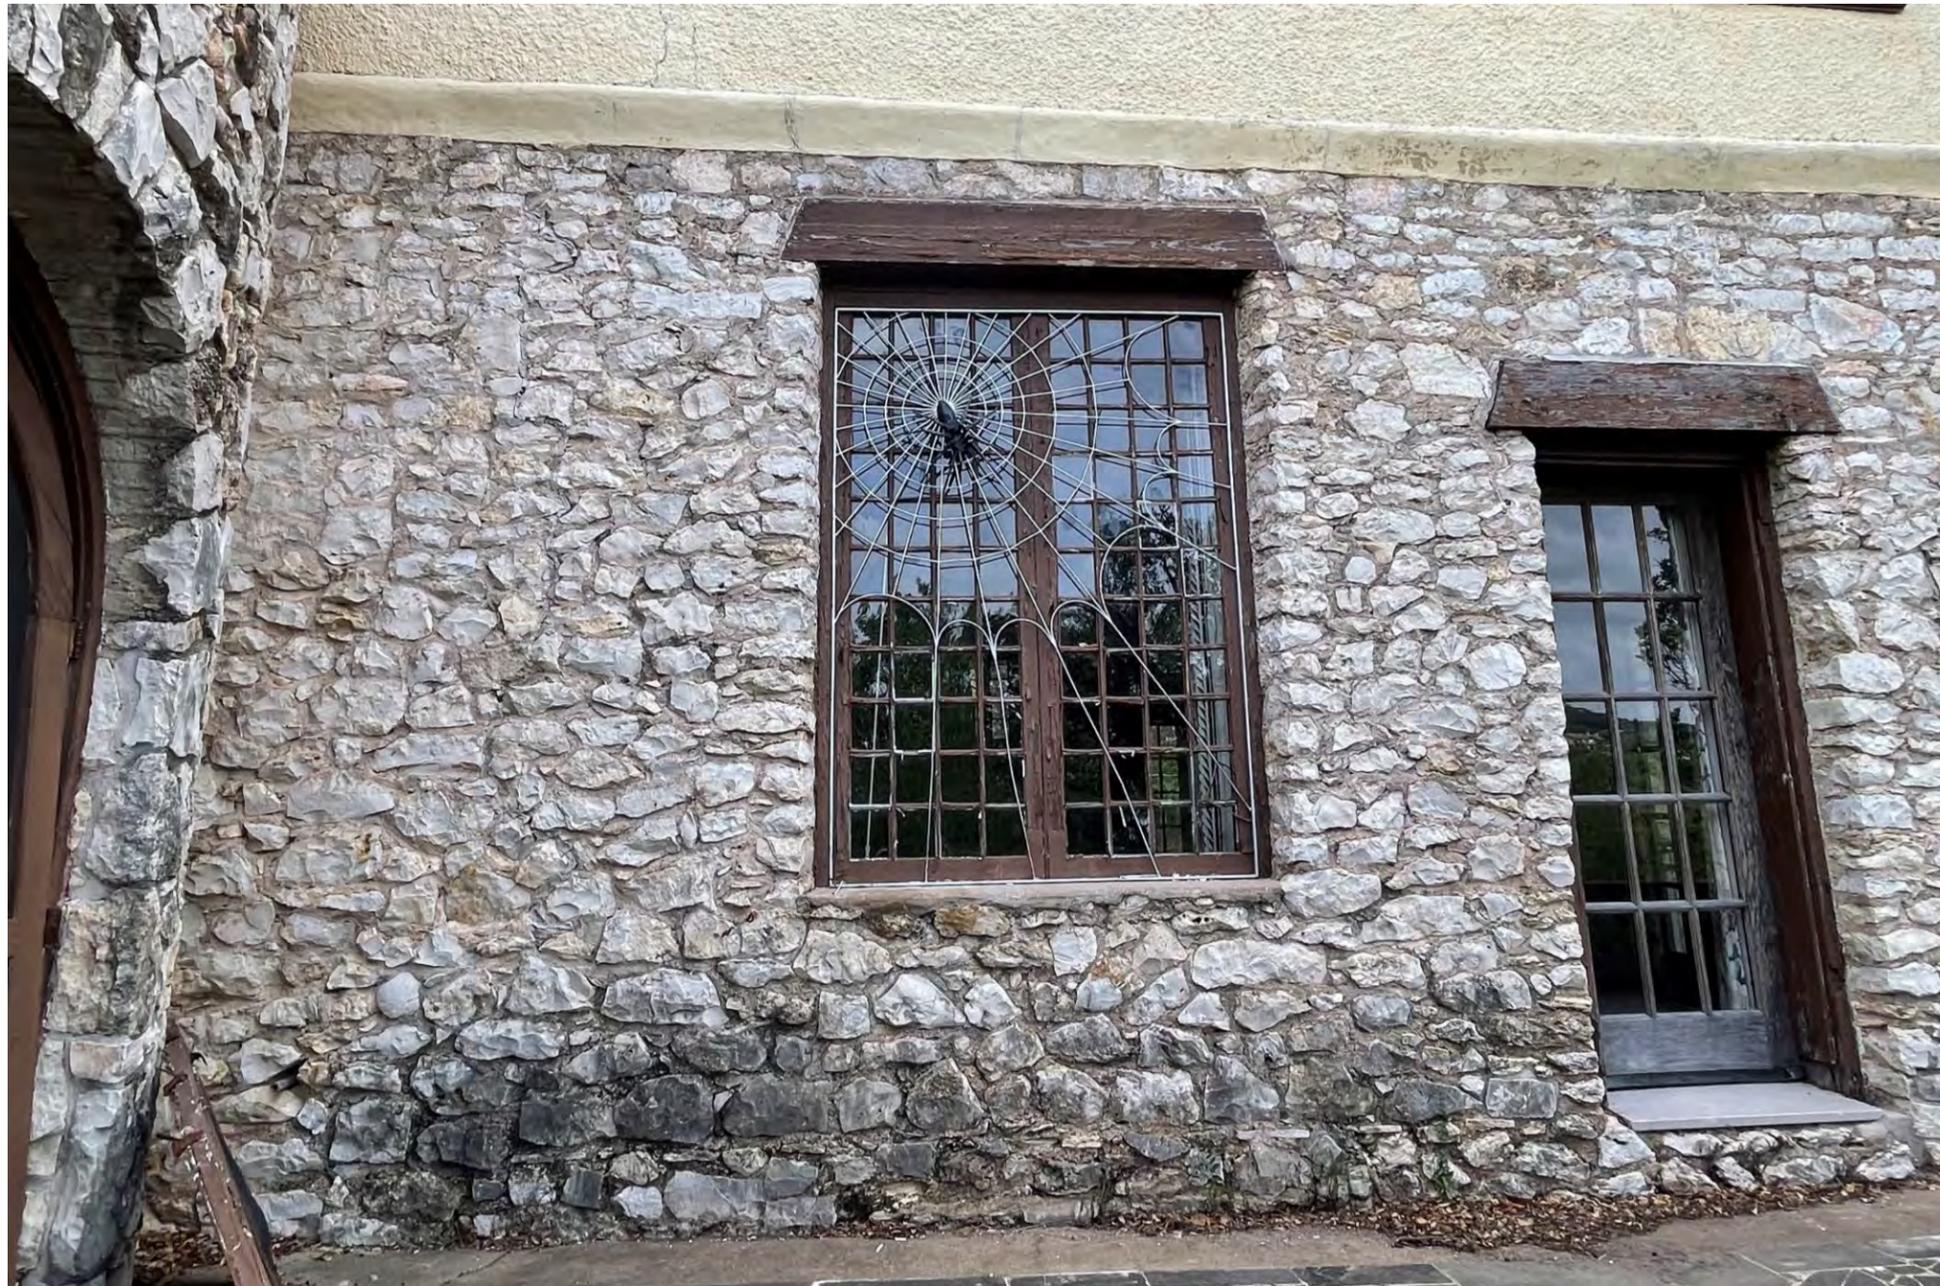
TWO STORY HOUSE EXTERIOR

1. THERE IS A CRACK THAT STARTS AT THE STUCCO SECOND FLOOR WALL AND RUNS DOWN FROM THERE.
2. THE CRACK CONTINUES THROUGH THE ROCK FIRST FLOOR WALL. THE WATER DAMAGED STONE CAN BE SEEN AT THE BOTTOM OF THE WALL.

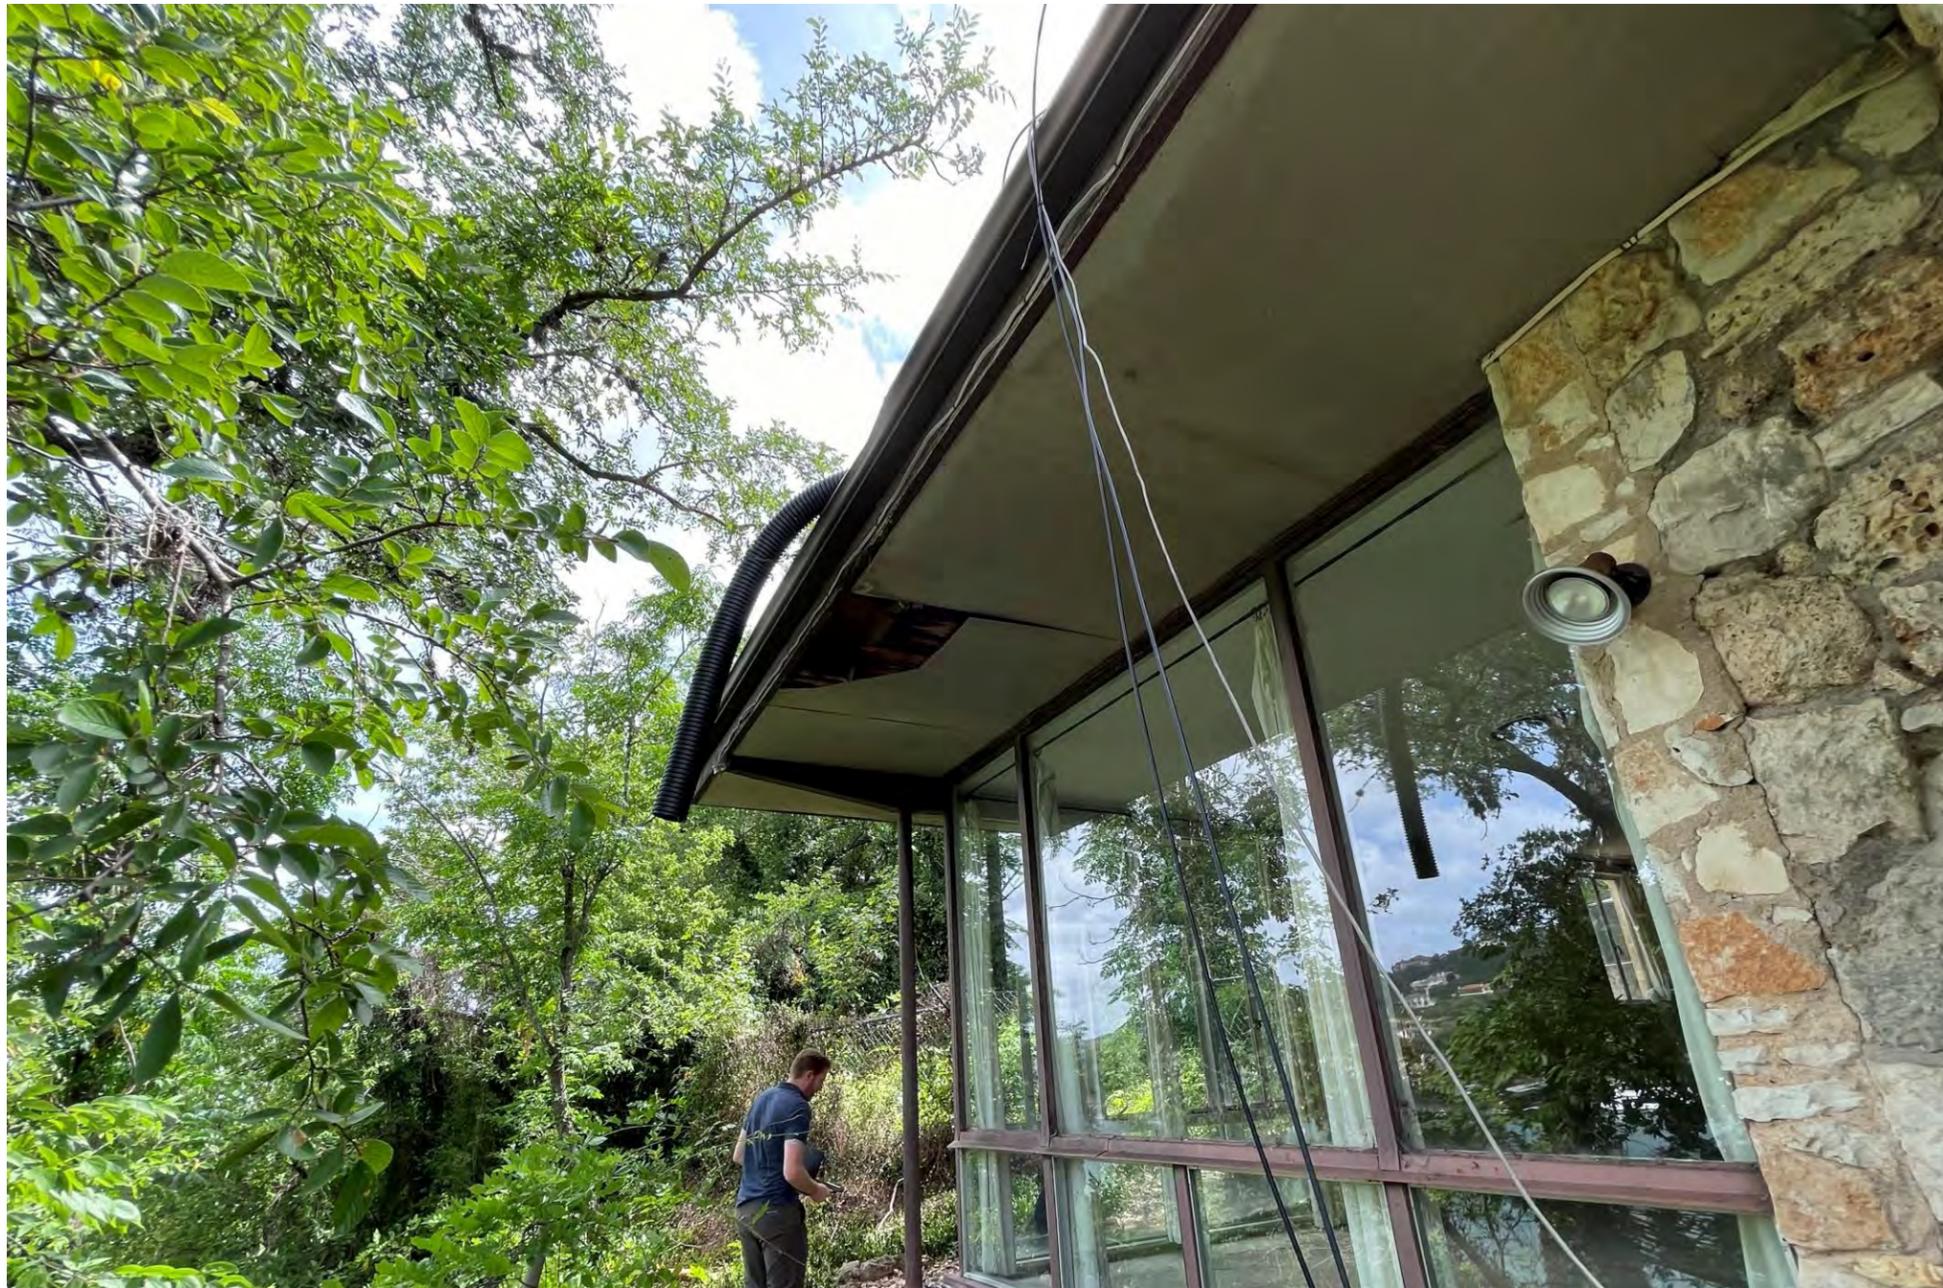
TWO STORY HOUSE EXTERIOR

1. THE ROOF SOFFIT IS DETERIORATING AND FALLING APART.
2. THE WOOD STRUCTURE WITHIN THE ROOF IS EXPOSED.

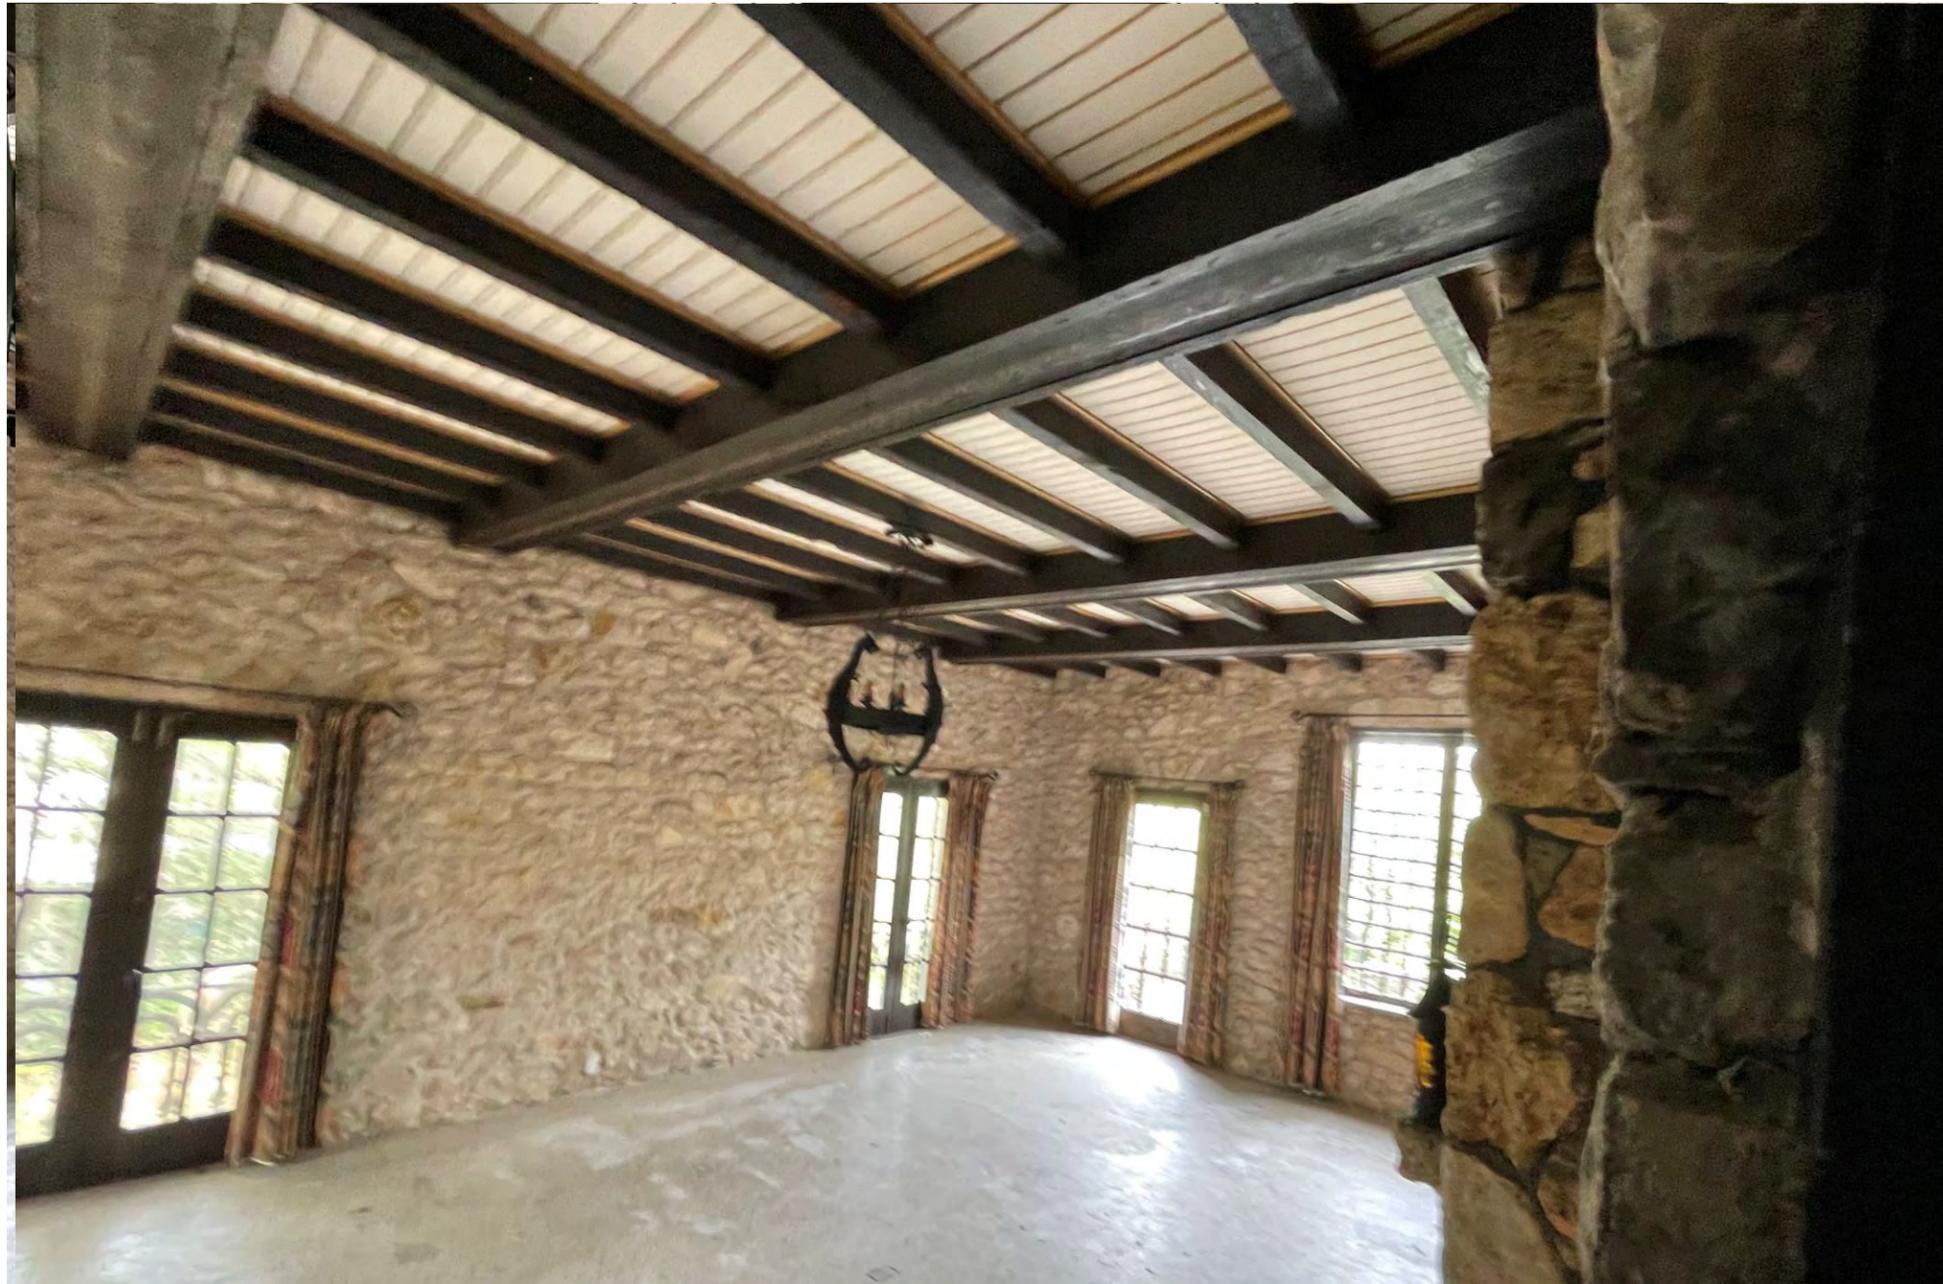
TWO STORY HOUSE INTERIOR

1. A STRUCTURAL ENGINEER HAS INDICATED THAT THESE BEAMS ARE INADEQUATE OF BEING STRUCTURALLY CAPABLE TO HOLD THE LOAD OF THE SECOND FLOOR.

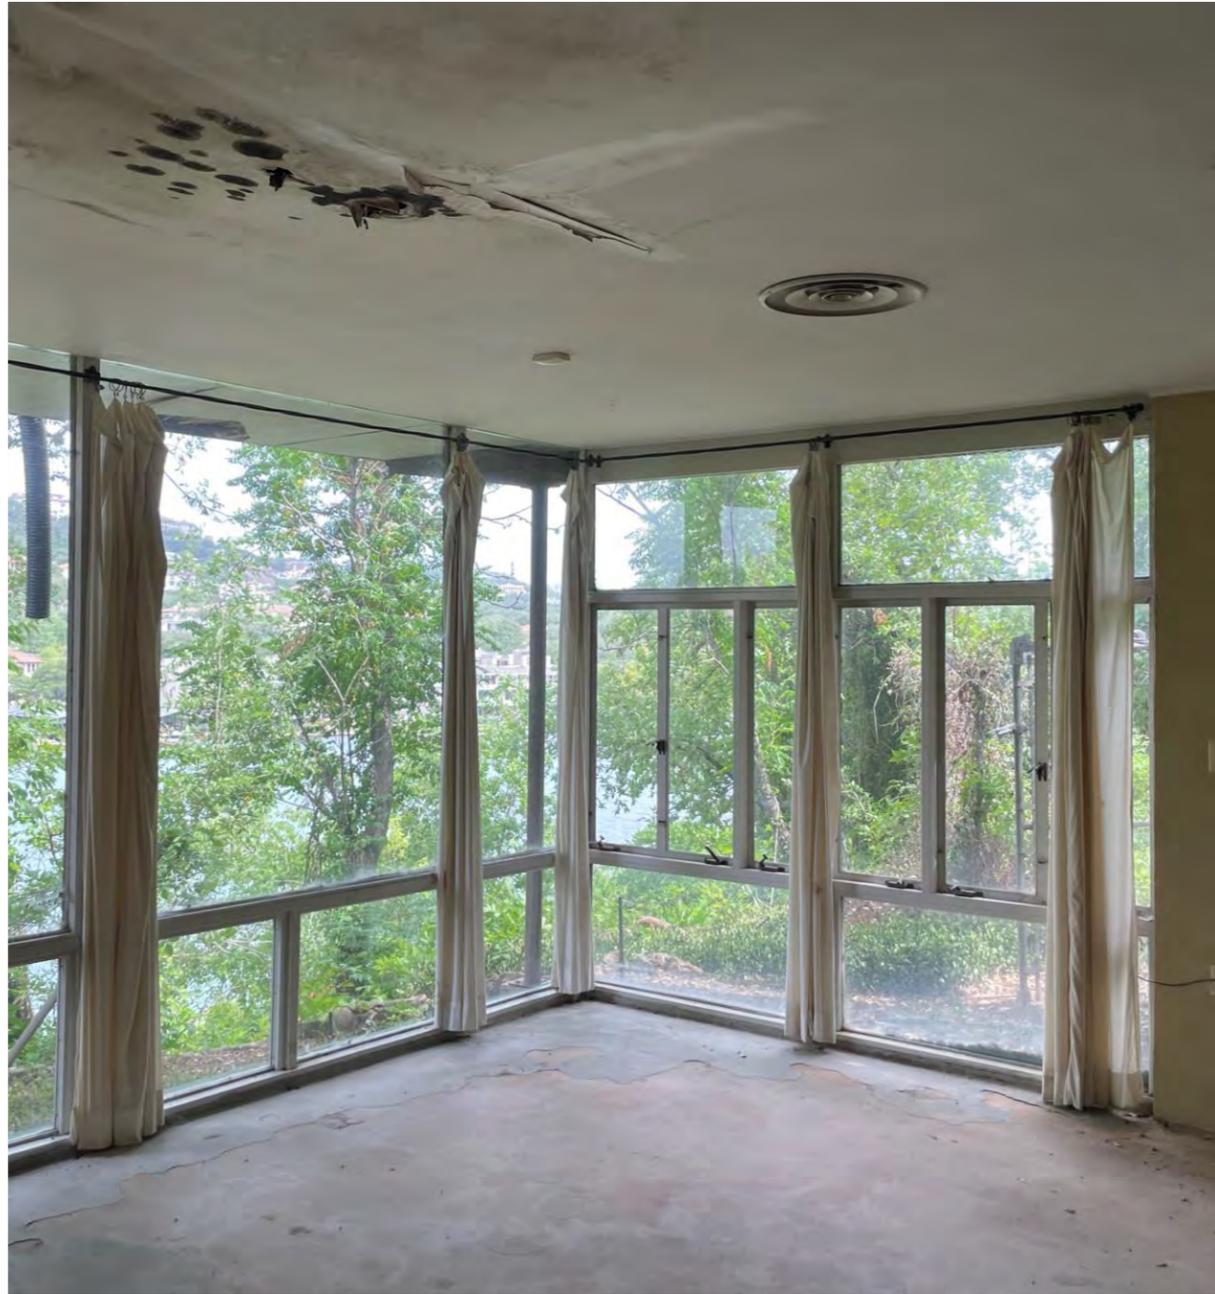
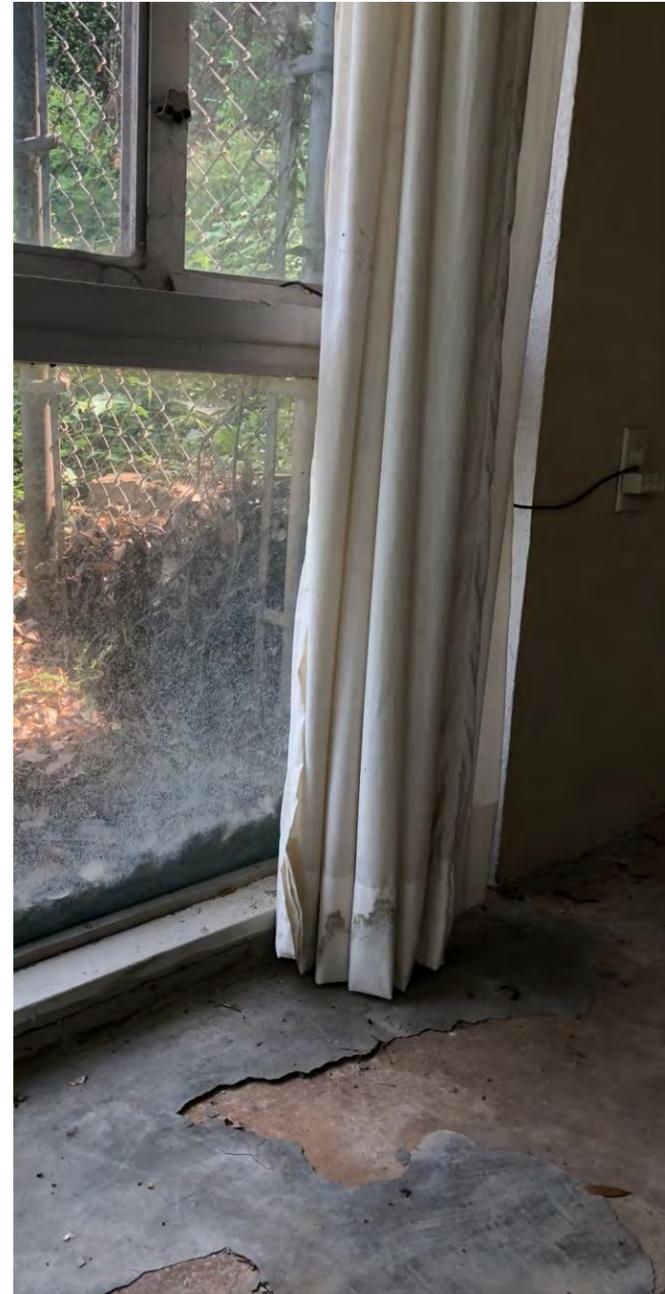
## TWO STORY HOUSE INTERIOR

1. THE FLOOR IS DAMAGED AND FLAKING. ON THE EXTERIOR, THE HEIGHT OF THE GROUND IS HIGHER THAN THE HEIGHT OF THE WINDOW SILL, ALLOWING WATER TO FLOW INTO THE HOUSE.
2. WATER IS DAMAGING THE CEILING IN LARGE AREAS. BLACK MOLD IS EVIDENT IN MULTIPLE LOCATIONS.
3. IN THIS LOCATION THE WATER DAMAGE IS ESPECIALLY EVIDENT AND DESTRUCTIVE. MOLD IS A POTENTIAL HEALTH HAZARD AND WOULD REQUIRE AN EXTENSIVE MITIGATION EFFORT.

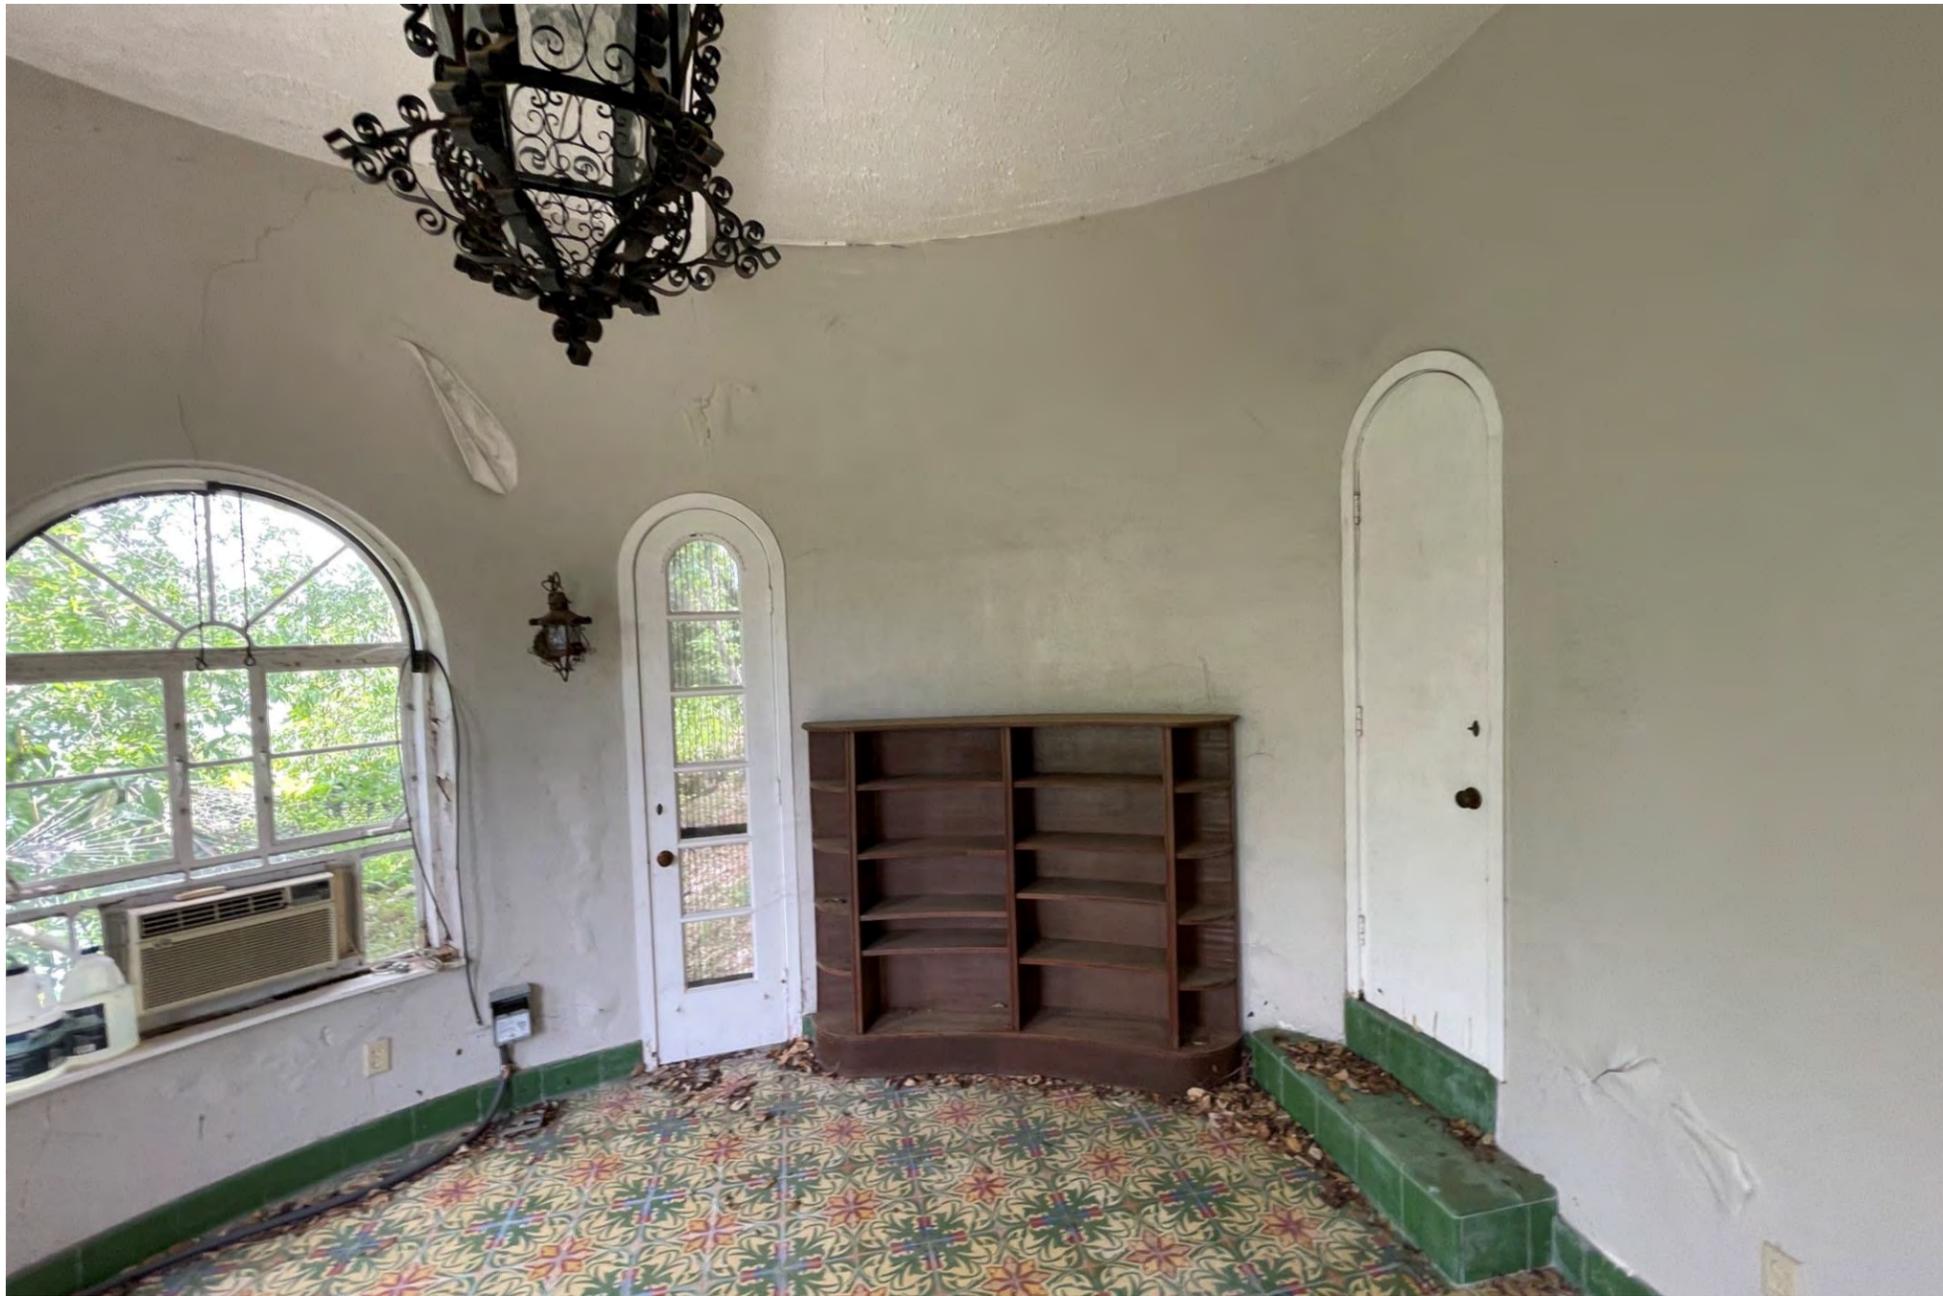
TWO STORY HOUSE INTERIOR

1. THE PLASTER DRYWALL IS FALLING APART AND CRACKING. THE DOOR IS TOO SMALL AND IS UP AGAINST STONE STAIRS.
2. THE PLASTER IS CRACKED AND FALLING APART.

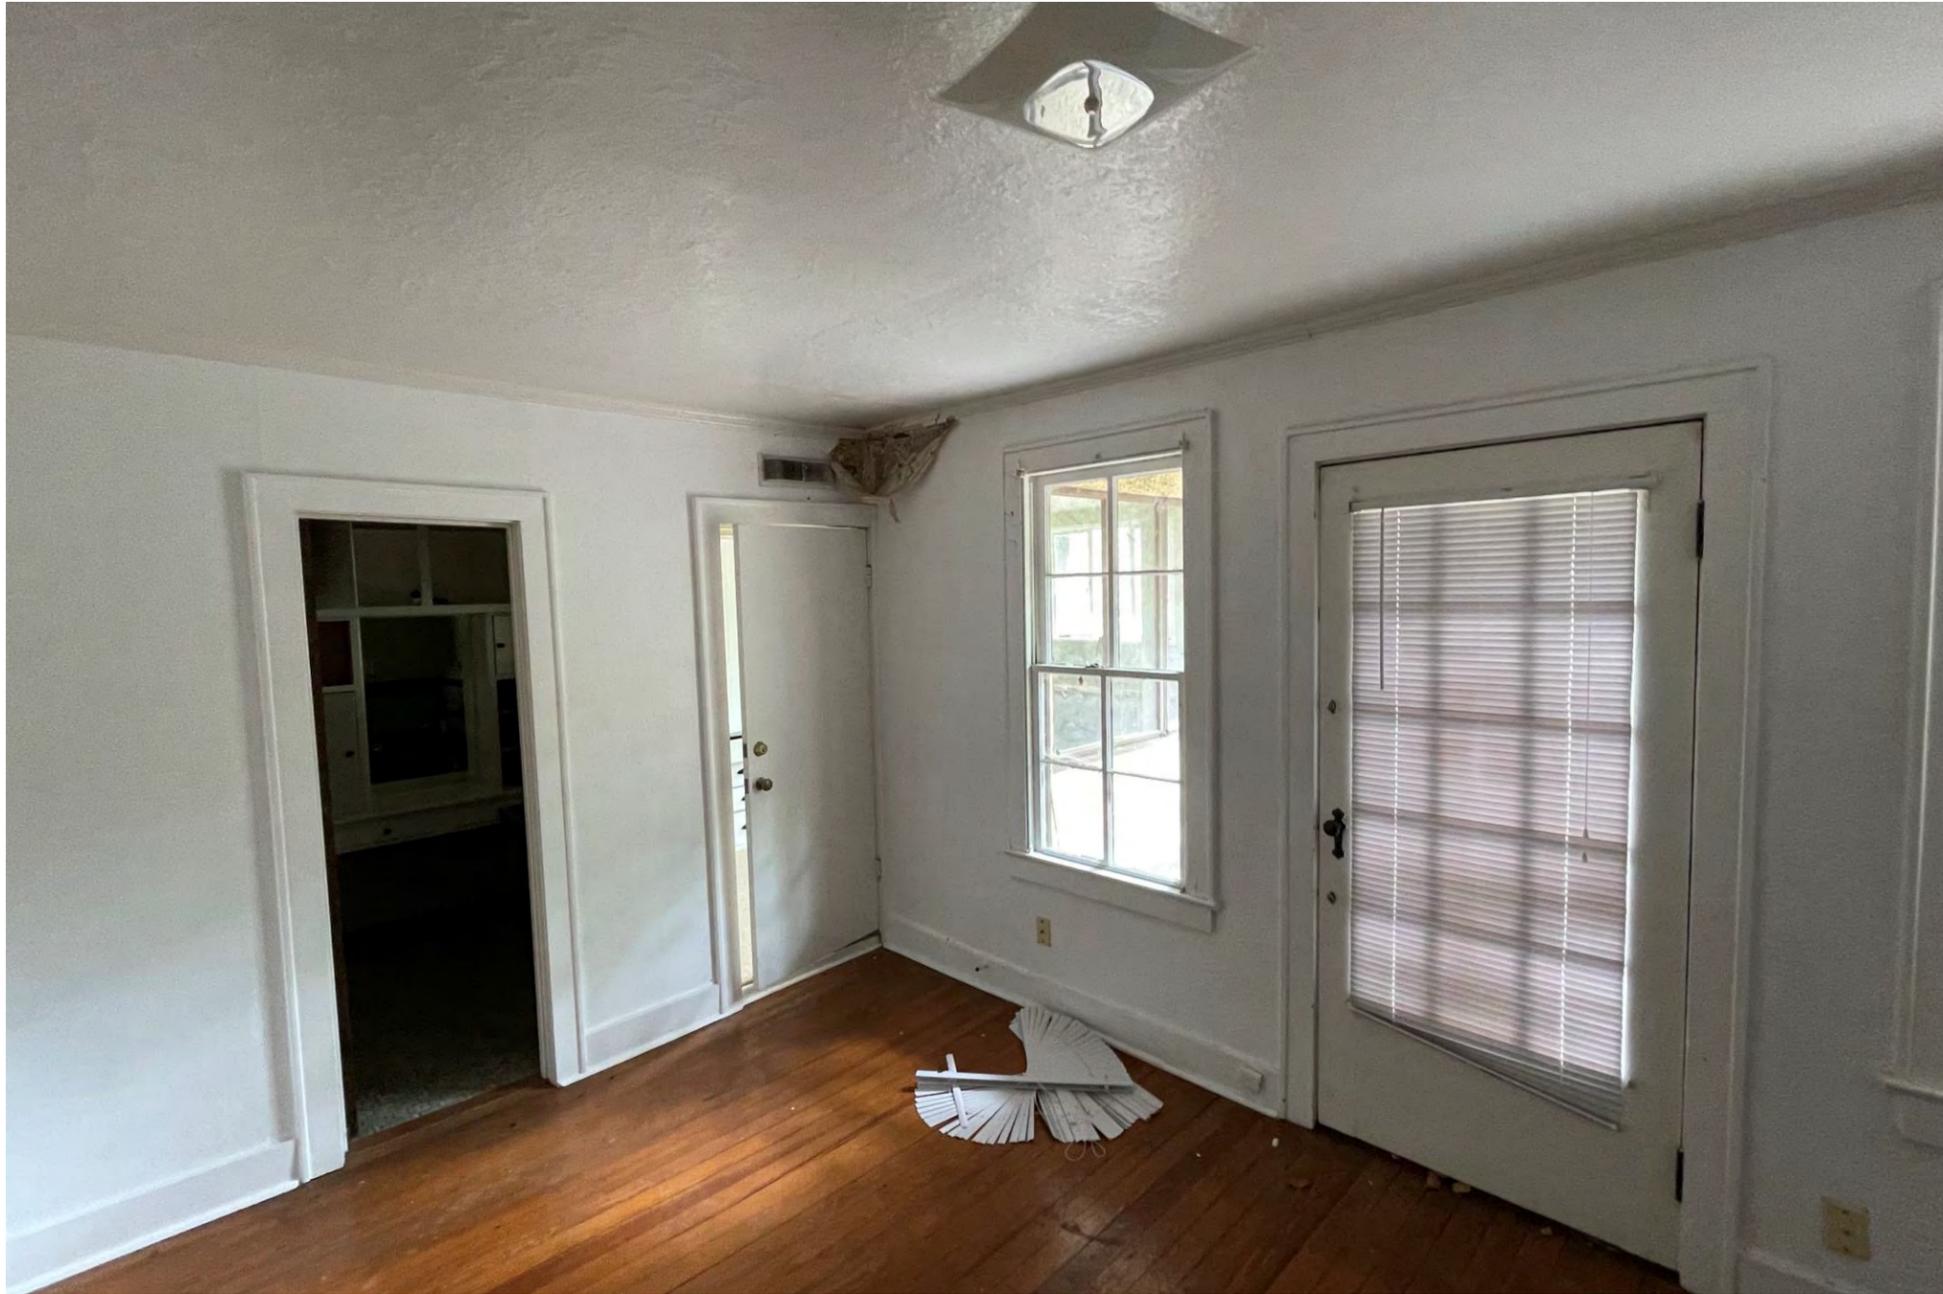
TWO STORY HOUSE INTERIOR

1. THE PLASTER AND THE TRIM ARE FALLING APART AND EXPOSING THE WALL BENEATH.
2. THE PLASTER IS CRACKING.
