Shoal Cycle SP-2021-0350C

September 7, 2022

Heritage Tree Variance Request

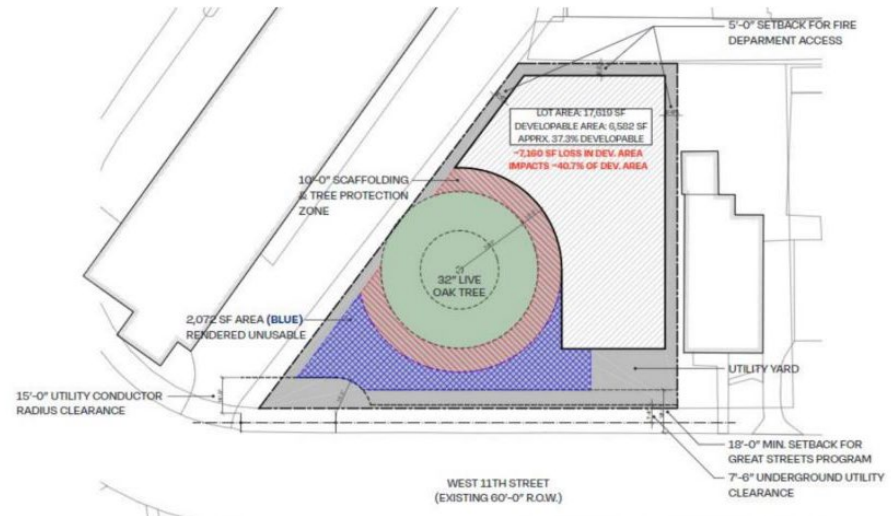
Site Constraints:

- The property is located in a portion of Downtown Austin that is ineligible for participation in the Downtown Density Bonus Program
- Restrictive Covenant requires 18'-0" setback along West 11th Street to align with Great Street Standards
- 5'-0" setback required along the northern, eastern and western property lines for fire department access
- The 32" Live Oak is centrally located on the property which divides the property and renders the southwestern portion (hatched in blue) unbuildable

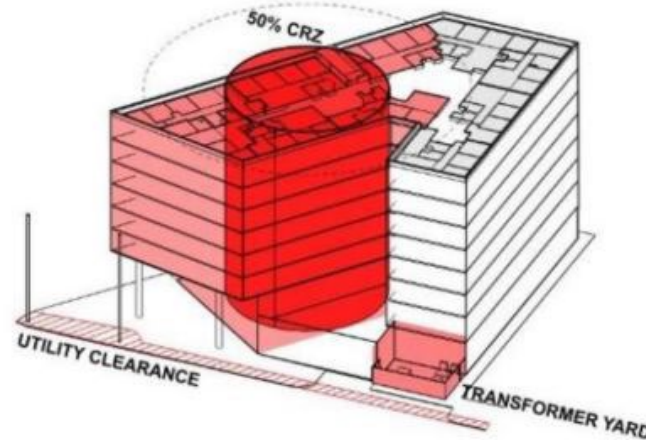
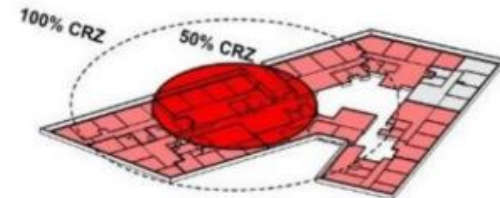
Site Constraints- buildable floorplates

The root zone of the 32" Heritage Live Oak occupies 28.9% of site

- Current location results in a reduction of over 50% of the gross square feet of buildable area
- Preservation of the Half critical root zone would result in a loss of 28 units (or 42%) of the proposed 67 units
- Preservation of the Full critical root zone would result in a loss of 60 units (or 91%) of the proposed 67 units

50% CRITICAL ROOT ZONE

67 UNITS → 39 UNITS

42% UNIT LOSS

100% CRITICAL ROOT ZONE

67 UNITS → 7 UNITS

91% UNIT LOSS
