Memo

Re: Shoal Cycle Reasonable Use Memorandum

**Live Oak at 812 West 11th Street
Austin, TX 78701**

Tree Risk Assessment Report

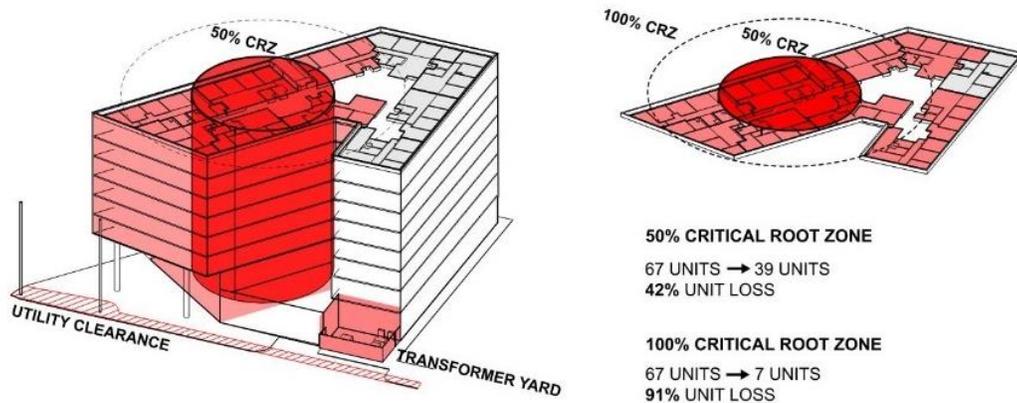
EXHIBIT B: Critical Root Zone Exhibit

The current intent is to develop a 67-unit workforce multifamily project and 3,500 square feet of ground floor retail. 100% of the units consist of 3-bedrooms and 2-bathrooms and are proposed to be workforce housing units, providing housing for up to 201 working individuals. Rents for each bedroom are projected to be 40% less than current studio apartment rates, providing much needed housing in Downtown Austin. As shown on Exhibit B below, if the tree were to remain, preservation of the 50% critical root zone would result in the loss of 28 of the proposed units which equates to 42% of lost proposed units. Preservation of the 100% critical root zone would result in the loss of 60 units, which equates to 91% of the total units lost.

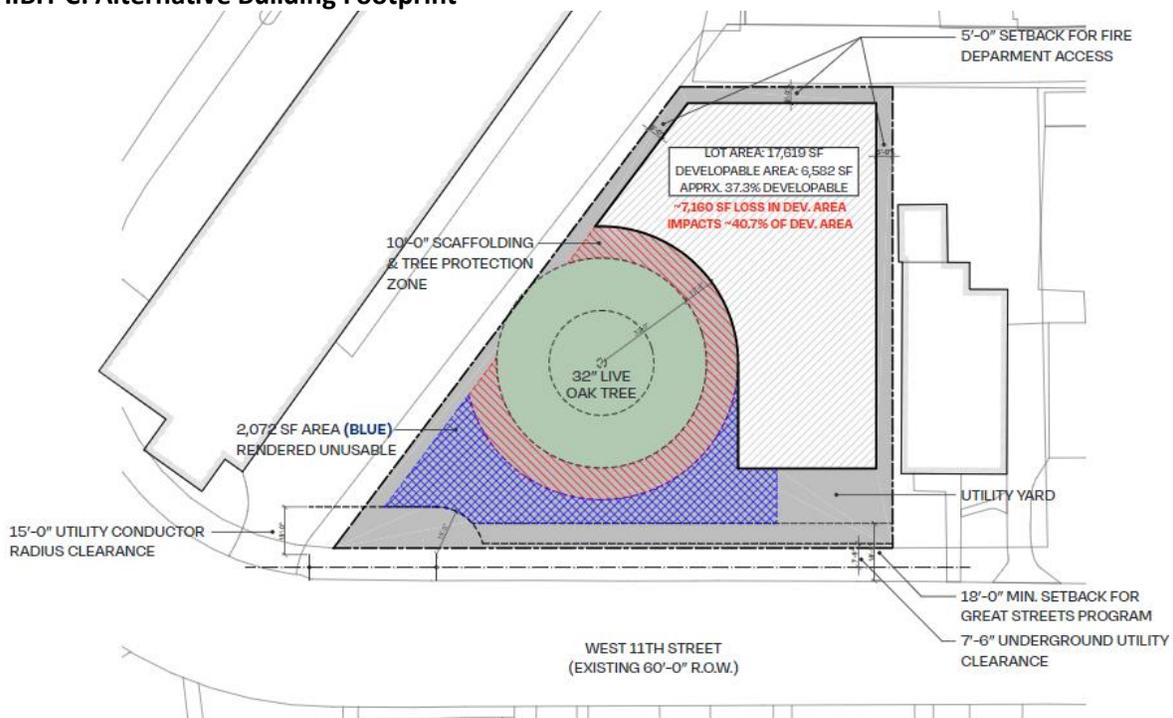
EXHIBIT C: Alternative Building Footprint

By keeping the existing tree, the developable area of the site and resulting building footprint are severely impacted and reduced to 37.3% of the lot area. Not only will the max FAR of 5:1 be unachievable, an efficient residential unit layout with appropriate separations, egress distances and corridor space will decrease the unit count from 10 units per typical floor, to an estimated 4 units per floor. Furthermore, the southwestern portion of the remaining footprint – approximately 25% of the “developable area” – is rendered unusable and structurally implausible to build. Exhibit C below shows the 25% unusable space, equating to 2,072 square feet of the remaining 8,654 square feet.

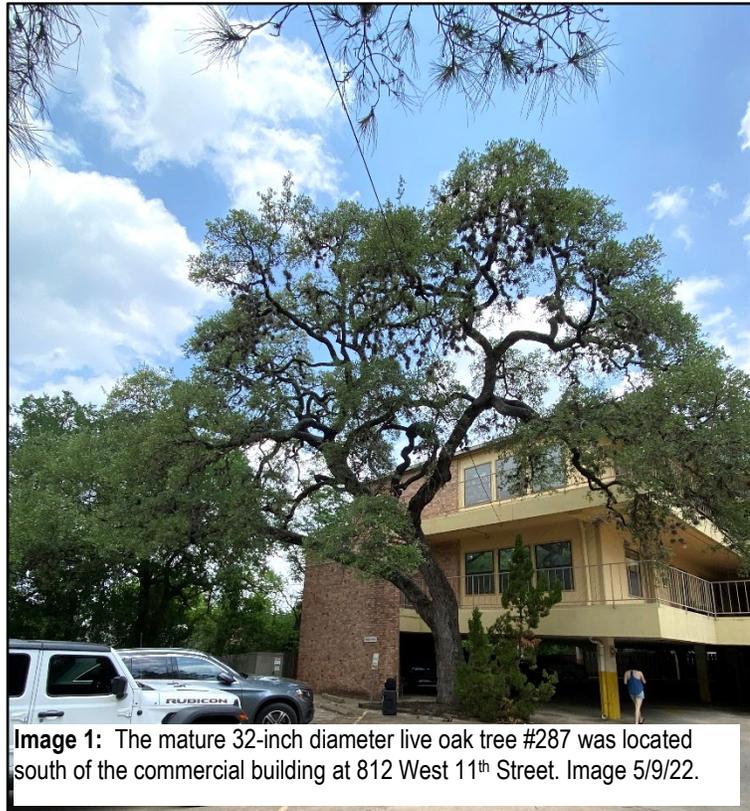
The root collar had 10 inches of fill removed. No decay was observed.

A mallet was used to sound the trunk. Sounding did not suggest the presence of decay.
