JUNE 28, 2022
22

RYAN STREET
ARCHITECTS

2002 SCENIC DRIVE RESIDENCE
Two Story House - Interior

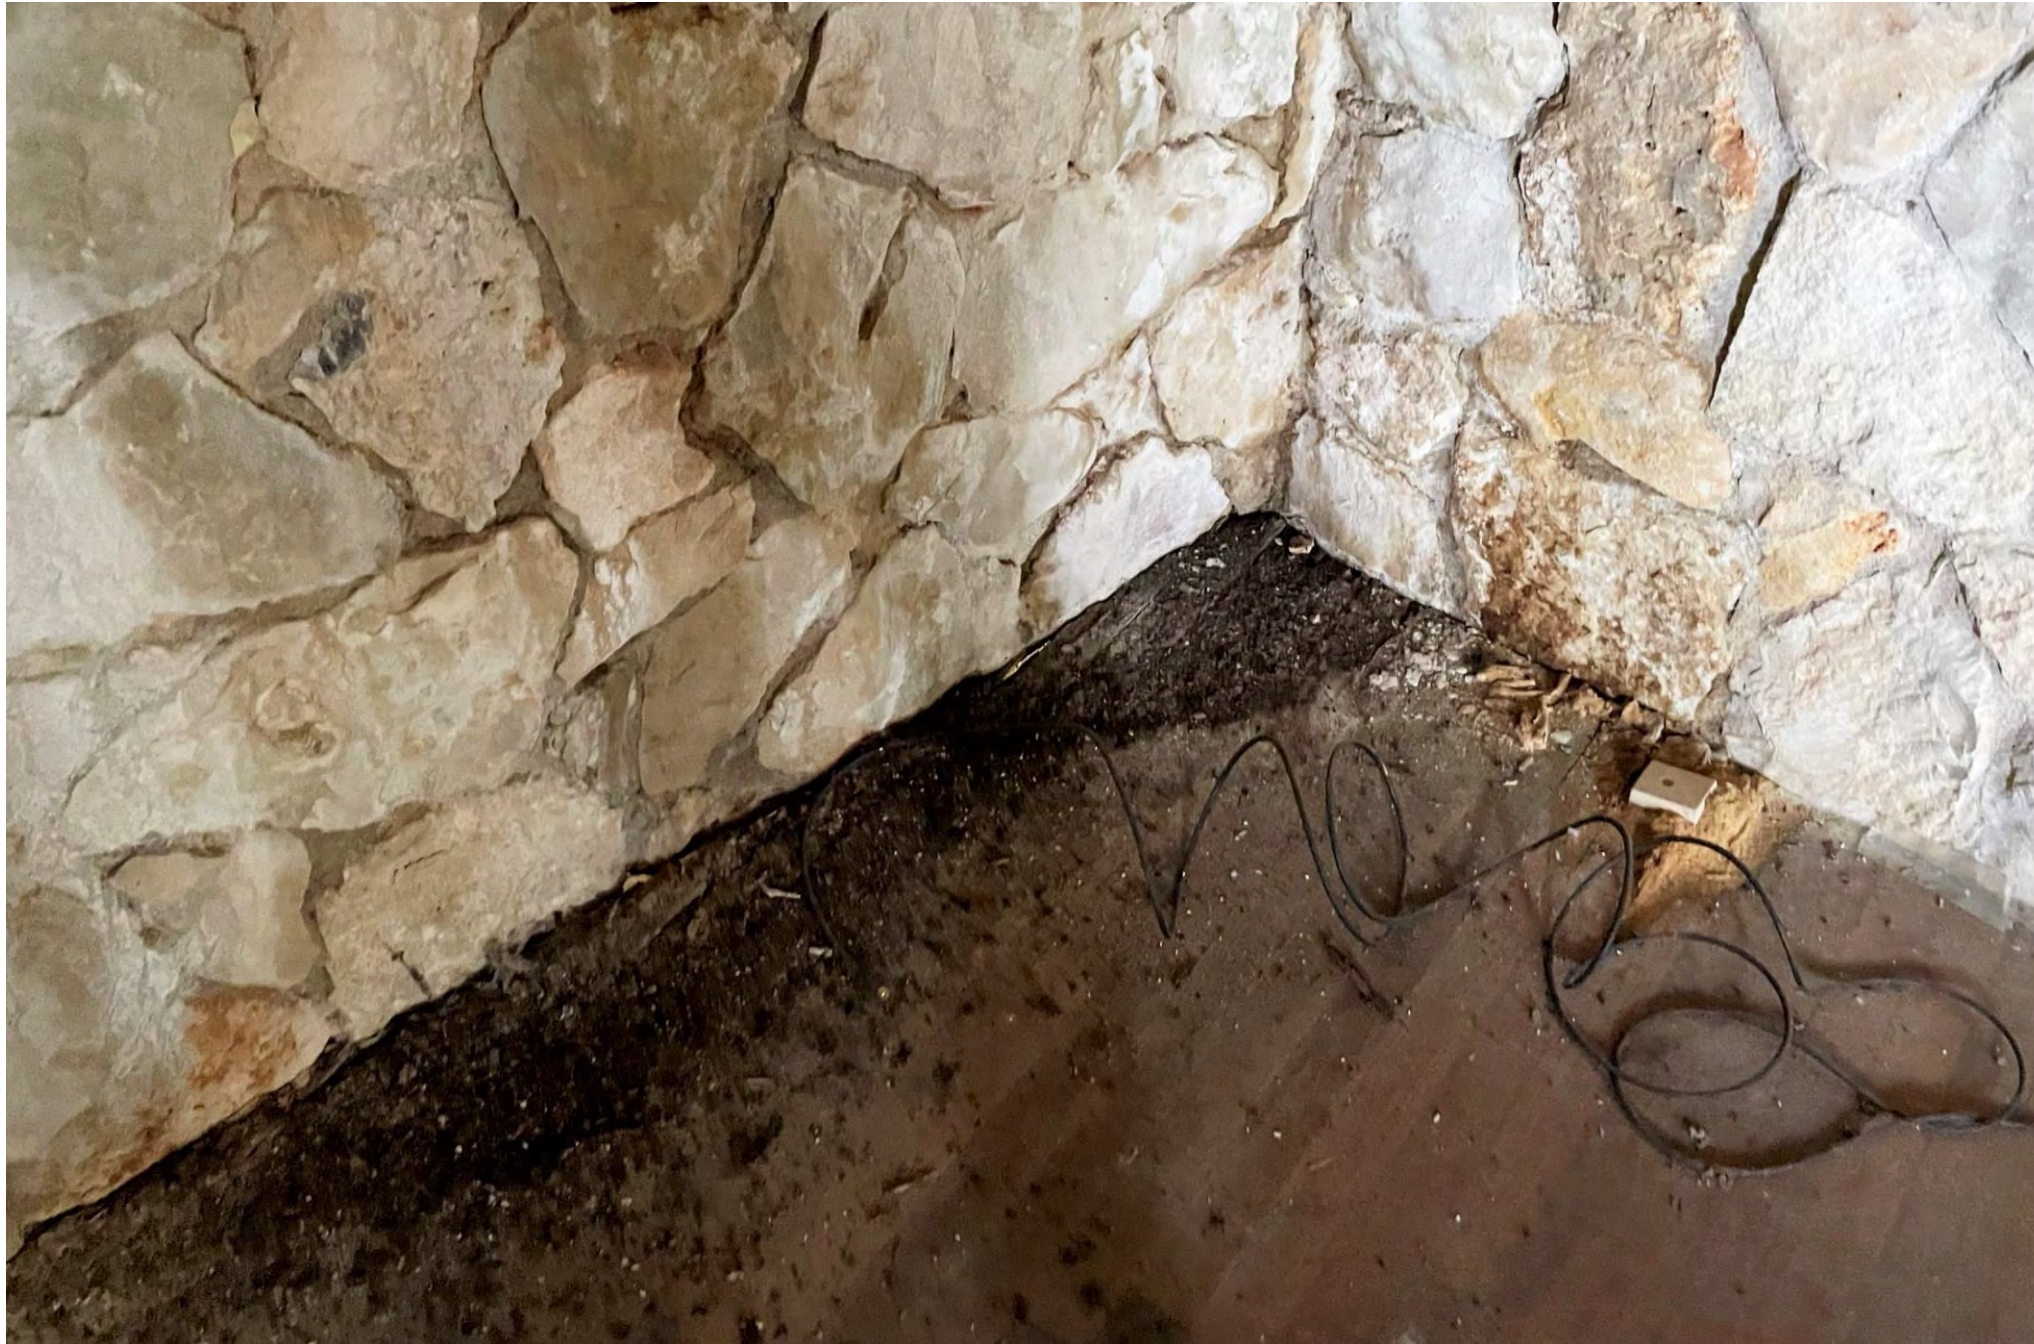
APARTMENT INTERIOR

1. CEILING FAILURE HAS ALLOWED DEBRIS AND DIRT TO COLLECT INSIDE THE APARTMENT. THE WOODEN FLOOR IS CRACKING AND DETERIORATING FROM WATER DAMAGE.
2. THE WOODEN FLOOR IS FALLING APART AND SEPERATING FROM THE WALL.

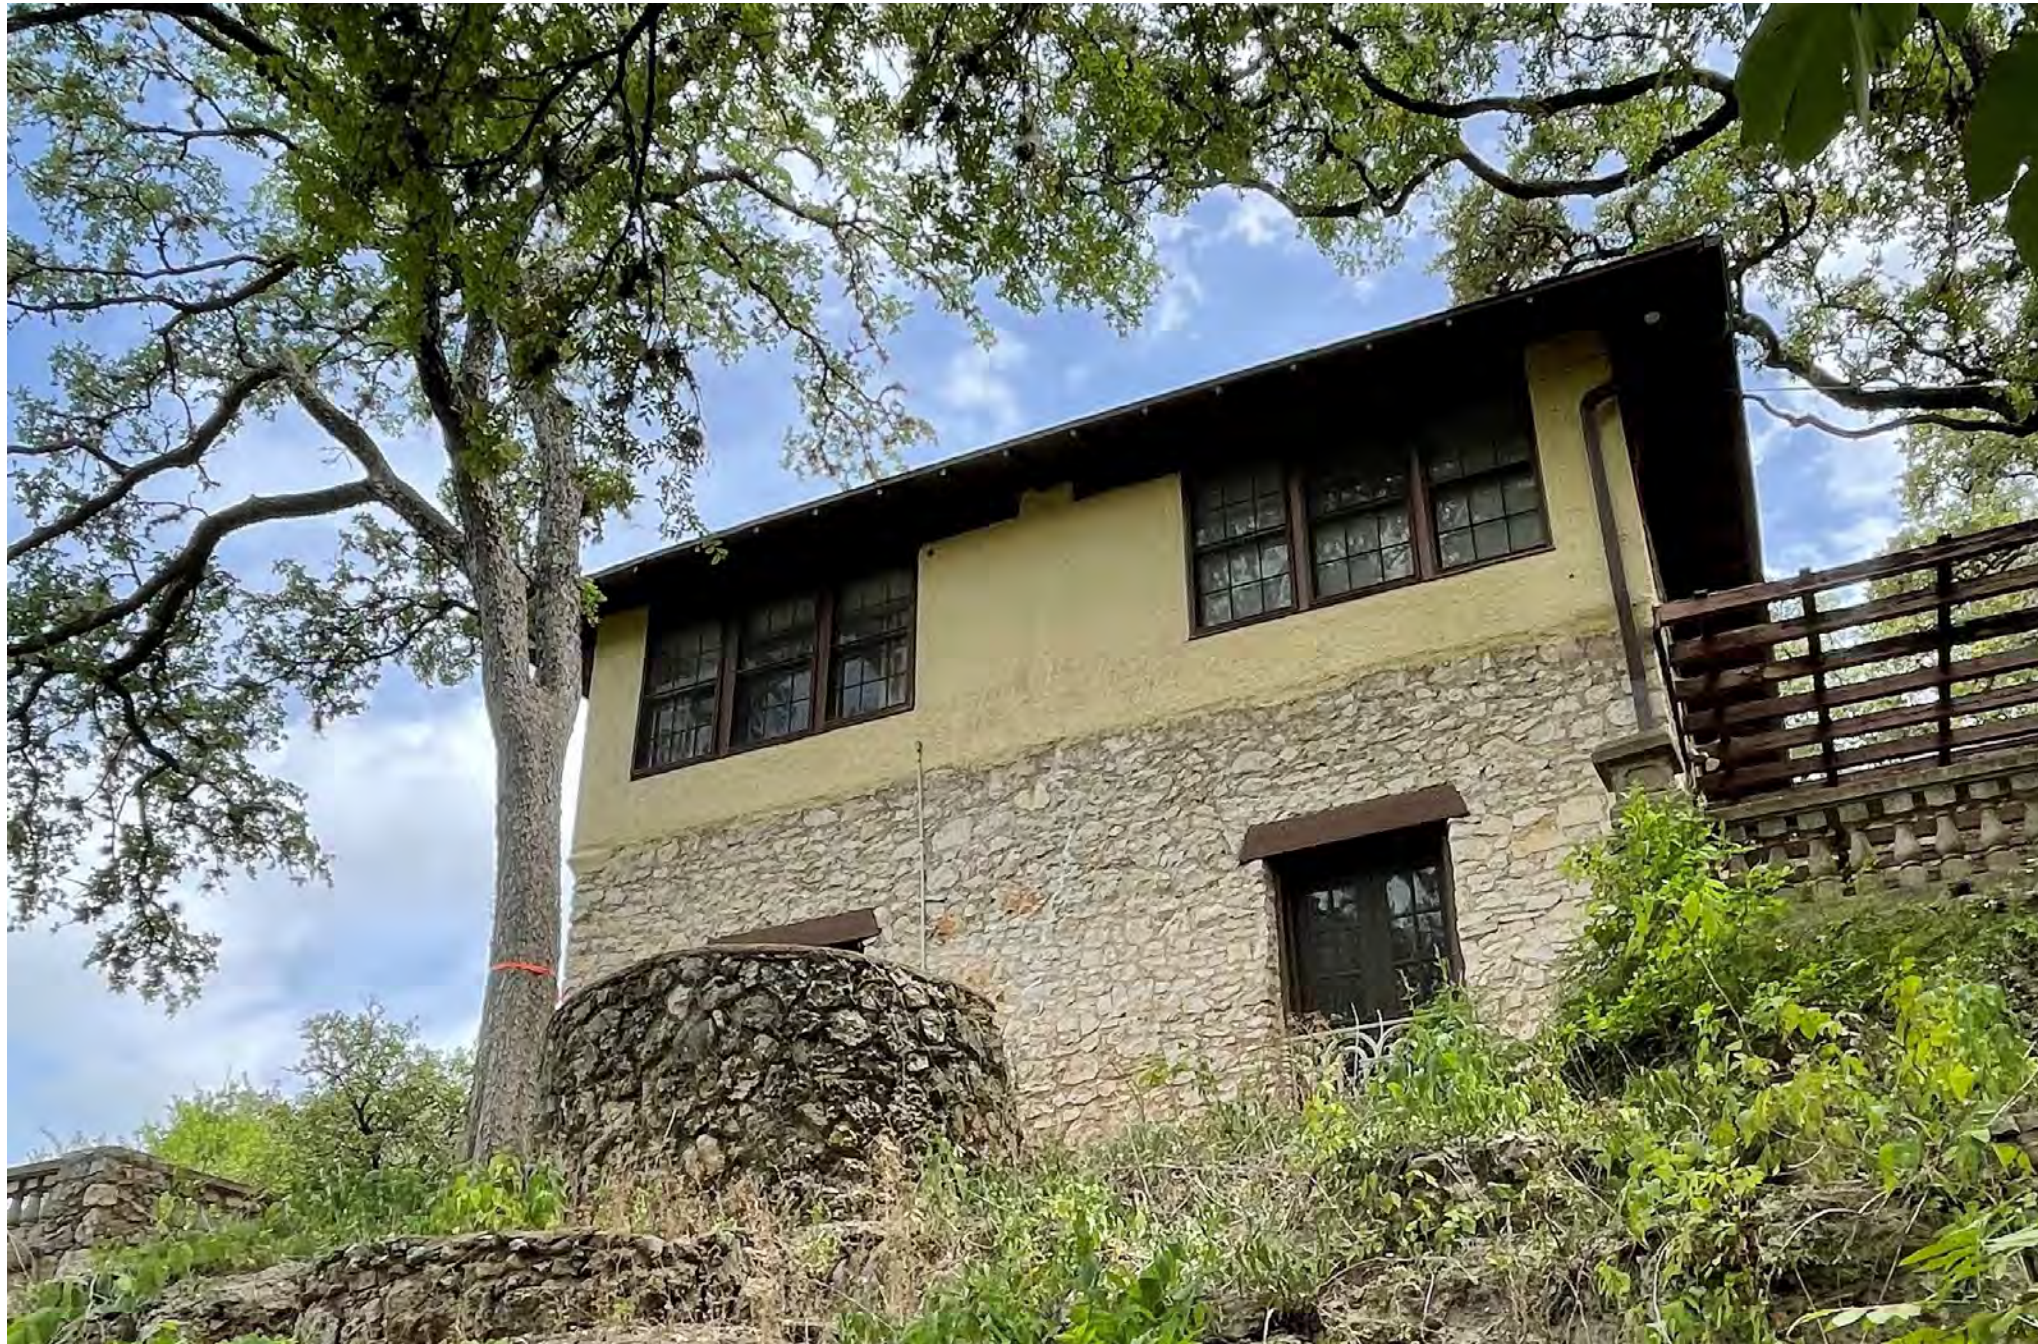
TWO STORY HOUSE EXTERIOR

1. THERE IS A CRACK THAT STARTS AT THE ROOF, GOES THROUGH THE STUCCO SECOND FLOOR, AND CONTINUES THROUGH THE STONE WALL TO THE GROUND. IT HAS BEEN FILLED AND COVERED WITH PLASTER. THE BOTTOM OF THE STONE WALL SHOWS WATER DAMAGE.

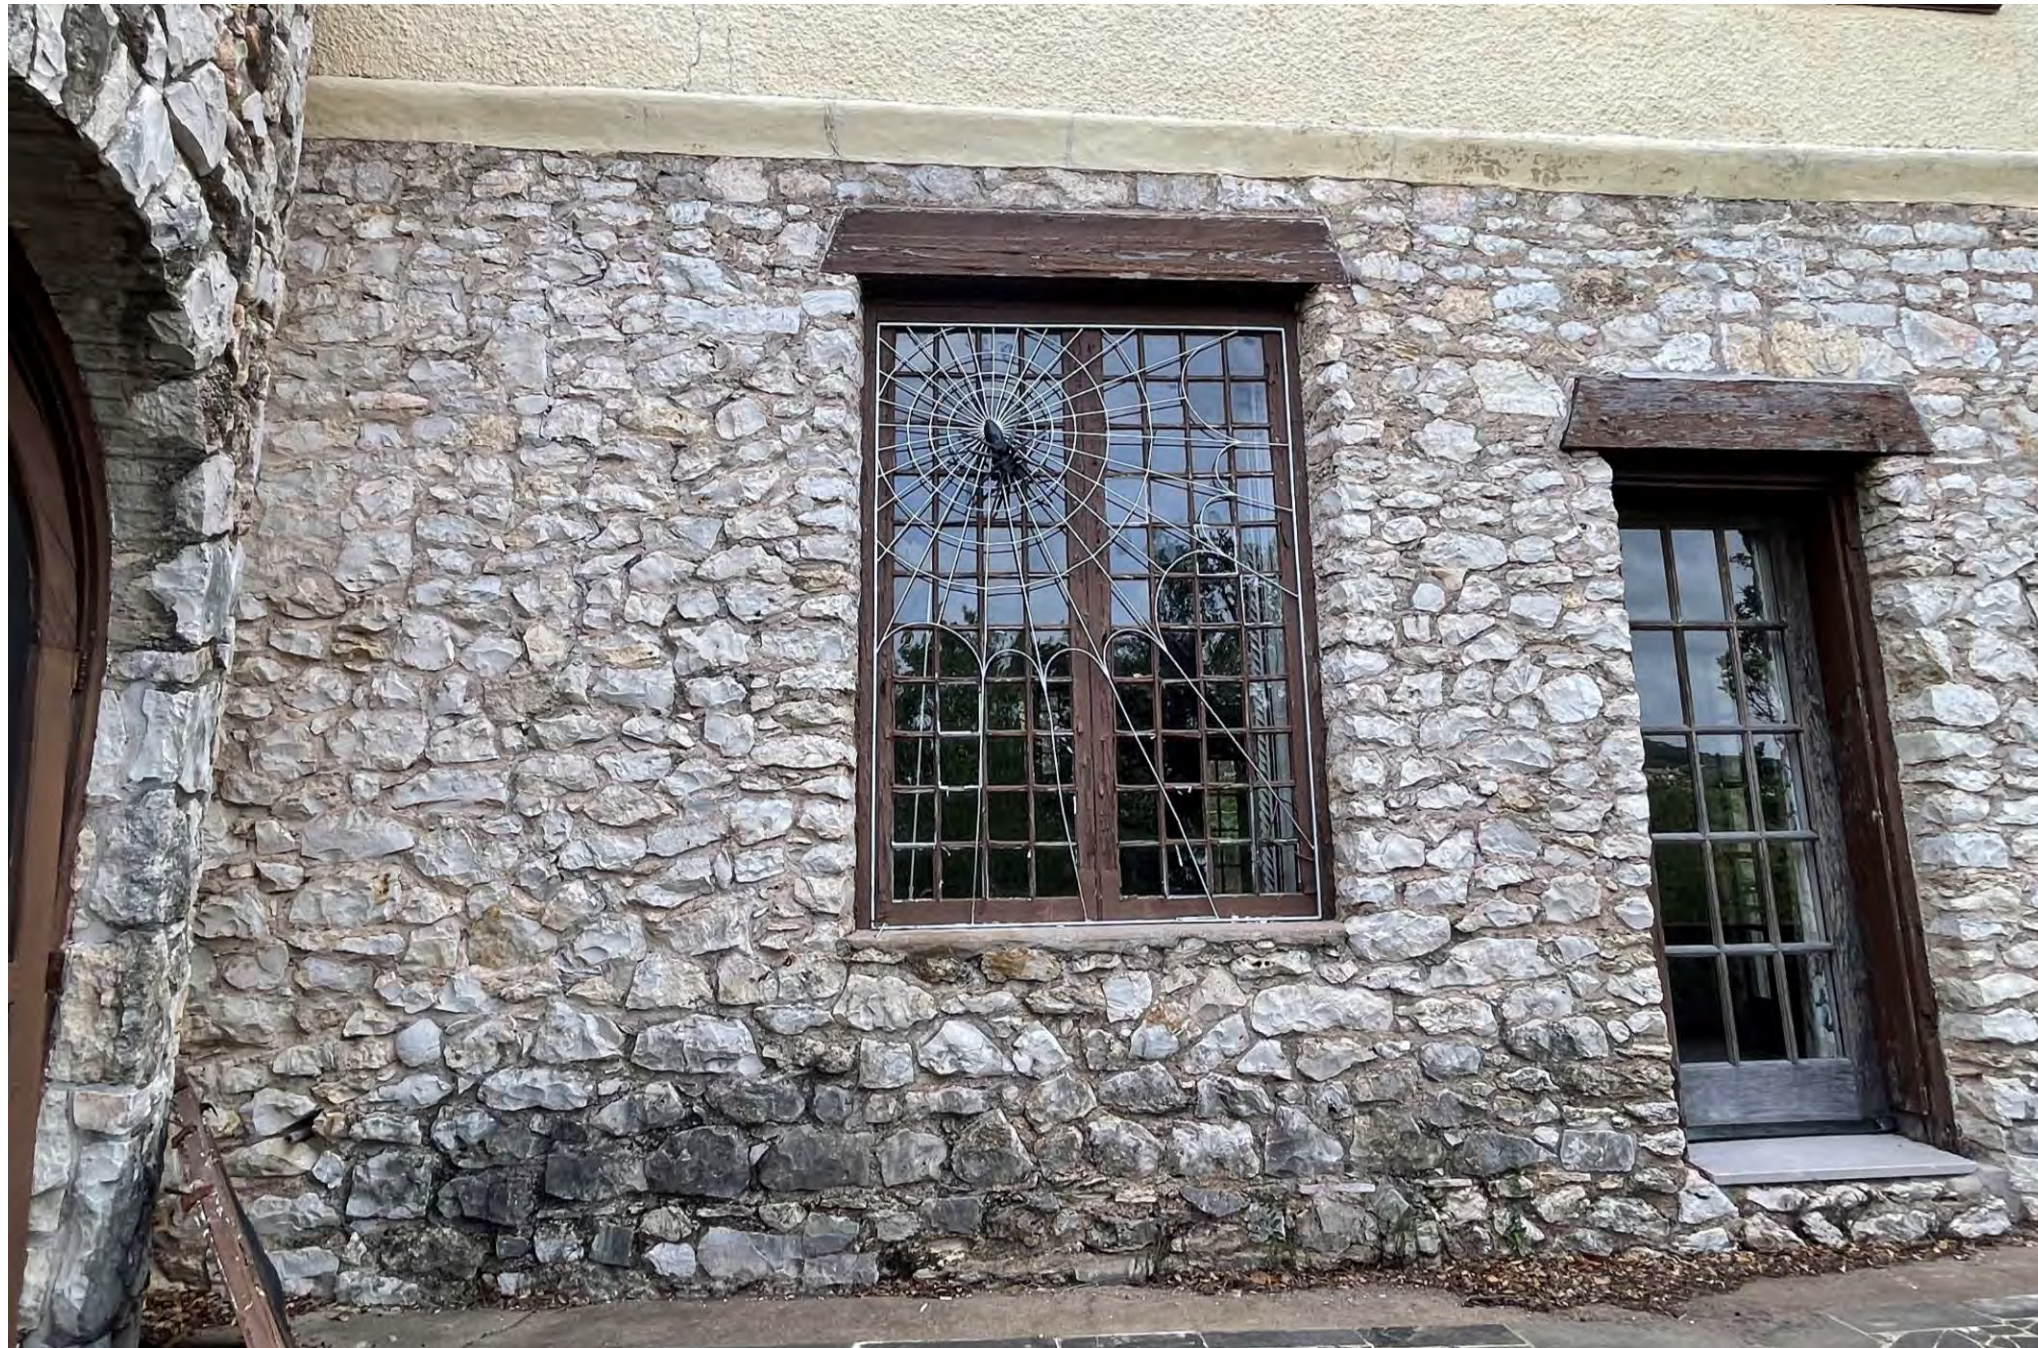
TWO STORY HOUSE EXTERIOR

1. THERE IS A CRACK THAT STARTS AT THE STUCCO SECOND FLOOR WALL AND RUNS DOWN FROM THERE.
2. THE CRACK CONTINUES THROUGH THE ROCK FIRST FLOOR WALL. THE WATER DAMAGED STONE CAN BE SEEN AT THE BOTTOM OF THE WALL.

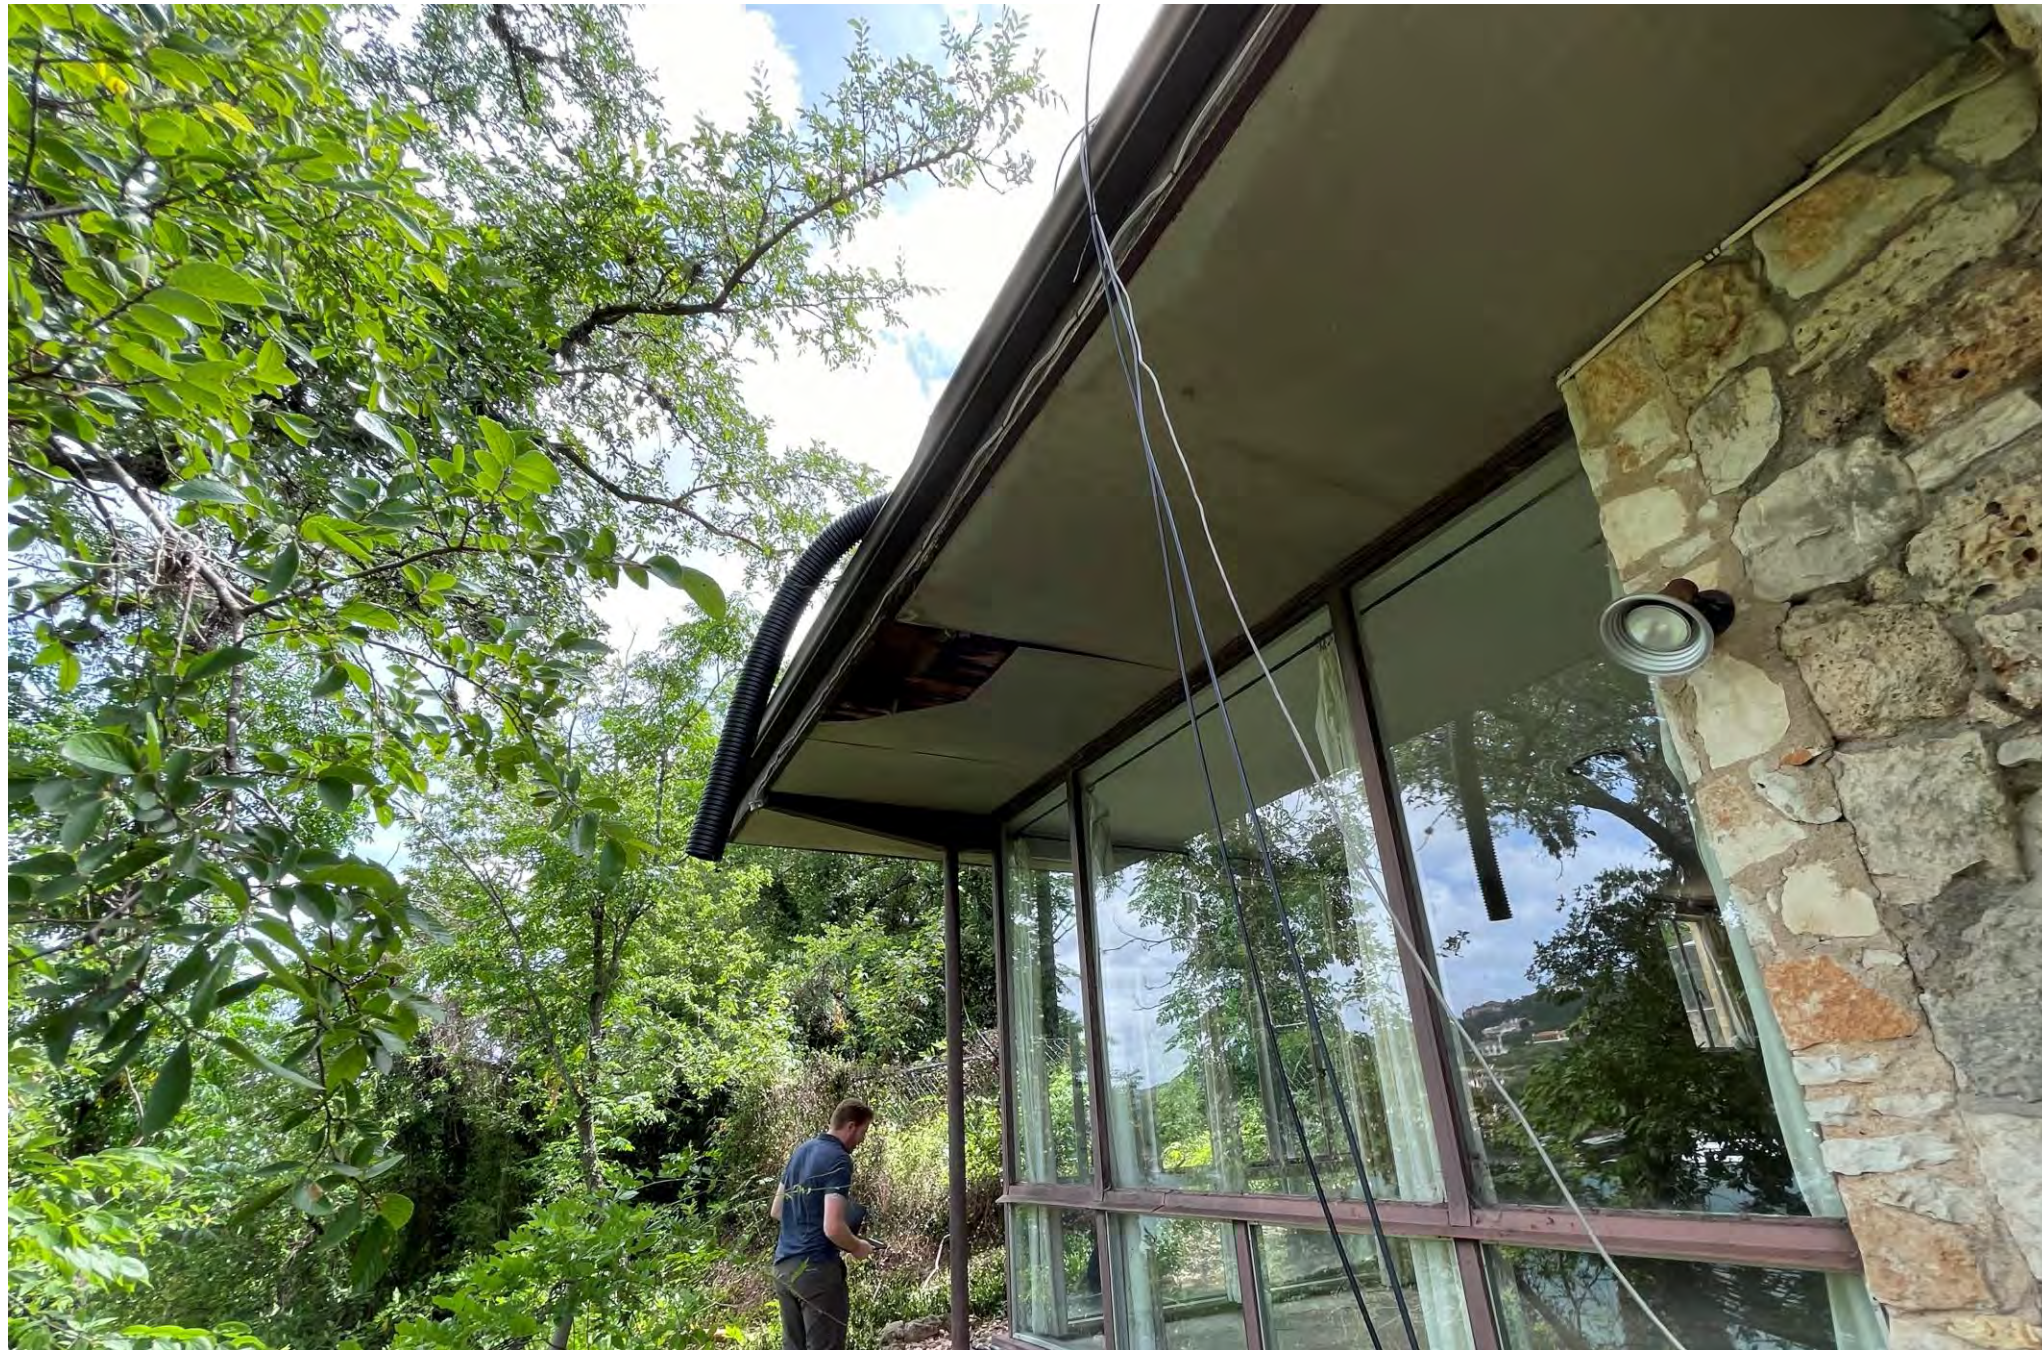
TWO STORY HOUSE EXTERIOR

1. THE ROOF SOFFIT IS DETERIORATING AND FALLING APART.
2. THE WOOD STRUCTURE WITHIN THE ROOF IS EXPOSED.

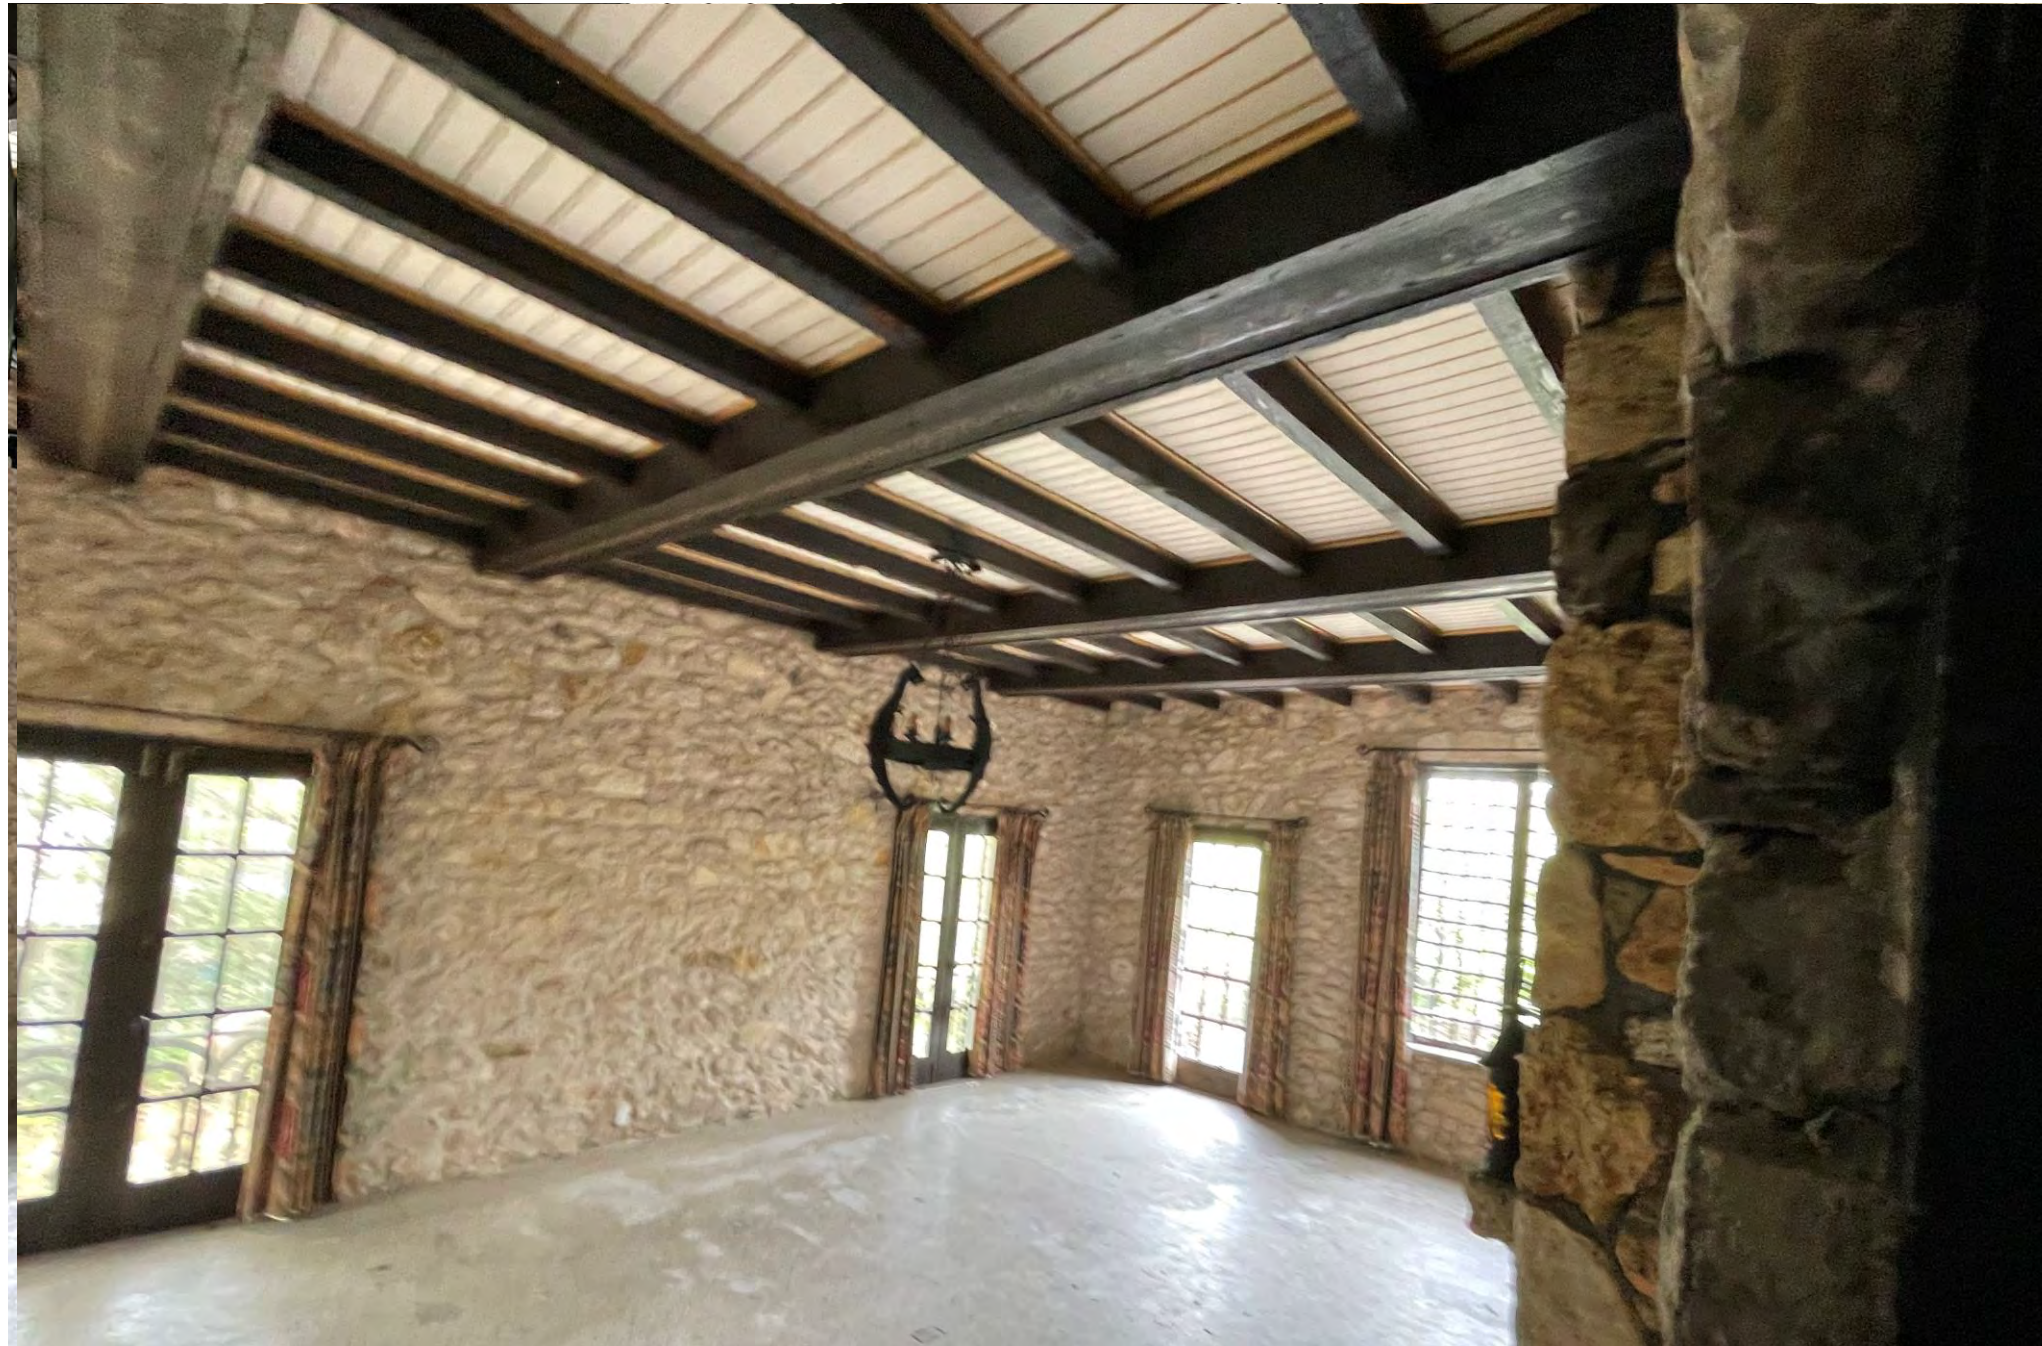
TWO STORY HOUSE INTERIOR

1. A STRUCTURAL ENGINEER HAS INDICATED THAT THESE BEAMS ARE INADEQUATE OF BEING STRUCTURALLY CAPABLE TO HOLD THE LOAD OF THE SECOND FLOOR.

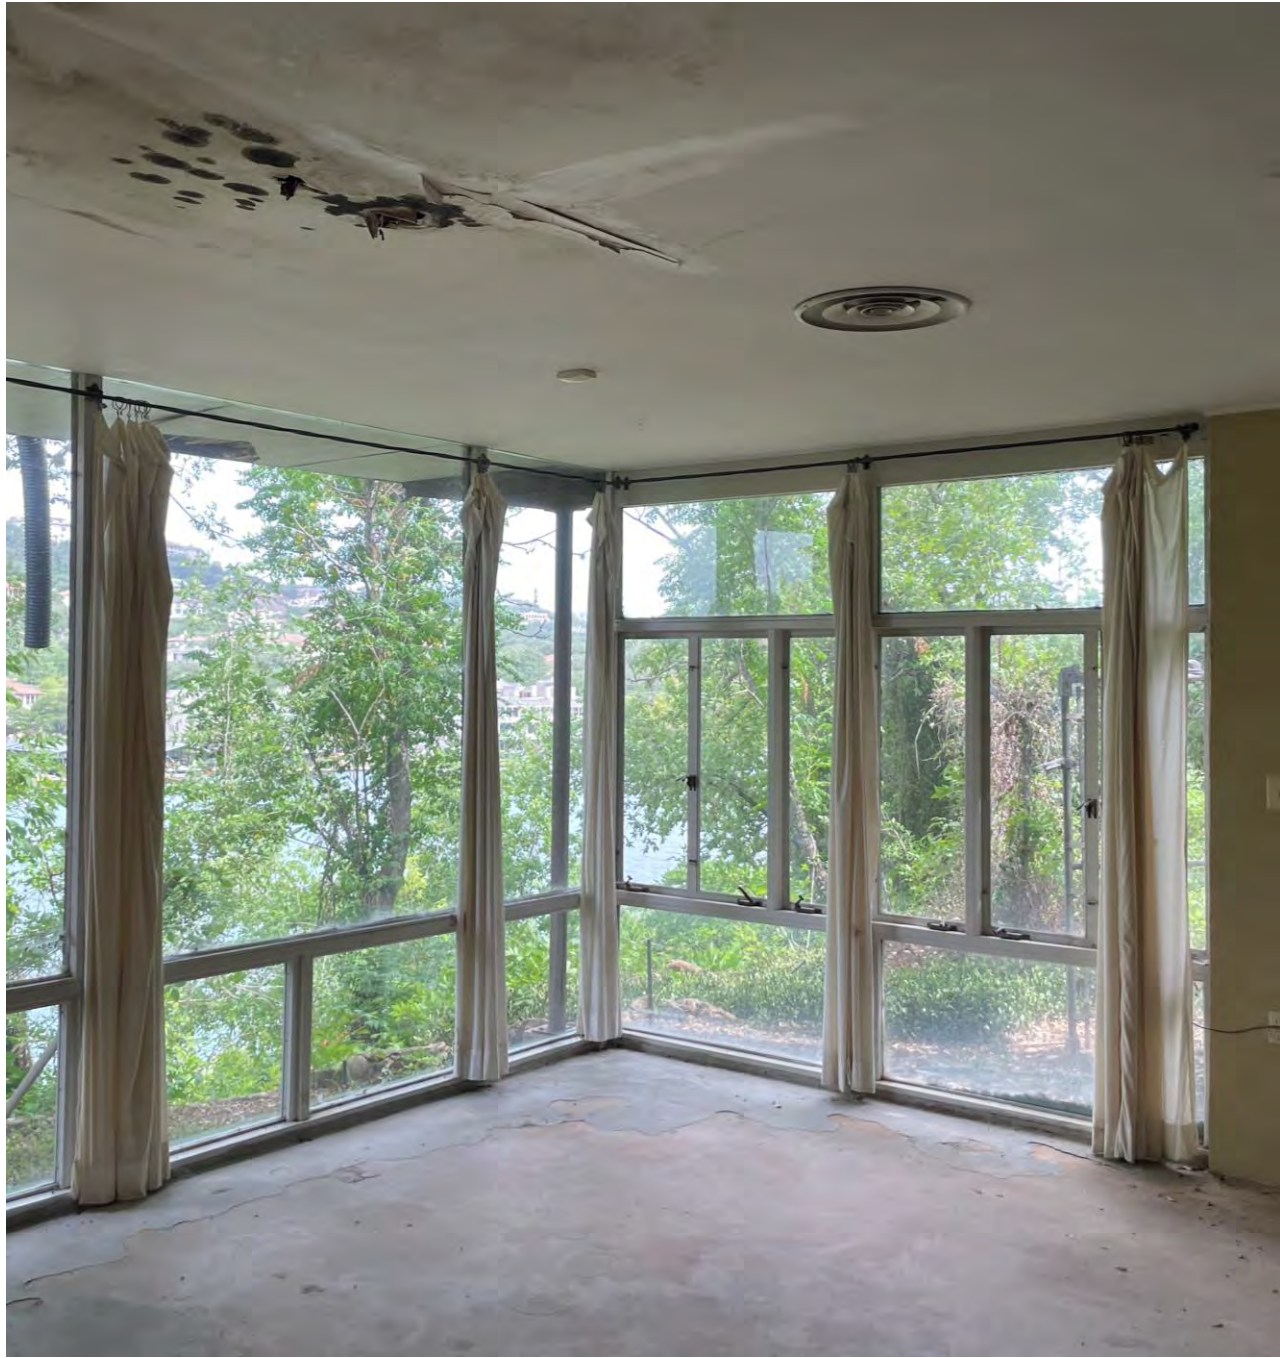
TWO STORY HOUSE INTERIOR

1. THE FLOOR IS DAMAGED AND FLAKING. ON THE EXTERIOR, THE HEIGHT OF THE GROUND IS HIGHER THAN THE HEIGHT OF THE WINDOW SILL, ALLOWING WATER TO FLOW INTO THE HOUSE.
2. WATER IS DAMAGING THE CEILING IN LARGE AREAS. BLACK MOLD IS EVIDENT IN MULTIPLE LOCATIONS.
3. IN THIS LOCATION THE WATER DAMAGE IS ESPECIALLY EVIDENT AND DESTRUCTIVE. MOLD IS A POTENTIAL HEALTH HAZARD AND WOULD REQUIRE AN EXTENSIVE MITIGATION EFFORT.

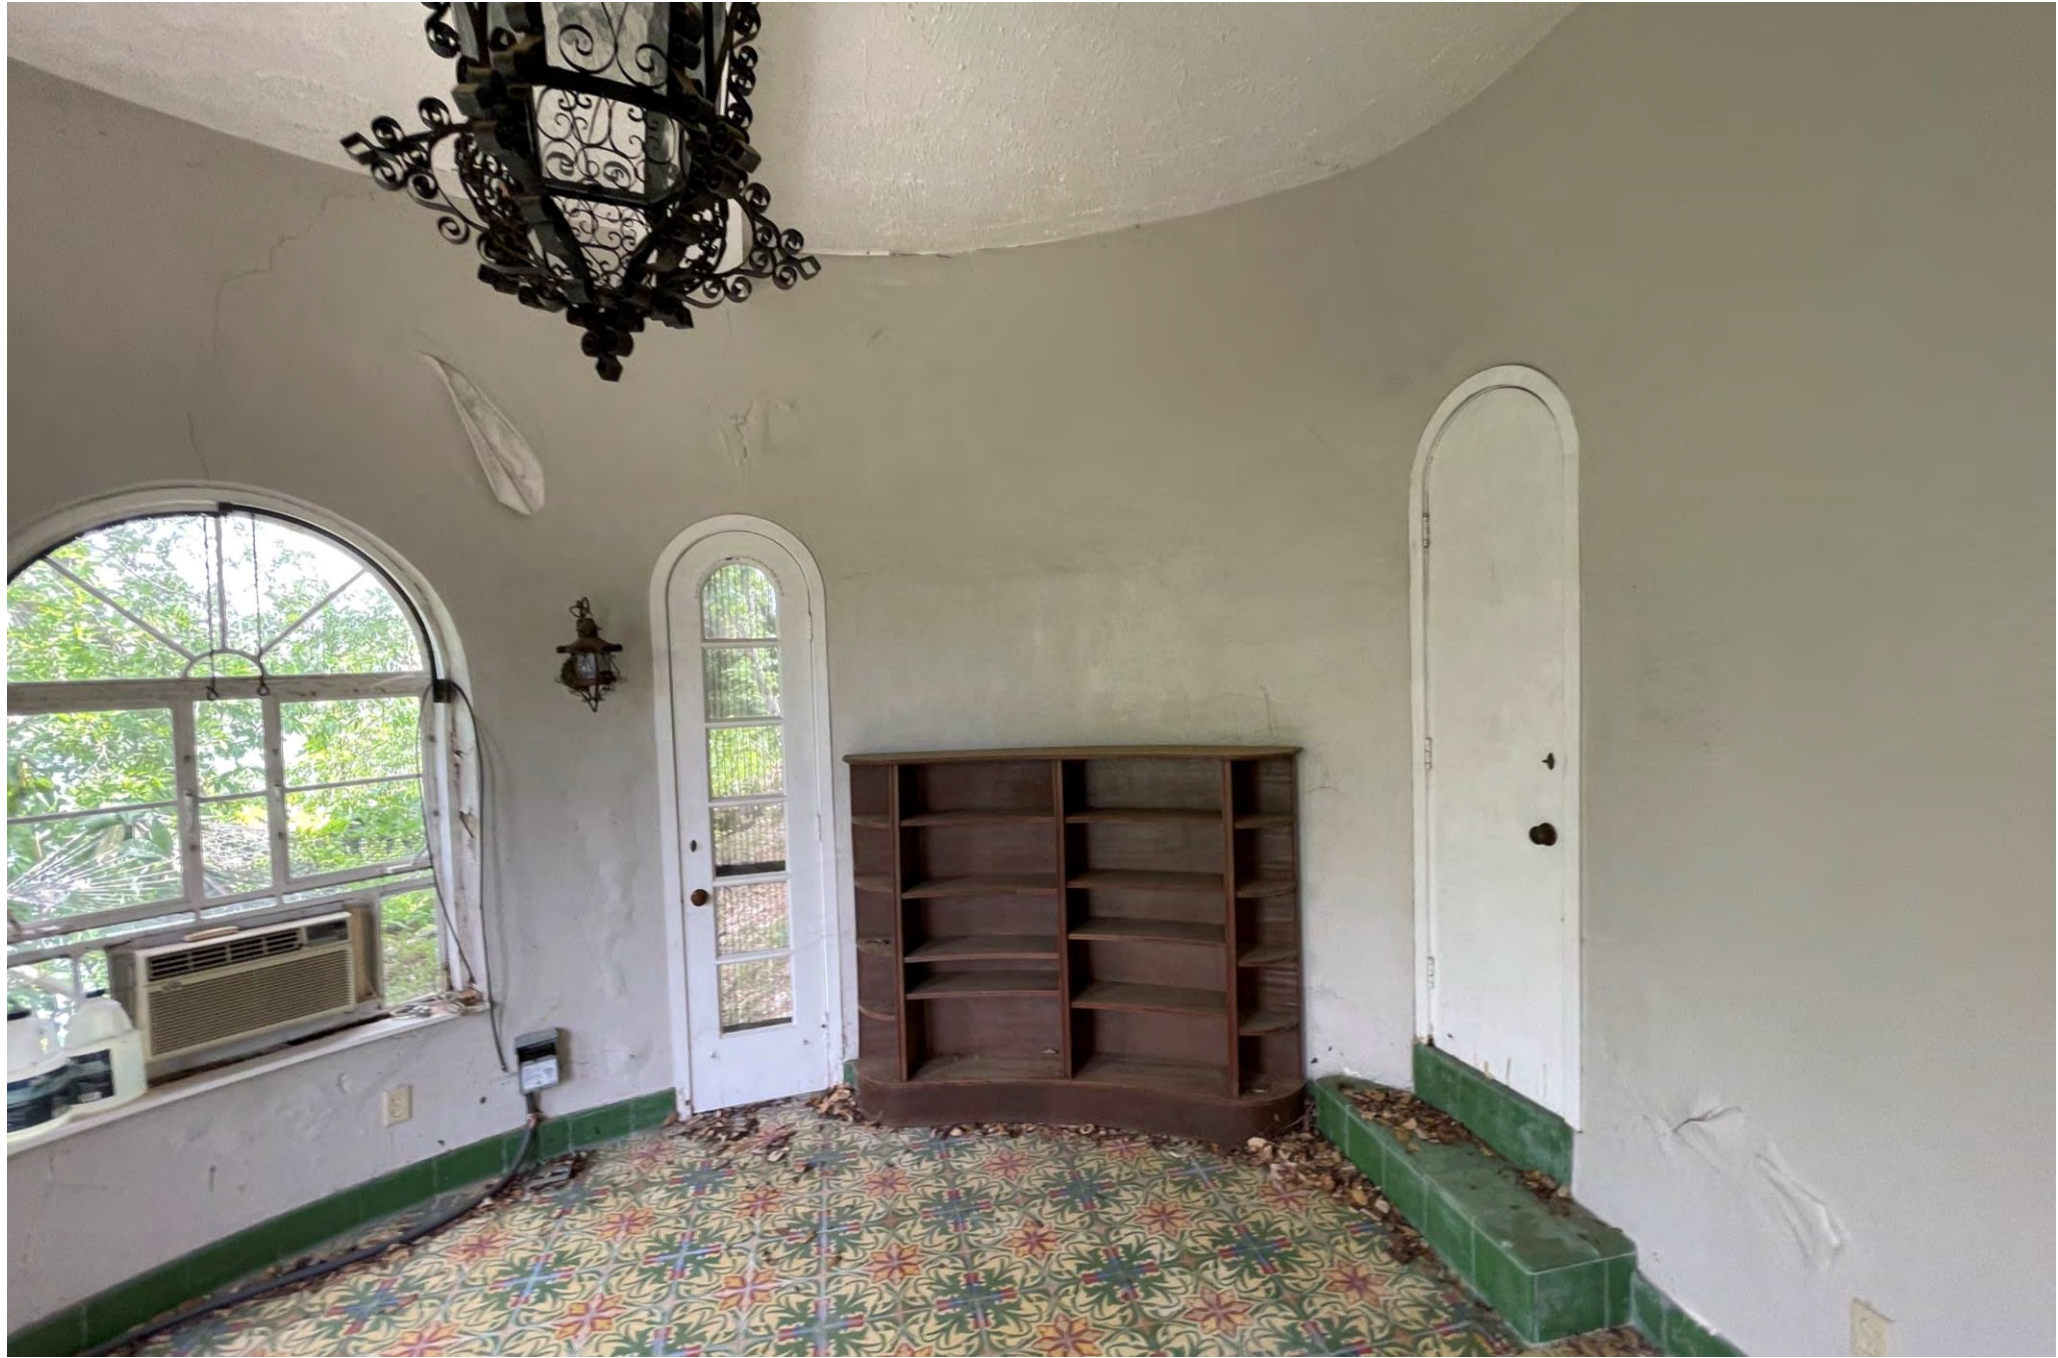
TWO STORY HOUSE INTERIOR

1. THE PLASTER DRYWALL IS FALLING APART AND CRACKING. THE DOOR IS TOO SMALL AND IS UP AGAINST STONE STAIRS.
2. THE PLASTER IS CRACKED AND FALLING APART.

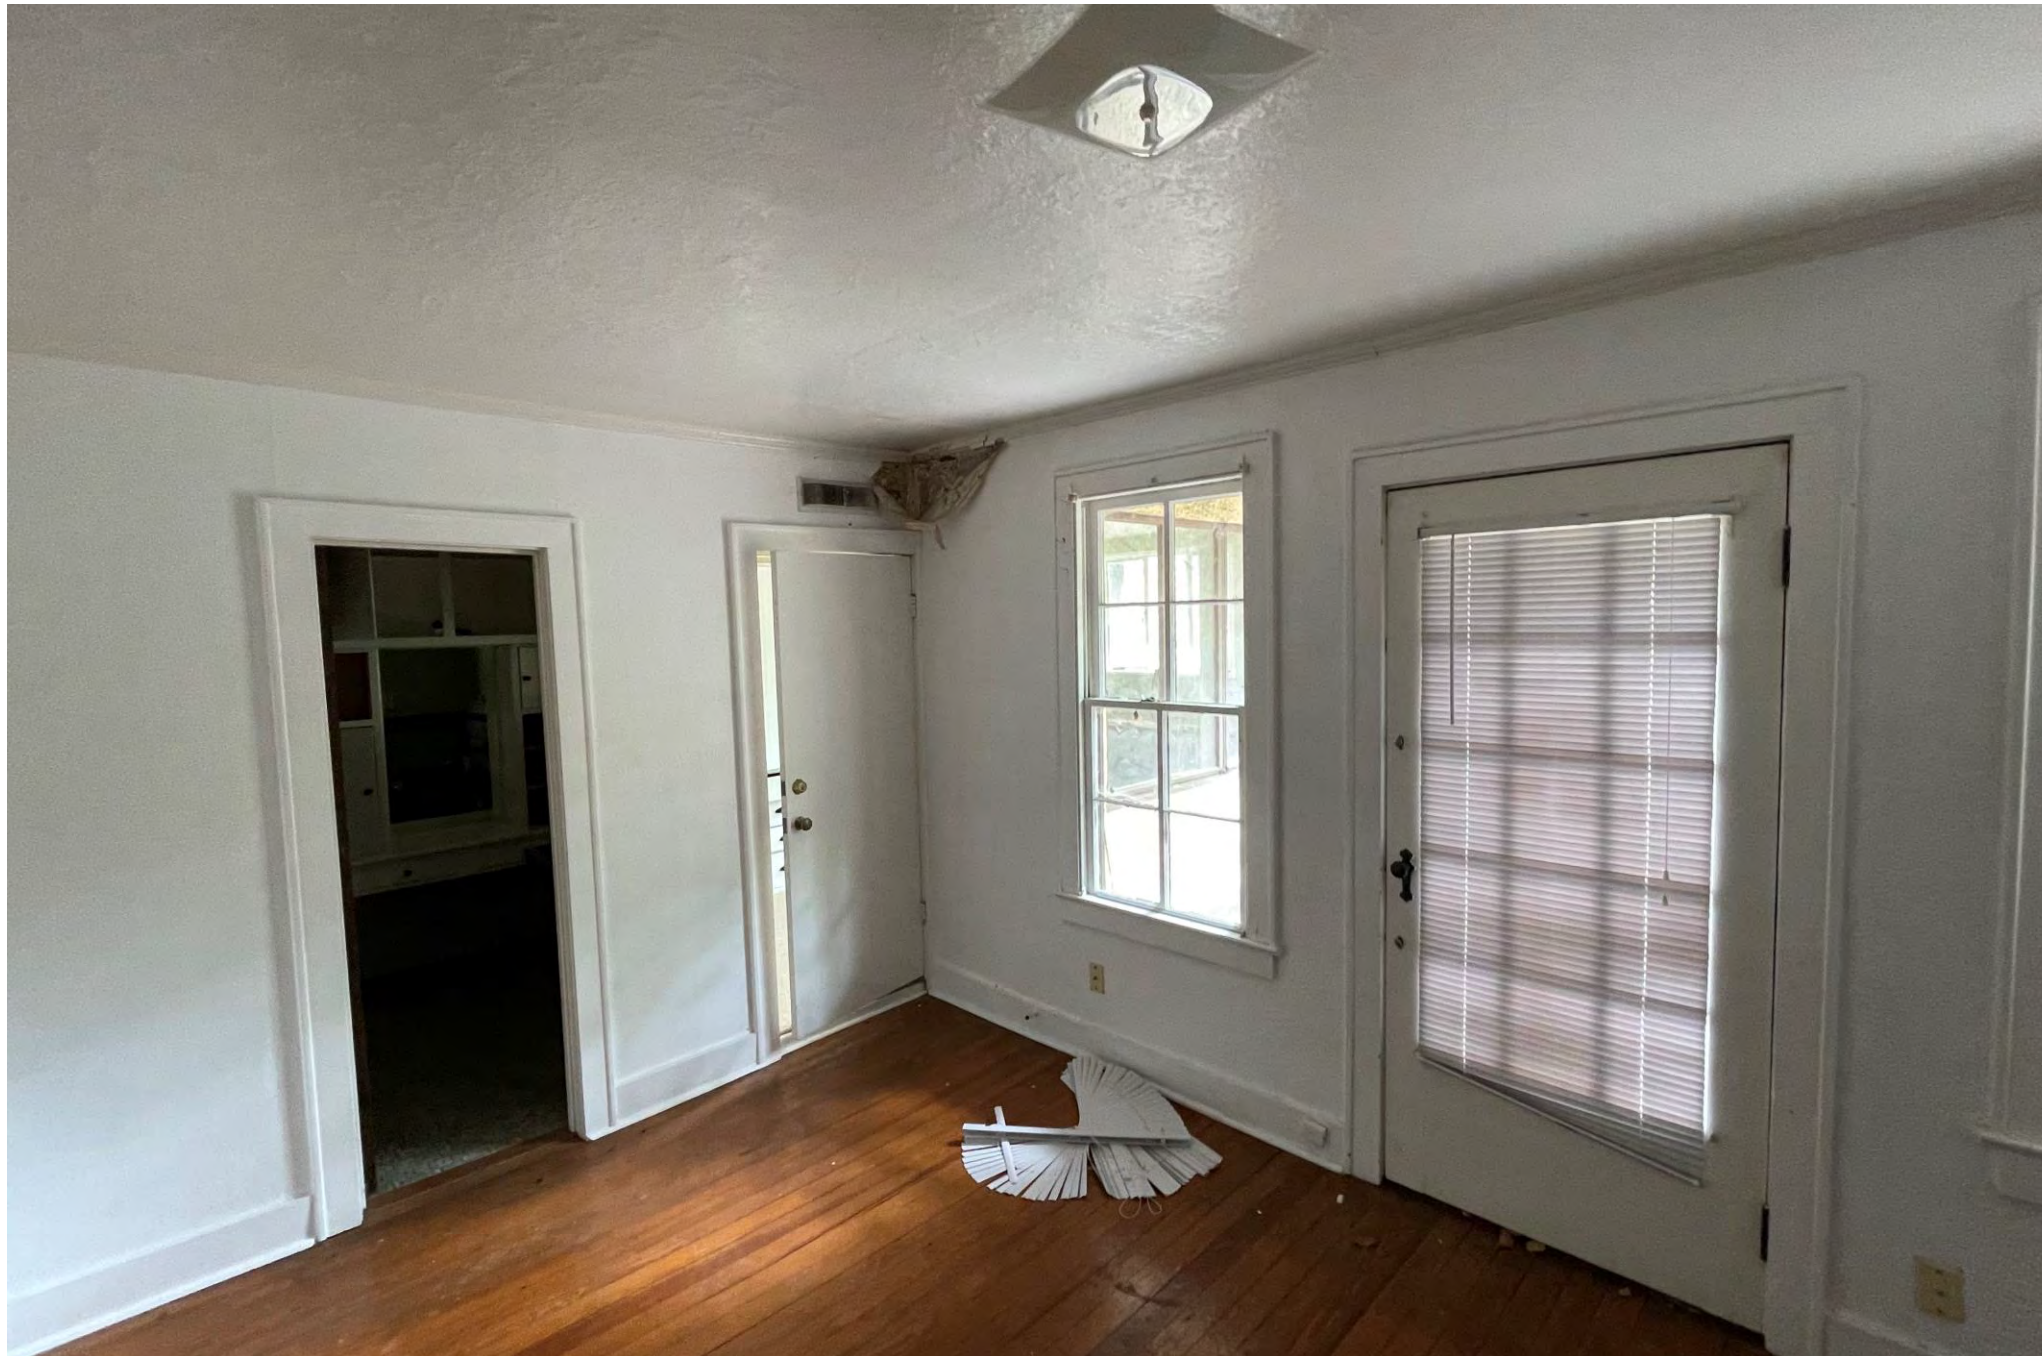
TWO STORY HOUSE INTERIOR

1. THE PLASTER AND THE TRIM ARE FALLING APART AND EXPOSING THE WALL BENEATH.
2. THE PLASTER IS CRACKING.
