JUNE 28, 2022
22

RYAN STREET
ARCHITECTS

2002 SCENIC DRIVE RESIDENCE
Two Story House - Interior

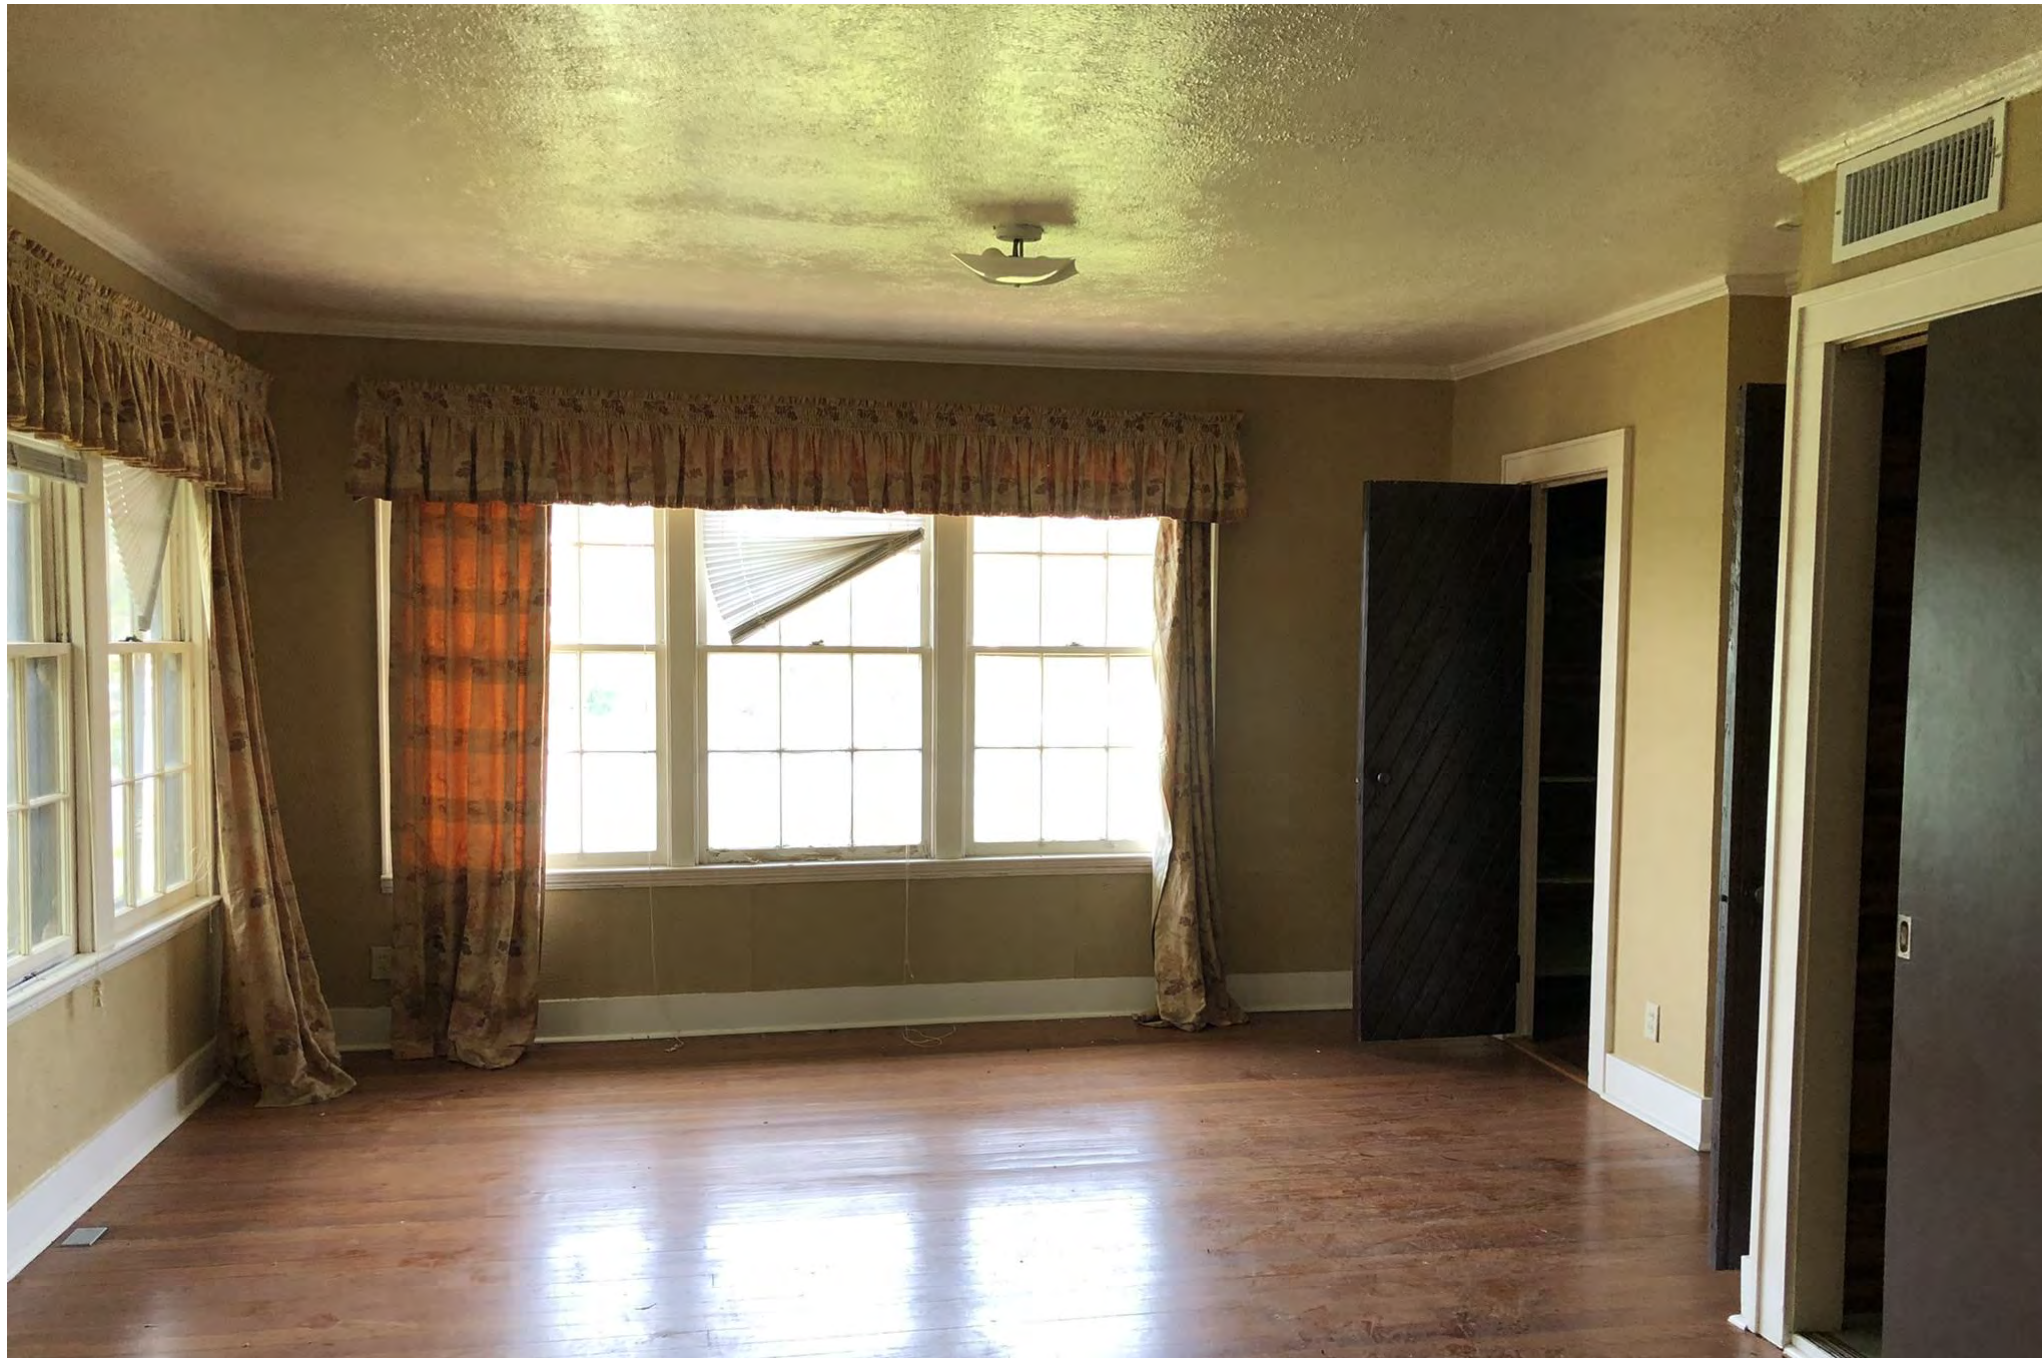
TWO STORY HOUSE INTERIOR

1. THE WINDOWSILL IS FALLING APART AND IS DROPPING DEBRIS ONTO THE WINDOW SILL AND FLOOR.
2. THE FLOOR IS BOWING DUE TO THE LACK OF STRUCTURAL SUPPORT BELOW.

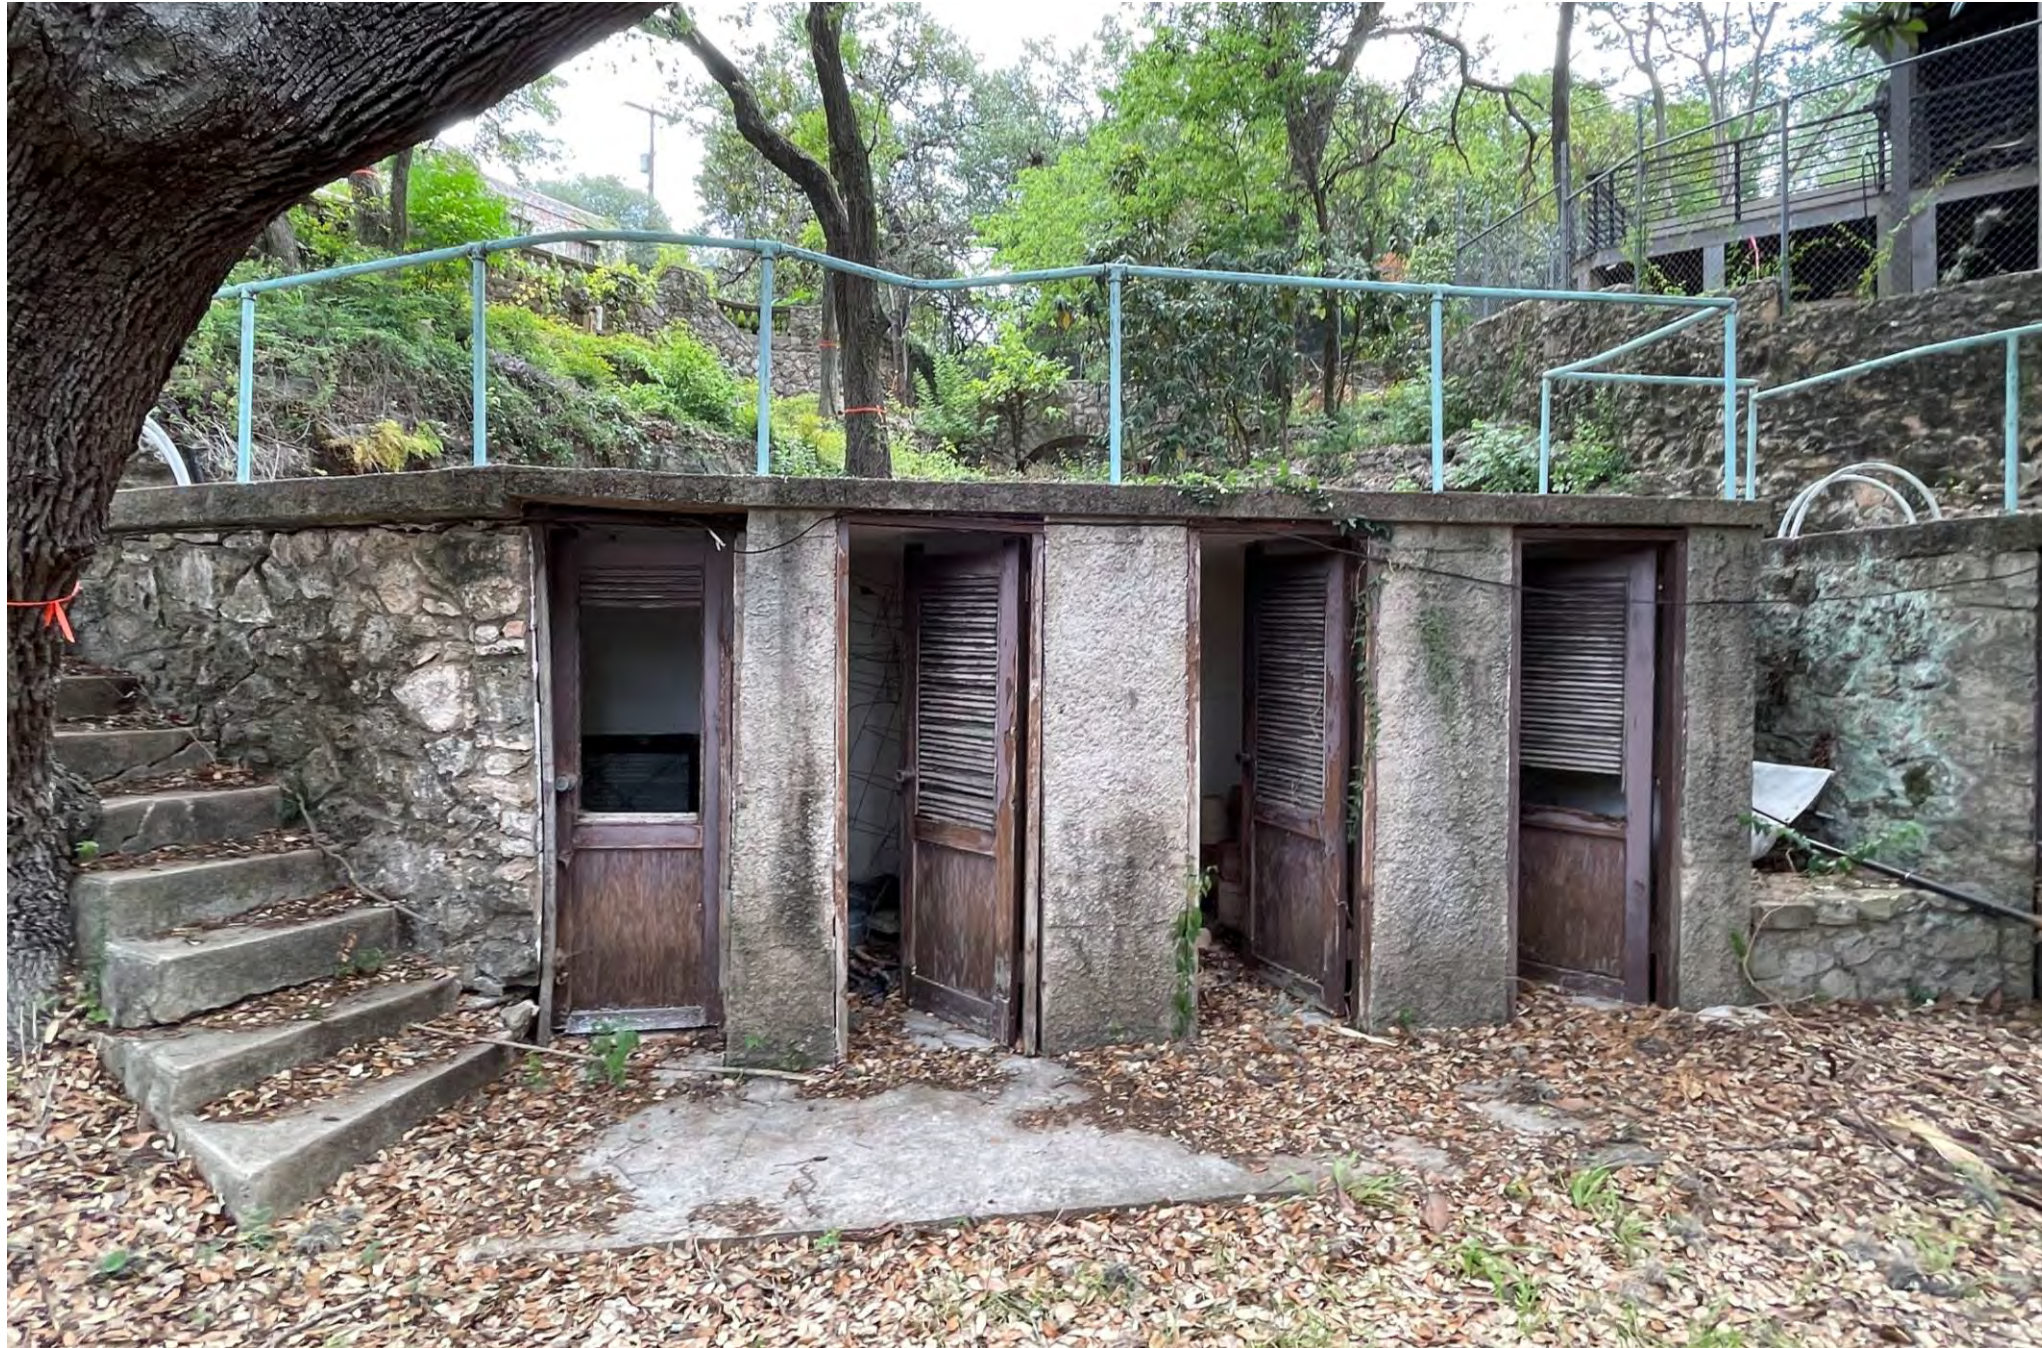
POOL AND LANDSCAPE EXTERIOR

1. CHANGING ROOMS - THE CONCRETE WALLS ARE SHOWING SIGNS OF WATER DAMAGE. THE WOOD DOORS ARE FALLING APART.
2. CHANGING ROOMS – ON THE INSIDE OF THE CHANGING ROOMS, THE WALLS ARE CRACKING AND THE FOUNDATION IS DAMAGED. DEBRIS IS COVERING THE FLOOR.

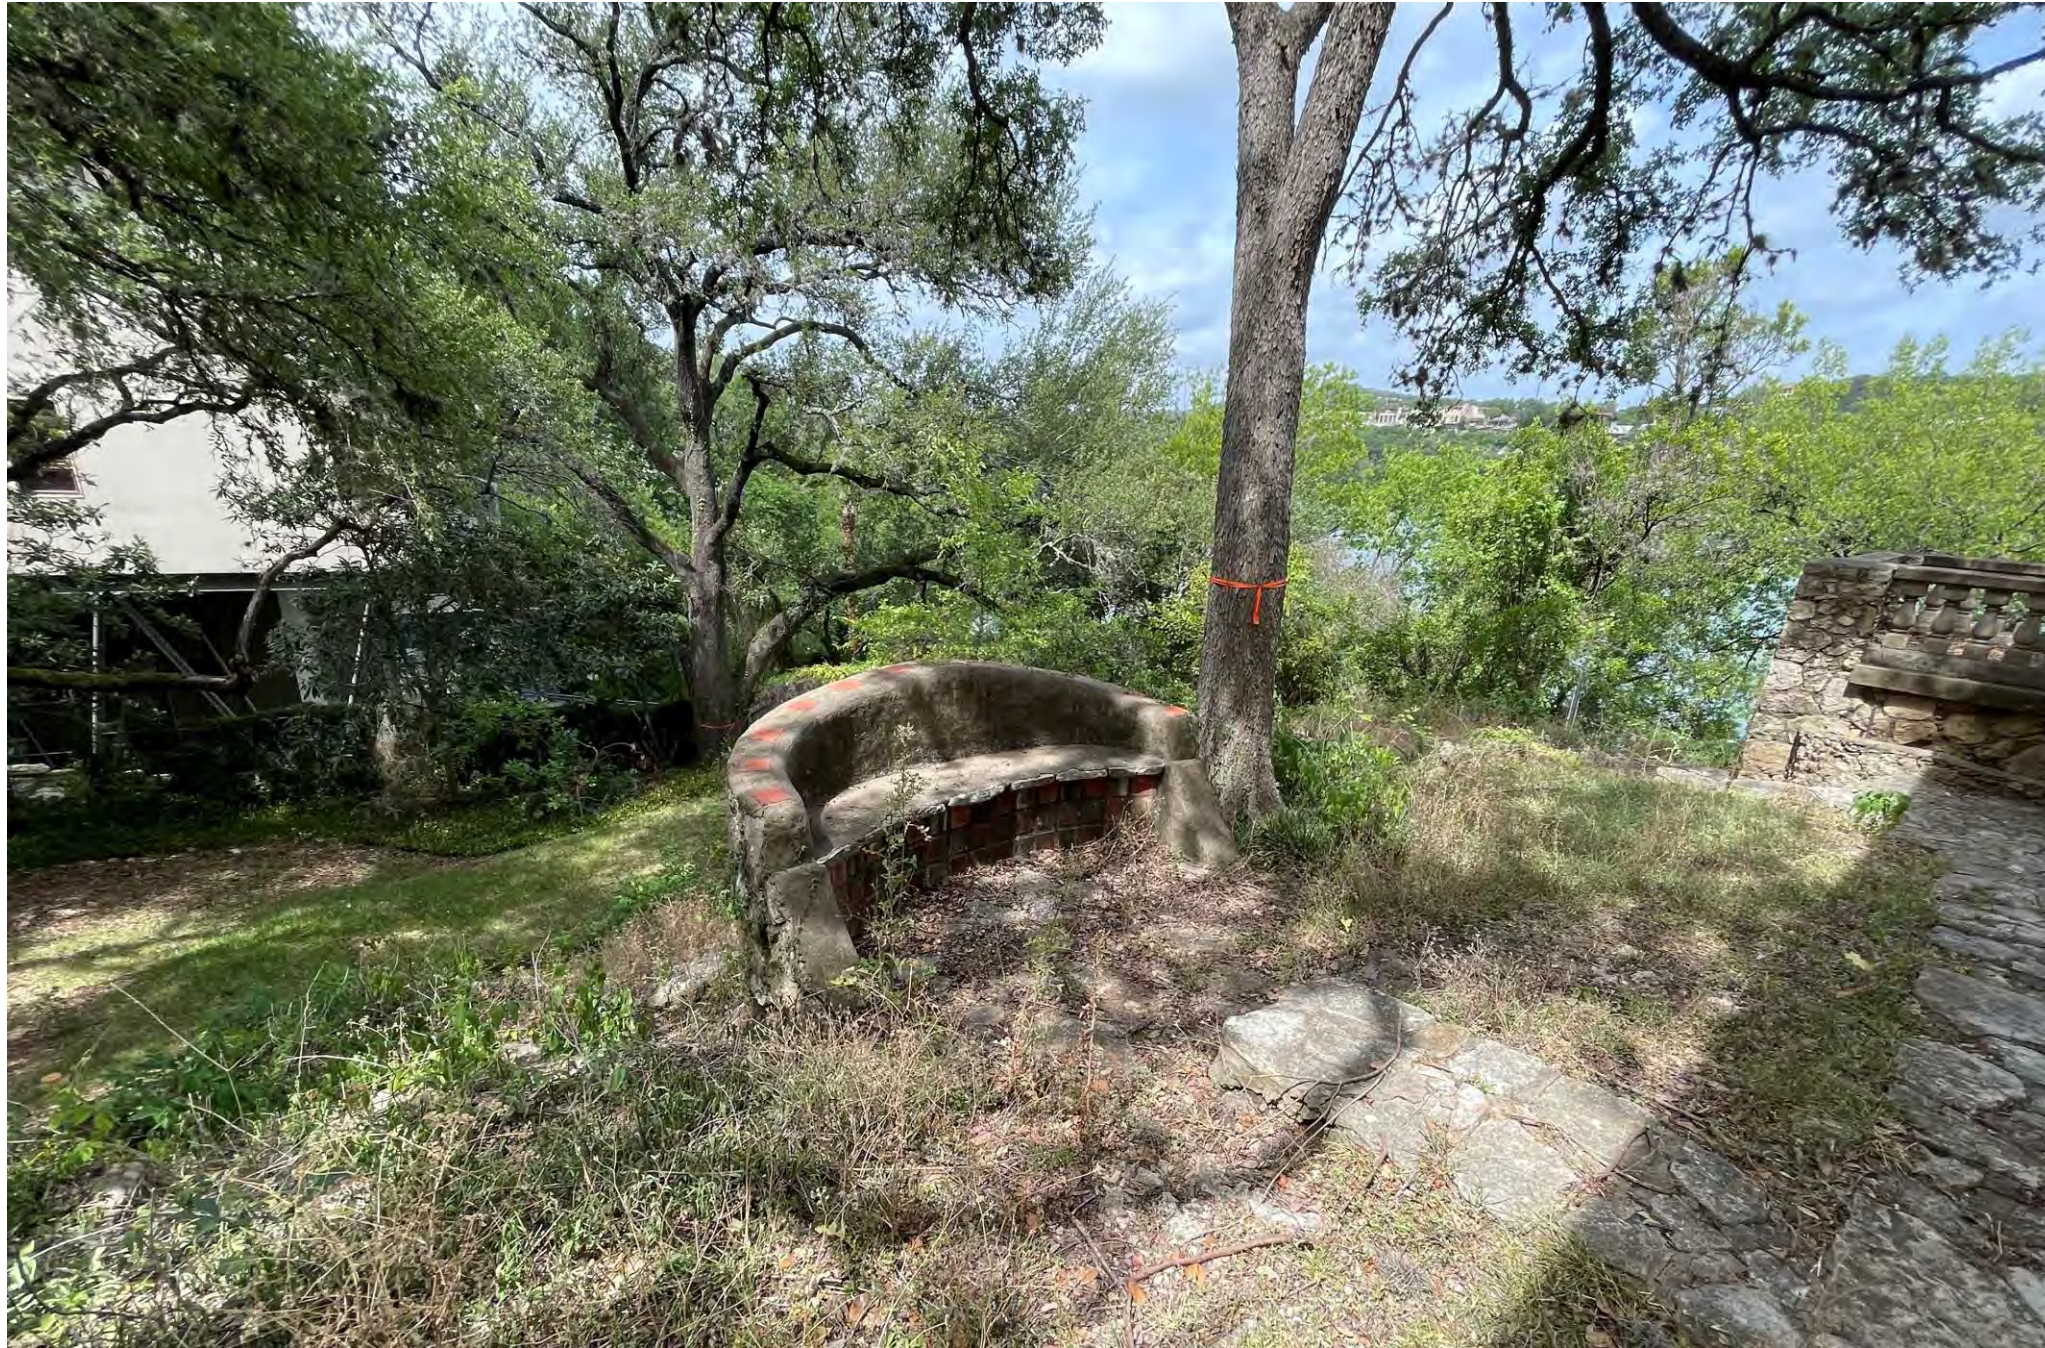
POOL AND LANDSCAPE EXTERIOR

1. FRONT OF BENCH – THE FINISH OVER THE CONCRETE BENEATH IS PEELING OFF.
2. BACKSIDE OF BENCH – THE BENCH IS CRACKED AND IS IN DISREPAIR.

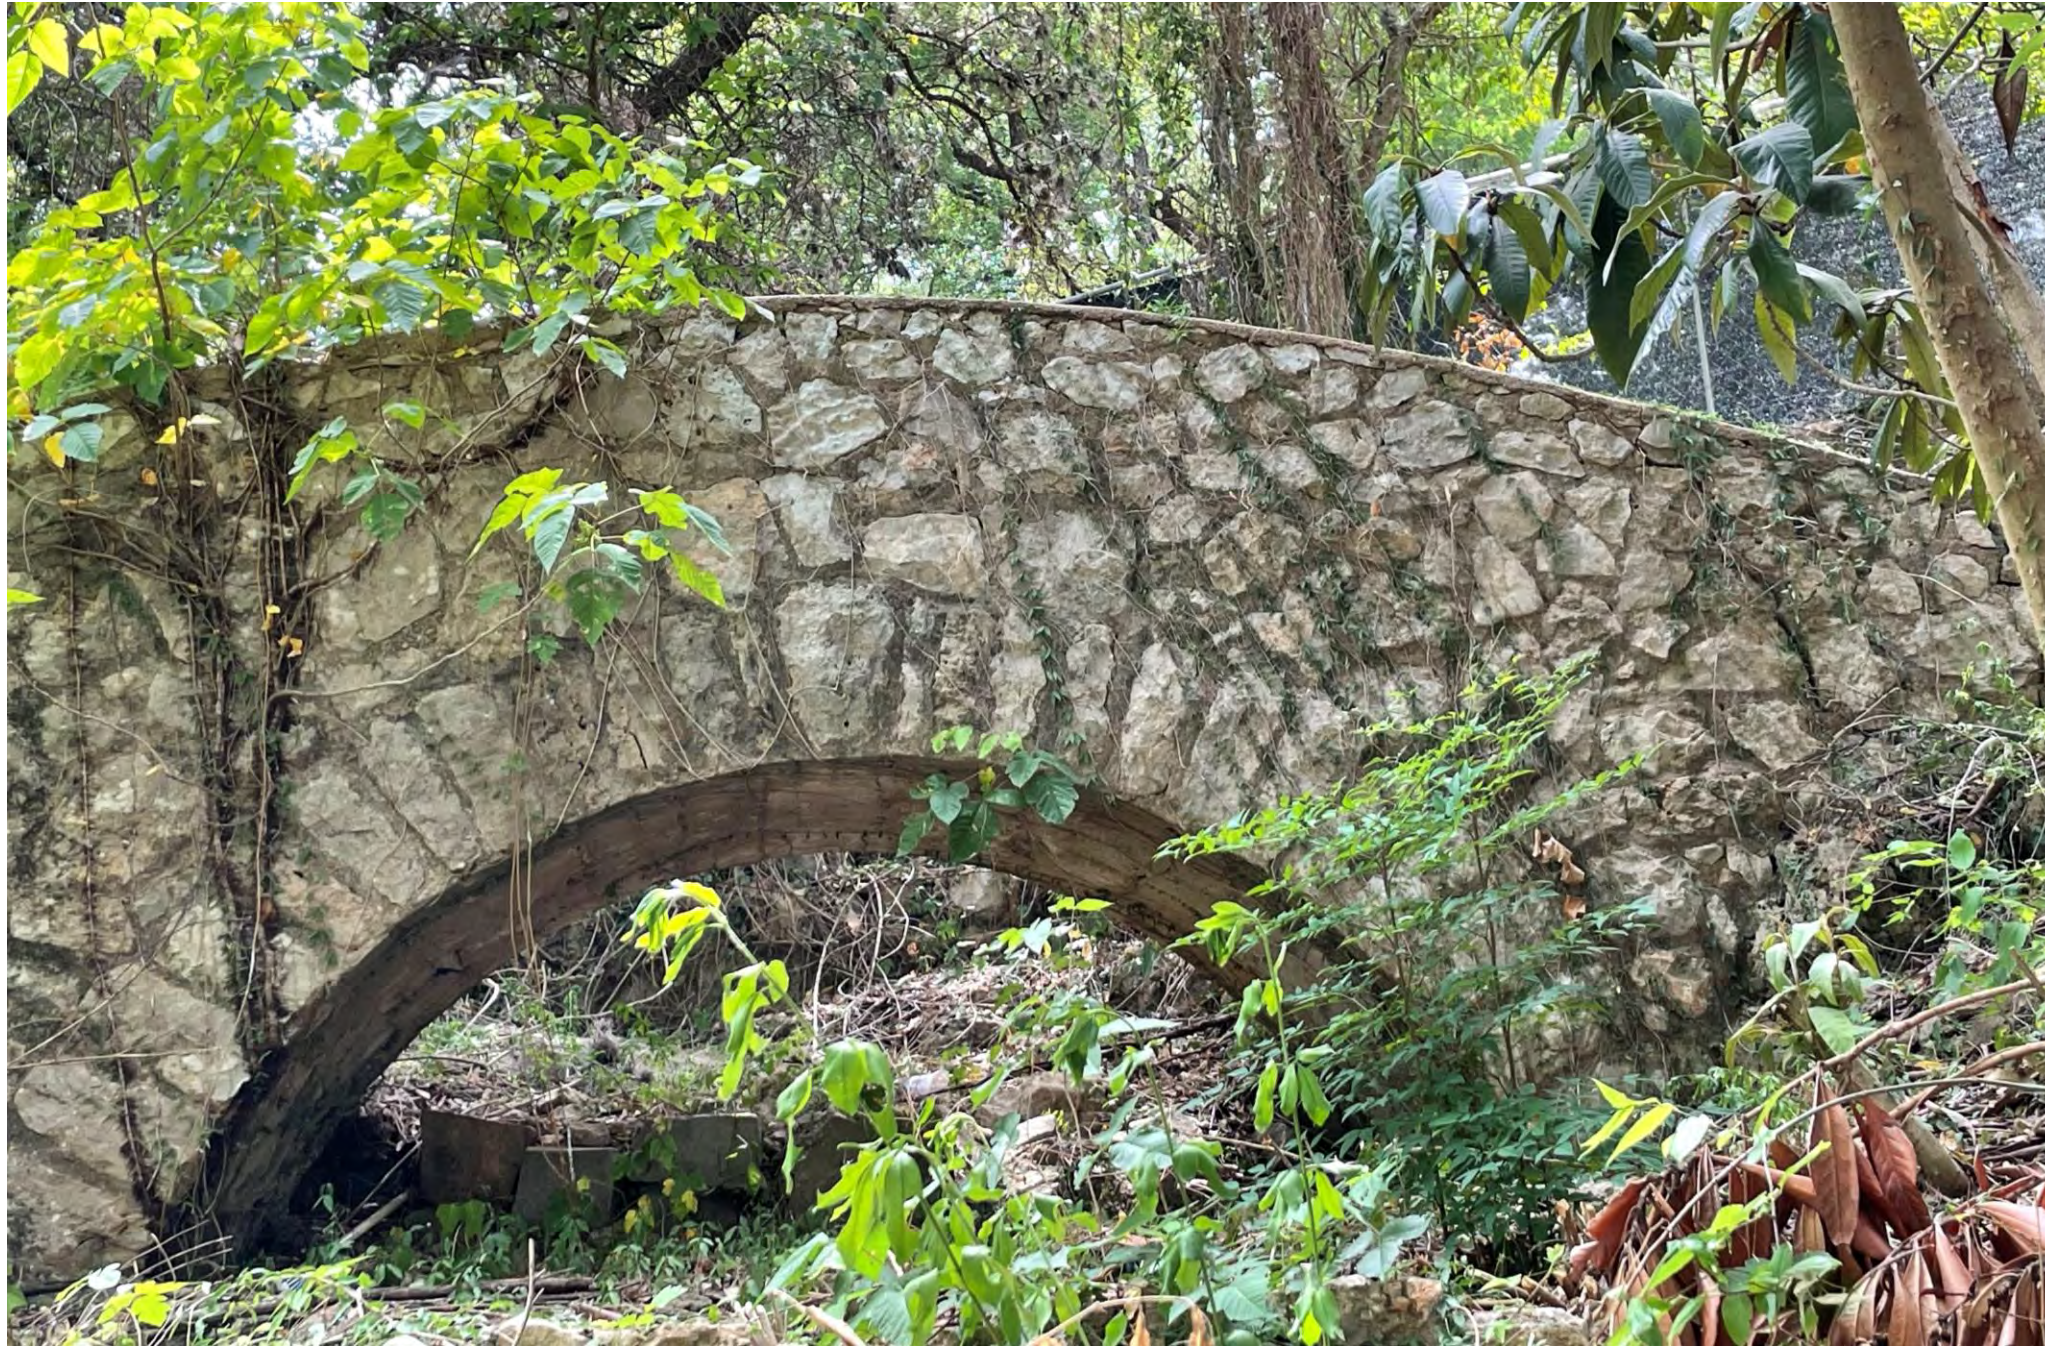
POOL AND LANDSCAPE EXTERIOR

1. THE BRIDGE IS CRACKING AND IS UNSAFE TO WALK OVER.
2. THE WALL IS CRUMBLING APART IN SEVERAL AREAS.

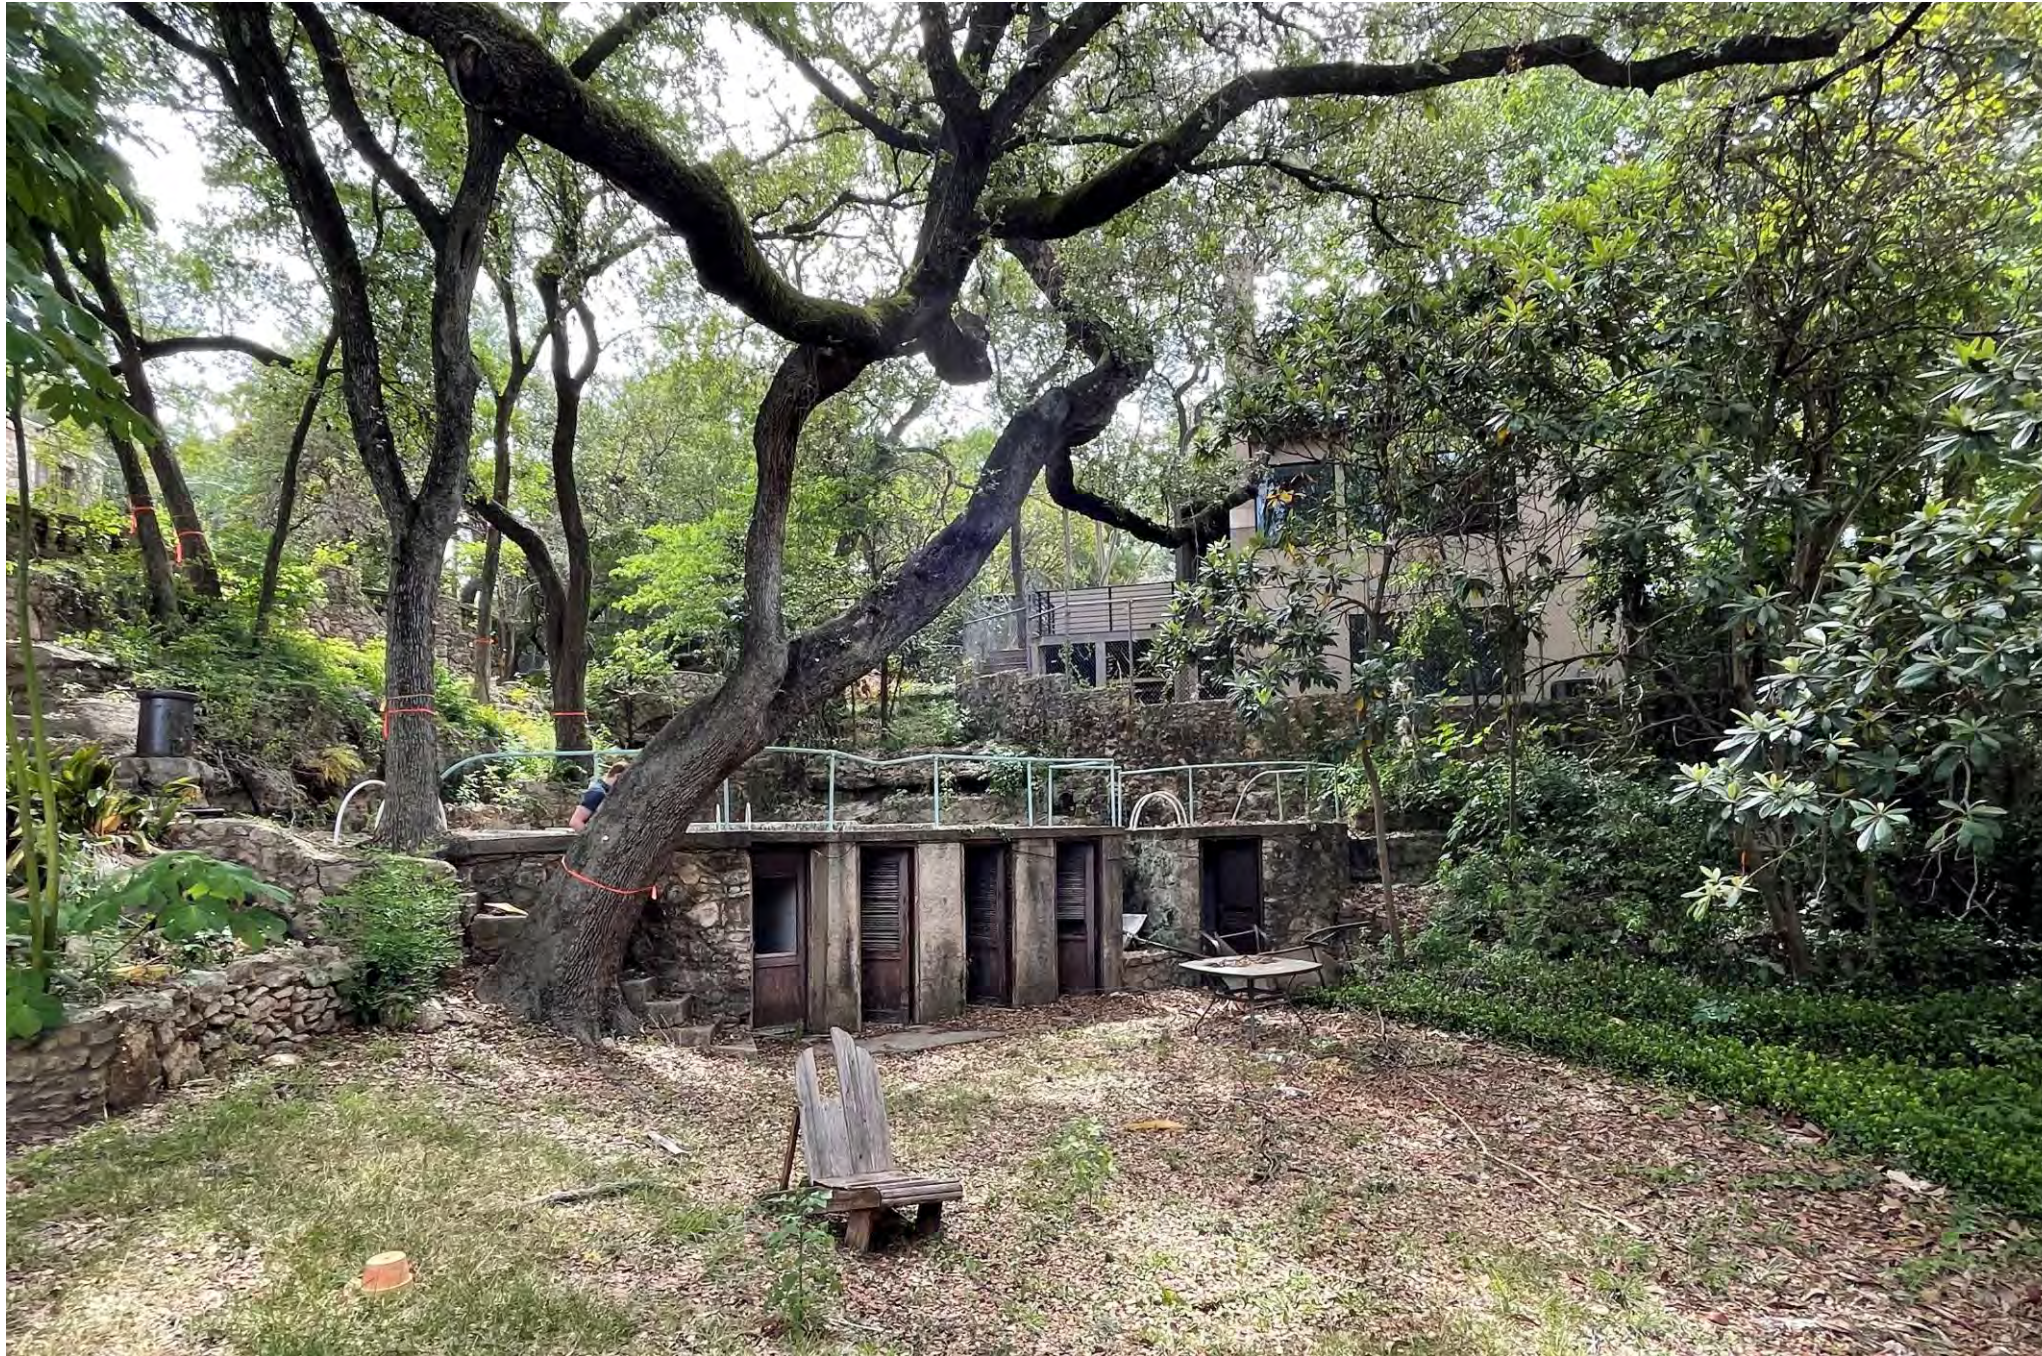
POOL AND LANDSCAPE EXTERIOR

1. THE CONCRETE STAIRS ARE CONSTRICTING THIS SIGNIFICANT TREE.
2. THE STAIRS ARE CRACKING AND MOVING DUE TO THE TREE'S GROWTH.
