# City of Austin - Bridges and Culverts

# Critical Infrastructure Assessment – Bridges 2017

# Condition Report on the Emmett Shelton Bridge on Redbud Trail over Lady Bird Lake

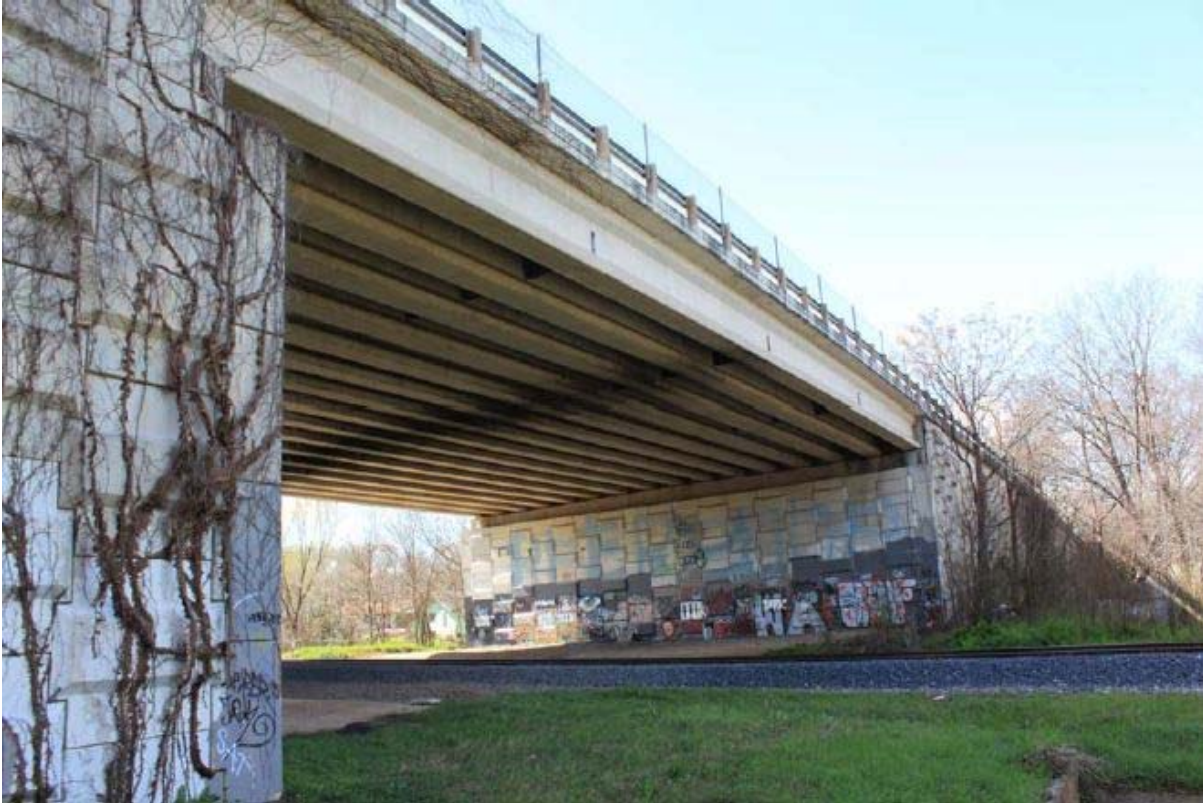
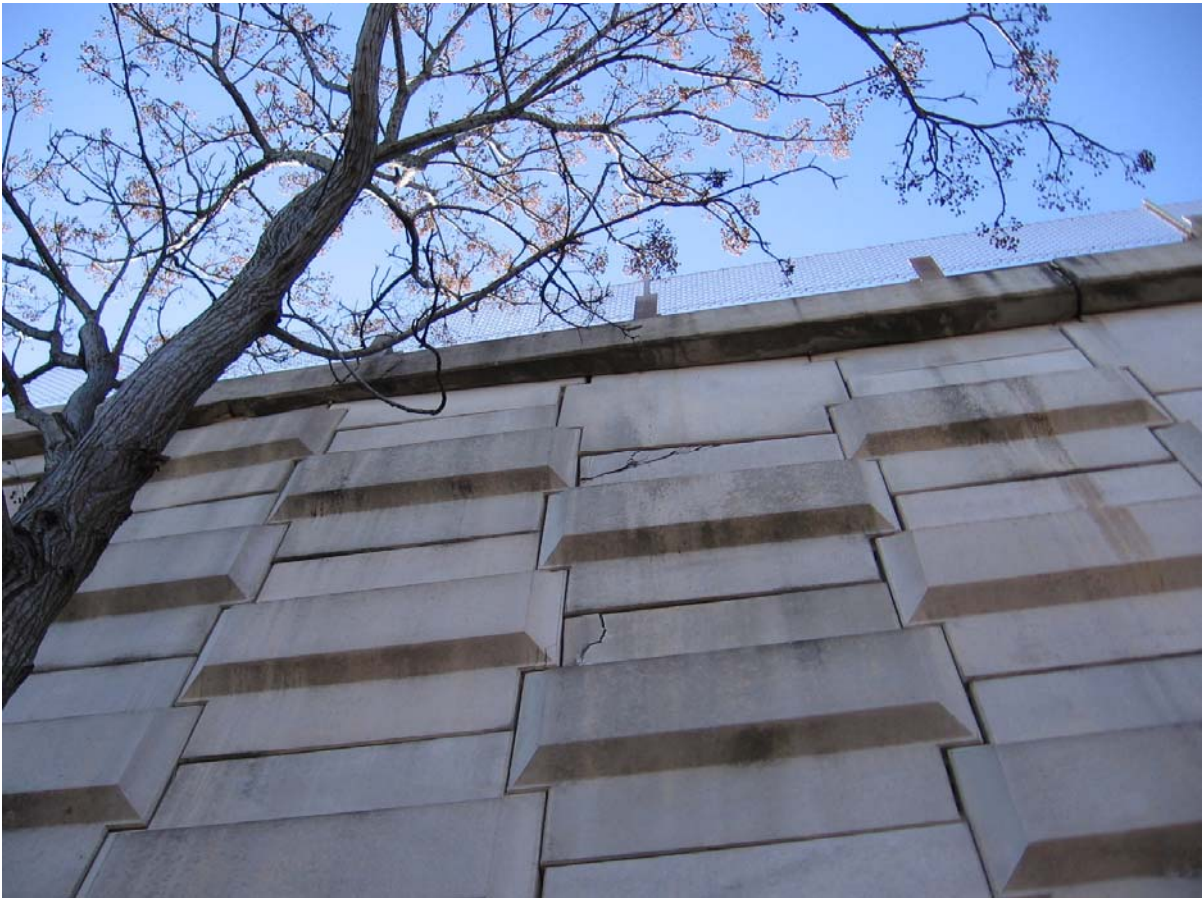
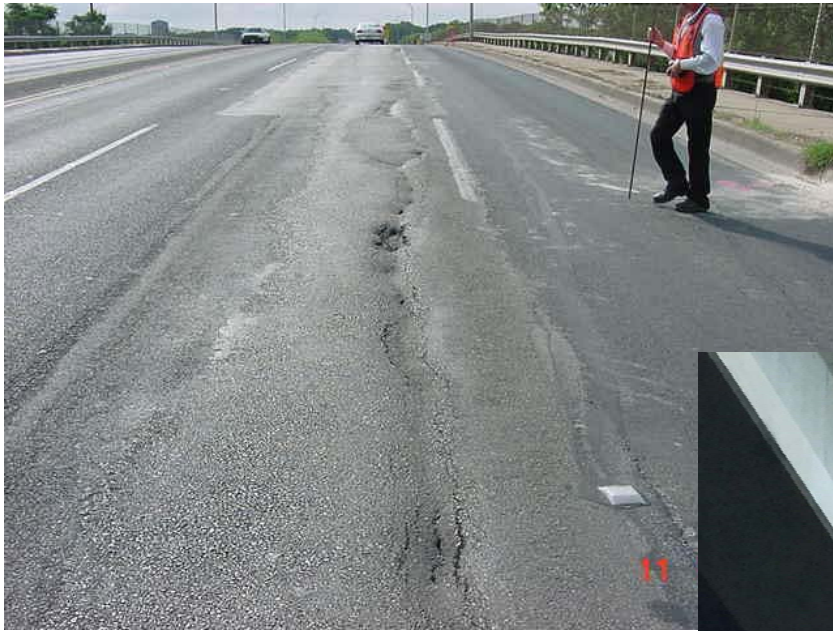
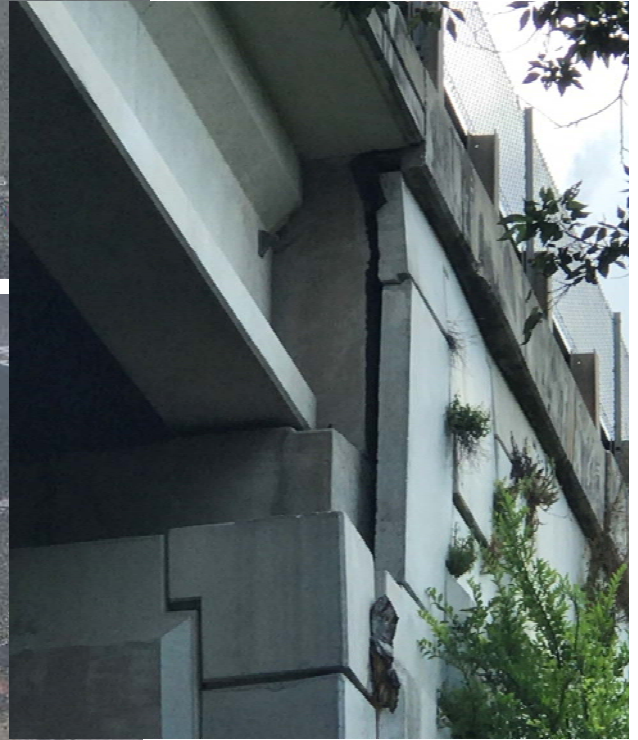
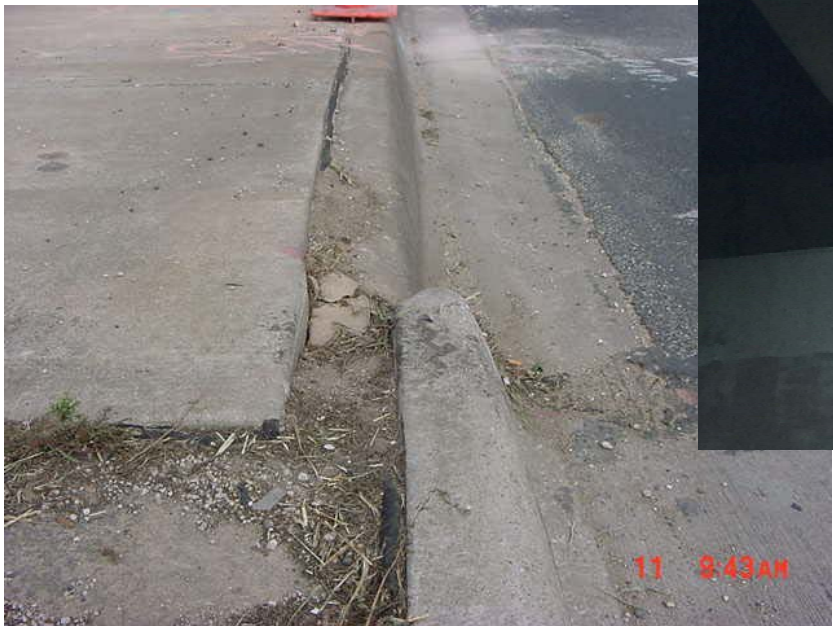
The west end of this large overpass structure exhibited movement immediately after its initial construction. Several experts were consulted for an evaluation of the situation at that time. Minor construction quality issues and marginal materials seemed to be the cause of these early concerns. Ultimately, the City decided to monitor the situation rather than reject the work entirely. The situation did stabilize and showed no significant movement for about 10 years.

Near the end of the 1990s movement was realized again by large cracks appearing in the roadway above. The MSE walls on both sides of the west approach embankment to the bridge have experienced movement and deflections that has caused noticeable separation between the sidewalk and the street. This movement has also triggered voids and major cracking in the roadway surface. So, after 20 years of monitoring and growing concerns over its condition, a recommendation and design was requested for the permanent repair of the west end.

The design that was tentatively selected for the west end of this overpass in 2003 was to extend the bridge for an additional span to lower the necessary height of the remaining MSE walls. However, we were not able to pursue this alternative at that time due to its very high cost. Other options such as soil nails and other geotechnical solutions were eliminated at that time due to feasibility concerns. Fortunately, it has come to our attention that a lot has changed in the industry since then. Numerous MSE walls of this generation have been repaired using several newer and more cost-effective techniques. For example, soil nailing technologies and equipment have advanced tremendously during this period. For this reason we want to reconsider all currently feasible options for the safe, efficient, timely, and cost-effective repair of this overpass embankment.

We are now requesting recommendations and design for the east end of the overpass since the east end was similarly constructed. We now know that there were minor flaws in the industry's design practices for the first generation of these walls which further compounded our construction issues. If a more practical, beneficial, and affordable repair method can be developed; we will recommend constructing repairs to the west end using the same method. Overall, it seems prudent to retrofit both ends to assure the overpass and bridge remain stable, safe, and reliable for their remaining service life of 50 or more years.

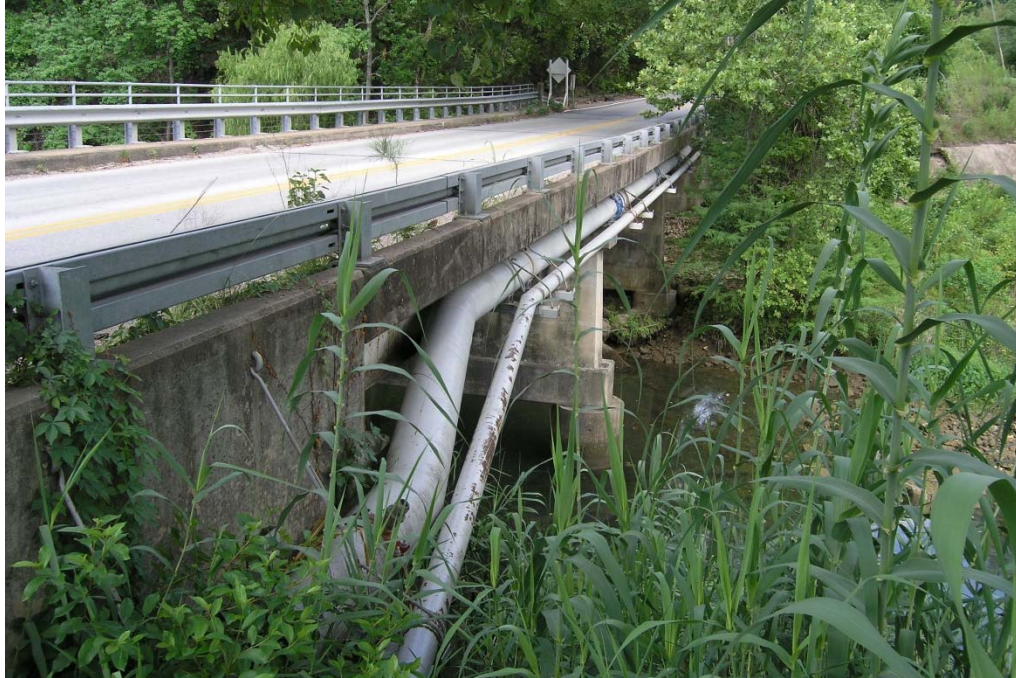
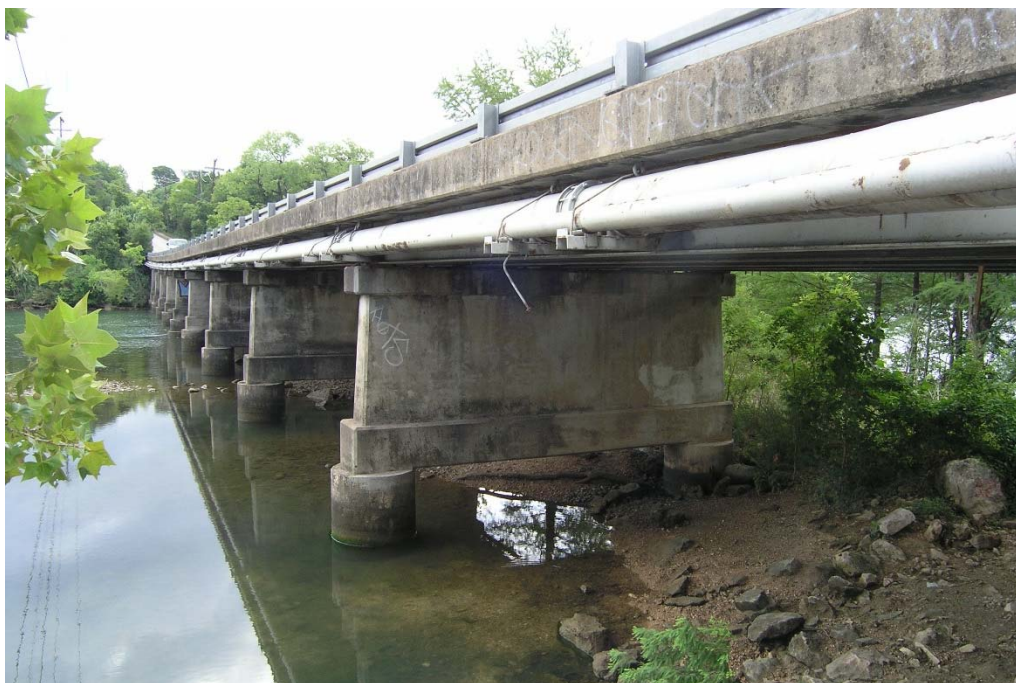
- The Emmett Shelton Bridges on Redbud Trail over Lady Bird Lake were originally built in 1948 making the structures 68 years old. There are actually two separate bridges. A 400 foot bridge spanning from the Austin side on the East bank to Redbud Isle and a 100 foot bridge to the West bank on the Westlake Hills side.

- This bridge may become critically and structurally deficient over the next few years and is at high risk of steel girders reaching their fatigue failure life (too many millions of loadings). We will attempt to monitor the bridge closely recognizing that these types of failures can be very serious and require quick remedial action without much warning. Fortunately, this structure has redundant girders meaning that a sudden catastrophic collapse as seen elsewhere in the nation is extremely unlikely.

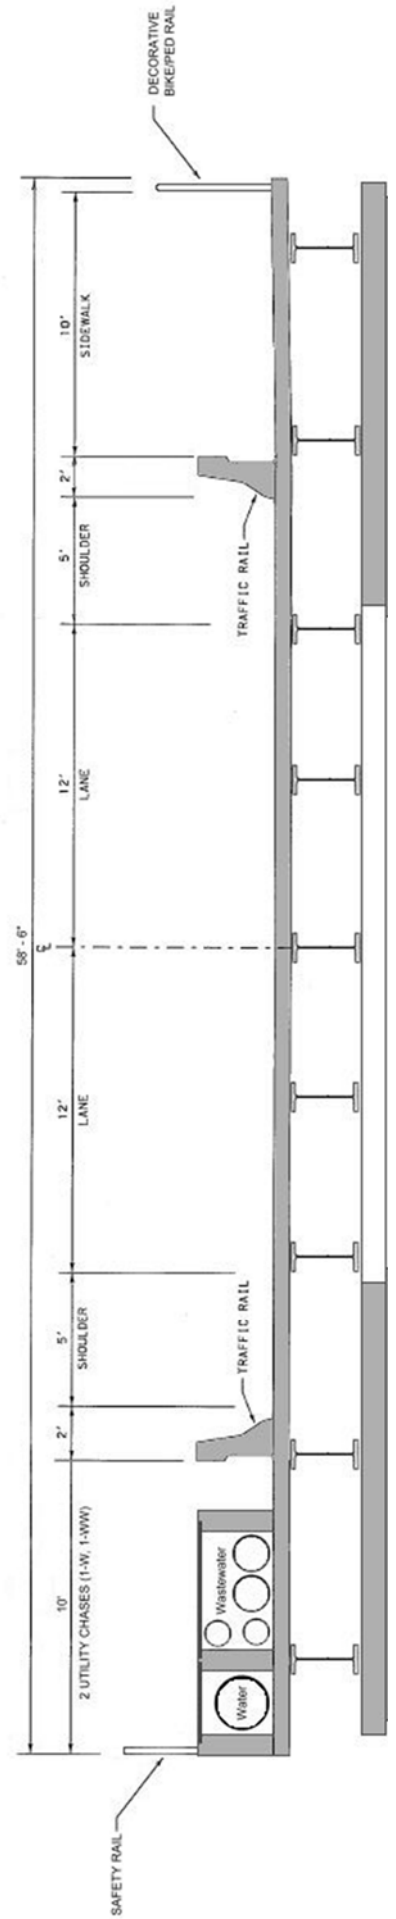
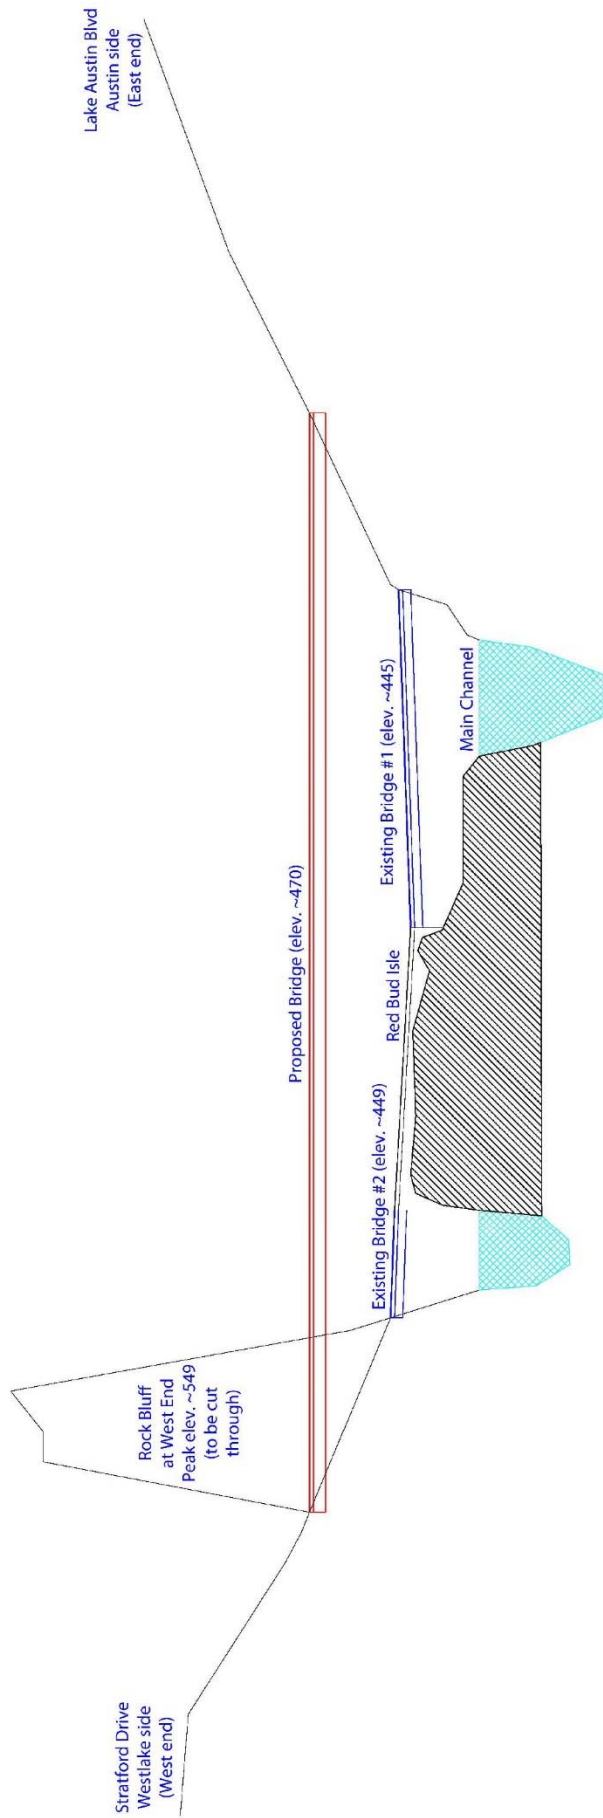
## Proposed Emmett Shelton Bridge on Red Bud Trail over Lady Bird Lake & Red Bud Isle Preliminary Planning Bridge Profile

Despite the deck improvements in 1998, the bridge is still at risk of its steel girders reaching fatigue failure (too many millions of load applications) over the next few years and becoming structurally deficient. If excessive distresses or damages are noted by inspections; severe load restrictions, limited allowable truck loadings per day, and lengthy detours or even closures are a distinct possibility. Unfortunately, any such limitations on bridge loadings would also jeopardize the required daily Ullrich WTP traffic.

There are also some serious waterway related concerns for the current structure. A study done for the LCRA as a tabletop study of a “rain bomb” event showed that the Red Bud Trail Bridge would be about 6” under water in a 100-year flood event and possibly could stay out of service for up to 3 days during such events. This period could even be longer if severe scouring were to compromise the stability of the bridge foundations as a result of flood waters or LCRA flood water releases.

- A single long-span bridge has been proposed as a replacement for the two bridge set-up. Major roadway geometry changes to Redbud Trail have also been proposed to benefit our Ullrich WTP truck traffic and all users.

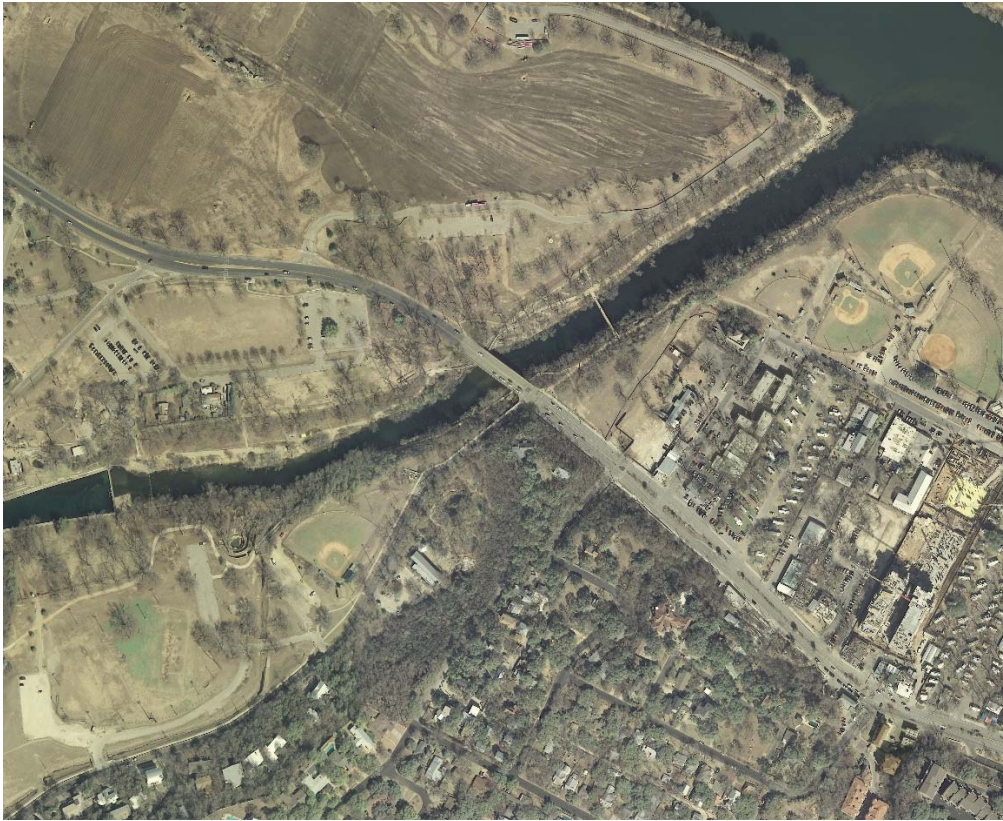
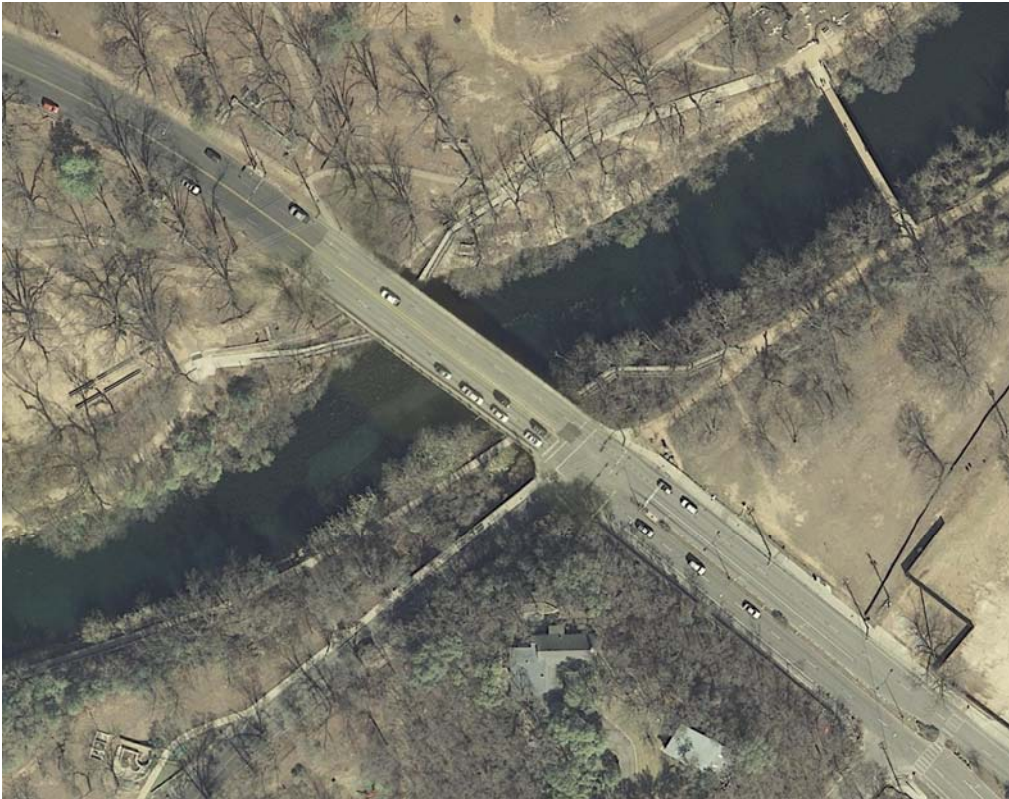
Proposed Bridge Deck: 220' x 89' = 19,580 SF  
1+6+(5+10+10)+15+(10+10+5)+6+1=89'

Existing Bridge Deck: 200' x 48' = 9,600 SF

This project includes the complete replacement of the obsolete Barton Springs Road Bridge over Barton Creek located near the intersection of Robert E Lee Road. Construction of the Public Works portions of this complex project is anticipated to cost around \$4 Million.

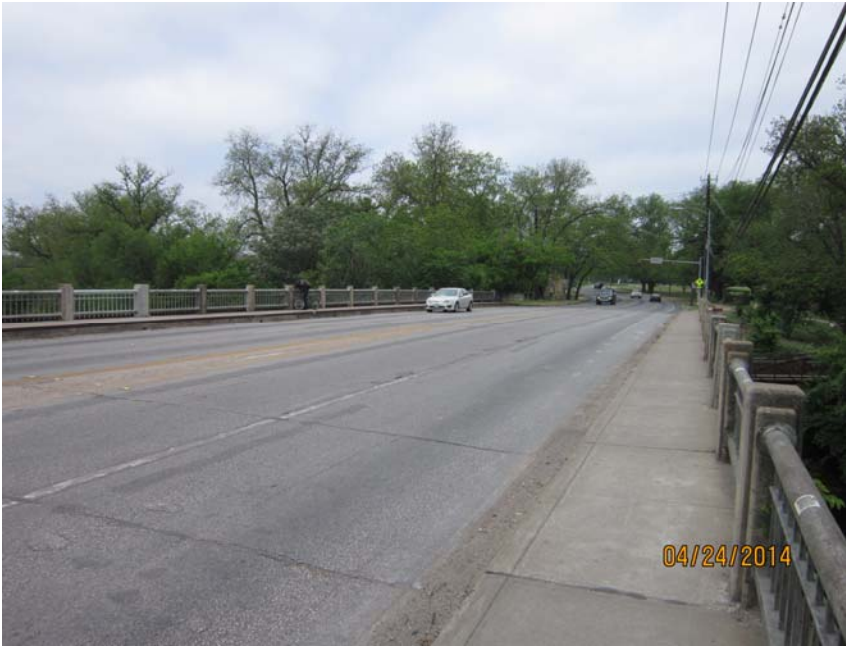
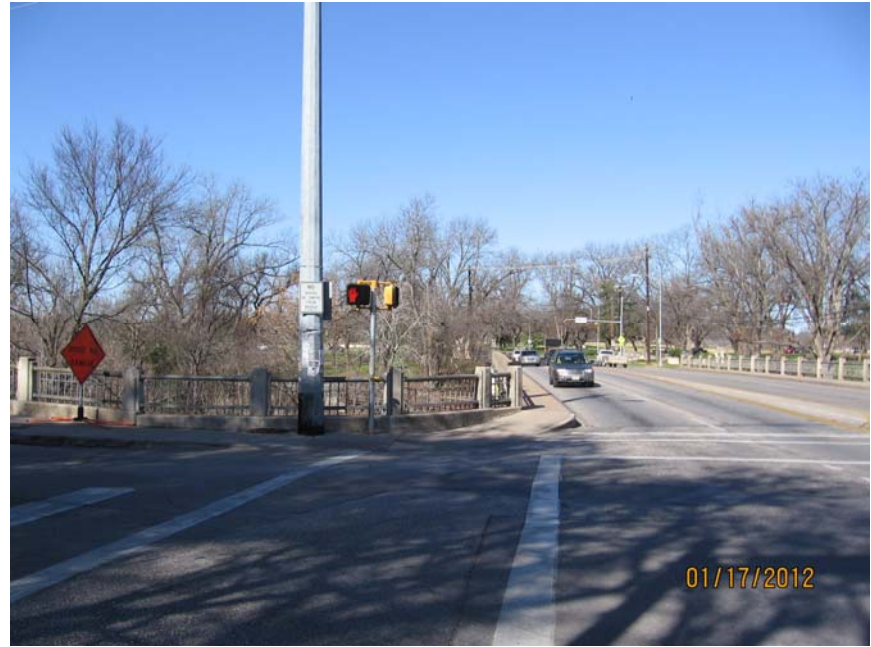
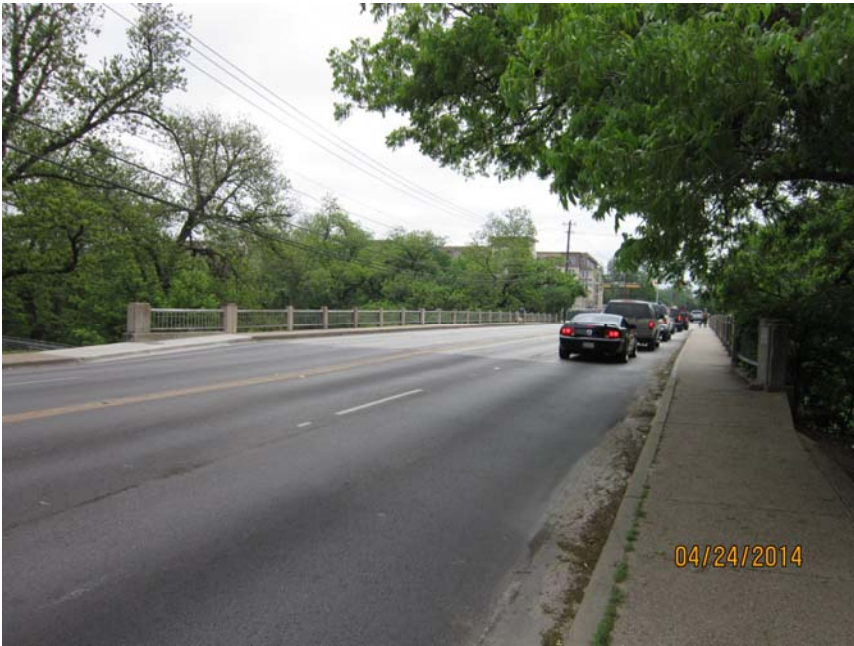
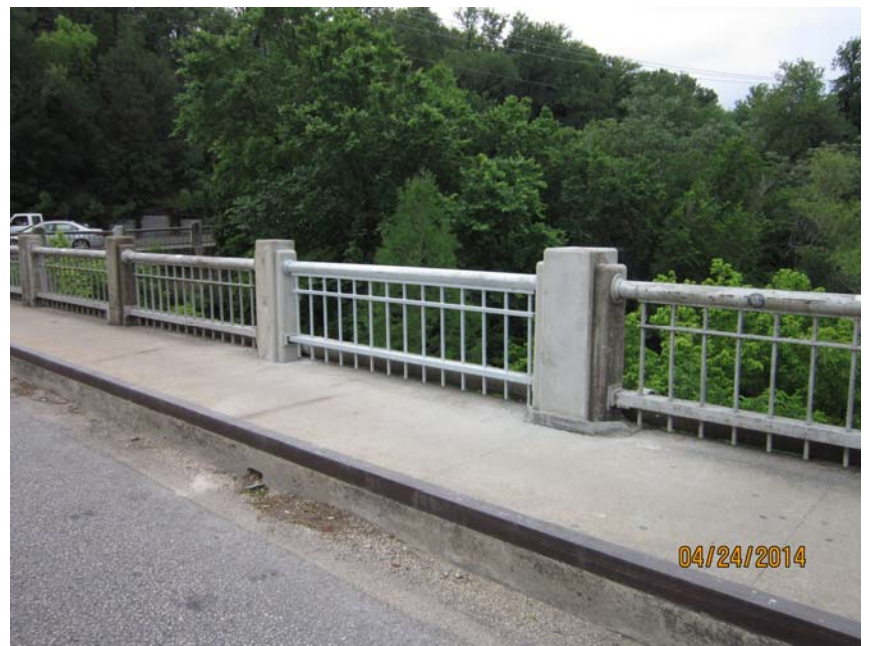
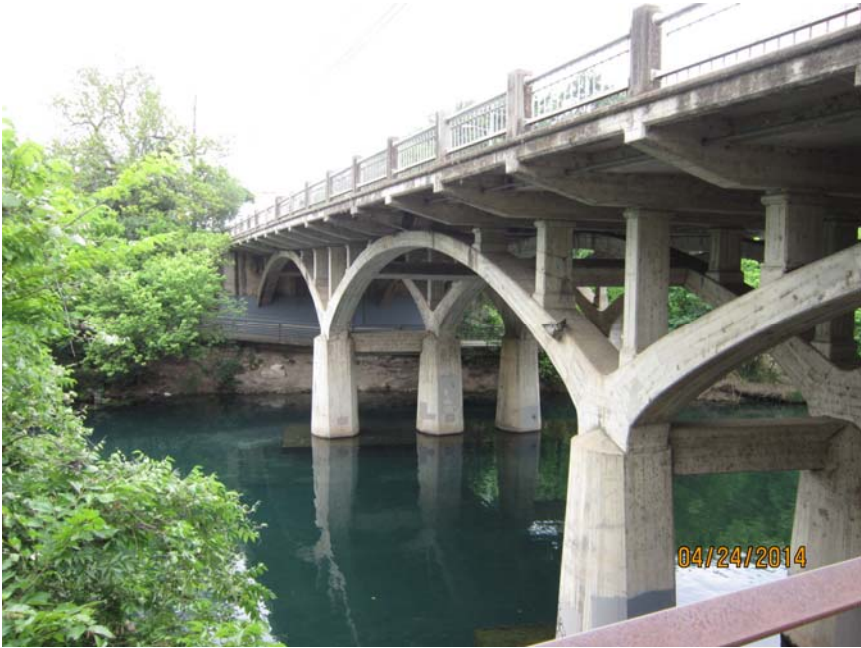
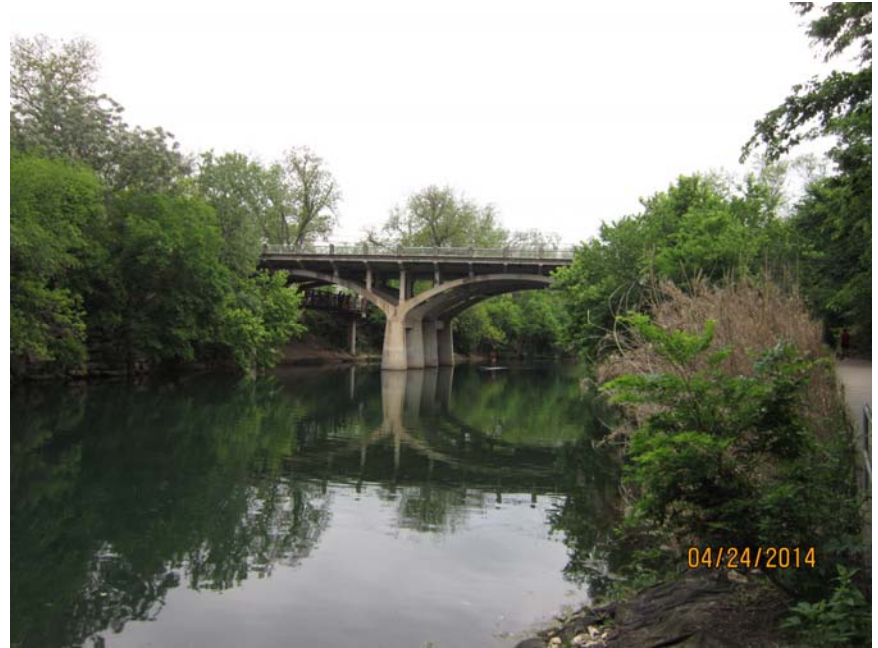
## E 9th Street Bridge over Waller Creek

Bridge was closed during the bridge inspection on 3/30/2016 for construction of utilities related to new hotel at 9th and Red River.
