### I. Qualitative Analysis

**QUALITATIVE ASSESSMENT**  
**AUSTIN AQUATIC FACILITIES NEEDS ASSESSMENT**

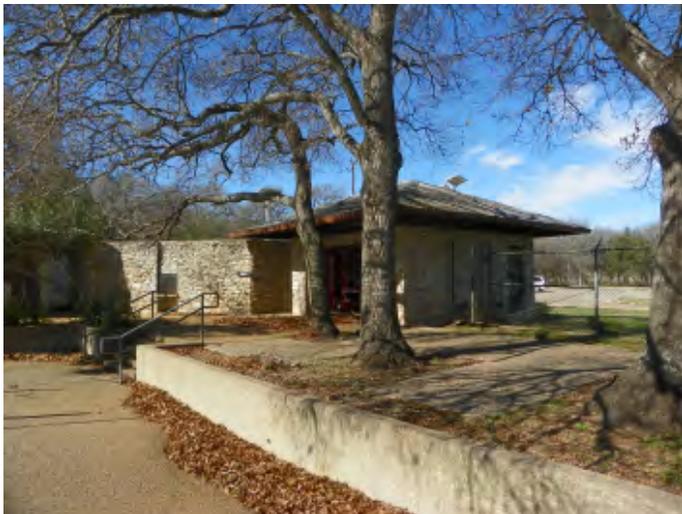
Pool House

BUILDINGS	Num	Size (Estimated)	Unit	Condition Level			Estimated Values of Repairs	Priority			Comments
				Good	Fair	Poor		H	M	L	
<b>POOL HOUSE</b>		s.f.	s.f.								
Repair Estimate - Restrooms		550				X	\$110,000	X			Recommend total renovation of area, bringing up to ADA compliance.
Repair Estimate - Vending		300				X	\$18,000	X			Recommend moderate maintenance repairs.
Roof Replacement Estimate - Vending		300					\$4,500	X			Recommend replacement of roof, gutter system/fascia.
Repair Estimate - Guard/ Admissions Area		400				X	\$24,000	X			Recommend moderate maintenance repairs.
Roof Replacement Estimate - Admission Area		400					\$6,000	X			Recommend replacement of roof, gutter system/fascia.
Separate from pump room?											Yes
Restrooms	1M					X					No mirrors; tile chipping (recommend replacing all tile); replace missing lens on ceiling fixture
	1W					X					No mirrors; wall tile chipped (recommend replacing all tile); missing spindles for toilet paper dispensers; minor cracking of glazed CMU

Inside pool fence? In park?											Inside pool fence
Exterior walls					X						Stone masonry (needs power washing)
Interior walls											
Roof						X					Gutter is rusted (rusted all the way through, in some places has good sized holes) and at end of life (recommend replacing); galvanized corrugated roof is
Doors											None entering restrooms - others listed in their areas
Floor/Drainage					X						Pebble finish concrete with area drains
Ceiling											
Lighting/Power						X					All restroom lighting is old, at end of life (recommend replacement)
Office						X					Currently used as a Help Area; top of counter 44"/36" (36" max per ADA); exposed wiring under counter; shelves under counter are painted plywood (recommend painting); 2'-8" wide door leading into storage room (electrical panel cover in here rusted, new shower seat stored in here, bare light bulb ceiling mounted)
Guard Room

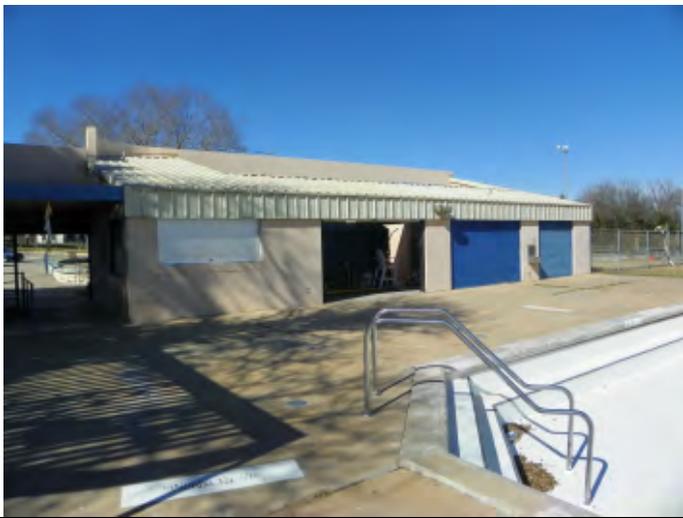
Pool House

BUILDINGS	Num	Size (Estimated)	Unit	Condition Level			Estimated Values of Repairs	Priority			Comments
				Good	Fair	Poor		H	M	L	
<b>POOL HOUSE</b>		s.f.	s.f.								
<b>Repair Estimate</b>		2185					\$327,750		X		Recommend total renovation of restroom/ shower areas along with performing other moderate maintenance/ repairs.
<b>Roof Replacement Estimate</b>		2185					\$32,775	X			Recommend immediate roof replacement.
Separate from pump room?											Yes
Restrooms	1M					X					HM frame/ door to plumbing chase is rusted/ deteriorated; water leaking inside chase; door swing for HC toilet is incorrect (hinge side should be opposite from grab bars/ toilet); steep rise/ bump up in floor to access non-HC toilet stall
	1W					X					CMU was partially removed to install HC controls in shower and patched back (not painted, holes around fixtures too big/ gaping); steep rise/ bump up in floor to access non-HC toilet stall

Inside pool fence? In park?											Inside pool fence
Exterior walls						X					Stucco w/ exposed fastener wall panels up high (wall panels need to be replaced - end of life)
Interior walls						X					CMU; all paint peeling
Roof						X					Exposed fastener metal roof (has been repainted/ repaired in the past) and is badly bent (bulging down in spots) and has pin holes (poor condition - recommend replacing); structural steel is rusting (needs cleaning/ painting)
Doors											
Floor/Drainage											Concrete w/ area drains
Ceiling											Open air, restroom area covered by exposed to structure roof
Lighting/Power											No lighting inside toilet/ shower area, wall mounted area light over changing area for each restroom (recommend replacing existing lighting and installing more in areas without lighting)
Office											None
Guard Room						X					Shares with the ticket area; repaint; 2 smaller coiling doors rusting and peeling (need to be painted); 1 new coiling door (good); ADA level counter (36" AFF, 38" max); open to struct.; storage room adjoining this area accessed only through this room

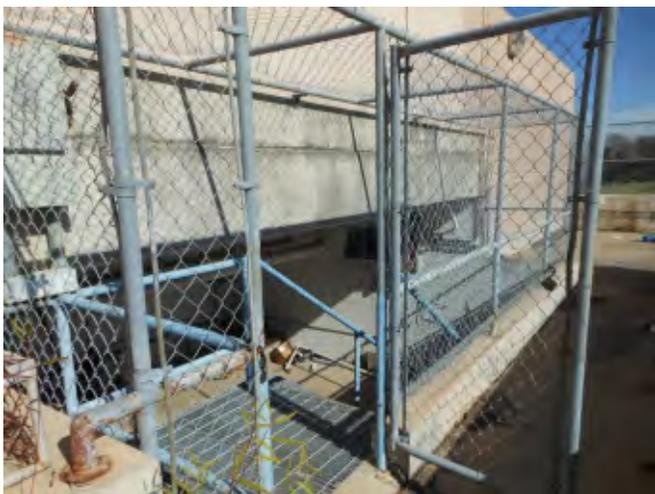
Pump House

Structural	Num	Size	Unit	Condition Level			Estimated Values of Repairs	Priority			Comments	
				Good	Fair	Poor		H	M	L		
<b>Pool House</b>												
Foundation, Restrooms				x							X	
Roof Framing				x							X	
<b>Pump Room</b>												
Walls	1					x	\$5,000	X			Efflorescence noted at wall between pump room and pool, evidence of leaking	
	2					x	\$2,000	X			Cracks in exterior brick wall	
Foundation					x					X	Efflorescence at exterior tank perimeter	
Slab					x				X		cracking at exterior water tanks	
<b>Pool Area</b>												
Slab to west of pool						x	\$7,500	X			Fill supporting slab has eroded away at north end, leaving slab unsupported, will need repair or replacement	
<b>TOTAL</b>							<b>\$14,500</b>

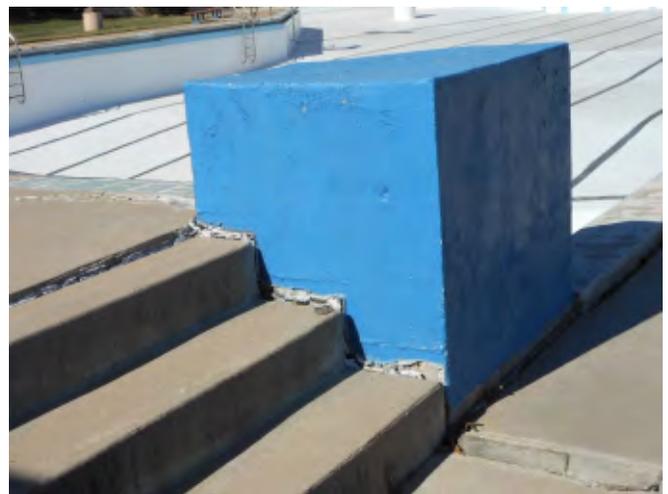
Deck / Stairs Moving away from pool

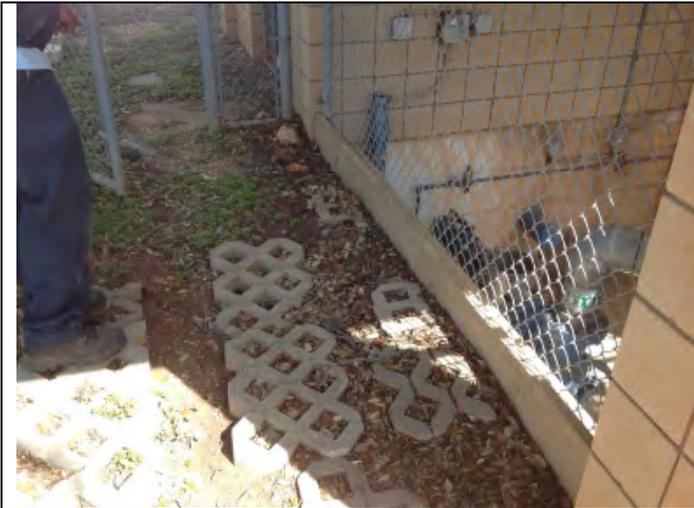
Grade issues at pump pit

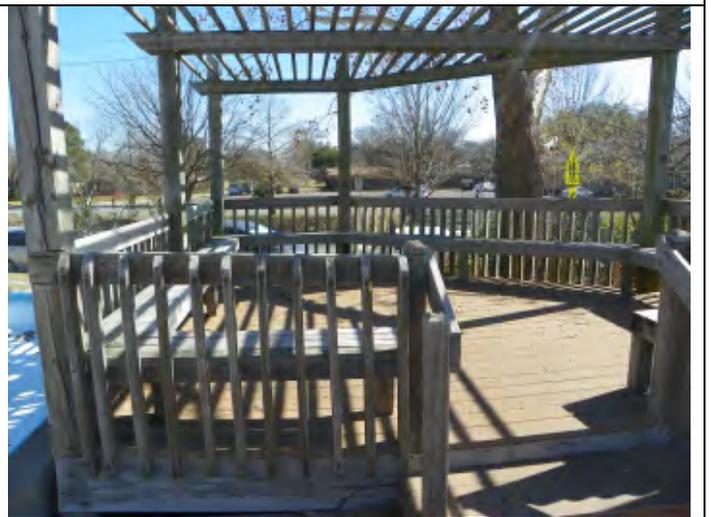
Structural	Num	Size	Unit	Condition Level			Estimated Values of Repairs	Priority			Comments
				Good	Fair	Poor		H	M	L	
<b>Pump House</b>											
Walls				x						X	Some Pitting due to chemicals
Foundation				x						X	Some Pitting due to chemicals
Slab				x						X	Some Pitting due to chemicals
<b>Restroom Outbuilding</b>											
Walls					x		\$2,000			X	Cracks in walls.
Slab				x						X	No obvious issues
<b>Pool</b>											
Floor					x					X	Difficult to determine slab condition due to swimmers in pool
Coping					x					X	Minor cracking
Joints					x				X		Differential movement obvious
Deck						x			X		Many large cracks
<b>Site</b>											
Walks					x		\$5,000		X		Several cracks
Standing water near entry											Standing water near pool entry
Pergola					x		\$10,000		X		Aging
<b>TOTAL</b>							<b>\$17,000</b>

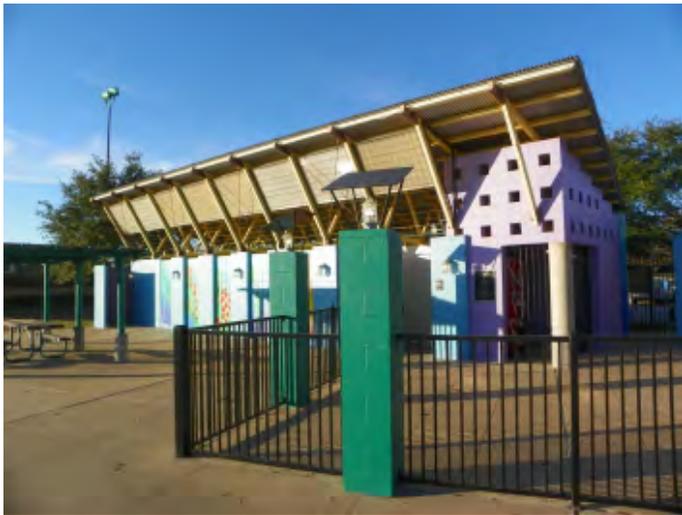
Pool House

BUILDINGS	Num	Size (Estimated)	Unit	Condition Level			Estimated Values of Repairs	Priority			Comments
				Good	Fair	Poor		H	M	L	
<b>POOL HOUSE</b>		s.f.	s.f.								
<b>Repair Estimate</b>		0					\$0				No pool house
Separate from pump room?					X						Yes
Restrooms	1M/ 1W					X					No ADA signage; recommend replacing light fixture, none of the plumbing fixtures are compliant, no turn-around and no approach; needs additional ventilation; restrooms are maintained by the parks department and not aquatics
Inside pool fence? In park?						X					Restrooms are in a separate building directly adjacent to the pool but serve the park and are kept locked during the winter
Exterior walls					X						Poured concrete walls (needs to be painted)
Interior walls					X						Same as exterior, CMU joints have voids that need to be should be repaired (needs to be painted)
Roof											Flat concrete slab
Doors					X						Tubular metal full height gate

Floor/Drainage					X						Concrete
Ceiling						X					Ceiling/ soffit of entire structure inside and out is peeling (looks like a skim coat)
Lighting/Power						X					Old lighting protected by rusted metal mesh
Office											None
Guard Room					X						Located in restroom structure across from entry gate; area serves as storage; no switch plates or light bulbs; door/ frame rusting at the bottom
Concessions/Vending											None
Men/Women Changing Rooms											None
Family Changing Rooms											None
Plumbing fixtures	M				X						Stainless toilet, porcelain coated sink (too low)
	W				X						Stainless toilet, porcelain coated sink (too low)
Toilet partitions											None
Showers											** see Site Inside Fence**
ADA Compliance						X					Only the wading pool can be accessed by wheelchair; steps are required to access the large pool; no handrails at steps; nothing compliant in both restrooms

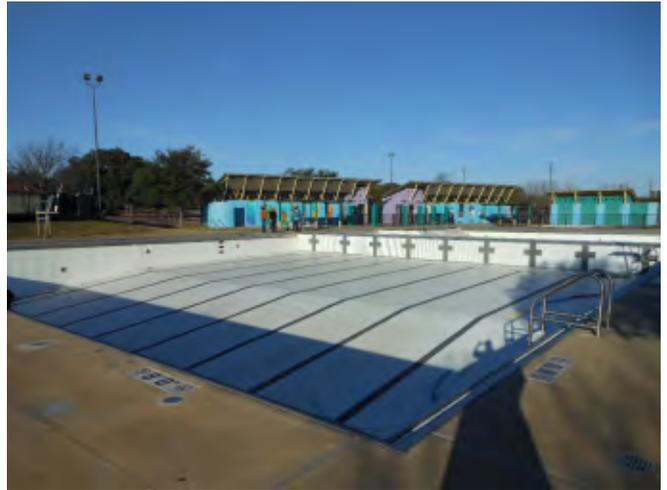
Pool

Backwash is straight to storm, needs holding tank. Gutter goes straight to waste.  
 Over all age and condition of the pool is very poor, filtration system needs replacement and the wading pool is in major need of renovation.  
 ADA Issues are present, there is no way to get to the pool without using steps.

Structural	Num	Size	Unit	Condition Level			Estimated Values of Repairs	Priority			Comments	
				Good	Fair	Poor		H	M	L		
<b>Pump Room</b>												
Walls				x							Nothing noted	
Foundation				x								
<b>Main Pool</b>												
Floor				x						X	Only minor cracking visible	
Coping				x						X	Only minor cracking visible	
Joints				x							Nothing noted	
Deck					x					X	Some cracking in deck and concrete beam by steps, poor drainage at trough	
<b>TOTAL</b>												
							<b>\$0</b>

**Drainage Issues:**  
Concrete gutter along the northeast edge of the pool should be removed and replaced.  
Grate cover by entrance is deteriorating. Should be removed and replaced. The new grate inlet adjacent to the existing is loose and should be secured to

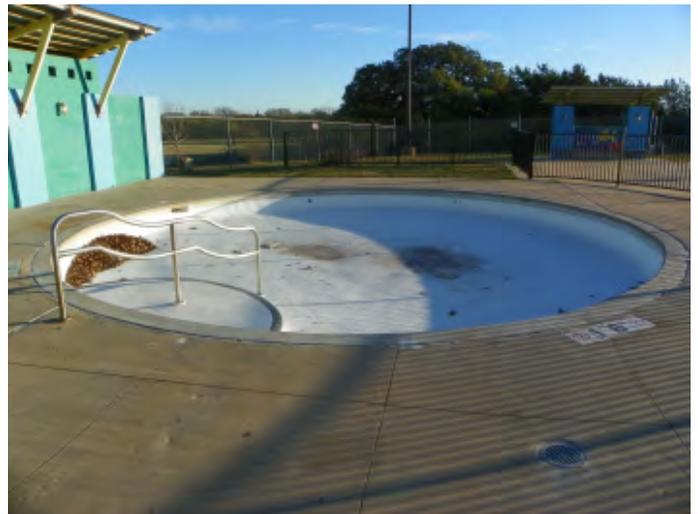
Wading Pool

SWIMMING POOLS	Num	Size	Unit	Condition Level			Estimated Values of Repairs	Priority			Comments
				Good	Fair	Poor		H	M	L	
UV system	N/A										
<b>WADING POOL</b>											
Shape / Dimensions		L'									
Depth -min/max		8" - 2'									
Surface Area		1,115.00	sf			\$111,500	X				
Volume		12,510	gal.								
Turnover Rate	N/A		GPM								Fill and Dump
Turnover Time	N/A		hrs								Fill and Dump
Pool floor					x						Concrete
Appearance						x					Painted, Flaking
Pool walls					x						Concrete
Appearance						x					Painted, Flaking
Coping						x					8" wide Concrete coping-2" high, missing in large areas
Deck		150				\$7,500	X				
ADA Compliance	N/A										
Circulation system	N/A					\$12,510	X				
Gutter	N/A										
Skimmers	N/A										
Returns / Inlets	1										Fill only
VGB drains											
Pump	N/A					\$2,500	X				
Pump Motor	N/A										
Strainer	N/A					\$1,000	X				
Valves											
Filters	N/A		s.f.

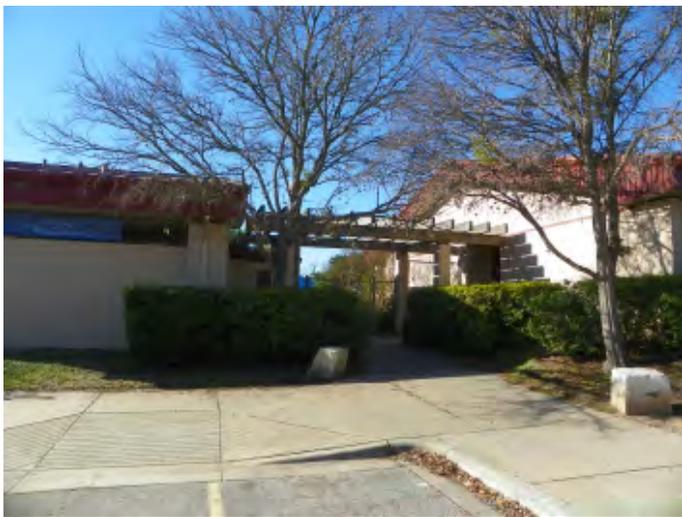
Pool House

BUILDINGS	Num	Size (Estimated)	Unit	Condition Level			Estimated Values of Repairs	Priority			Comments
				Good	Fair	Poor		H	M	L	
<b>POOL HOUSE</b>		s.f.	s.f.								
<b>Repair Estimate</b>		2,600					\$156,000		X		Recommend performing immediate preventative maintenance to the roof and its structure. Minor ADA issues need to be addressed.
<b>Roof Repair Estimate</b>		2,600					\$39,000		X		Roof will need replacement within the next 5 years.
Separate from pump room?											Yes
Restrooms	1M				X				X		42" AFF to bottom of reflective surface of mirror (too high - 40" AFF max, too fogged, unusable); robe hooks broken; holes in wall next to urinals; no wire cage protection on suspended heating elements; robe hooks are all broken; toilet roll holders rusting
	1W				X				X		43" AFF to bottom of reflective surface of mirror (too high - 40" AFF max, too fogged, unusable) and soap dispenser is higher; no wire cage protection on suspended heating elements; bench supports rusting; robe hooks are all broken; toilet roll holders rusting

Inside pool fence? In park?											Inside pool fence
Exterior walls				X						X	CMU up to 8' - open caging up to roof
Interior walls				X						X	CMU - could use a fresh coat of paint
Roof						X			X		Wood truss w/ steel tube members (rusting, needs to be painted), steel angle (peeling - needs to be painted) attached to wood 2x4 (badly peeling - needs to be painted) at top and bottom edges of corrugated metal roof (needs galvanization touched-up)
Doors					X				X		Hollow metal; all hinges very rusted (needs to be replaced, recommend stainless); some frames beginning to rust
Floor/Drainage									X		Floor drains; bottom bolt of door/ gate has deeply scraped the floor at the circular entrance
Ceiling					X				X		Exposed structure (needs to be painted)
Lighting/Power										X	Incandescent wall and pendant fixtures with fluorescent bulbs installed
Office											None
Guard Room					X				X		Workroom with countertop (35.5" AFF); loose abandoned conduit (needs to be removed)

Concessions/Vending						X			X		Rusted hinges on door from vending area to storage
Men/Women Changing Rooms											Integrated into restrooms
Family Changing Rooms											None
Plumbing fixtures	General					X			X		Water heater in plumbing chase rusted (Women); rusty screws sticking out from wall near water heater and rusted mop hook strip (Men)
	M								X		2 stainless toilets; 3 stainless urinals; 2 sinks (escutcheon covers rusted); 5 showers

Structural	Num	Size	Unit	Condition Level			Estimated Values of Repairs	Priority			Comments
				Good	Fair	Poor		H	M	L	
<b>Pool House</b>											
Foundation, Entry					x				X		Cracking in flatwork next to circular column
Foundation, Restrooms	1F				x		\$3,200			X	Shrinkage cracking in floor slab
	1M				x		\$1,600			X	Several cracks, hole at wall/slab joint in shower, recommend filling holes with grout
Benches						x	\$3,200		X		Embed connections to CMU rusted
Roof Framing					x		\$4,800		X		Wood Trusses with steel connection plates, some corrosion on steel plates requiring removal of corrosion and re-painting
<b>Pump Room</b>											
Walls				x							Nothing noted
Foundation					x					X	Efflorescence at exterior tank perimeter
Slab					x					X	Water ponds next to tank
Roof structure					x		\$3,200		X		Wood Trusses with steel connection plates, some corrosion on steel plates requiring removal of corrosion and re-painting

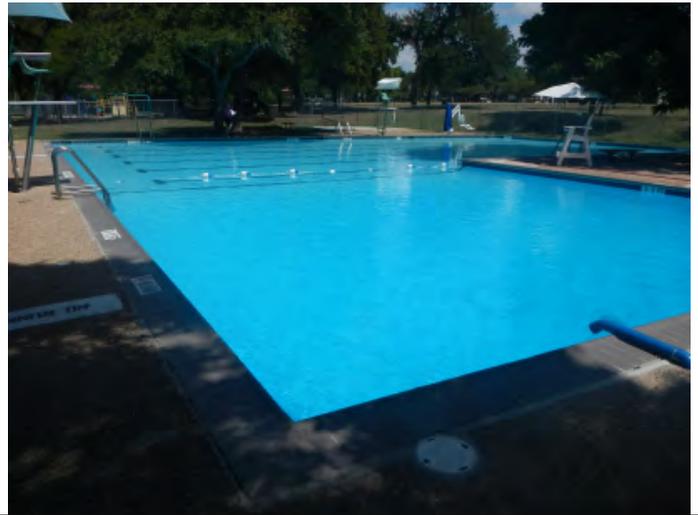
Pool

Structural	Num	Size	Unit	Condition Level			Estimated Values of Repairs	Priority			Comments	
				Good	Fair	Poor		H	M	L		
<b>Pump Room</b>												
Walls					x		\$500			X	Separation noted at joint between CMU and concrete walls, hole in wall on south side	
Steel roof beams						x	\$5,000		X		Most steel members have rust, will require removal by wire brush and grinding, and repainting	
Slab				x							Some cracks, pitted concrete	
<b>Restroom</b>												
Walls				x								
Slab					x		\$500		X		Several rust spalls	
<b>Main Pool</b>												
Floor					x				X		many areas where paint was missing, some cracking	
Joints					x				X		sealant needed	
<b>Entry</b>												
Roof structure						x	\$20,000	X			Glulam beams at entry arbor are delaminating and need repair/replacement	
<b>TOTAL</b>												
							<b>\$26,000</b>

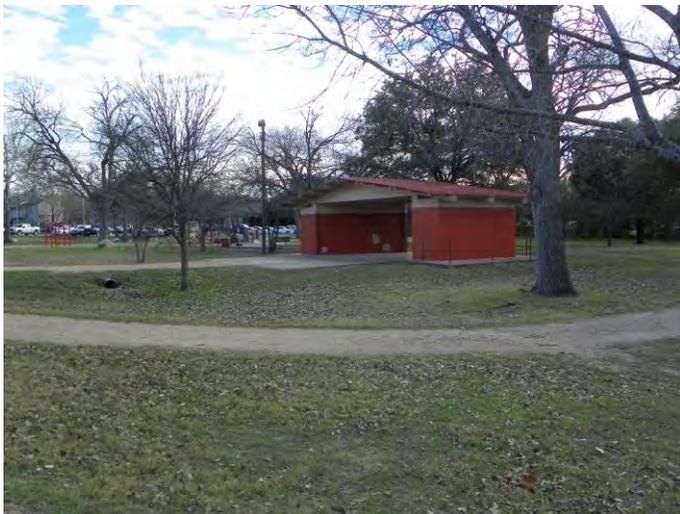
Park Bathrooms

Structural	Num	Size	Unit	Condition Level			Estimated Values of Repairs	Priority			Comments
				Good	Fair	Poor		H	M	L	
<b>Pool House</b>											
Foundation, Restrooms	1F				x		\$3,200		X		Shrinkage cracking in floor slab
Benches						x	\$3,200		X		Embed connections to CMU rusted
Roof Framing					x		\$4,800		X		Wood Trusses with steel connection plates, some corrosion on steel plates requiring removal of corrosion and re-painting
<b>Pump Room</b>											
Walls				x						X	Nothing noted
Roof structure					x		\$3,200		X		Wood Trusses with steel connection plates, some corrosion on steel plates requiring removal of corrosion and re-painting
<b>TOTAL</b>							<b>\$14,400</b>

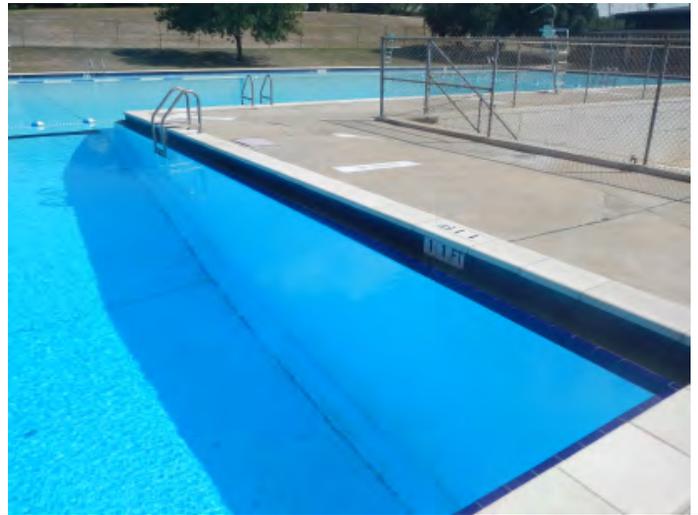
Pool

<b>Main Pool</b>											
Floor				x						X	Only minor cracking visible
Coping				x						X	Some cracking
Joints					x		\$500			X	Sealants need replacement
Deck					x		\$10,000	X			Cracking and vertical discontinuities, replace or repair deck.

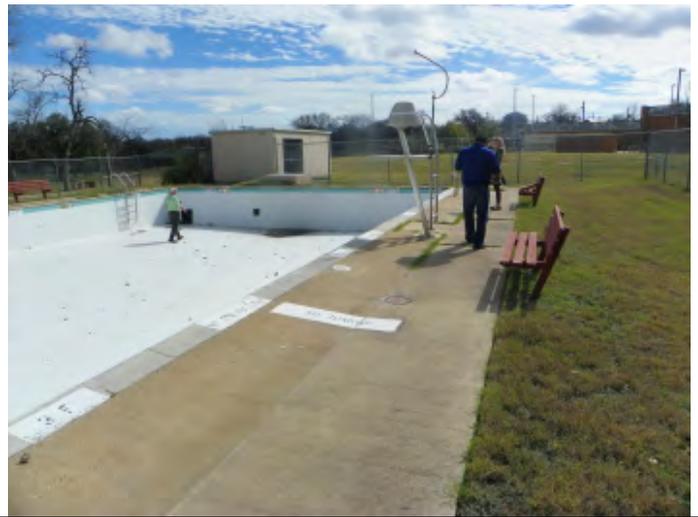
Pool

Structural	Num	Size	Unit	Condition Level			Estimated Values of Repairs	Priority			Comments	
				Good	Fair	Poor		H	M	L		
<b>Pump Room</b>												
Walls				x							Nothing noted	
Foundation				x								
<b>Main Pool</b>												
Floor				x					X		visible crack in center of pool	
Coping					x				X		Some cracking	
Joints						x			X		Major crack in joint across pool	
Deck					x				X		Some cracking at re-entrant corners due to lack of control joints	
<b>TOTAL</b>												
							<b>\$0</b>

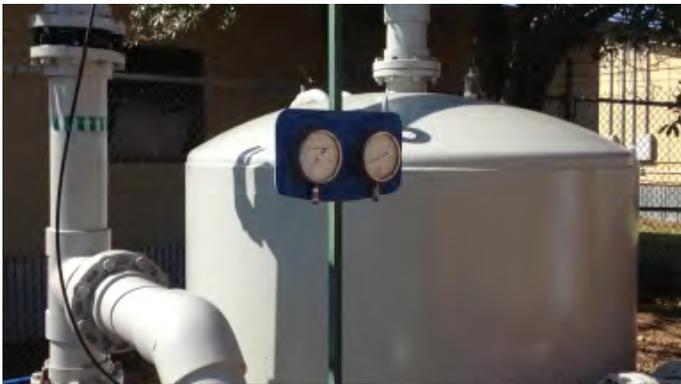
Filter Recently repainted

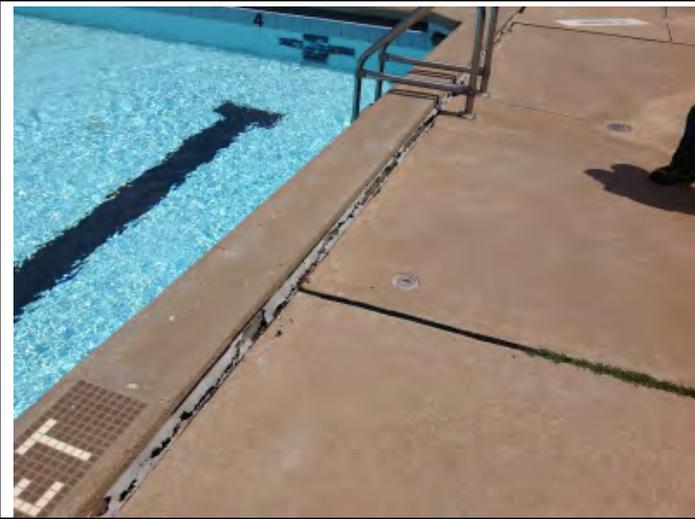
Deck Pulling back from pool

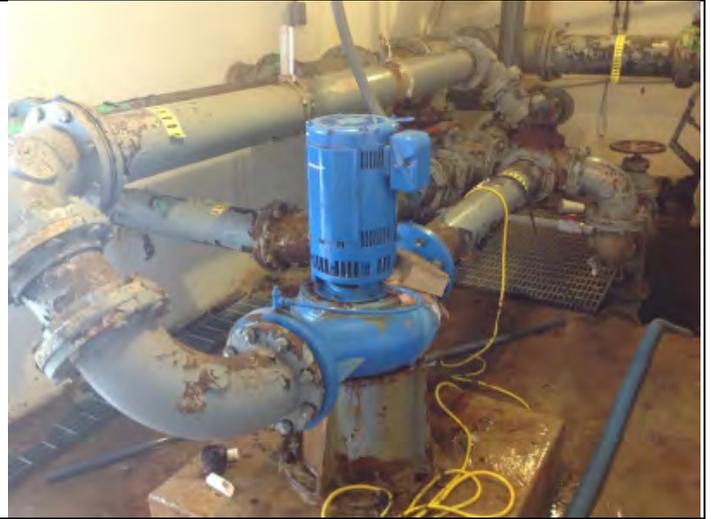
Old piping and Valves

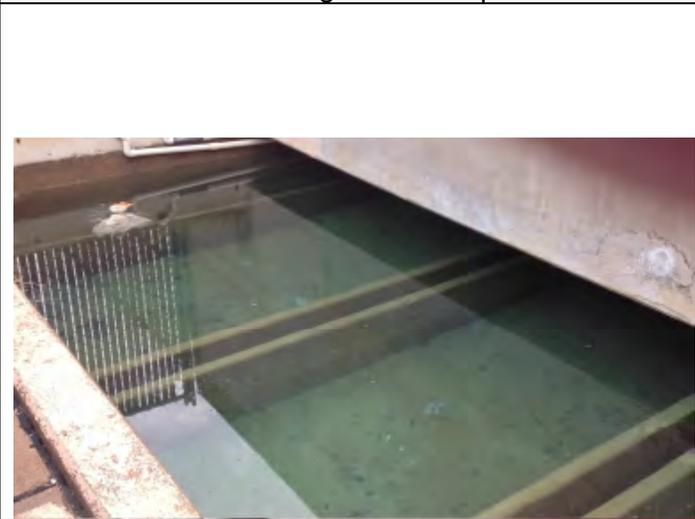
Sand is returning to pool from filters

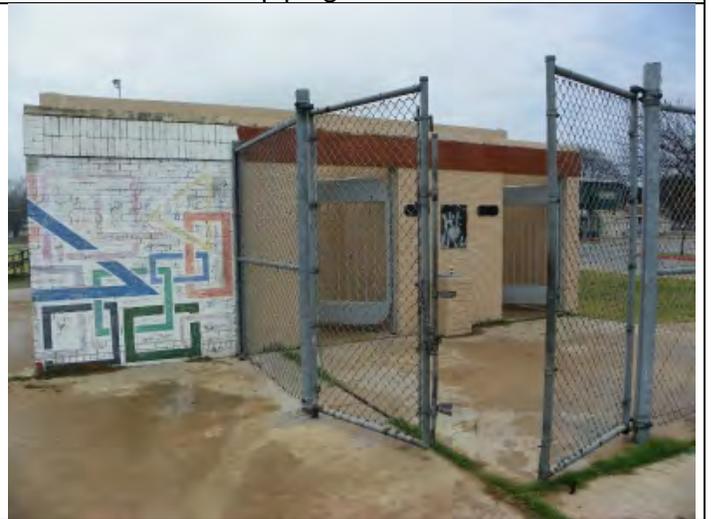
Restrooms outside of fence

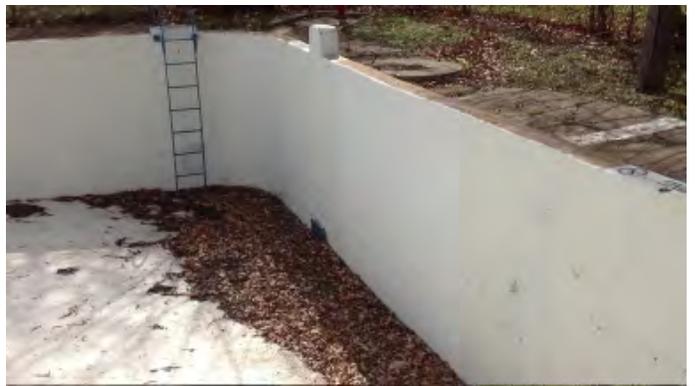
Old Ladder

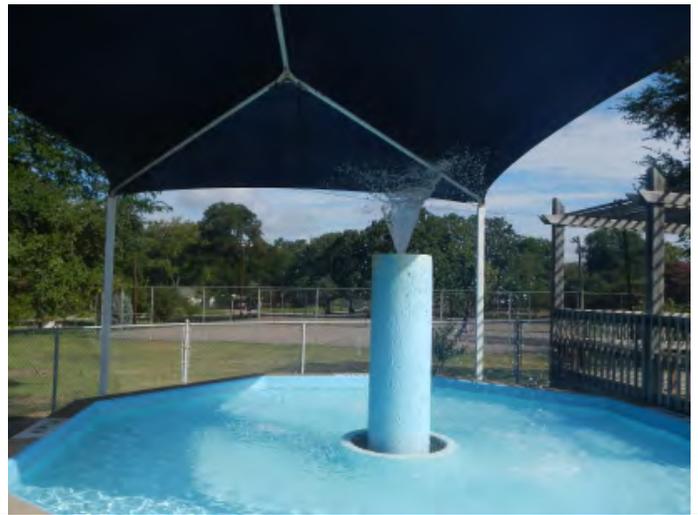
Wading Pool

**Drainage Issues:**  
 Splash from fountain and runoff from pool deck has caused soil erosion on north side of wading pool. Concrete edge has been undermined. Regrade area and add soil stabilization or concrete on north side of wading pool.  
 Ponding occurs at the pump house near the pool deck. Regrade area. May be able to add french drain to improve drainage.

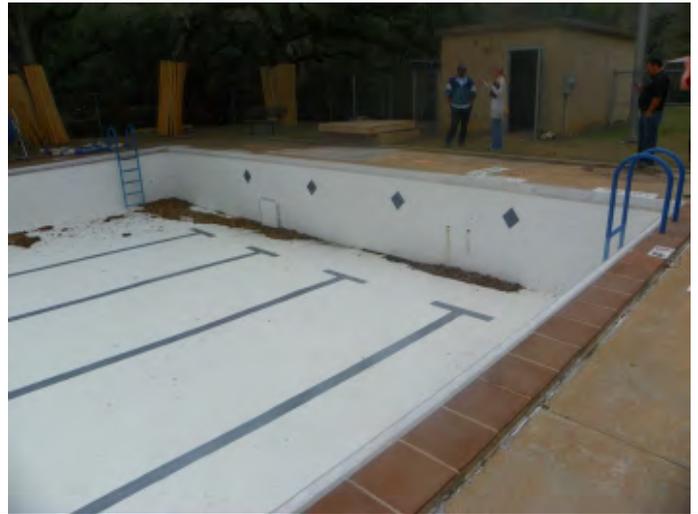
Pool											
Floor					x				X		Narrow cracks in bottom extend in long direction
Gutter cover					x				X		welds are pitted in several locations
Joints					x				X		No caulk in wall/deck slab intersection
Deck					x		\$2,000		X		Deep raveled crack with settlement near drain and other location, edge spalls

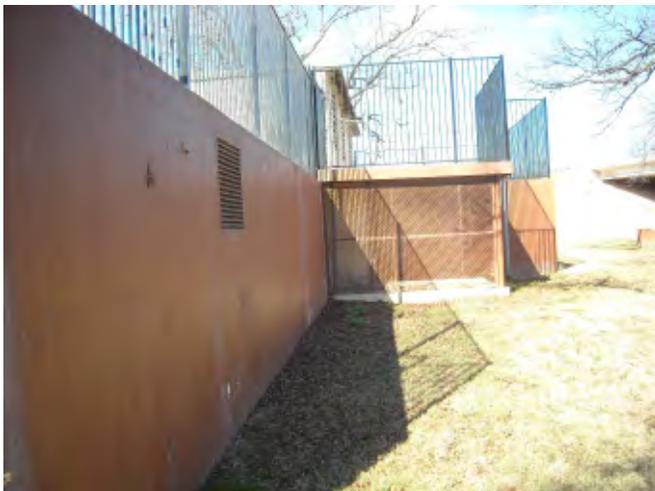
Pump House

Structural	Num	Size	Unit	Condition Level			Estimated Values of Repairs	Priority			Comments
				Good	Fair	Poor		H	M	L	
<b>Pump Room</b>											
Walls				x						X	Nothing noted
Foundation				x						X	
Door						x	\$2,000		X		Severely rusted, and falling apart
Bracket supports						x	\$500		X		Severely rusted
<b>Restroom</b>											
Walls				x						X	
Slab				x						X	
<b>Main Pool</b>											
Floor				x							Nothing noted
Coping				x							Nothing noted
Joints				x							Nothing noted
Deck Slab					x			X			corner cracks, settlement
<b>Wood Deck/Pergola</b>											
Roof					x		\$200		X		End joist rotated, splitting
Column					x		\$500		X		Column grain split, bending/shrinkage rotation where handrail let-in
Floor					x		\$2,000	X			Deck not level, dipped center to stairs
<b>TOTAL</b>							<b>\$5,200</b>
