## *APPENDIX H: UT's Guadalupe Street Corridor Safety Study and Recommendations*

## FINAL REPORT

**DATE:** October 14, 2016  
**TO:** Mr. David L. Rea  
**FROM:** Brian D. Van De Walle, P.E. PTOE  
**JOB NUMBER:** 069225002  
**RE:** Safety Study  
Guadalupe Street Corridor

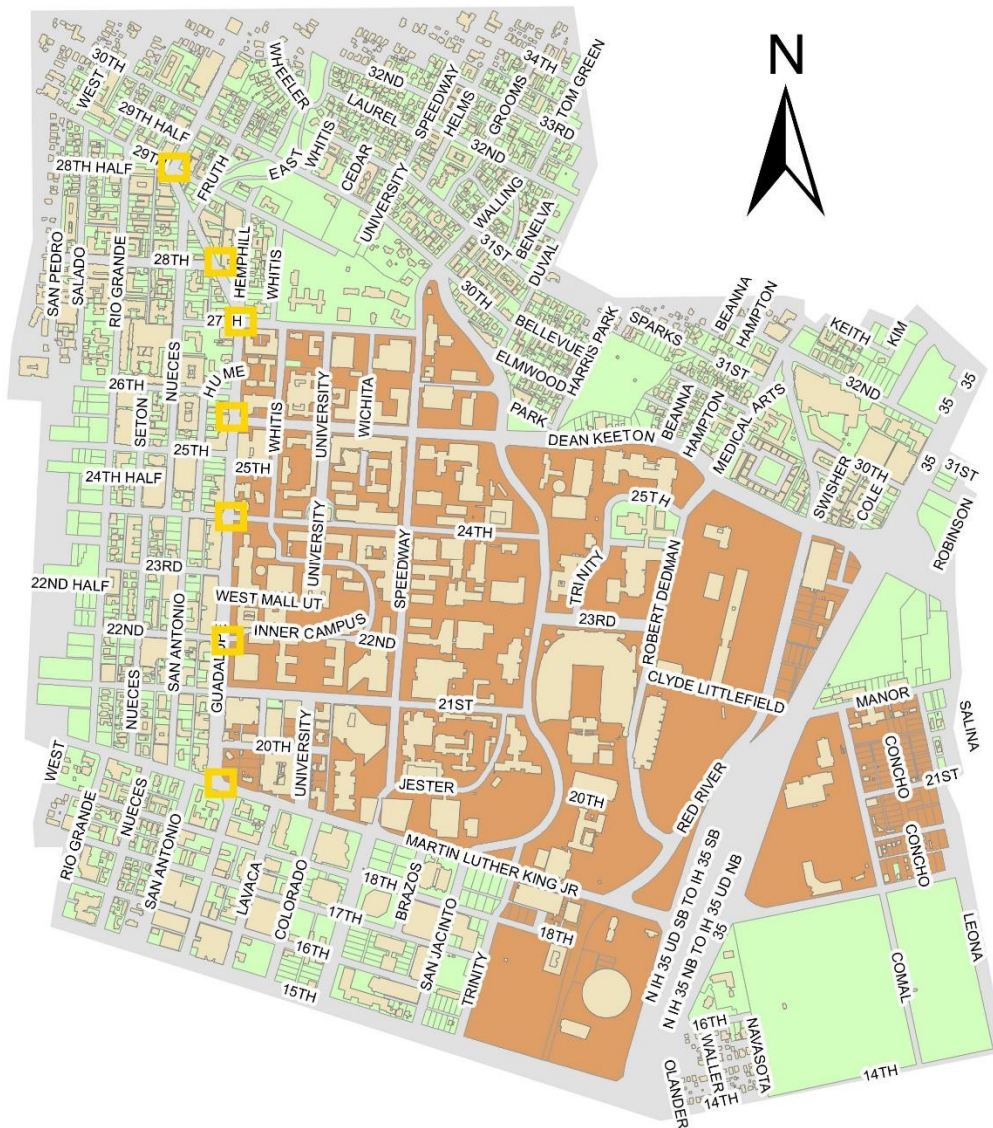
Figure 1 – Top 7 Hot Spot Accident Locations by Score

After evaluation of crash data and walk audits of the seven (7) hot spots with the City and the University, impacts of potential safety improvements were developed. Recommended countermeasures for short-term safety improvements by intersection are described in the following section. **Figure 1** shows locations of the top seven (7) hot spots.
