Existing Conditions Assessment for the Dougherty Arts Center

prepared for the
City of Austin
Parks and Recreation Department
15 September 2010

Existing Conditions Assessment for the **Dougherty Arts Center**

DOUGHERTY ARTS CENTER
GENERAL STRUCTURAL ASSESSMENT

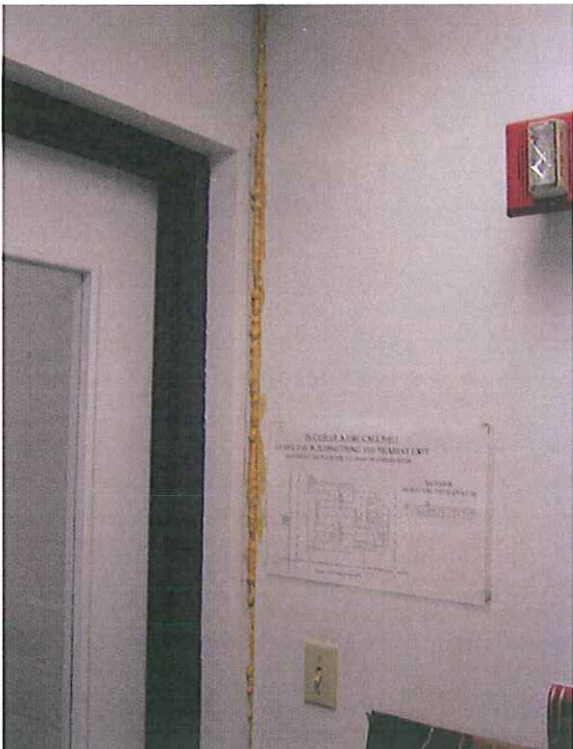
5. Conspicuous gap at staircase and 2nd floor corridor west side of Area A

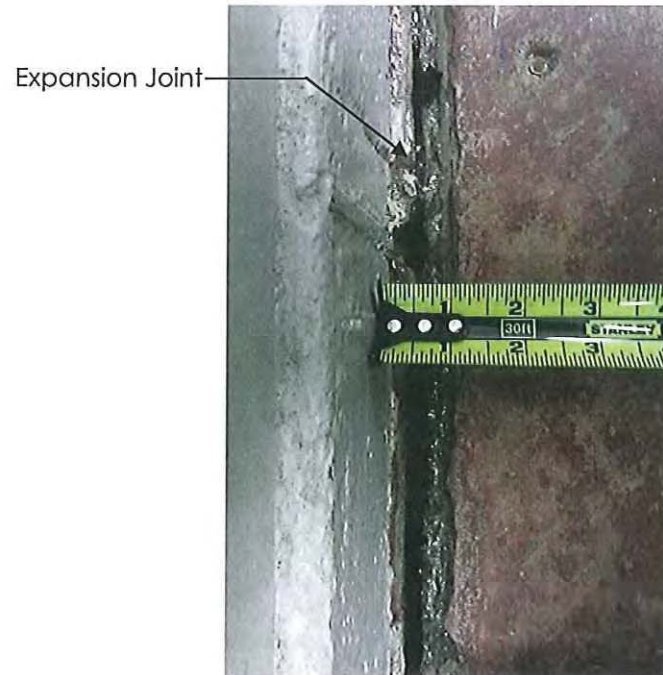
Overall, the foundation appears to be adequately supporting the self weight of the building and the current occupancy loads. However, there are signs of dilapidation in areas A and D. Photo 1 is taken along the perimeter of the west side of area B, in which it depicts the expansion joint separation between the slab and the perimeter grade beam. This visible separation indicates movement of the foundation. Furthermore, the severe cracks visible in area D are more than normal temperature and shrinkage cracks, thus re-indicating the foundation has experienced movement. Elevations should be taken throughout the foundation to determine the amount of settlement. In addition, it should be noted that the structure may require to be re-leveled with the addition of piers along the perimeter of the building. It should also be noted that additional foundation work will be required to adequately support any required framing modifications as discussed in Superstructures (page 4).

Photo 1: Expansion joint between perimeter grade beam and slab

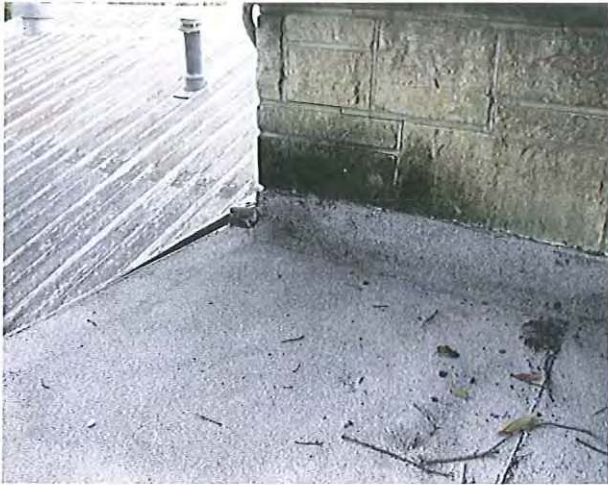
Photo A-1.1 Mold at wall flashing.

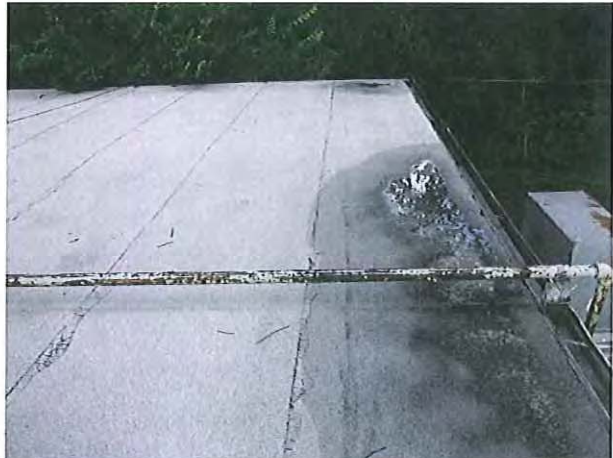
Photo A-2.2 Looking west, ponding at roof edge

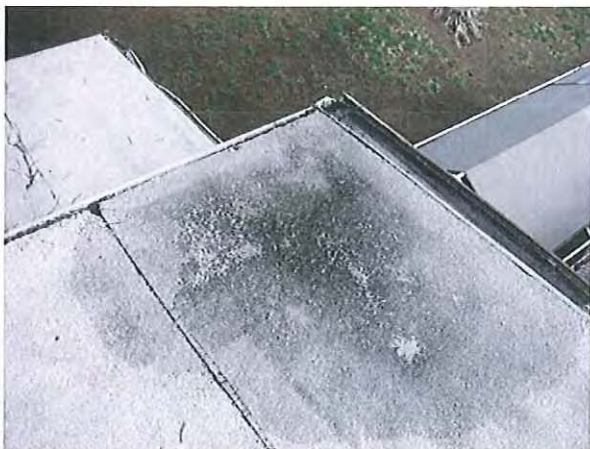
Photo A-2.3 Evidence of ponding in NW corner.

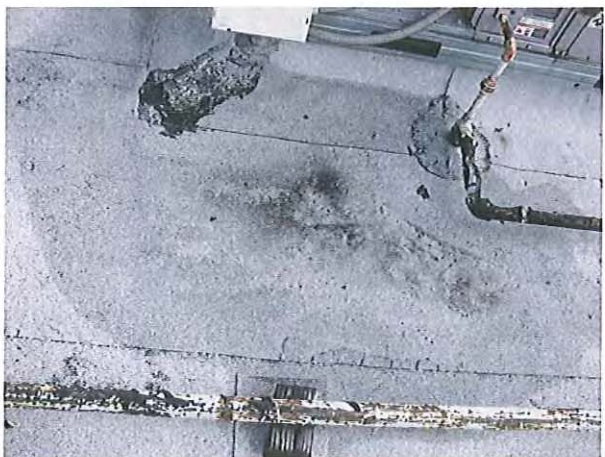
Photo A-2.4 Evidence of ponding near RTU.

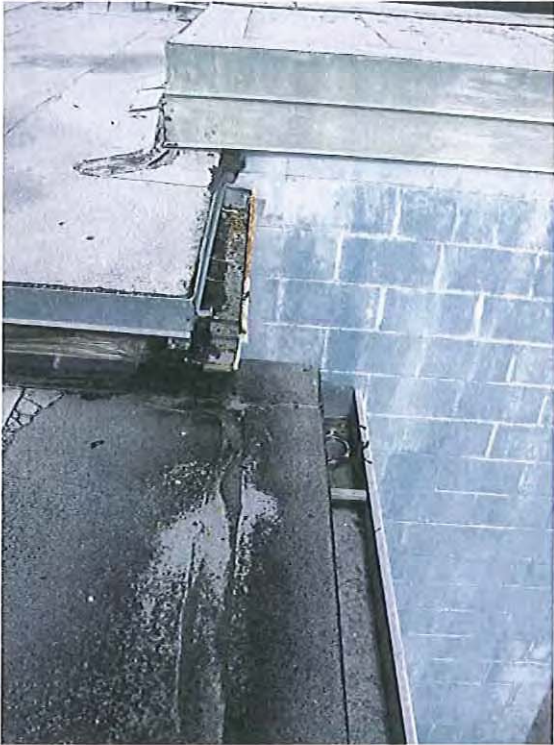
Photo A-3.1 NW corner w/ evidence of ponding.

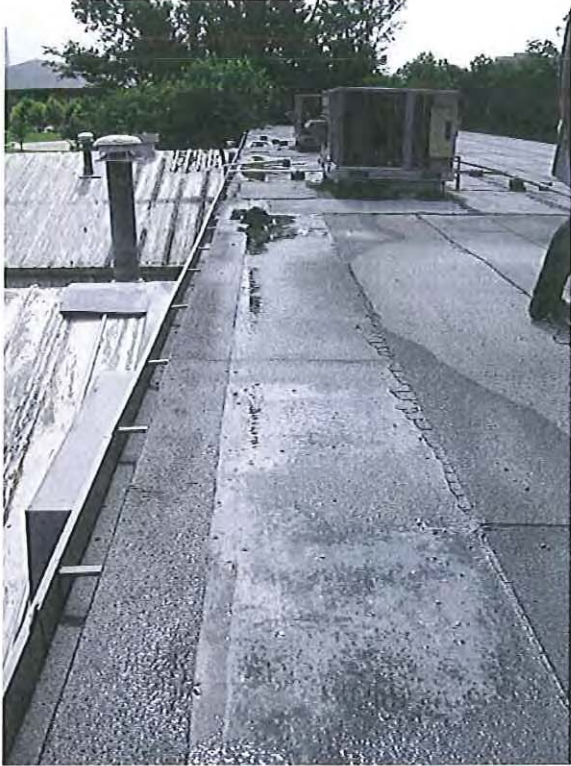
Photo A-3.2 Ponding along North edge.

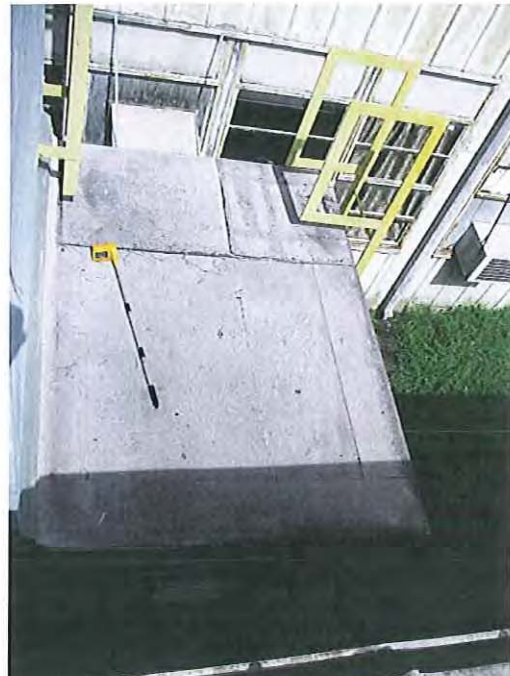
Photo A-6.1 Membrane aged, but serviceable.

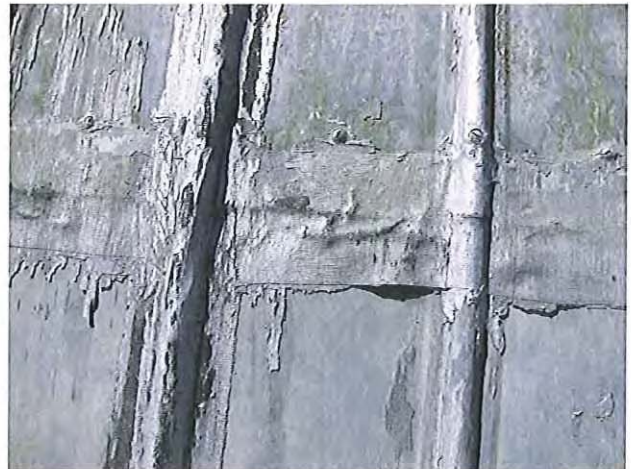
Photo C-1.2 Seal at lap joints not watertight.
