Tree Assessment and Recommendations

Duncan Park BMX Trail Area

Developed by PARD Urban Forestry Program Staff:

July 14, 2011

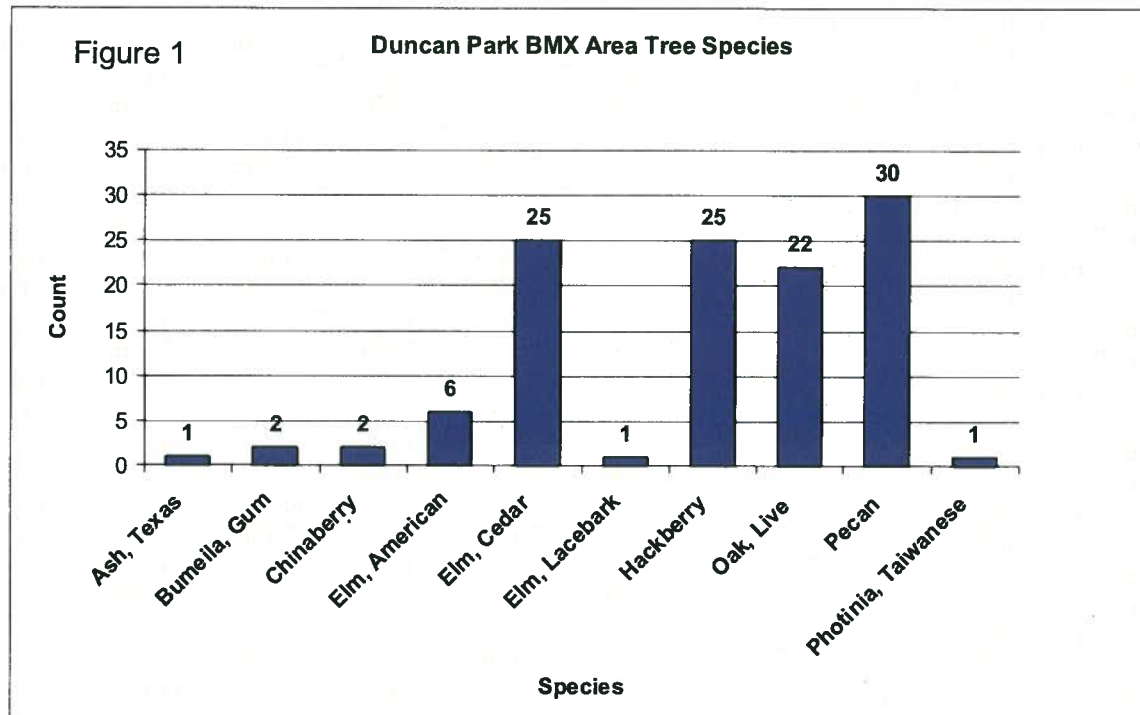
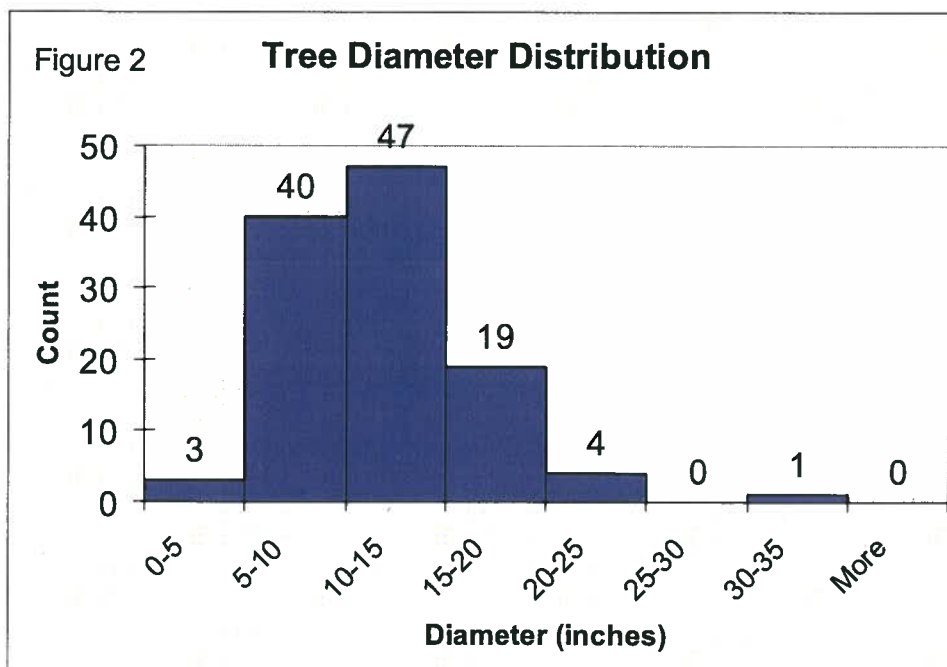
The tree assessment was performed on 115 trees within the BMX site. The four most common trees were pecan, cedar elm, hackberry, and live oak. Figure 1 illustrates the species composition of the site and Figure 2 shows a diameter distribution of the trees on site.
