Barton Springs Sunken Garden

Sunken Garden Improvements Phase I

Preliminary Engineer's Report

October 29, 2013

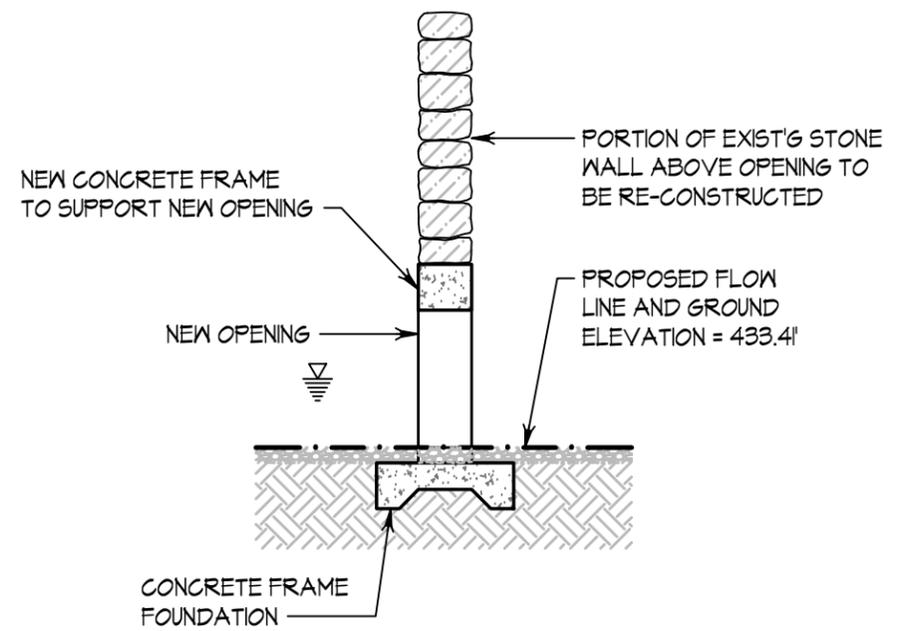
2 WALL SECTION @ PROPOSED OPENING
 1/4" = 1'-0"

The plugged concrete pipe remnants and the loose concrete debris beneath and around the wall opening need to be removed. The concrete pipe extends approximately 6 feet inside the enclosure and penetrates through the existing wall opening (Figure 2.2). Remnants of the pipe are also present on the exterior side of the wall under a mass of old concrete (Figure 2.1.2, in previous section).

for more information on water-flow analysis.) We anticipate that the opening be approximately 3 feet tall and 3 feet wide and will be framed with a cast-in-place reinforced concrete structure. The concrete frame will be roughly one foot thick on each side and above the opening, and will likely have a concrete spread footing foundation below the cobble stone channel. Once the concrete frame is installed, then the original stone wall can be reconstructed around it.

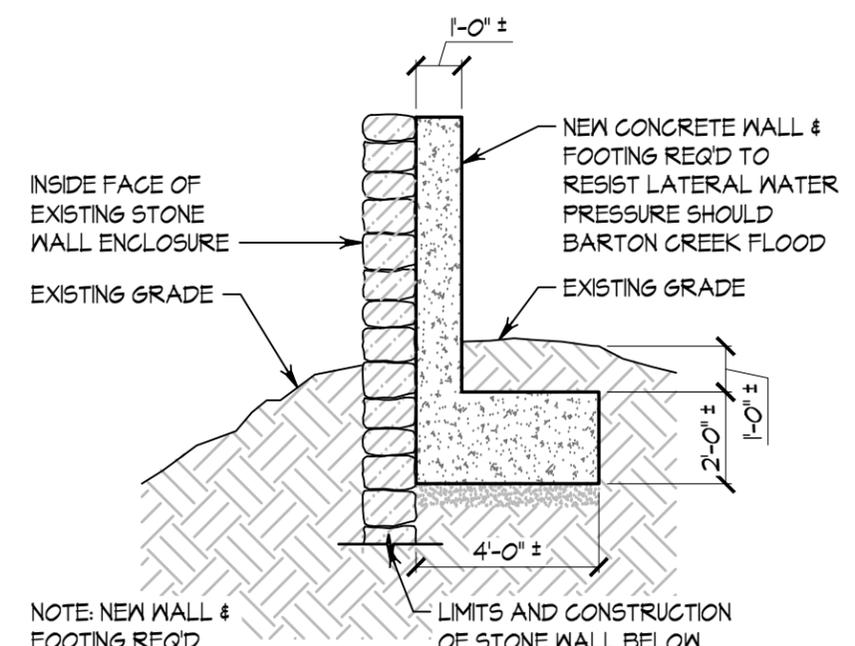
4 SECTION @ PROPOSED WALL STRENGTHENING
 1/4" = 1'-0"

If a means is implemented to prevent backflow from entering the enclosure, the existing stone wall would be subjected to large lateral forces that it cannot support in its current condition. Closing the wall opening will result in a buildup of large lateral hydrostatic forces as the water level rises outside the enclosure wall. Efforts to strengthen the stone wall so that it is capable of holding water would be extensive. Strengthening of the wall would likely include a new cast-in-place reinforced concrete wall and footing constructed against the outside of the north face of the stone enclosure wall.

The portions of the enclosure wall that are damaged or in a state of disrepair (see Section 2.1) require restoration, including the repair or reconstruction of deteriorated portions of the stone wall and replacement of degraded mortar to ensure that the wall will continue to support itself and so that further deterioration is prevented. It may also be necessary to repair portions of the wall beyond the extents of obvious damage.

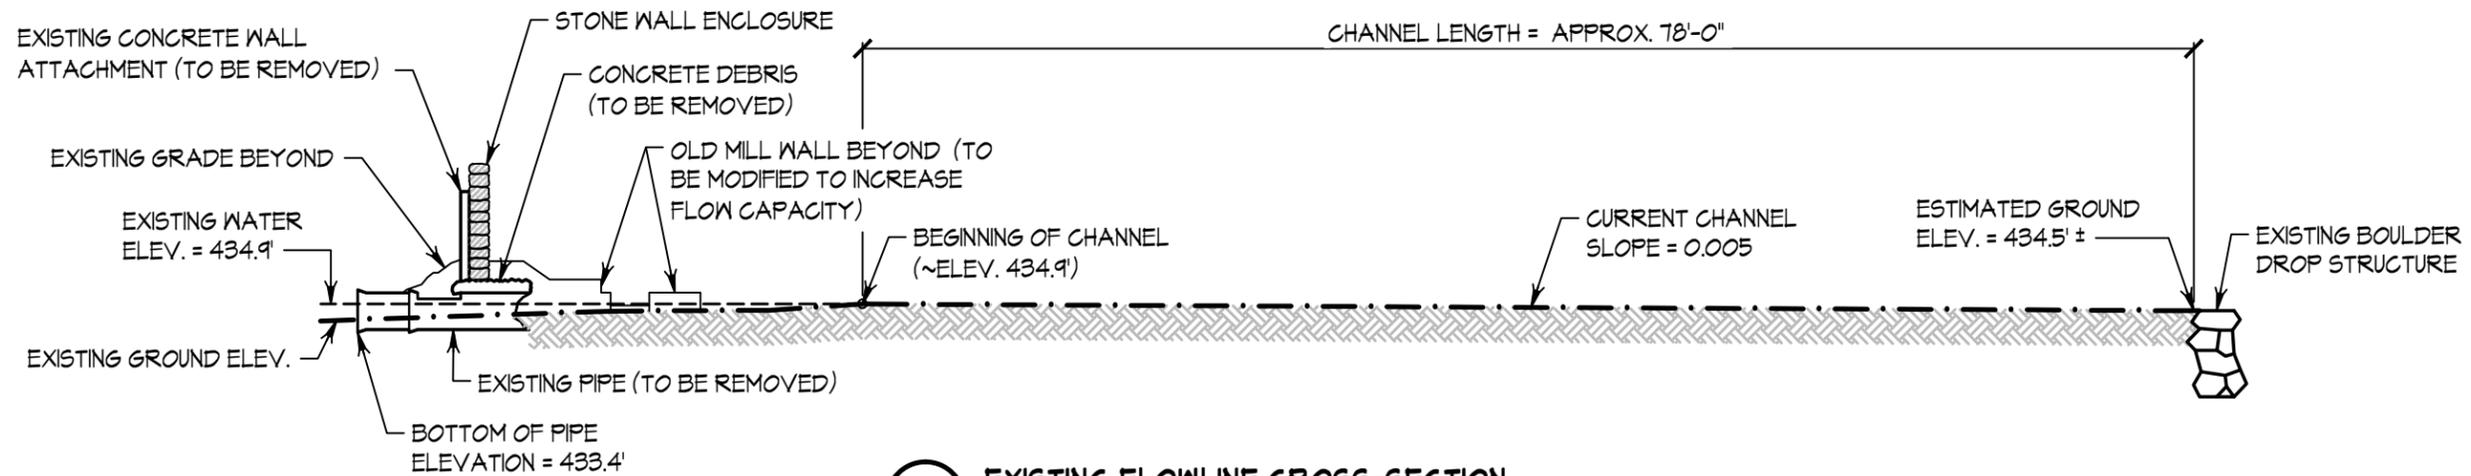
1 EXISTING FLOWLINE CROSS-SECTION
3/32" = 1'-0"

At the time of our visit, it was determined that the depth to the bottom of the existing concrete pipe at the enclosure exit (18" ± below the current water level) was the preferred flow line elevation. While this elevation would ideally be the highest flow line elevation between the enclosure and Barton Creek, we observed that the pool of stagnant water continued beyond the enclosure and was blocked by a highpoint in grade near the beginning of the channel (See Figure 1.2.4). The remainder of the channel leading down to Barton Creek was dry (Figure 2.1.4).
