Environmental Technology Verification Report

Nutrient Reduction in Domestic Wastewater From Individual Residential Homes

F.R. Mahony & Associates, Inc. Amphidrome™ Model Single Family System

NSF International

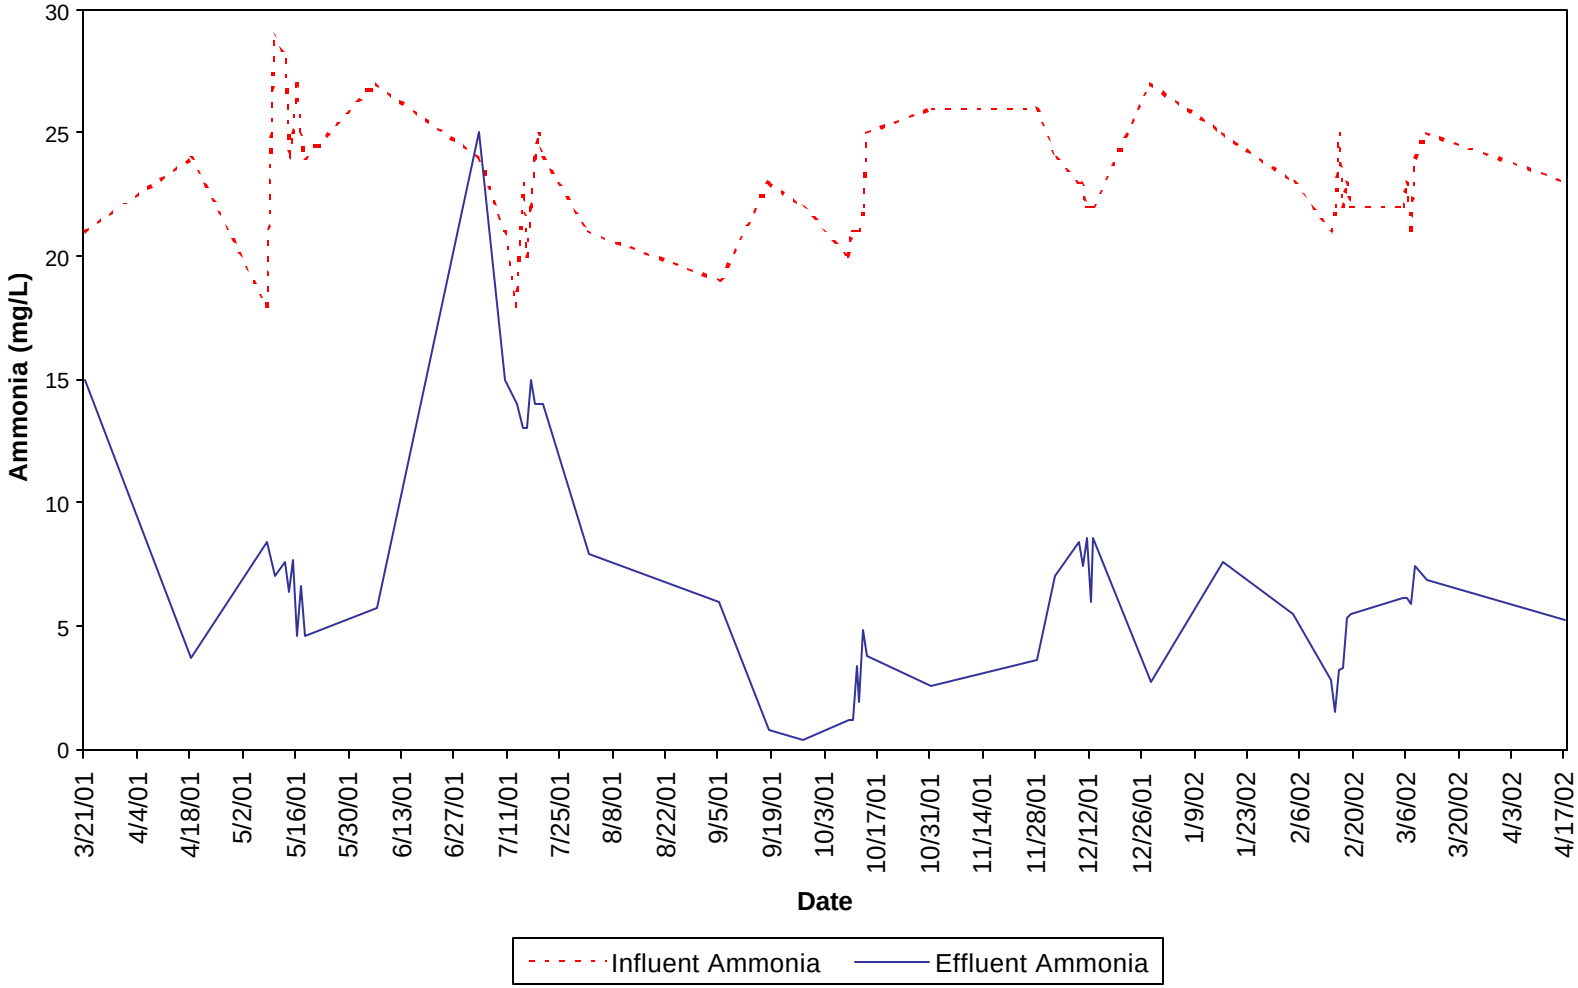
Figure 4-4. Amphidrome™ System Ammonia Nitrogen Results

On July 3, a routine monthly sample was collected and the data clearly showed that some type of upset had occurred. The nitrification process was severely impacted as shown by influent and effluent ammonia levels of 24 mg/L and 25 mg/L, respectively. The nitrate levels dropped to less than 0.1 mg/L, which would be typical of influent wastewater, and indicating no nitrate was being produced by the nitrifying organisms. Further, the alkalinity of the influent and effluent were similar (effluent was actually slightly higher). The upset was caused by a lack of wastewater returning to the anoxic tank. The return pump was found to be running continuously on June 21 during an inspection by FRMA. The pump had slipped off the guide rails, fallen off

its pedestal, and the recycle line had disconnected from the pump. The pump was operating, but only pumping water within the clear well. The float switch did not trigger the PLC to shutoff the pump. Therefore, from about June 6 (based electrical records) until June 21 when the problem was found, there was no recirculation of wastewater to the anoxic tank. During this time, wastewater from the anoxic tank was only receiving once through treatment in the biofilter. After flowing by gravity through the biofilter, the wastewater was collected in the clear well and discharged once per day from the system. The pump was resecured on the pedestal within the guide rails on June 21.

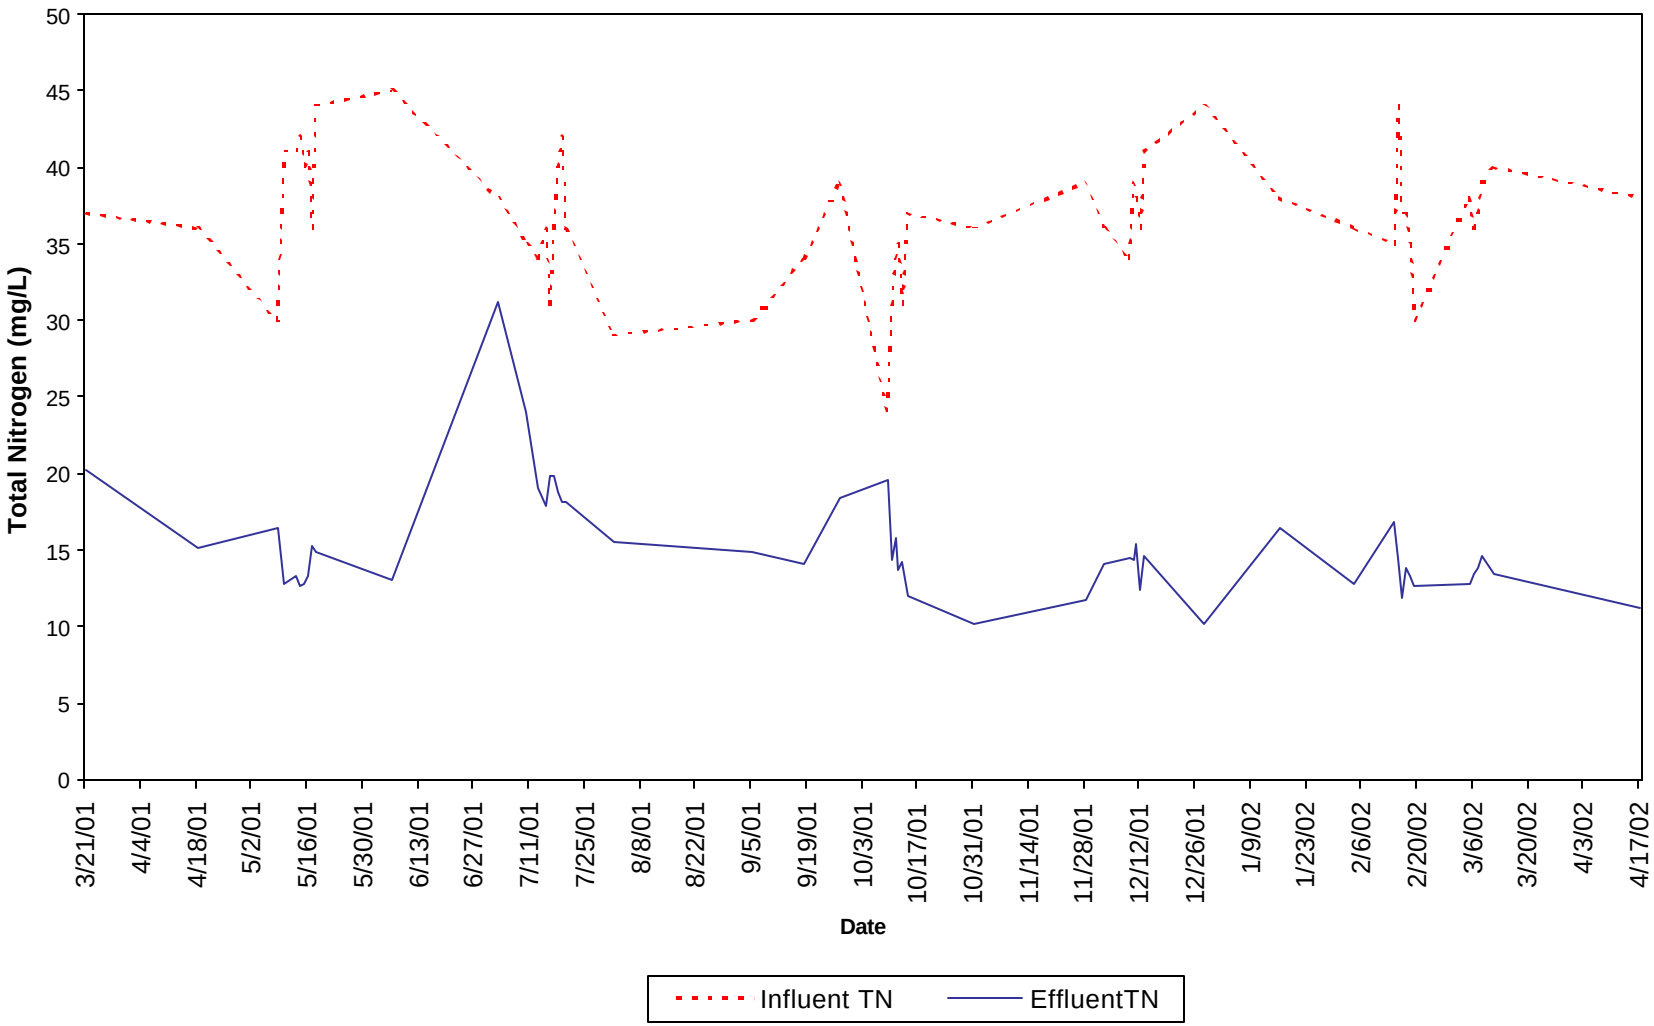
Figure 4-5. Amphidrome™ System Total Nitrogen Results

During the October 2001 to January 2002 period, including the power/equipment failure stress test in December, the system produced steady results, with TN in the effluent of 10 to 16 mg/L, a removal efficiency of 57 to 77 percent. The TN in the effluent was a mix of TKN and nitrate. After the low load stress test ended and flows returned to design levels, the nitrification and denitrification processes returned to the performance and balance levels found during the May and June 2001 period, prior to the upset condition in early July. The power/equipment failure stress test, performed on December 3 did not have a major impact on the system. The TKN and ammonia levels did increase somewhat compared the previous data point in November, but TN performance remained similar as the nitrate levels decreased somewhat during the post stress test monitoring period.

The verification test provided a sufficiently long test period to collect data that included both a long run of steady performance by the Amphidrome™ System and a period of reduced nitrification and denitrification efficiencies. During the months of April through June, following startup, the TN removal was in the 45 to 71 percent range, with effluent concentrations typically in the 13 to 16 mg/L range. The upset resulting from the dislocation of the return pump dramatically impacted the nitrification process in early July. Following the upset, the system recovered by the end of July and continued to remove substantial amounts of TN. During the last eight months of the verification test, the TN removal was in the 52 to 77 percent range. Effluent TN concentration ranged from 10 to 20 mg/L, with most concentrations in the 13 to 15 mg/L range. Data collected from the two low or no flow stress tests indicate that overall system performance for TN was not impacted. However, the concentrations of TKN/ammonia and nitrate changed during these lower flow periods. Nitrification was enhanced during low flow periods with a commensurate increase in nitrate concentrations in the effluent.
