**HISTORIC LANDMARK COMMISSION  
APRIL 27, 2015  
DEMOLITION AND RELOCATION PERMITS  
HDP-2015-0213  
4707 WOODVIEW AVENUE**

Demolish a ca. 1945 house.

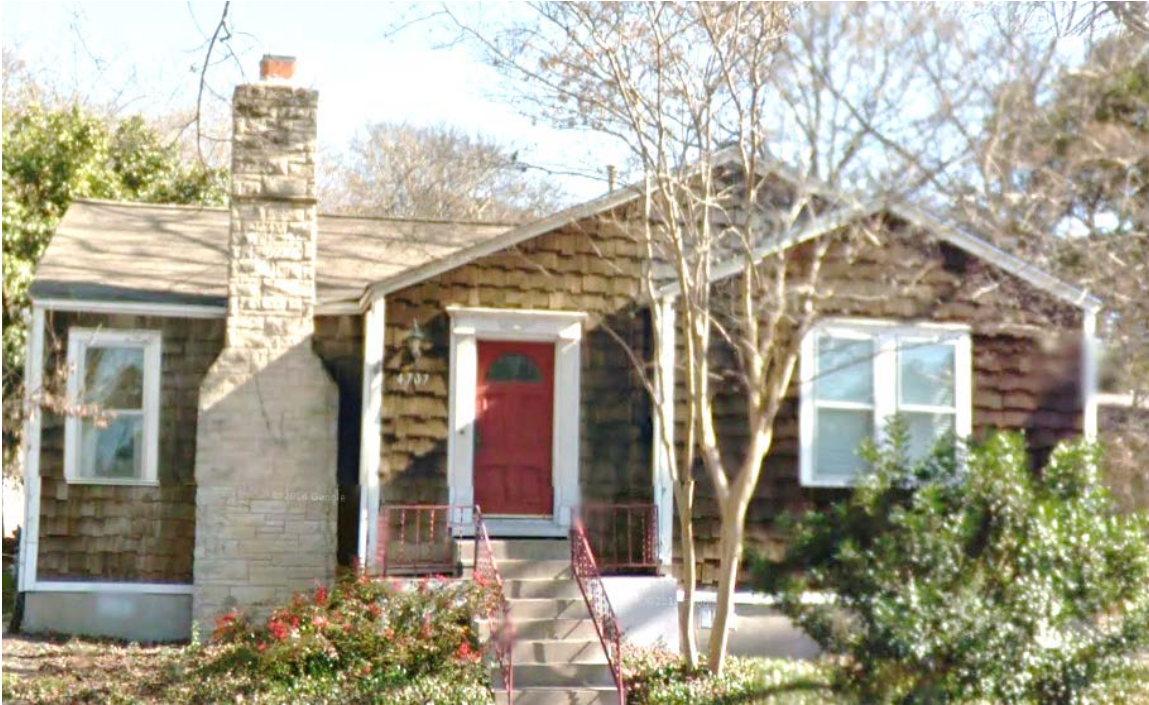
4707 Woodview Avenue  
ca. 1945

One-story, roughly rectangular-plan frame house with a front-gabled bay containing a smaller front-gabled bay, and a side-gabled addition to the left; battered stone exterior chimney to the left of the principal front-gabled block; the door surround has pilasters; single and paired 1:1 fenestration; weathered wood shingles.
