HISTORIC LANDMARK COMMISSION
JULY 25, 2016
PERMITS IN NATIONAL REGISTER HISTORIC DISTRICTS
NRD-2016-0044
1715 SUMMIT VIEW PLACE
OLD WEST AUSTIN

PROPOSAL

Demolish a ca. 1928 house.

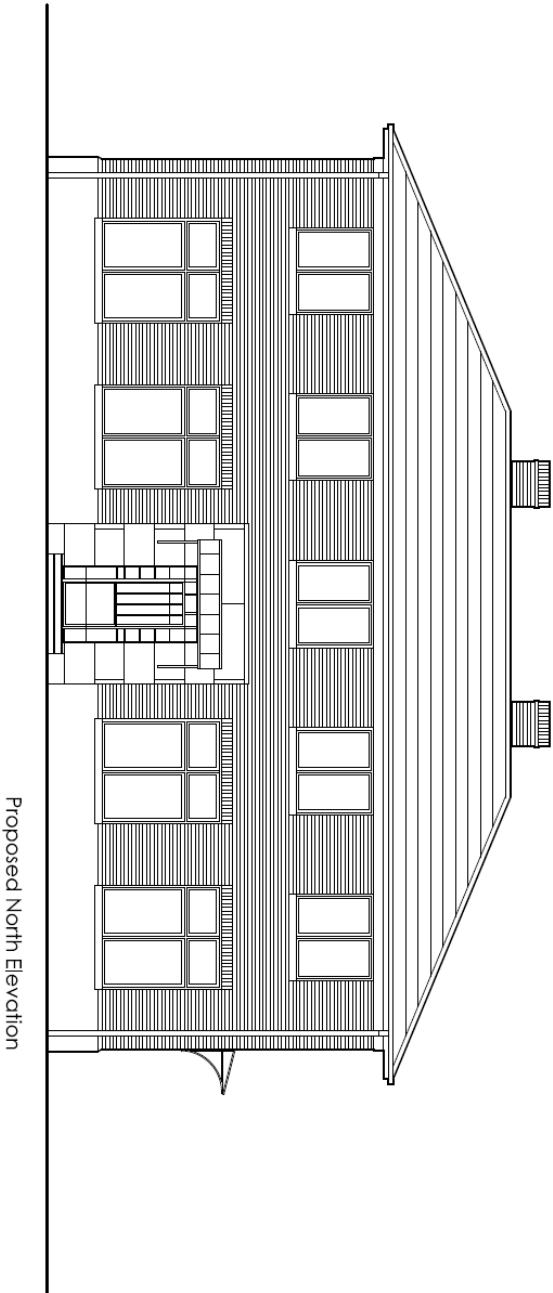
Proposed North Elevation

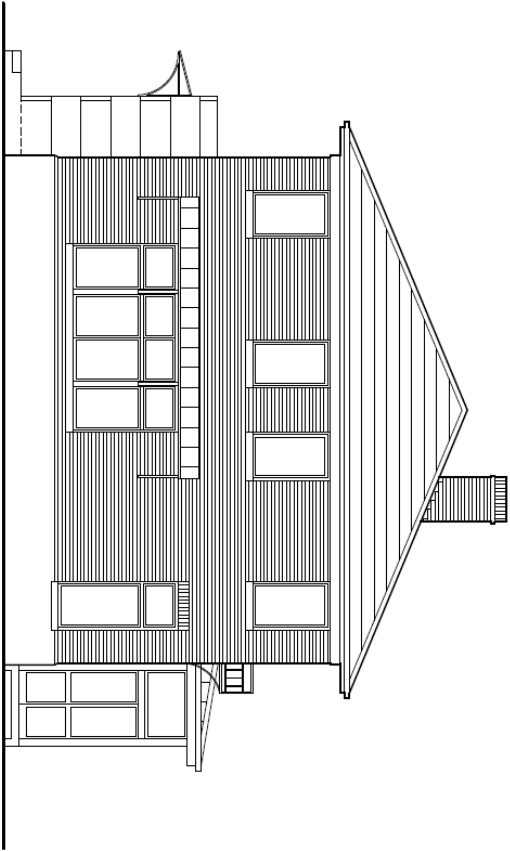
Proposed West Elevation

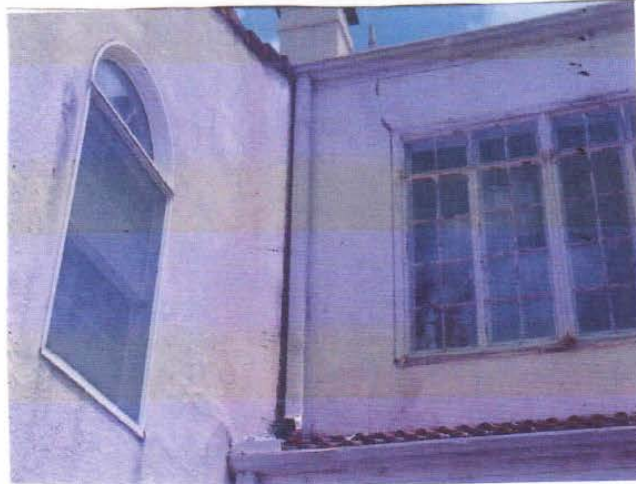
Damaged Exterior Stucco

1. Stucco: Cracks/unsealed stucco was observed on all sides of structure. This issue is allowing significant amounts of moisture into the interior walls. In most cases, the sheathing located behind the stucco is rotten.
2. Windows: Improperly flashed and in many cases rotten exterior window trim was observed throughout the structure. This issue is allowing significant amounts of moisture into the interior walls.
3. Doorways: Improperly flashed and in many cases rotten exterior doorway trim was observed throughout the structure. This issue is allowing significant amounts of moisture into the interior walls.
4. Interior: Significant mold growth/water damaged was observed at approximately 40% of the interior wall/ceiling materials and within the HVAC ductwork. The most likely cause of the observed damage is roof/siding leaks located throughout the structure.

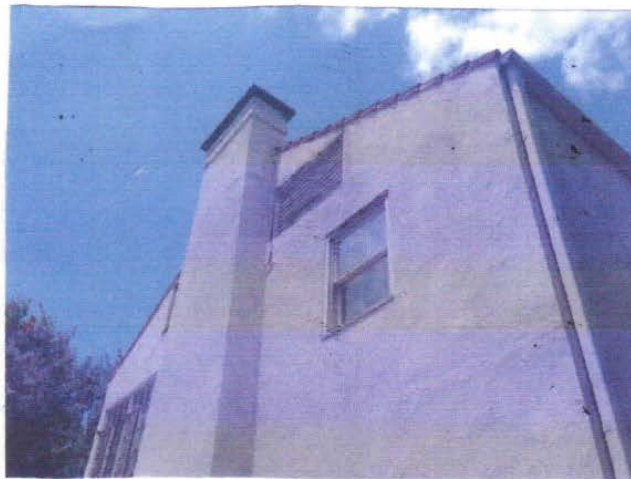
Damaged Exterior Stucco

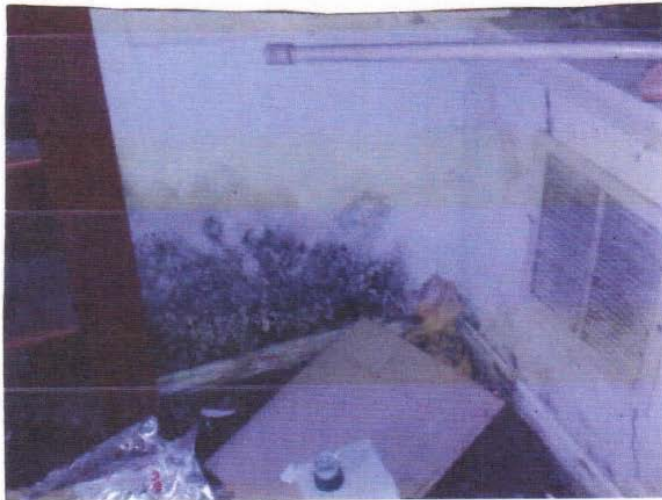
Typical Mold Damage

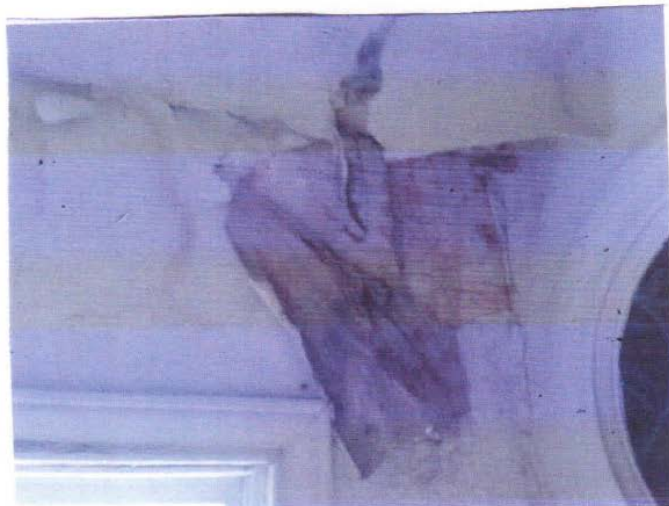
Typical Mold Damage
