HISTORIC LANDMARK COMMISSION
PERMITS IN NATIONAL REGISTER HISTORIC DISTRICTS
MARCH 26, 2018
 NRD-2018-0007
 3108 Glenview Avenue
 Old West Austin Historic District

PROPOSAL

Construct a new front porch, a second-story front addition, and two ground-floor additions at the side and rear; and replace all windows and siding.

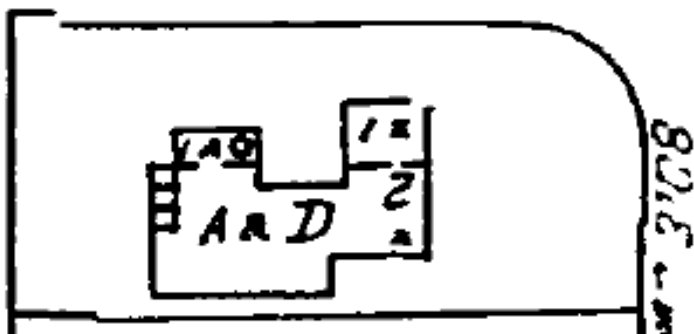
Detail from 1962 Sanborn Fire Insurance Map showing a two-story house with a rear apartment and garage.
