Plans and Specifications

PLANS AND SPECIFICATIONS OF PROPOSED WORK: Plans and specifications for project describing the work proposed in detail.

Heritage Grant Proposed Work Hardeman House at Symphony Square

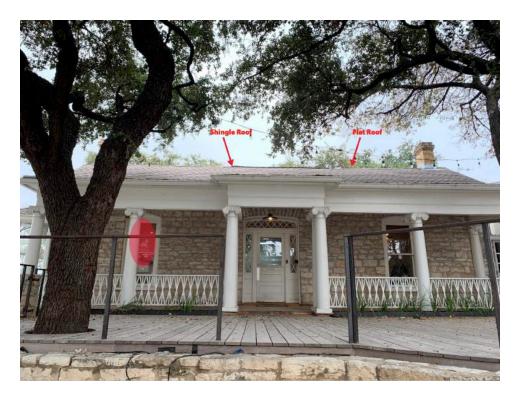
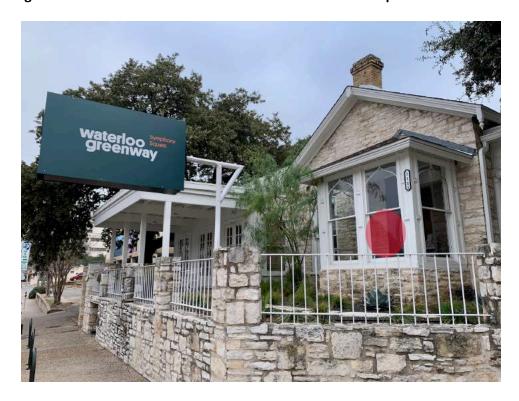
Shingle roof and flat roof identified above. Windows to be replaced marked in red.

Replace Existing Damaged Shingle Roof: Replace existing asphalt shingles with fiberglass shingles that more accurately represent the original roofing material, which was likely cedar shakes. Fiberglass shingles are made of a woven fiberglass base mat, covered with a waterproof asphalt coating, and topped with ceramic granules that shield the shingles from harmful UV rays. Because of the composition of the fiberglass mat, less asphalt is needed to give the shingles their durability and strength, making them a lighter and more environmentally friendly option than traditional organic-mat asphalt shingles. Fiberglass roofing provides many benefits, as it is a tough and very resilient material that is non-porous, does not change shape, and won't dry out. Fiberglass shingles also contain less asphalt than organic mat-based shingles and are easier to transport, providing a lower overall environmental impact. The proposed replacement shingles are from GAF Camelot II Lifetime Designer Series. See attached for material selection.

Replace Existing Damaged Flat Roof: Replace all Thermoplastic Polyolefin (TPO) and Modified Bitumen roofing materials with a new 60-millimeter TPO roofing system. TPO is a single-ply reflective roofing membrane made which is typically installed in a fully adhered or mechanically attached system, allowing the white membrane to remain exposed throughout the life of the roof. TPO is environmentally friendly, is resistant to ultraviolet, ozone and chemical exposure, and delivers benefits like lower roof surface temperatures, greater energy efficiency, superior puncture resistance against hail and enhanced indoor comfort.

Reglaze Two Exterior Windows: Demo (2) Plexiglass inserts and replace with ¼" single-paned, tempered glass. Previous tenants replaced windows with thin sheets of plexiglass, which is energy inefficient and provides no real safety barrier. The original windows will remain intact, with only the glass being reglazed and restored to historical specifications.
