Cedar & Oak

2502 Park View Drive Austin, TX

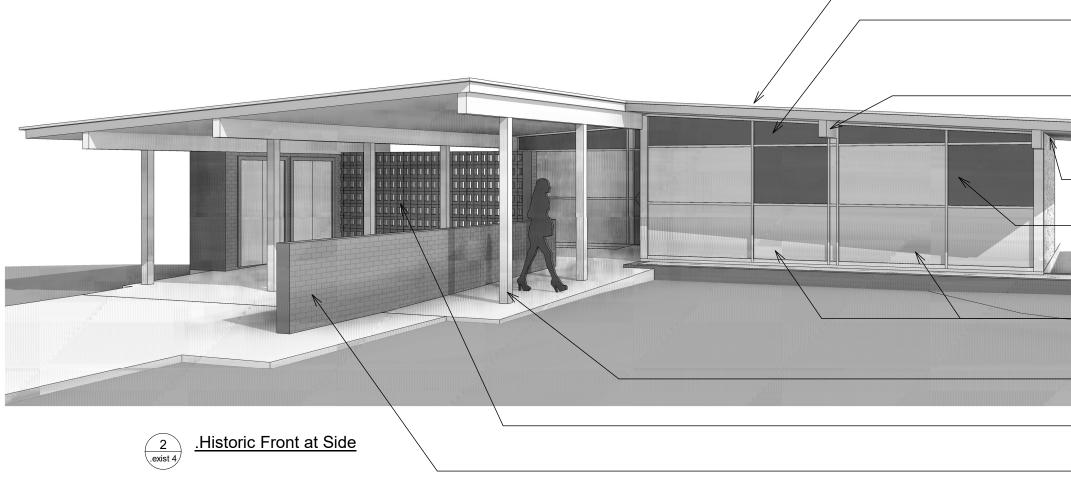
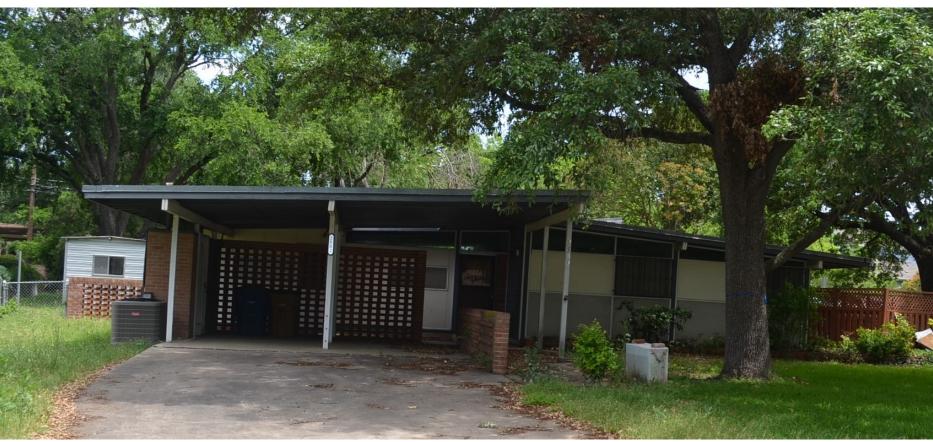
NEW METAL ROOF STANDING SEAM OVER MEMBRANE W/ SPRAY FOAM INSULATION AT UNDERSIDE OF ROOF DECK

REPAIR & AIR SEAL WINDOW FRAMES. REPLACE ALL GLASS WITH NEW INSULATED AND TEMPERED GLASS PER LIFE SAFETY REQUIREMENTS. GLASS OPENINGS TO REMAIN SAME SIZE.

EXPOSED RAKE BEAMS REPAIR & PAINT

WALL PLATE TO REMAIN AS IS, +/-7'-7"

REPLACE EXISTING ASBESTOS PANELS WITH NEW SMOOTH WALL PANELS (HPL OR FIBER CEMENT SMOOTH FINISH) NEW PANELS TO MATCH EXISTING SIZE

REPLACE EXISTING 2-CAR CARPORT WOOD COLUMNS WITH NEW STEEL COLUMNS PAINTED

PERFORATED BRICK WALL AT REAR OF CARPORT TO REMAIN

LOW BRICK WALL REMAINS, REPOINT & REPAIR
AS NEEDED. GROUT COLOR TO MATCH EXISTING
