**APPEAL TO
PLANNING COMMISSION
HISTORIC LANDMARK COMMISSION DENIAL OF A CERTIFICATE OF APPROPRIATENESS
REVIEW SHEET**

HISTORIC NAME: Mitchell-Robertson Building (C14H-2004-0008)

ADDRESS: 909 Congress Avenue

**907 – 909 – 911 CONGRESS AVENUE
AUSTIN, TEXAS
FAÇADE DECONSTRUCTION / RECONSTRUCTION
SCOPE OF WORK / OUTLINE TO COMPLETE**

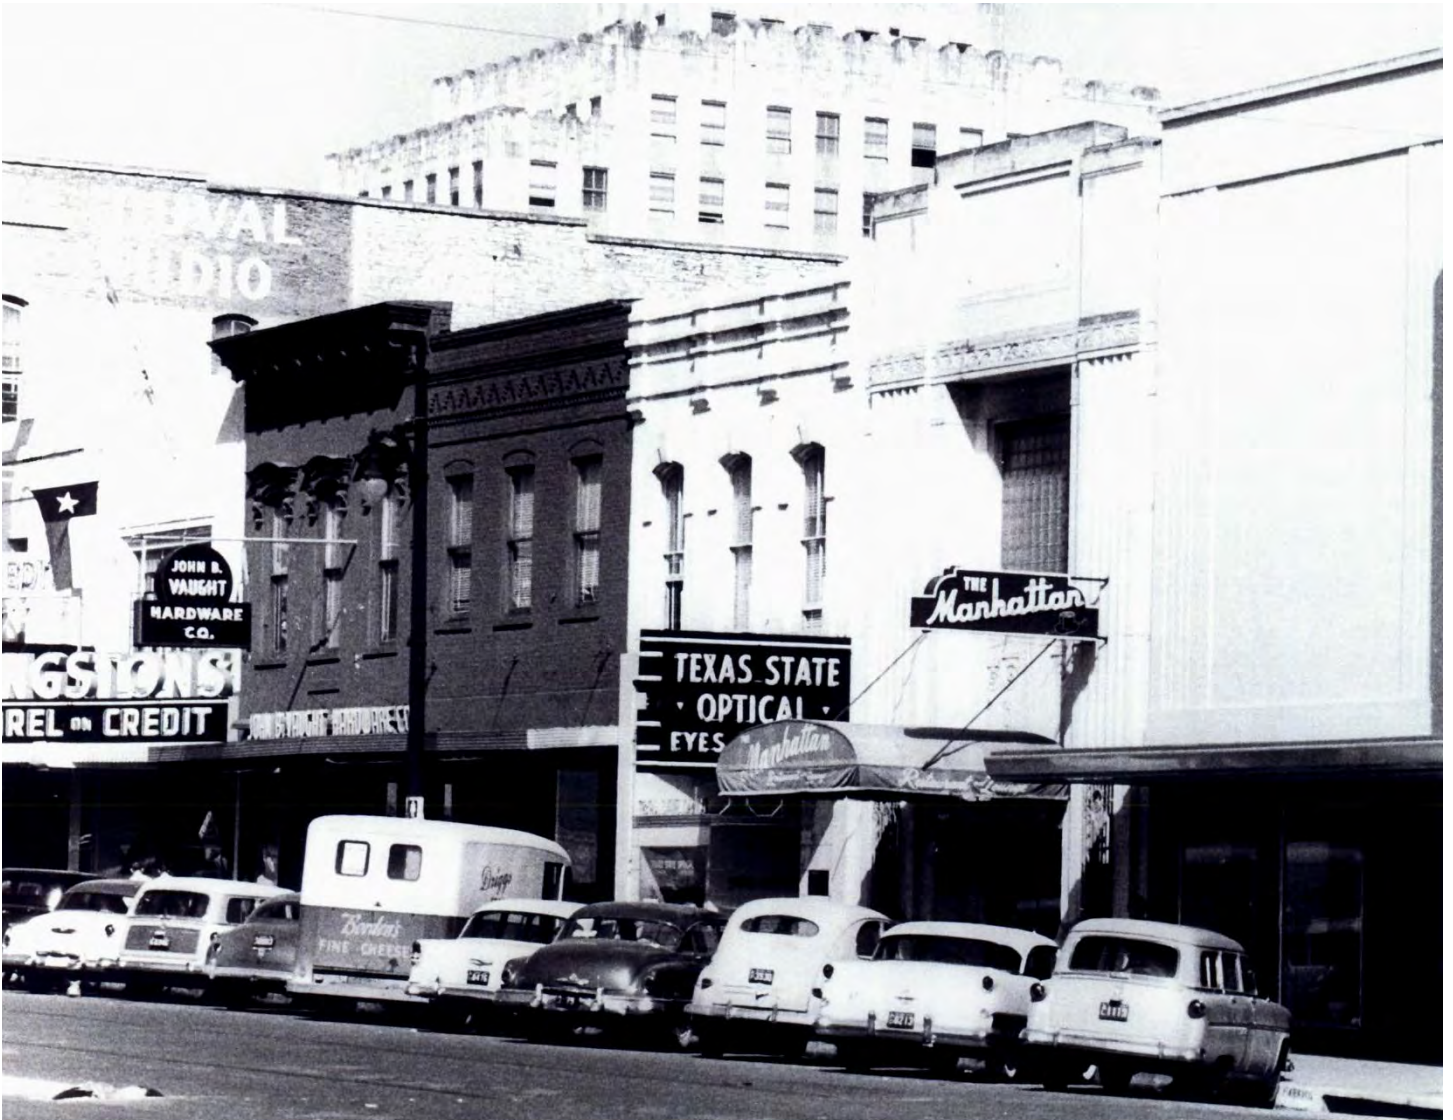
Historic photograph of 911 Congress Ave. (John B. Vaught Hardware Co.), 909 Congress Ave., and 907 Congress Ave. (Texas State Optical), Historic Preservation Office files, no date.

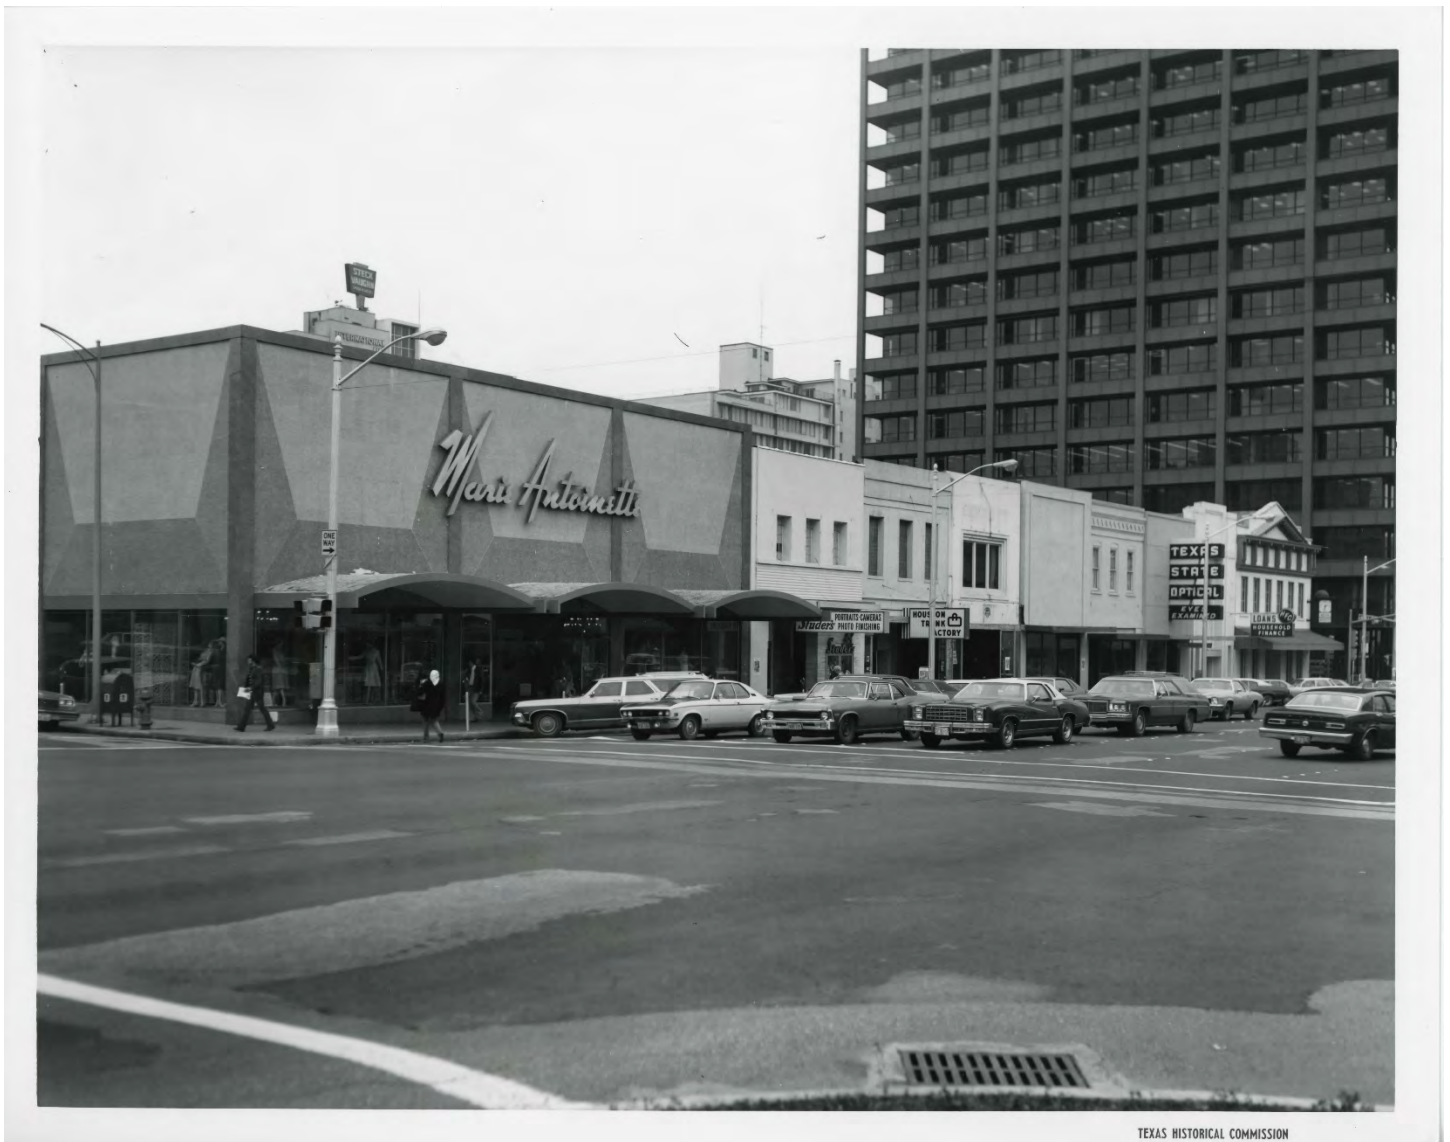
909 Congress Ave. (building to the left of Texas State Optical sign), National Register nomination for Congress Avenue Historic District, February 1978.

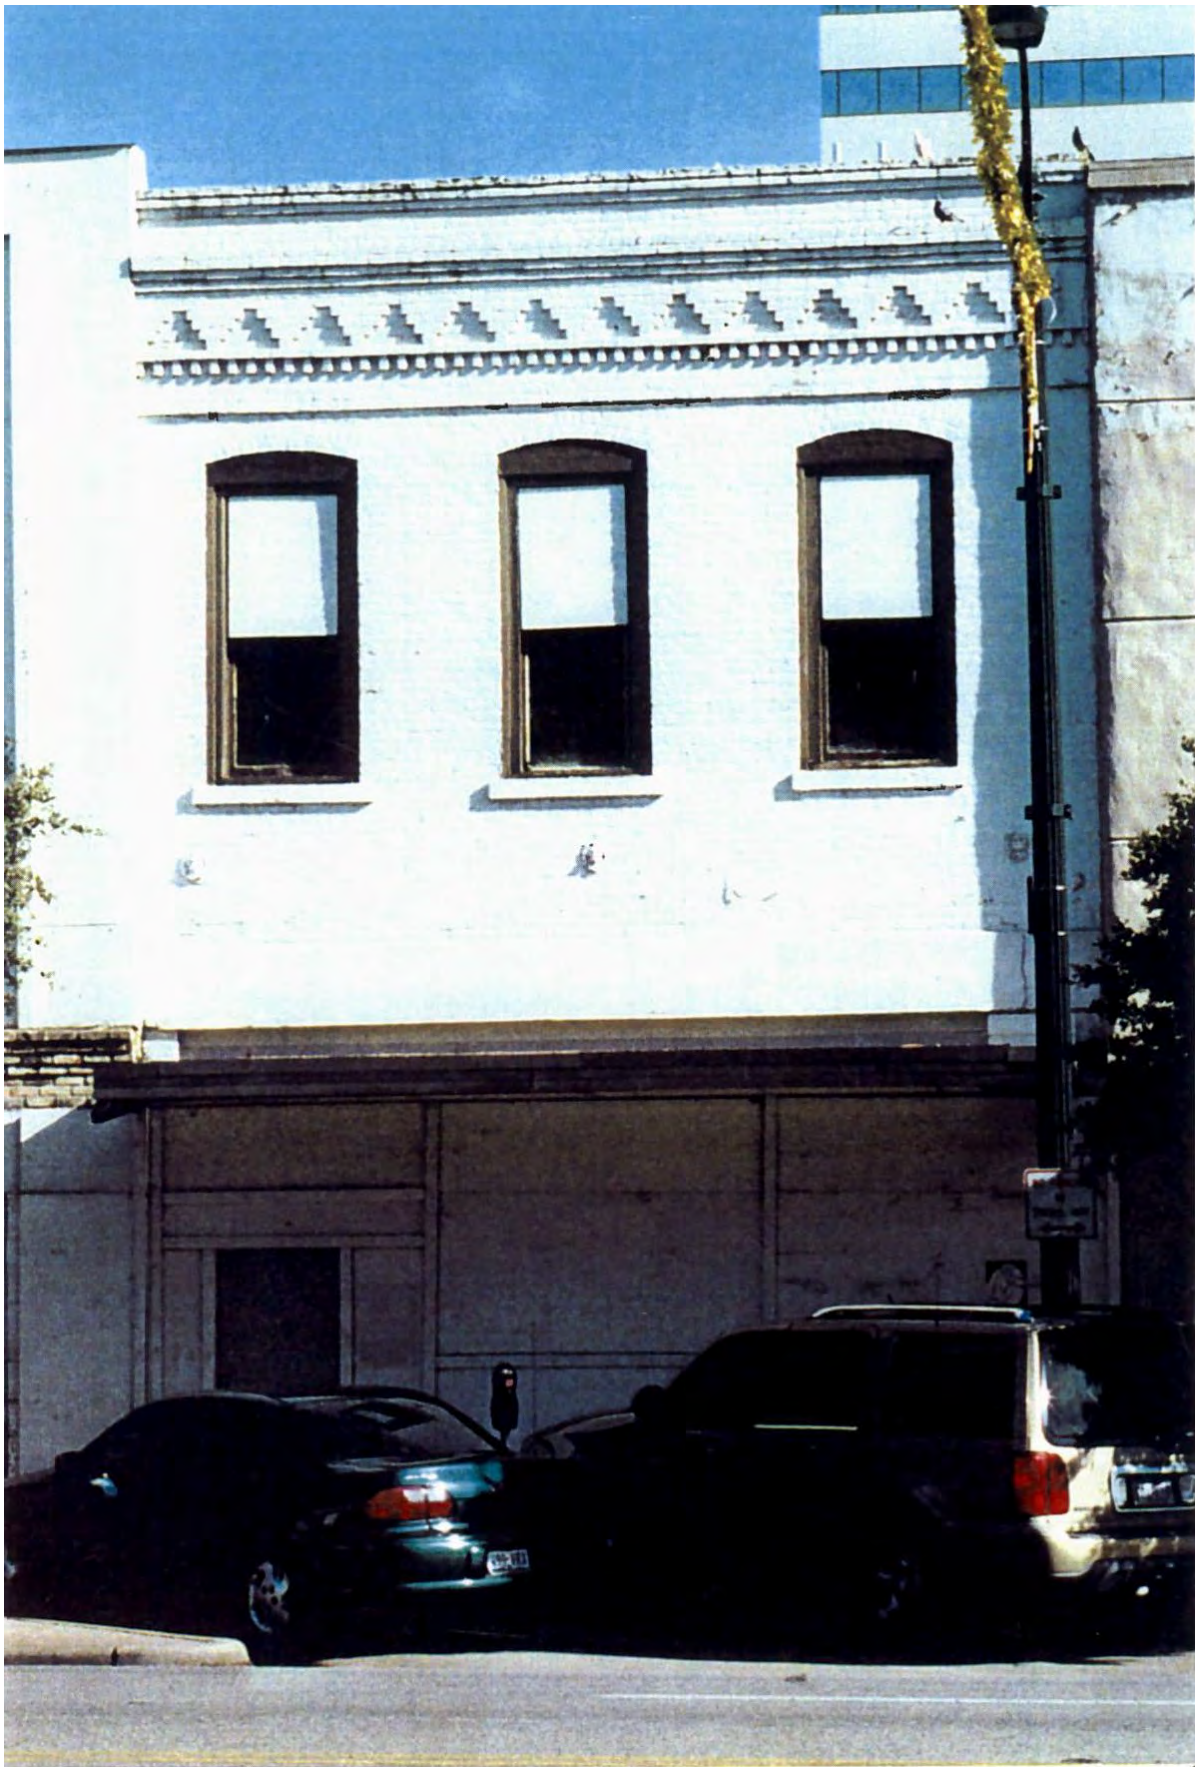
909 Congress Ave., historic landmark nomination, 2004.

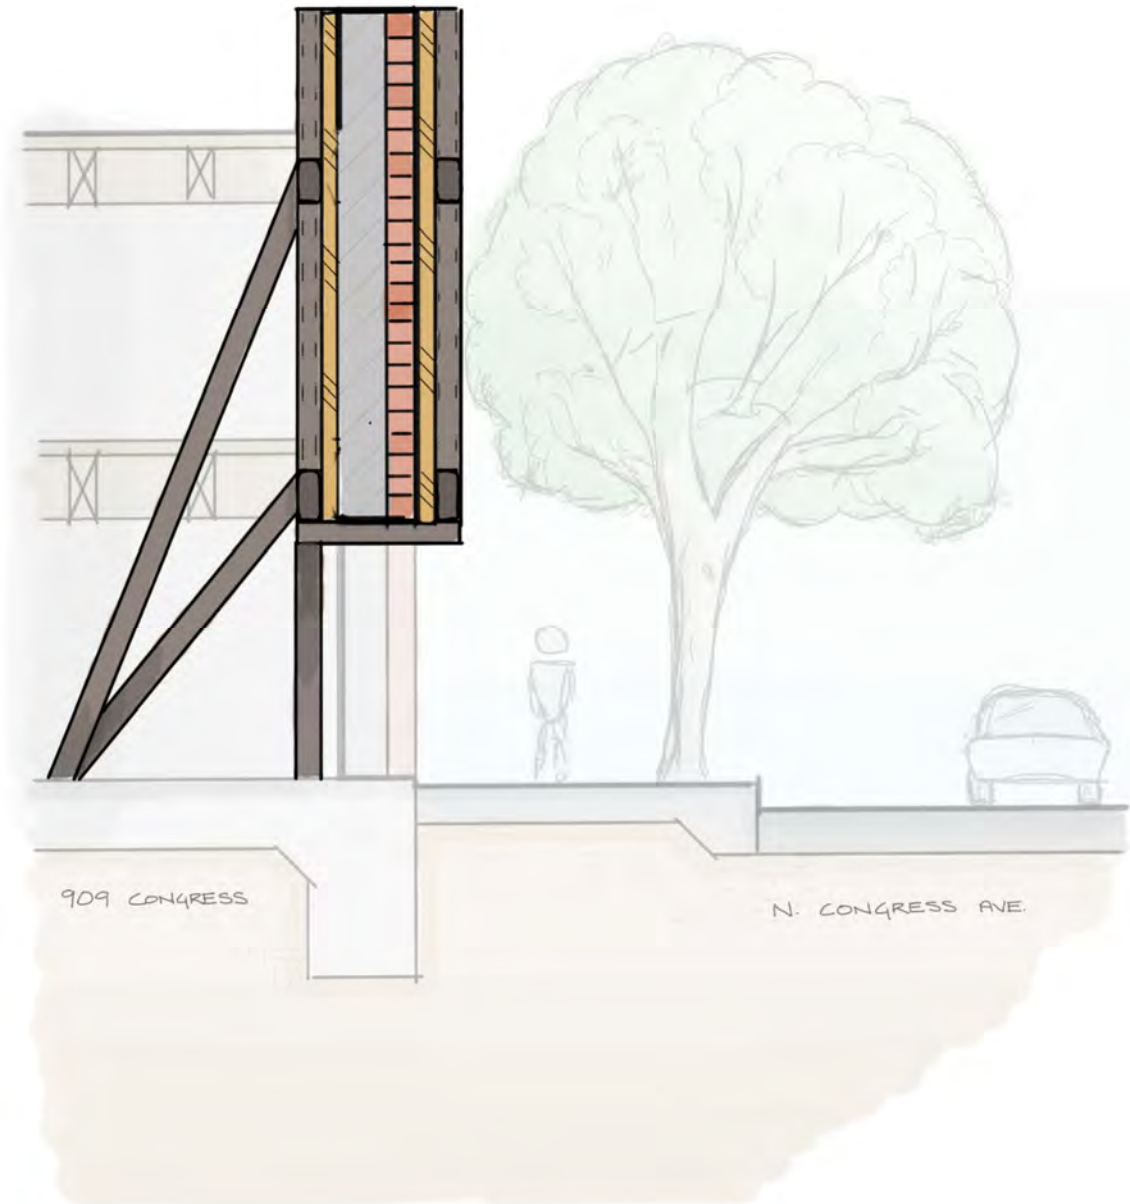
Option 1 - Brace into Lot

A steel frame structure with plywood sheathing could be utilized to sandwich the area of brick façade to be saved. This would allow for a structure that is stiff enough to not cause irreparable damages to the brittle façade. This steel structure would then have to be laterally braced towards the lot and away from Congress Avenue using steel diagonal members that would bear on new foundations within the extents of the existing buildings to provide gravity and lateral support of the brick façade as demolition and construction occurs around it. Due to the extent of demolition required in and around this particular building, this option will likely not be feasible as contractors would likely not be able to complete their scope of work around the proposed bracing elements.

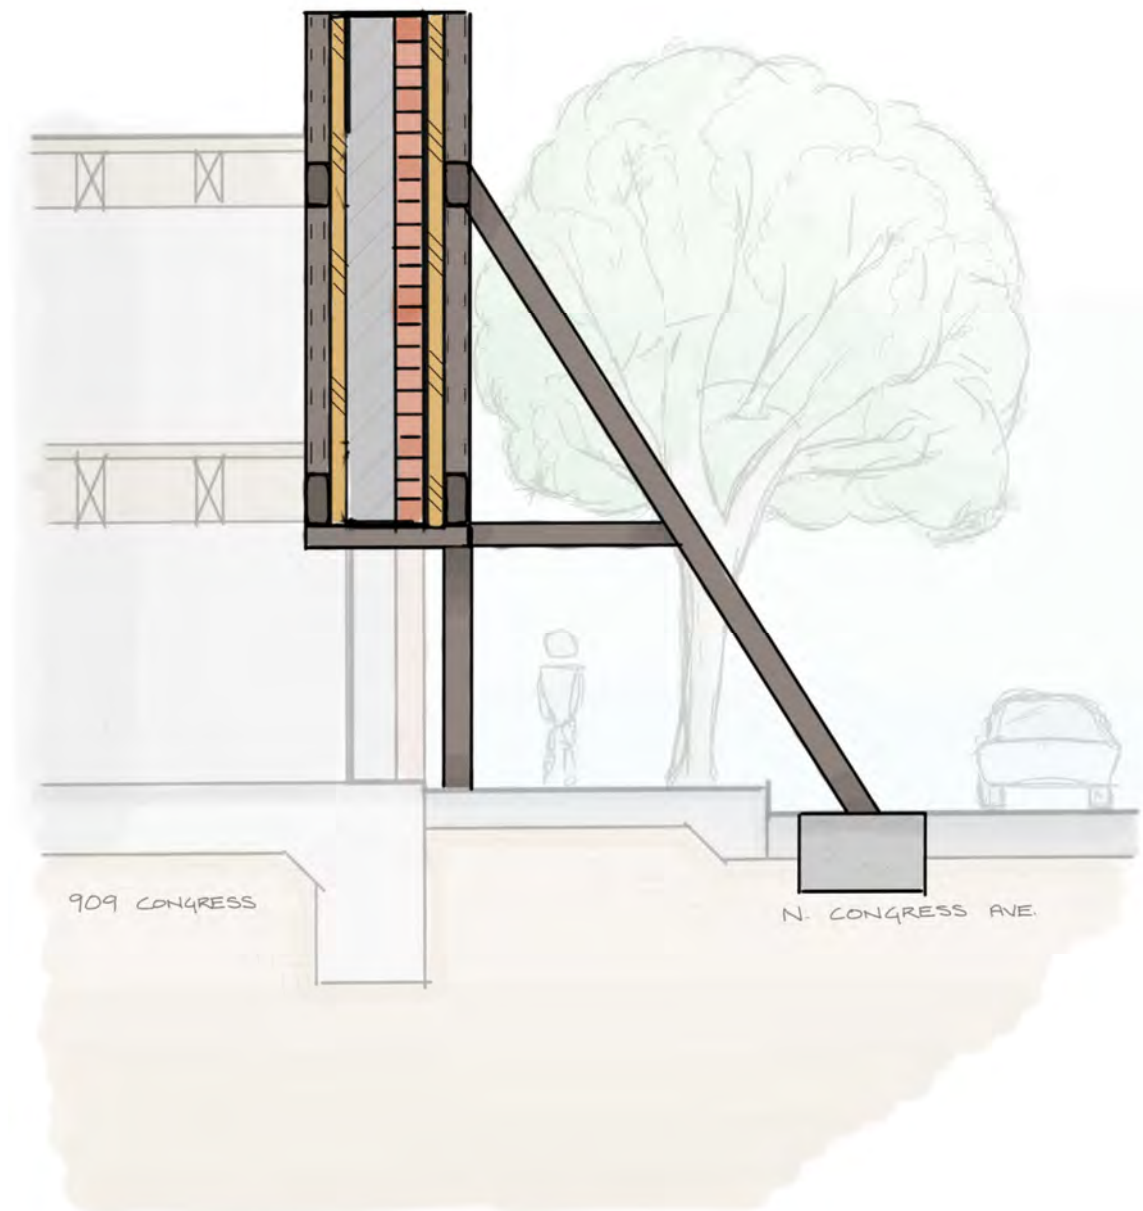
Option 2 - Brace toward Congress Avenue

Similar to Option 1, a steel frame structure with plywood sheathing could be utilized to sandwich the area of brick façade to be saved. This would allow for a structure that is stiff enough to not cause irreparable damages to the brittle façade. This steel structure would then have to be laterally braced towards Congress Avenue using steel diagonal members that would bear on new foundations within the sidewalk or parking areas to provide gravity and lateral support of the brick façade as demolition and construction occurs around it. Bracing elements would have to be attached down through the sidewalk and/or the street parking spots for an extended amount of time until demolition and new construction are completed. This solution would cause significant interruptions to Congress Avenue and may incur excessive fines for impeding the right of way making this option improbable. Additionally, having the bracing elements in the public domain could increase the risks of accidents occurring that would cause distress and potential damage to the masonry.

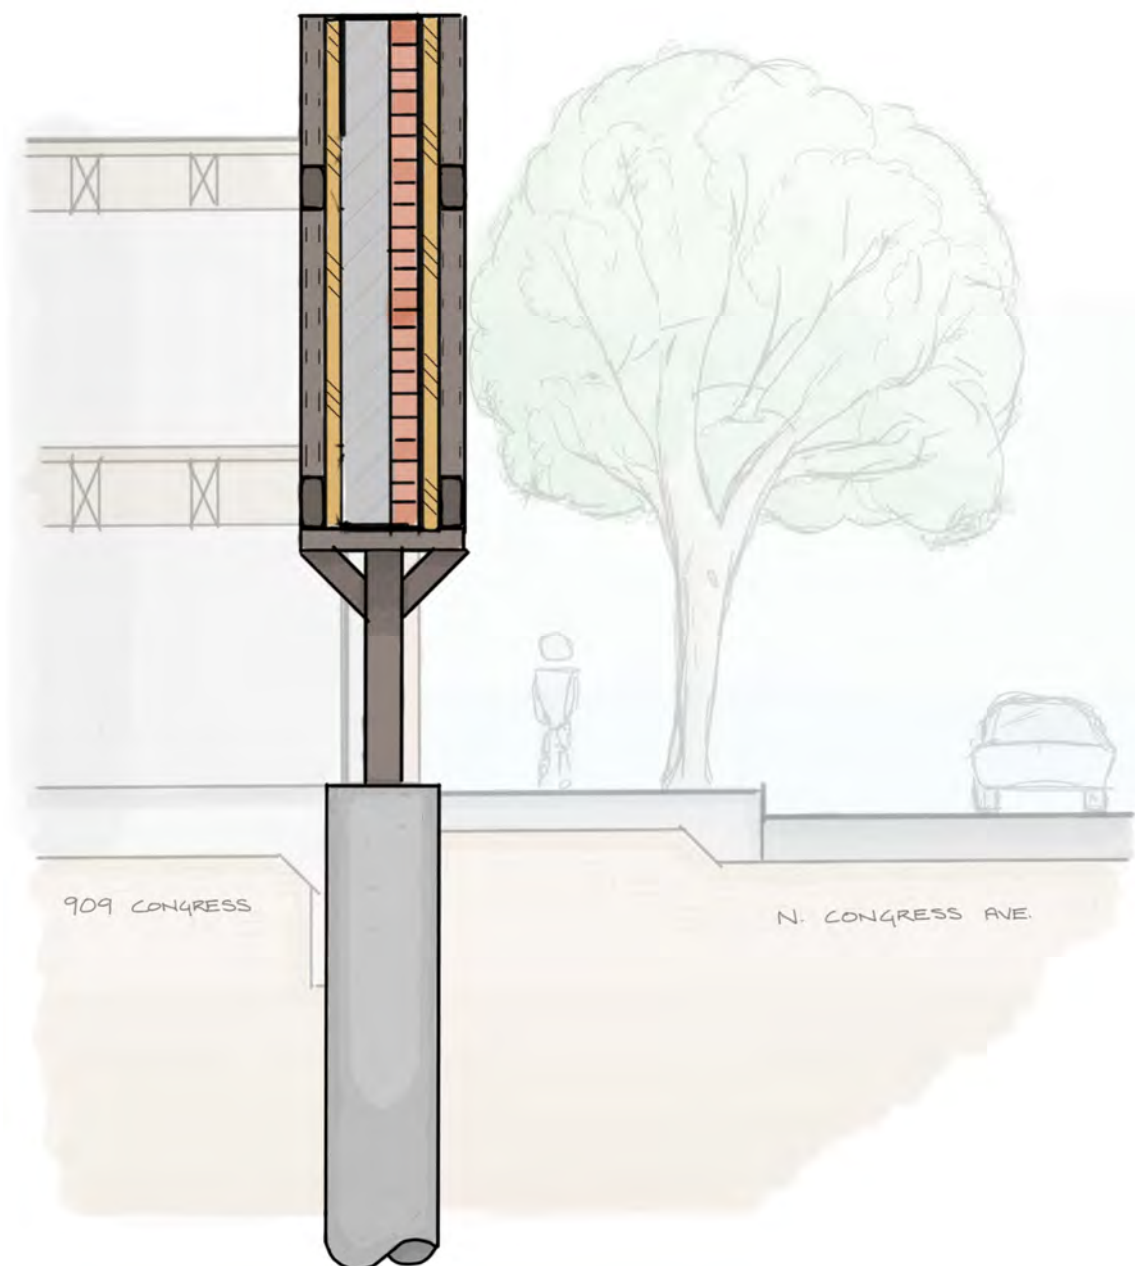
Option 3 - Brace with Cantilevered Columns

A similar steel frame structure as described in Options 1 and 2, but with far stiffer vertical elements as this option will not require any additional steel diagonal bracing for support. This steel frame will be supported from below with steel columns that are supported by a series of new concrete piers socketed into limestone. All steel elements will have to be designed to resist wind loads and provide adequate stiffness to prevent compromising the suspended masonry. Concerns with vibration during construction of the forthcoming development present a significant concern to the weakened masonry that might not be able to withstand consistent disturbance that is standard for a construction site. It is the opinion of this office that the vibration and general disturbance caused during construction may very likely cause irreparable damages to the masonry while it is being suspended in place. Additionally, drilling the concrete piers directly below this brick façade as part of the bracing installation may also cause vibrations that damage the façade.

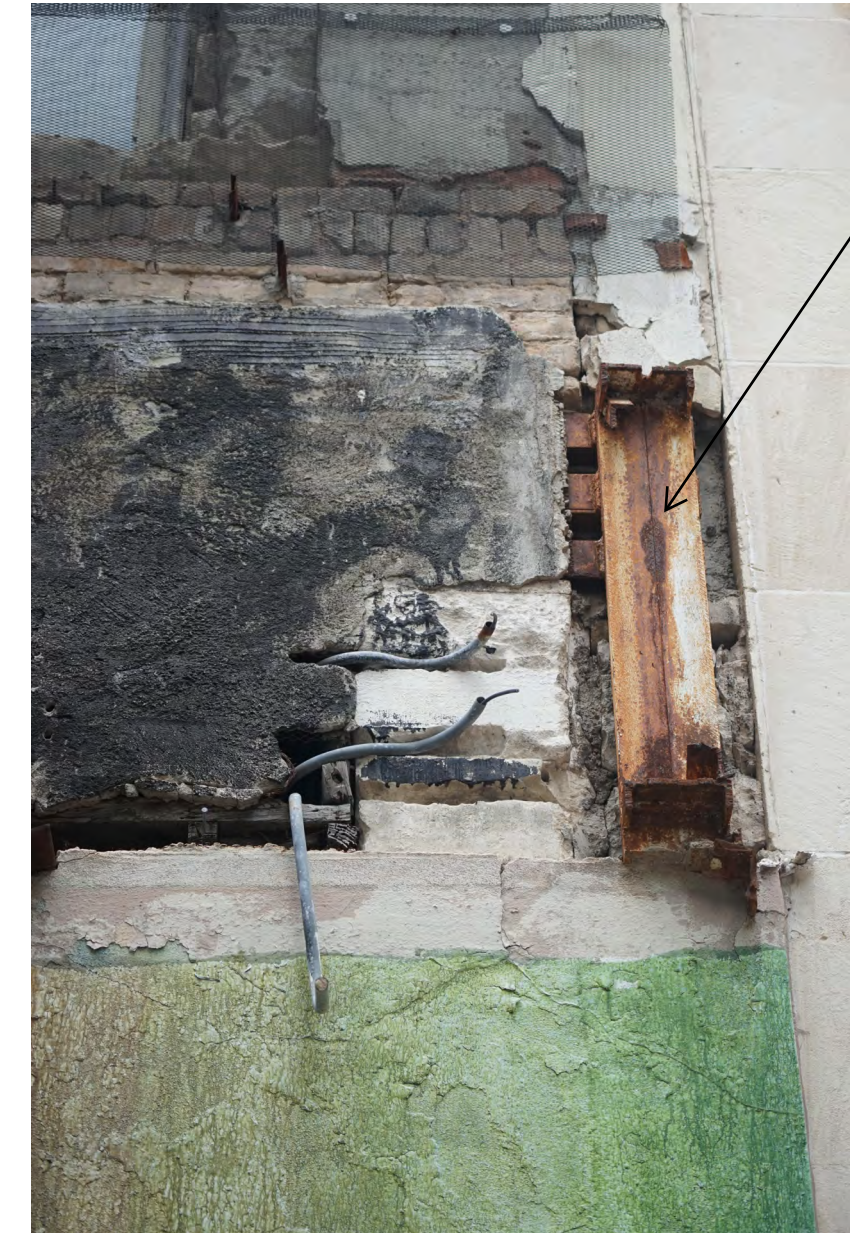
2 907 SOUTH SIDE WALL DETAIL

SIGN BRACKET FOR TSO SIGNS
THAT CHANGED FROM THE 40S
THROUGH THE 60S

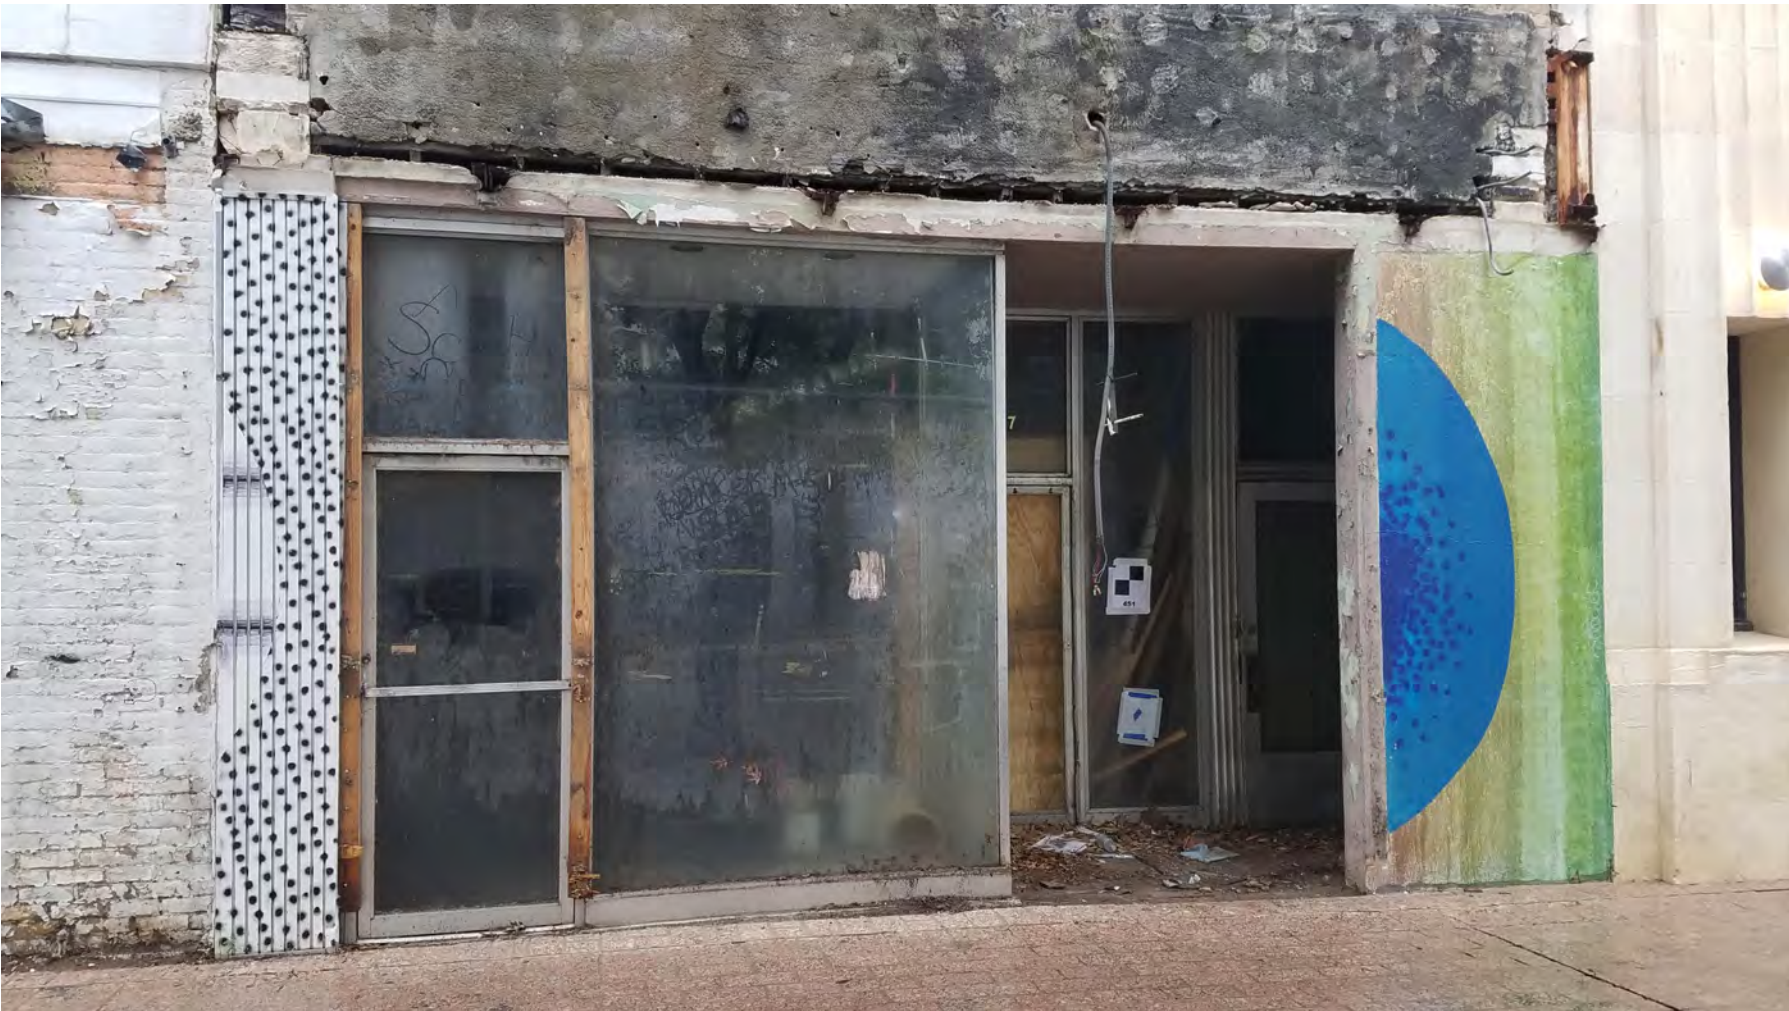
9 907 STOREFRONT

NOTE: EMBEDDED STONE AND WOOD STRUCTURE ARE PRESUMED TO BE ORIGINAL. AS STUCCO IS REMOVED MAY REVEAL ADDITIONAL INFORMATION ABOUT ORIGINAL STREET LEVEL CONSTRUCTIONS.
