SP-2021-0079C

OVERALL

OSP01

## ENVIRONMENTAL RESOURCE INVENTORY SKY MOUNTAIN DEVELOPMENT, AUSTIN, TEXAS ATTACHMENT A

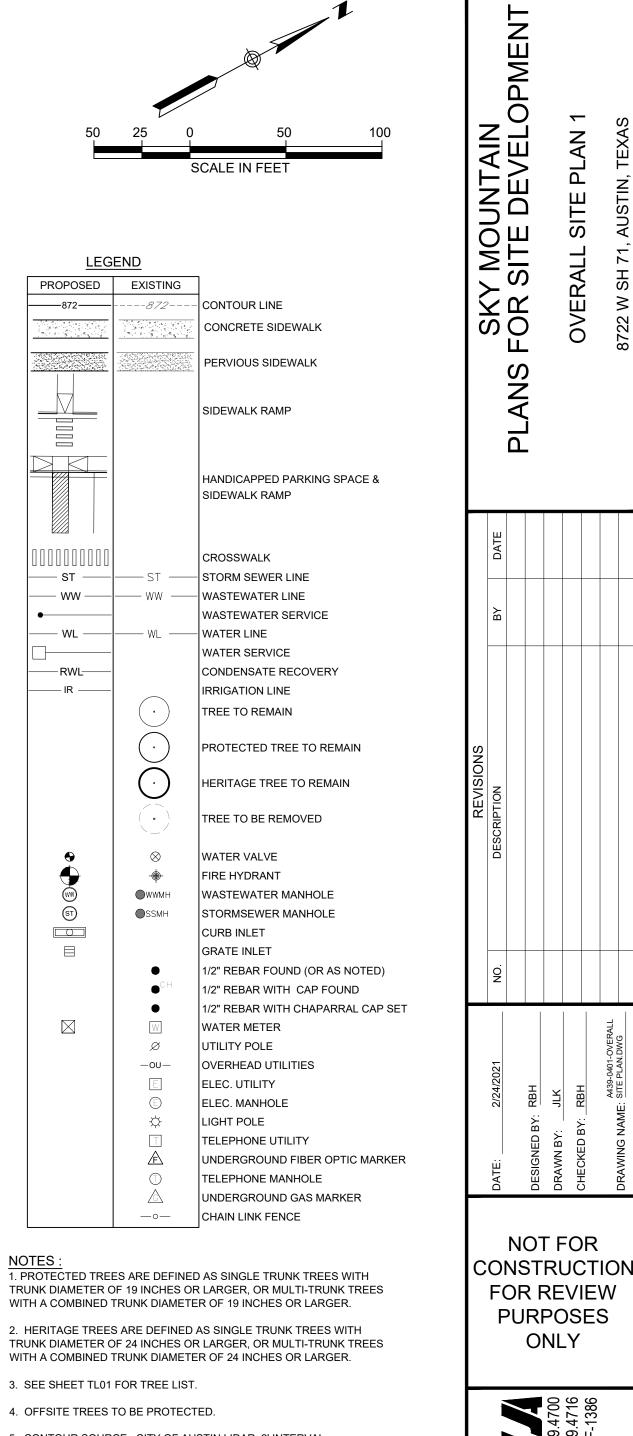
4. OFFSITE TREES TO BE PROTECTED.

5. CONTOUR SOURCE: CITY OF AUSTIN LIDAR, 2' INTERVAL

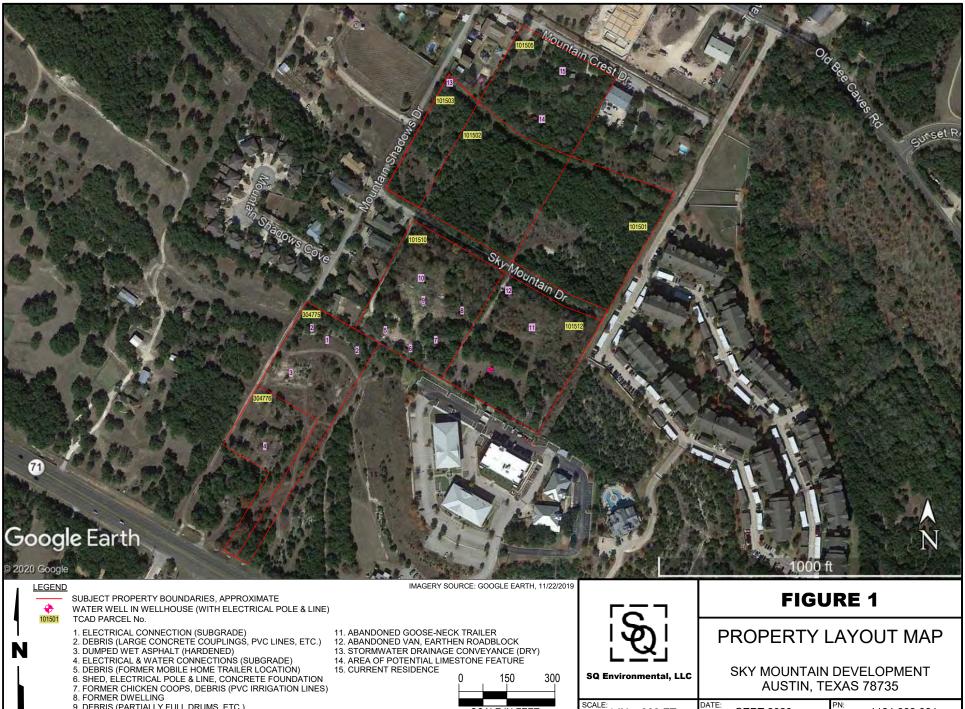
13. STORMWATER DRAINAGE CONVEYANCE (DRY) 14. AREA OF POTENTIAL LIMESTONE FEATURE **15. CURRENT RESIDENCE** 300

9. DEBRIS (PARTIALLY FULL DRUMS, ETC.)

As discussed, no sensitive geologic features, including springs, seeps, point recharge features, bluffs, canyon rimrocks or wetlands, nor any faults, caves, streams, fractures, solution zones, vugs, or cavities were observed on the property during the site assessment. Although a steep gradient is present in the central portion of the property, adjacent south of Sky Mountain Dr, the gradient is less than 60 degrees and is not classified as a canyon rimrock. A potential limestone feature at ground surface was observed in the northern portion of the property at the residential parcel located at 8703 Mountain Crest Dr. The potential limestone feature was characterized by three sides measuring approximately 50 ft in length trending northeast to southwest and 20 ft in width northwest to southeast, with a depth of approximately 7 ft at the lowest point. The floor of the feature contains loose soil, and the sidewalls are fractured or stacked limestone (not massive limestone). No water was present at the time of the site assessment, and the area appeared to have been dry for a long period of time. The sidewall on the southwestern portion appeared to be naturally eroded and was not present; a wooden deck/boardwalk was located on the southeast side. Additionally, no fractures or solution zones were observed in or near the potential feature.

This potential limestone feature may be a sinkhole that historically ponded water runoff, or a former seep (based on the presence of water in historical aerials). As discussed above, the southwestern sidewall is no longer present and therefore the feature does not hold water (although the area appears to be dry and no evidence of a current or recent seep or spring were observed). No hydrophytic vegetation or hydric soils were observed at the time of the site assessment, which would be an indicator of a seep. The potential limestone feature is not considered a Critical Environmental Feature (CEF) due to its presence only recently in geologic terms, the lack of water, the lack of hydrophytic vegetation and hydric soils, and probability of man-induced creation or alteration.
