HEIERMAN - HISTORIC LANDMARK COMMISSION REVIEW

The Heierman Building

115 E. 5th Street
Austin, TX 78701
Travis County

Renovation, Selective Demolition of Non-Historic Elements,
New Construction, and Addition to Existing Structure.

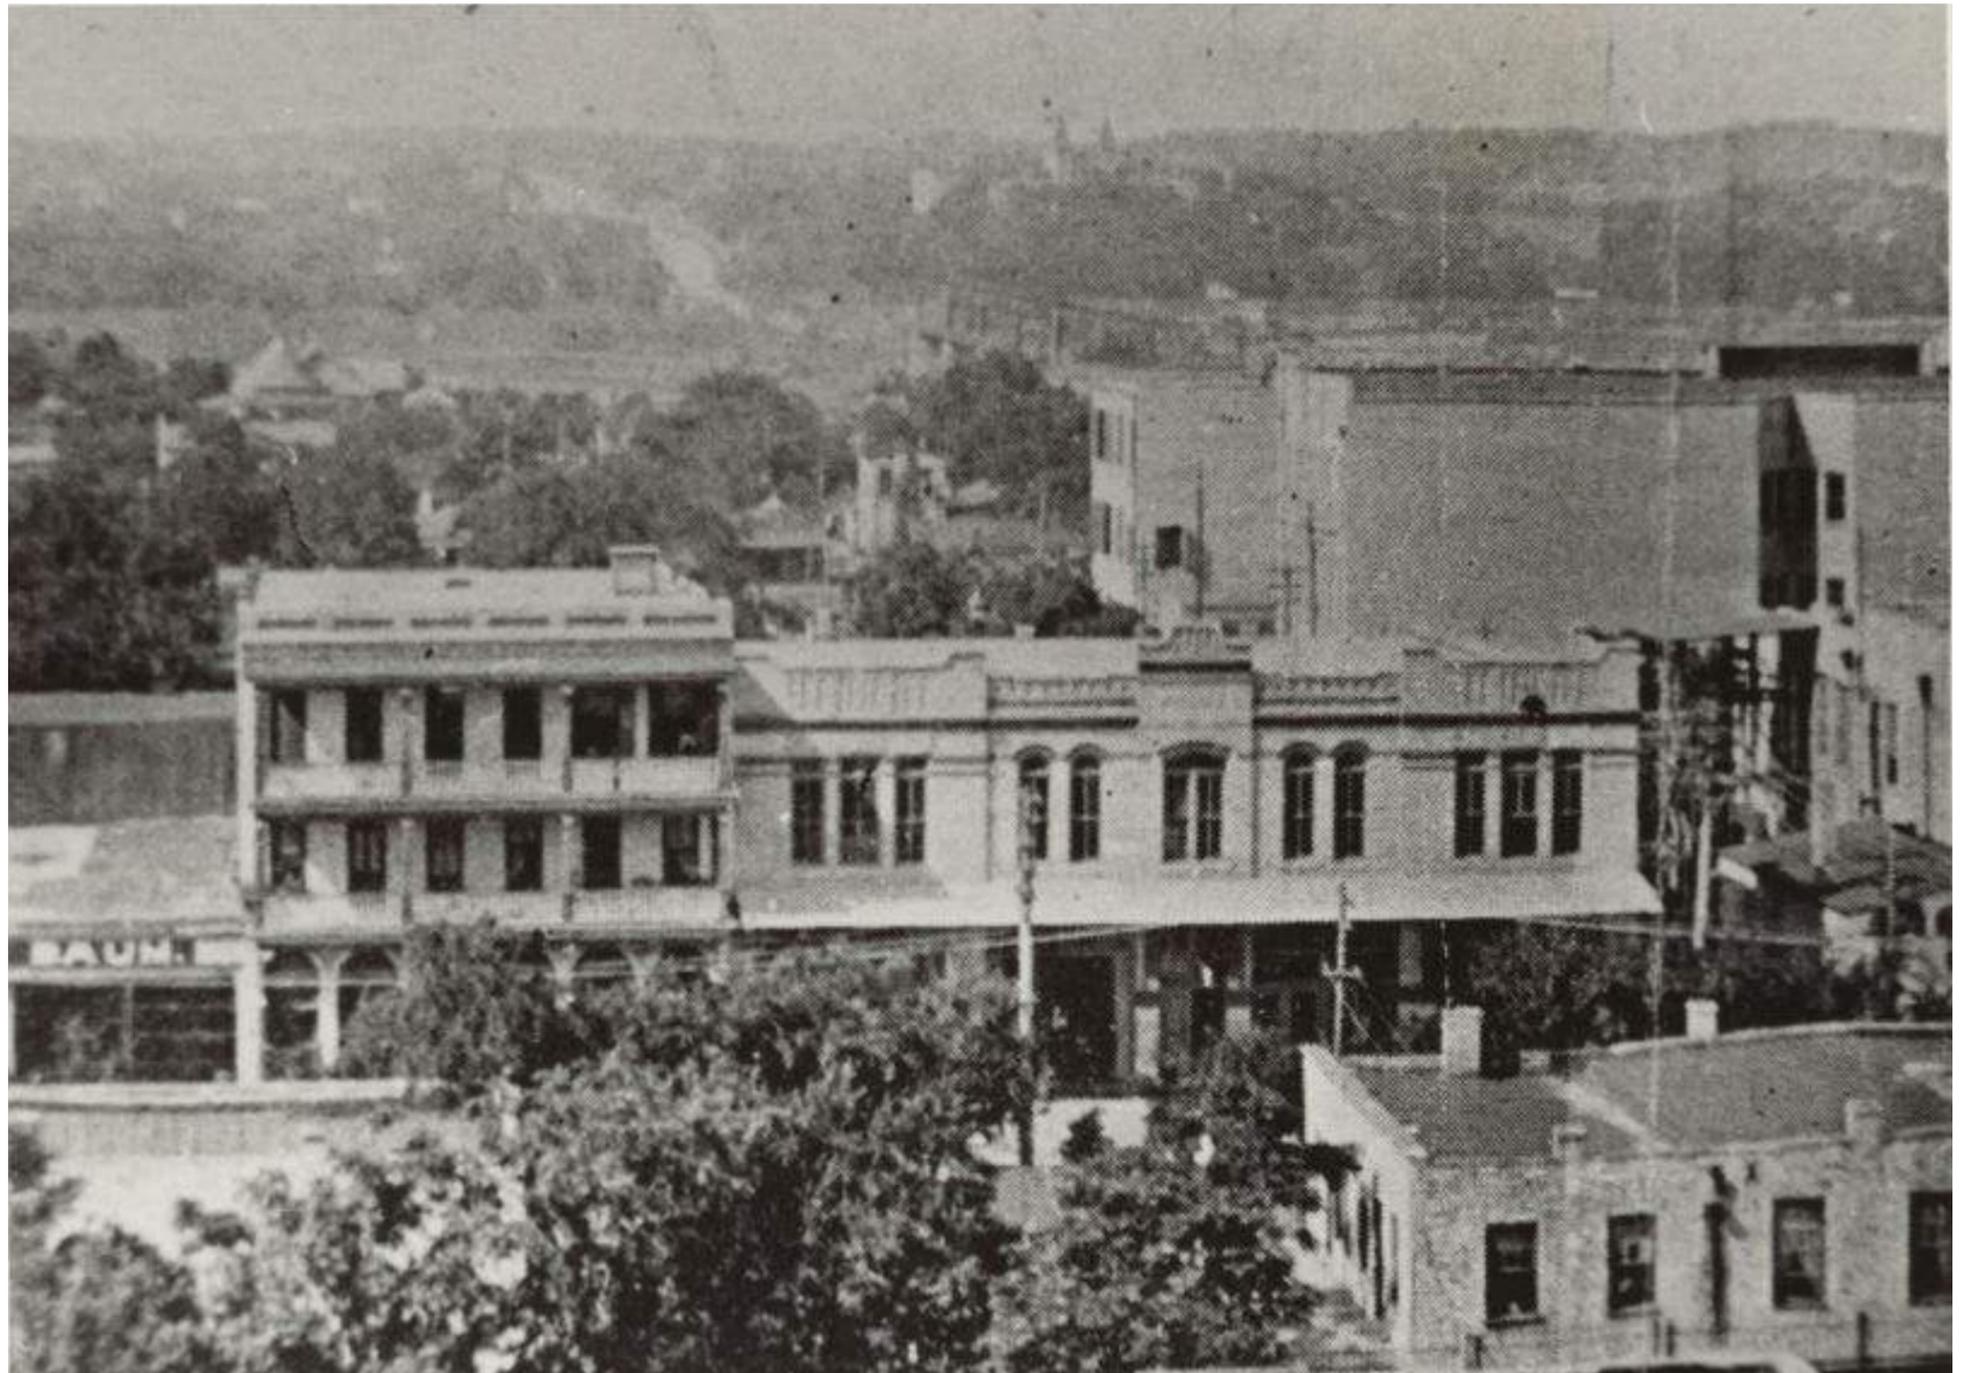
C. 1925

Aside from changes in color and signage, the facade stayed fairly similar to this until the 1970's.

Modifications to the 1887 design:

- Double wood gallery and six-bay arched openings removed.
- Most upper level door openings converted to windows.
- 1920's era storefront added at the ground level with two recessed entries.
- Plaster finish added over masonry at upper levels.
- Metal fire escape added.

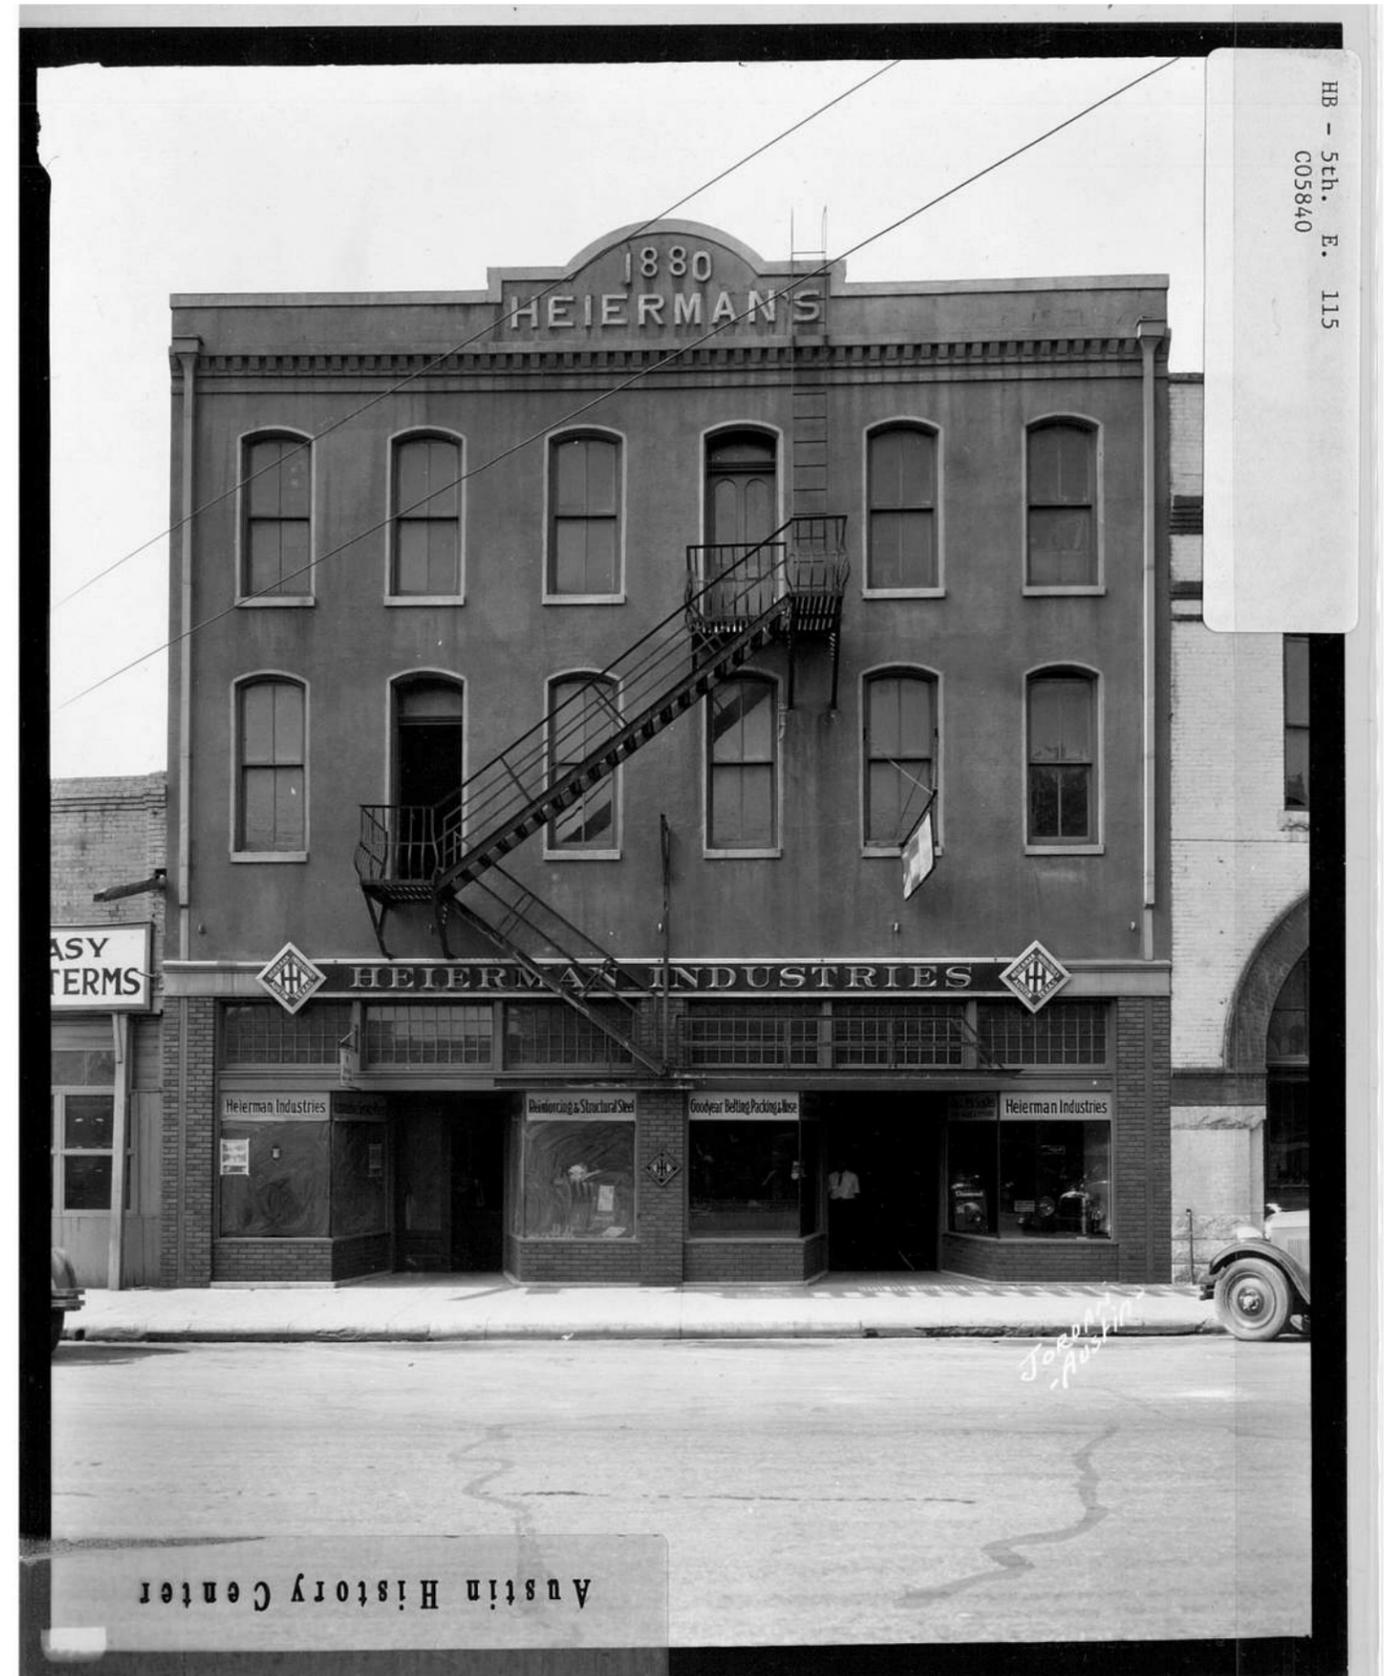
C. 1972

Same design as the 1925 photo, with changes in paint color, mechanical equipment additions, and signage removal.

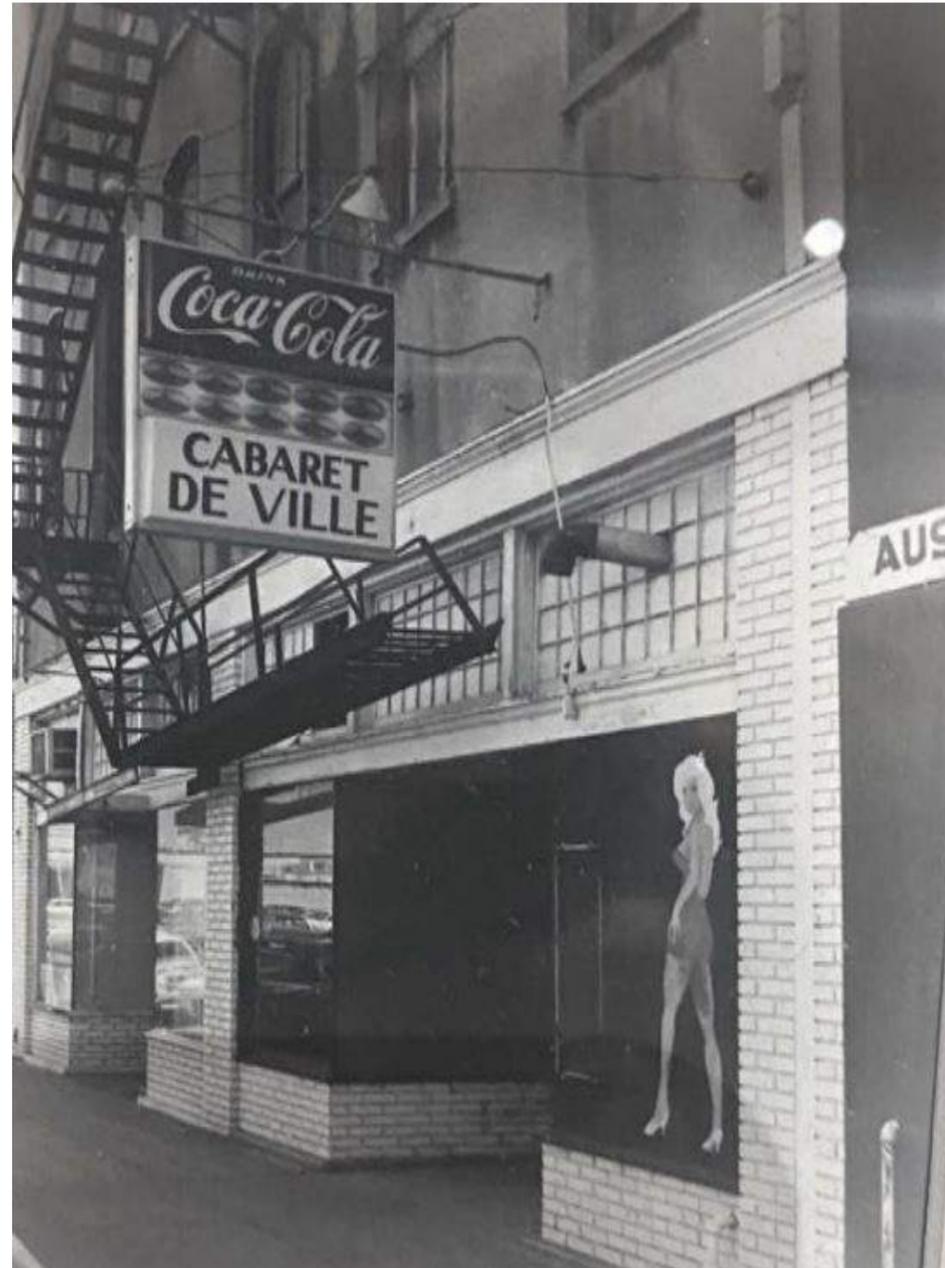
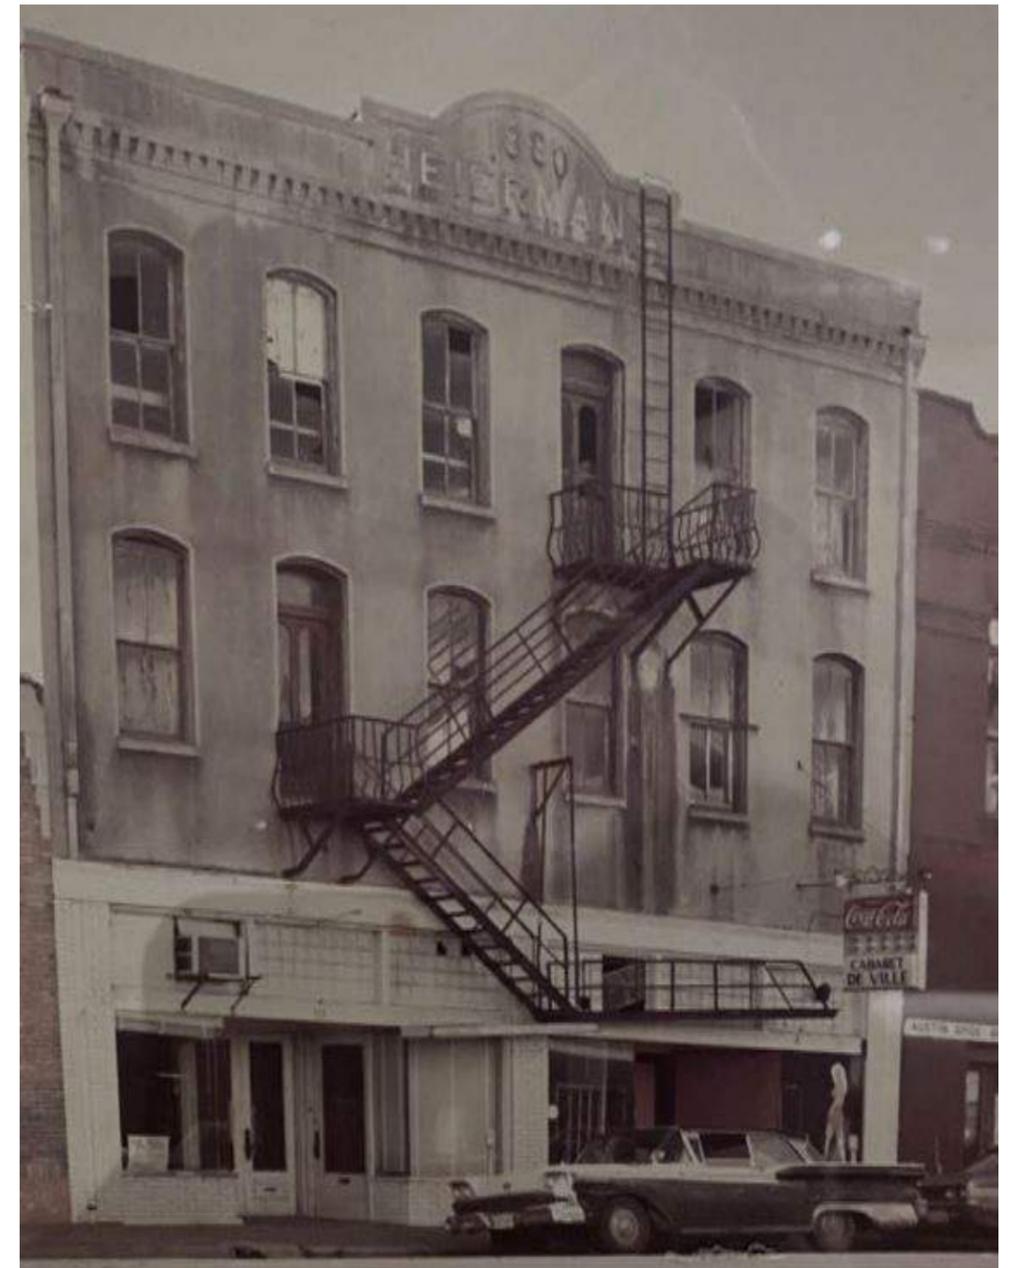
C. 1975

Renovated design representing the state of the Heierman Building when it was recorded as a Texas Historic Landmark in 1974.

Modifications to the 1920's design:

- In 1973, the building was sandblasted inside and out.
- The ground floor 1920's style storefront was replaced with one that mimicked New Orleans style facades.
- All windows on the primary facade were replaced with single pane tinted glass, fixed in wood mullions (previously double-hung).

This is very close the current building design with a few notable exceptions: there is now a door to the egress stair, added sidelites at the entry door, and the entire entry is currently not recessed as shown.

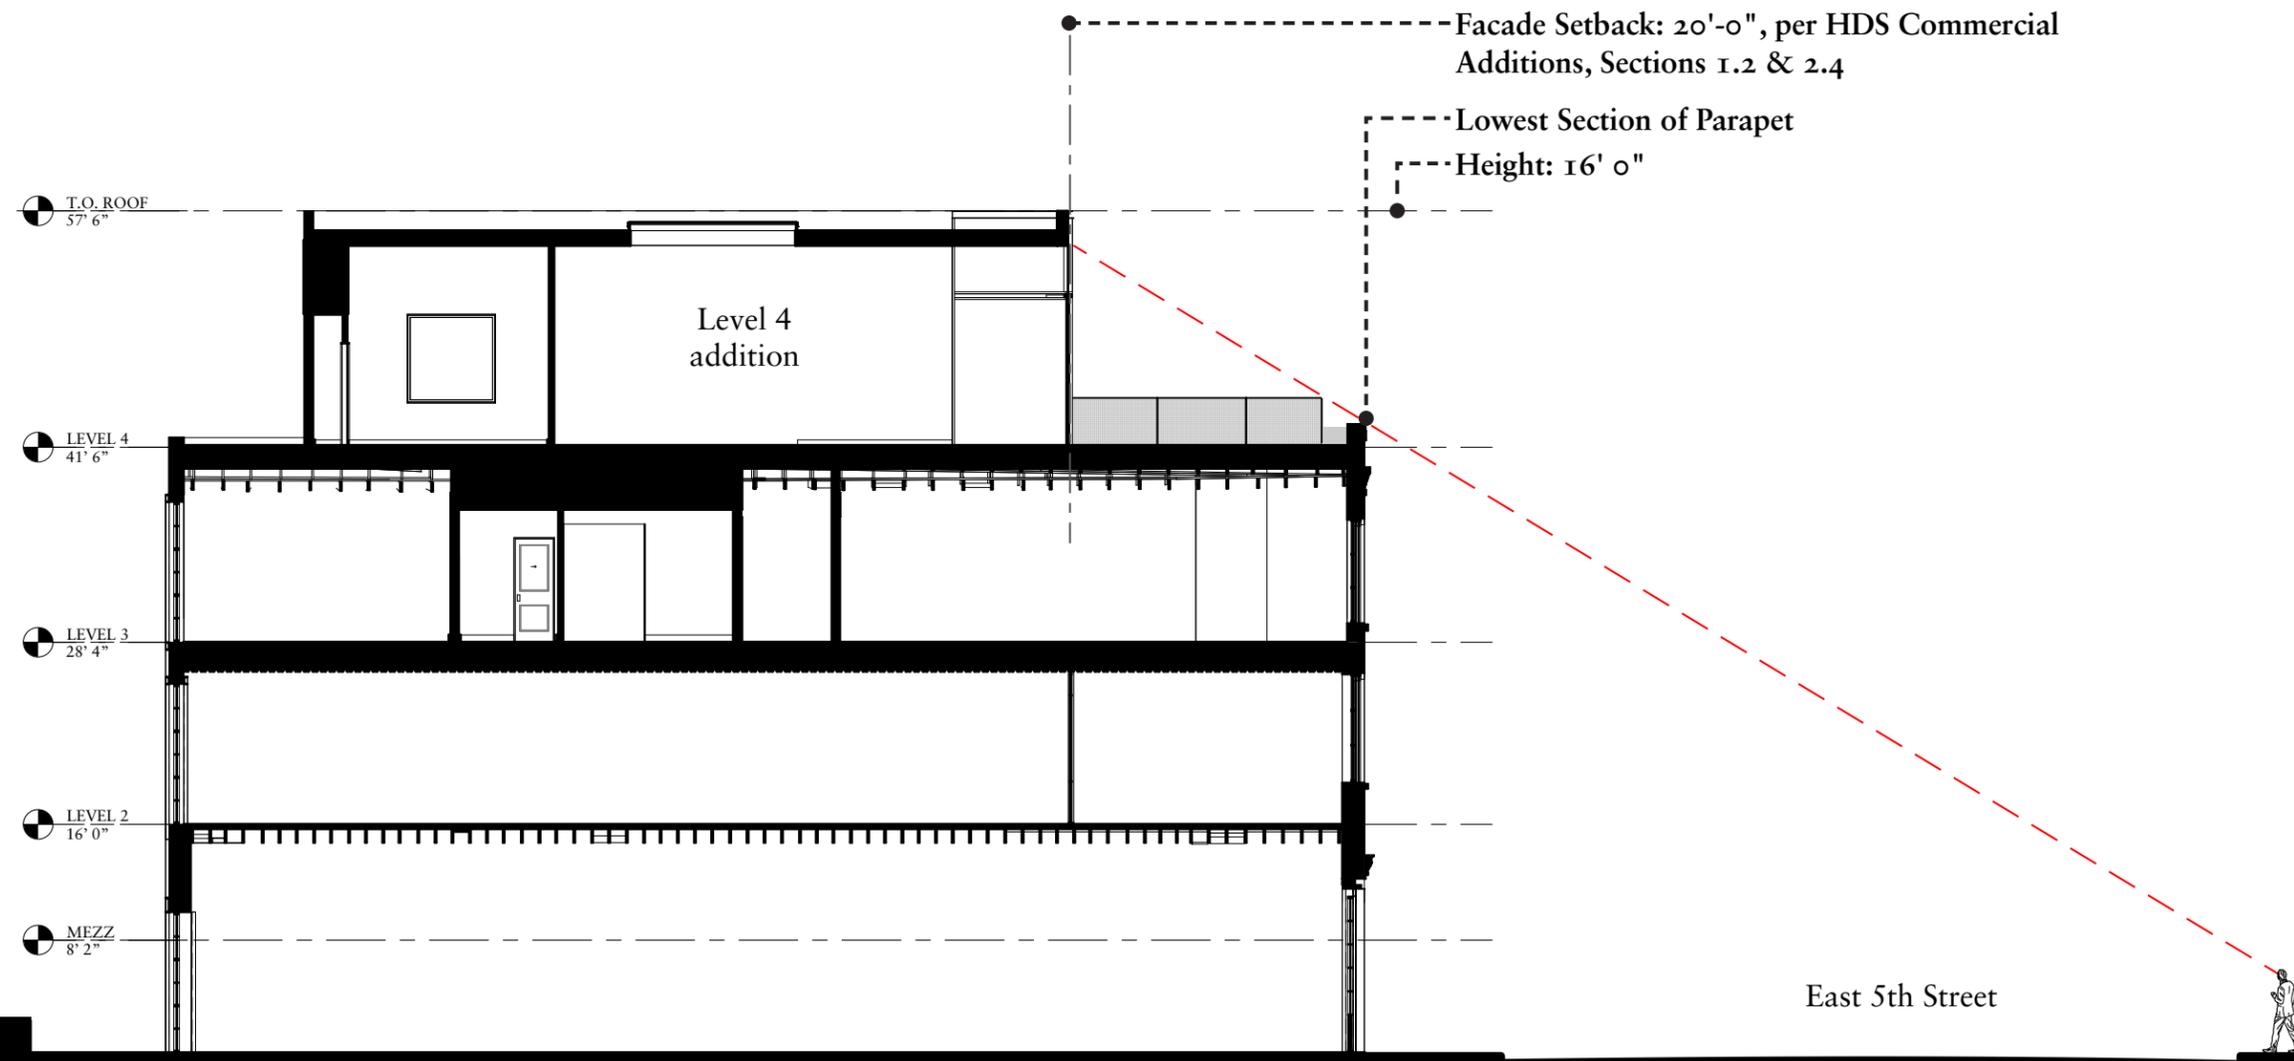
Section through 5th Street

Original Window Pattern - - - - -

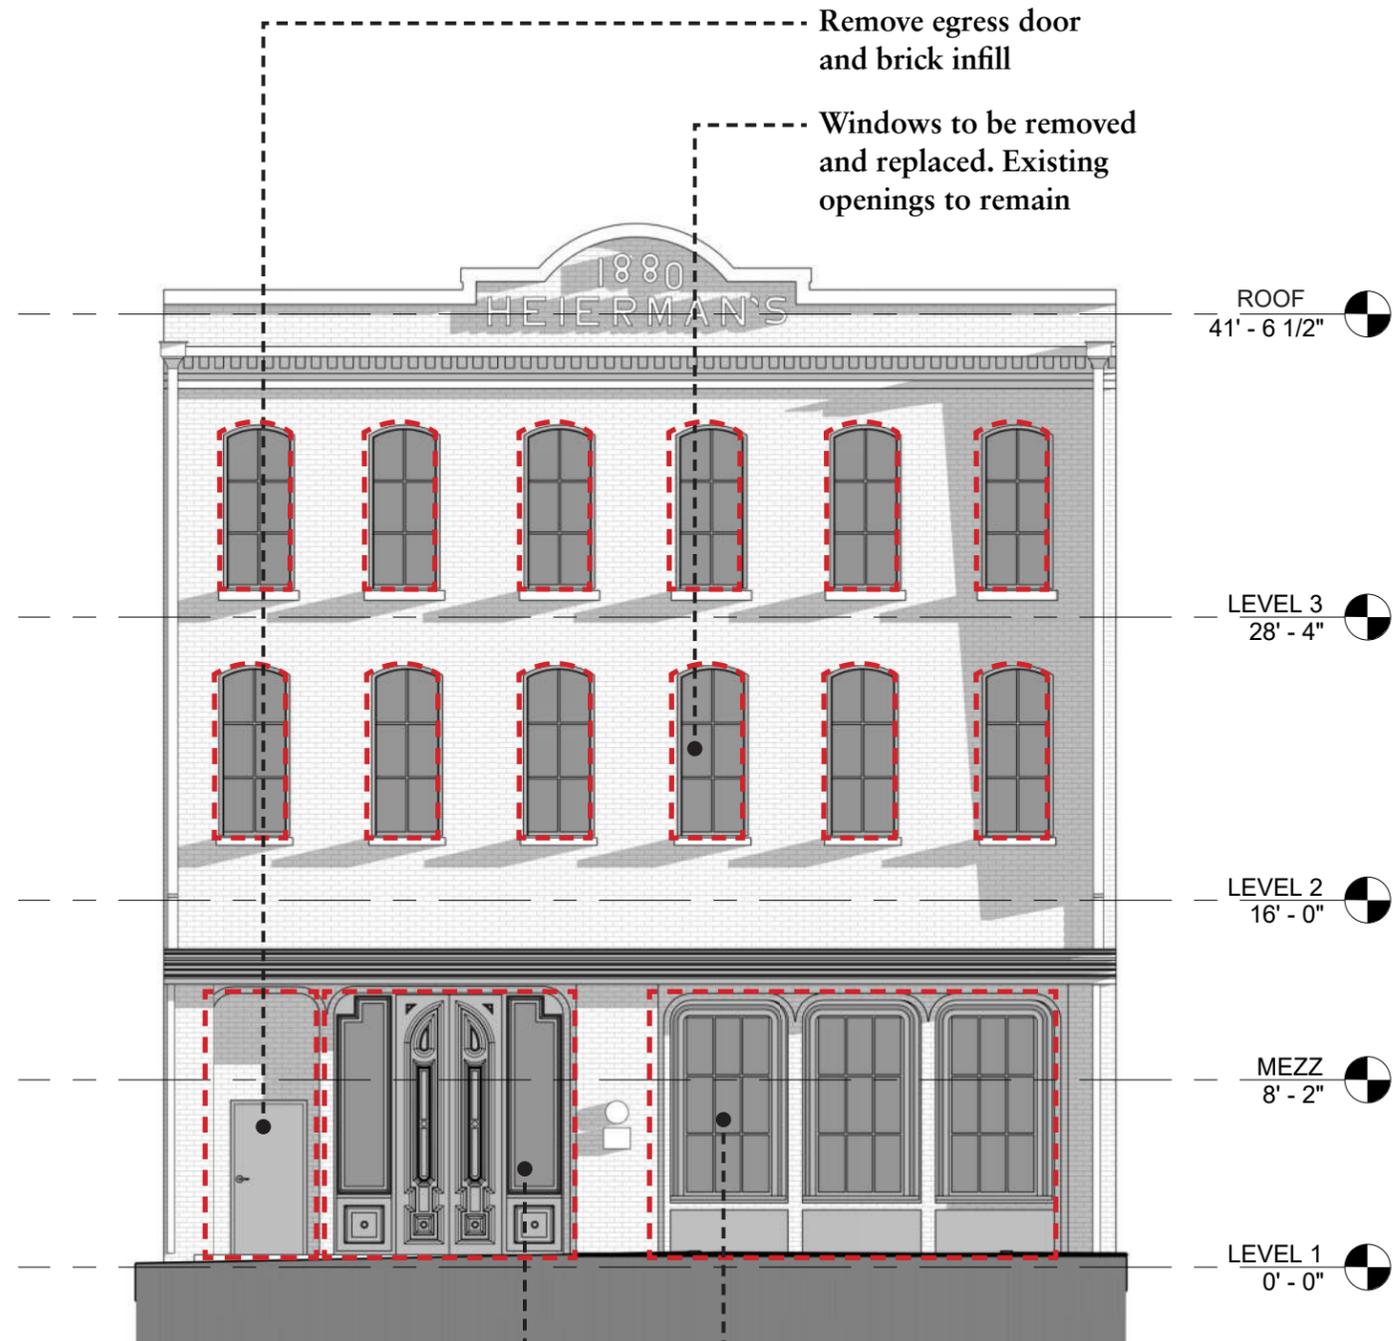
Existing Conditions

Remove egress door and brick infill

Windows to be removed and replaced. Existing openings to remain

Remove existing storefront assembly

Remove sidelites and salvage entry door

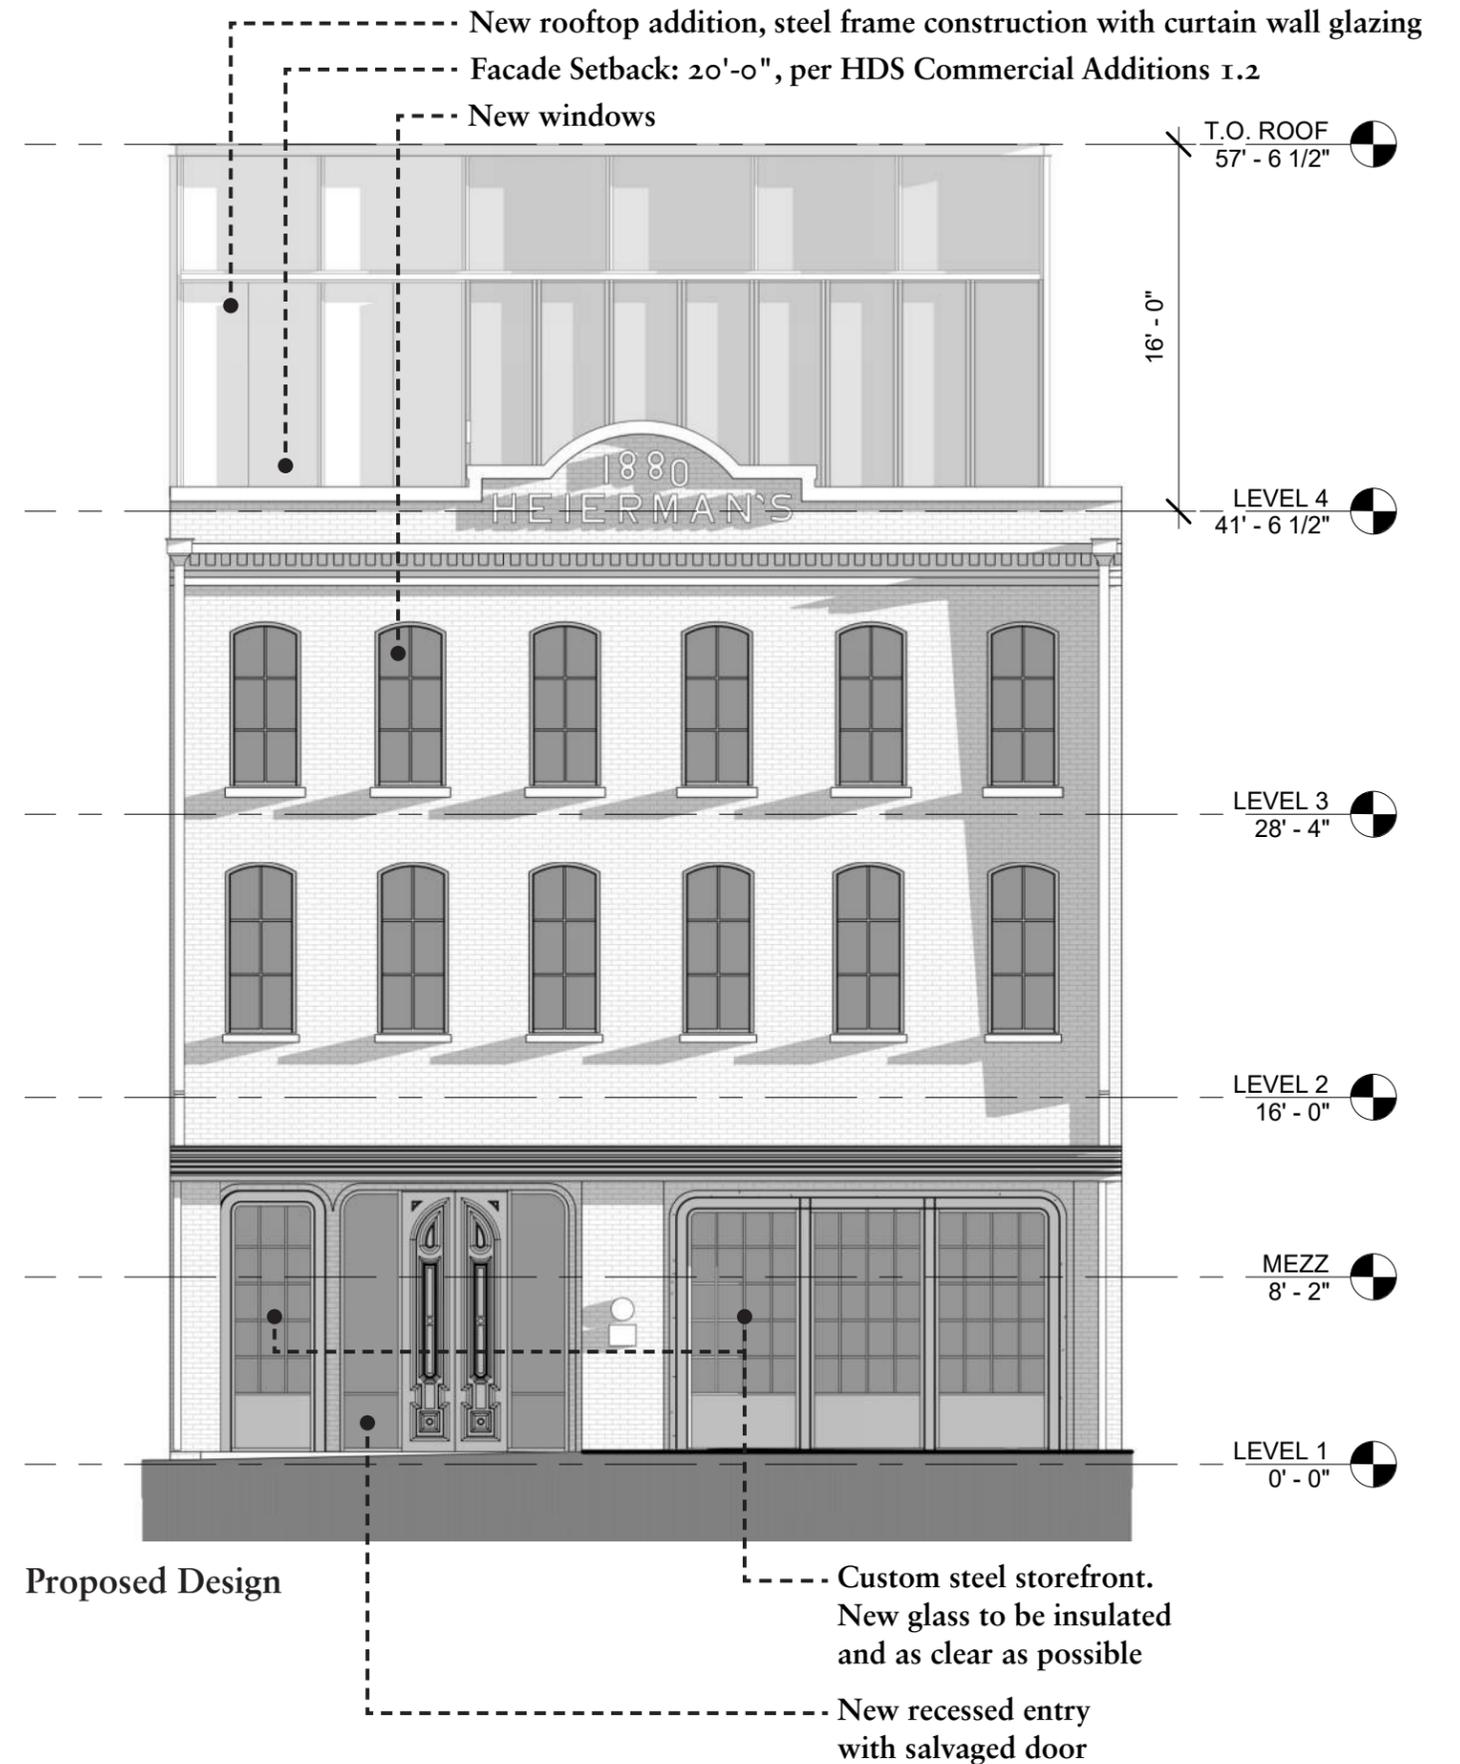
Proposed Design

New rooftop addition, steel frame construction with curtain wall glazing

Facade Setback: 20'-0", per HDS Commercial Additions I.2

New windows

Custom steel storefront. New glass to be insulated and as clear as possible

New recessed entry with salvaged door

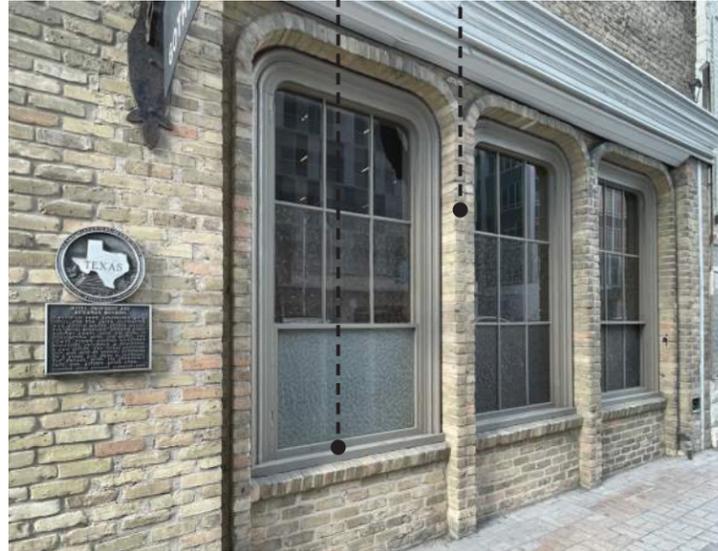
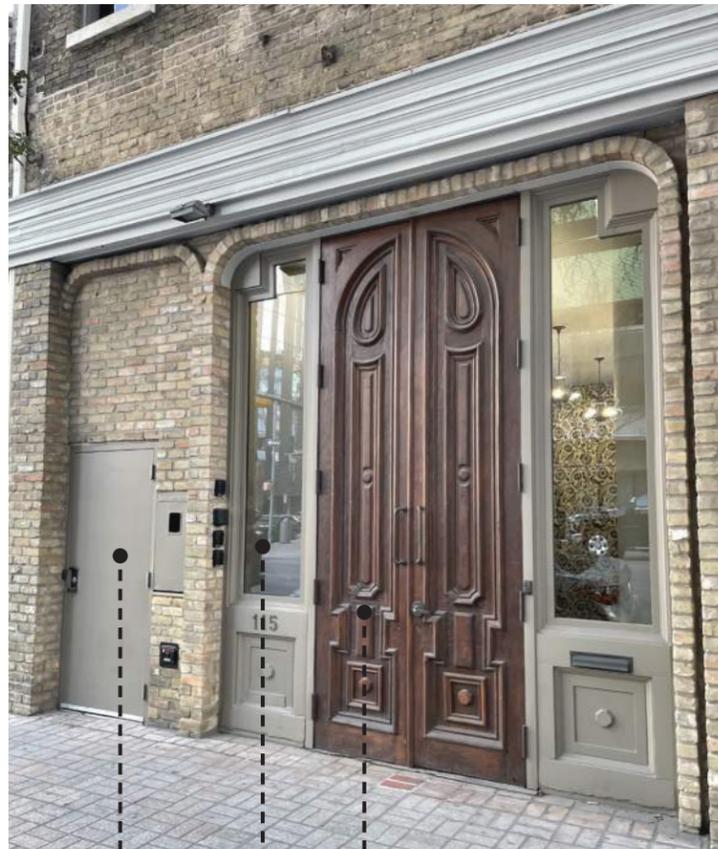
--- Remove windows and sill
 Remove intermediate brickwork

----- Preserve entry door
 ----- Remove sidelites
 ----- Remove egress door and brick infill

----- Custom steel storefront. New glass to be insulated and as clear as possible

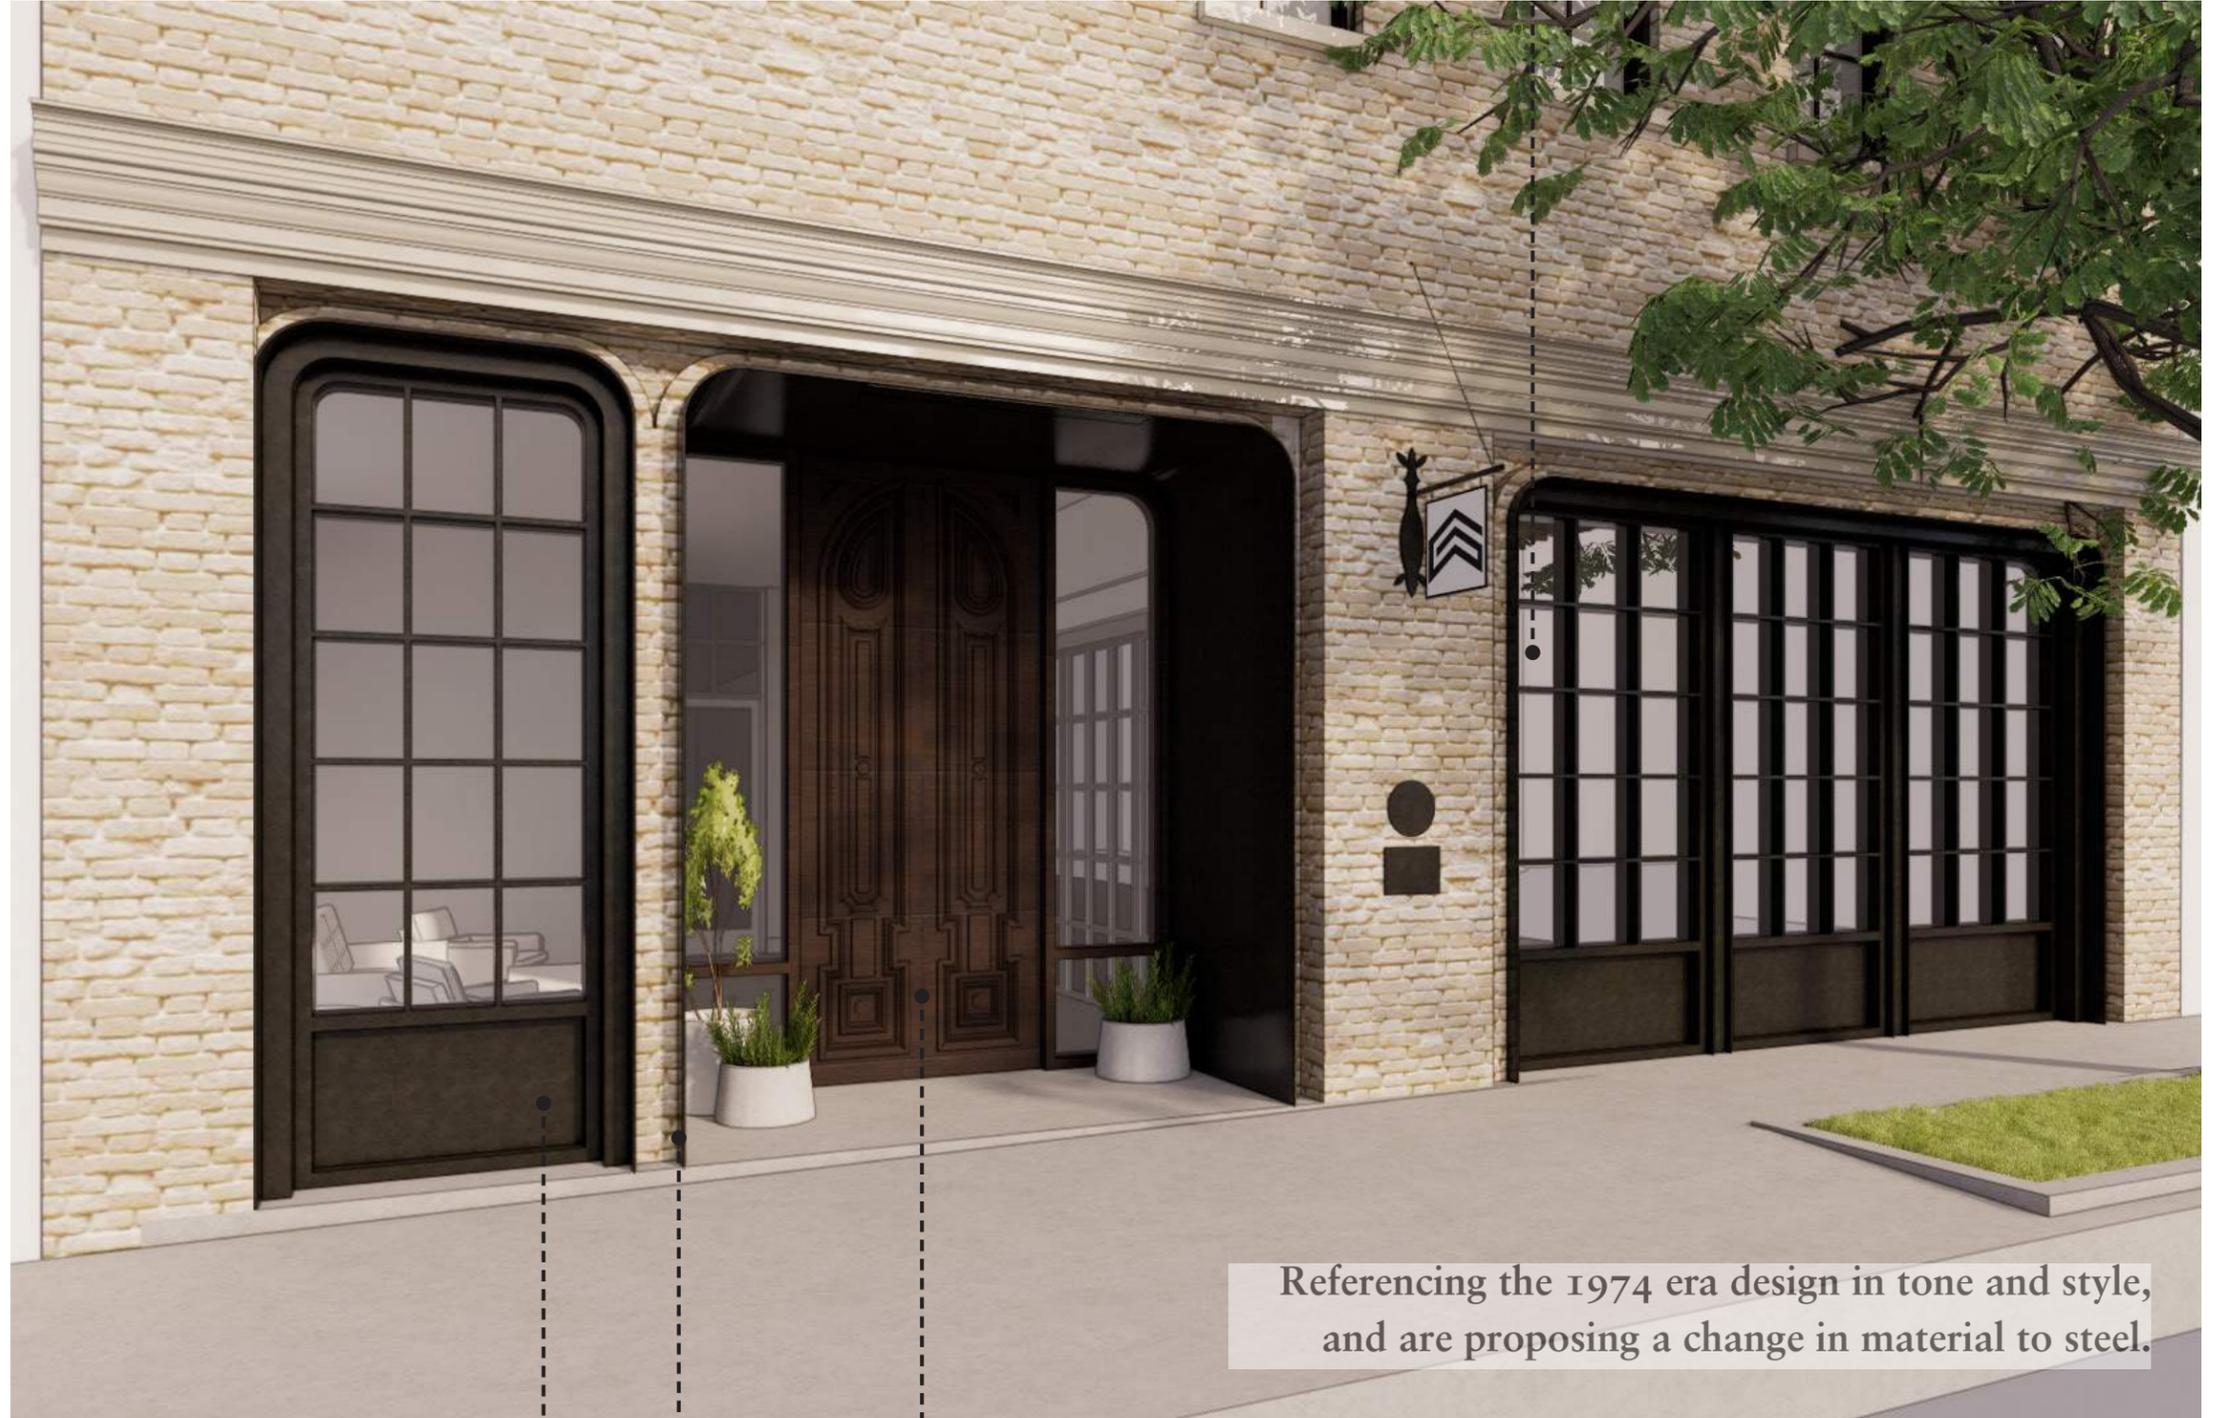
Referencing the 1974 era design in tone and style, and are proposing a change in material to steel.

----- New recessed entry with salvaged door
 ----- Blackened plate steel frame
 ----- Custom steel storefront. New glass to be insulated and as clear as possible

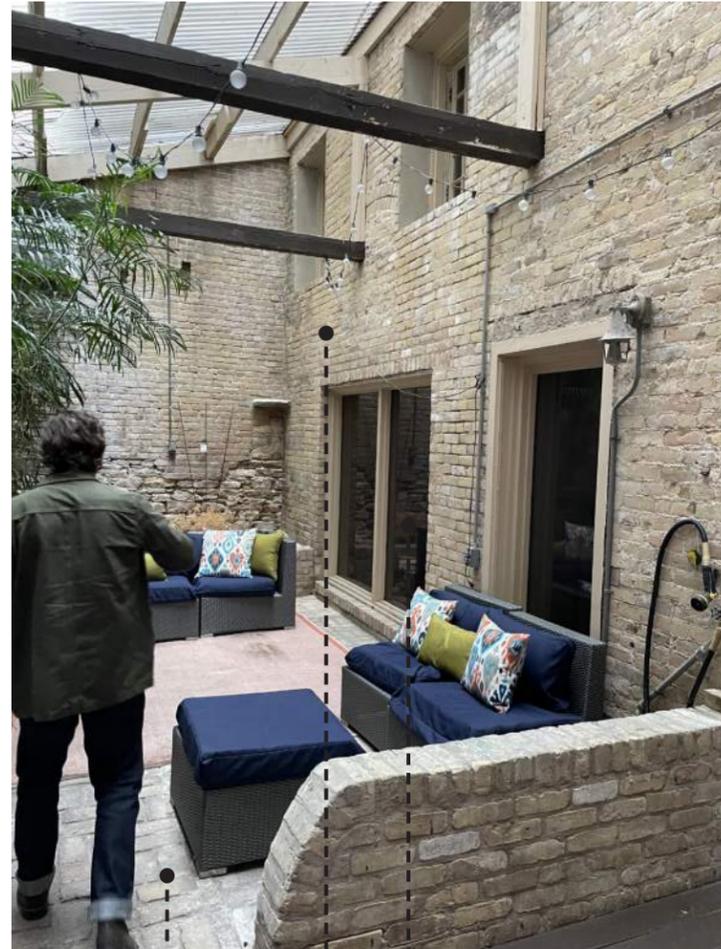
Punched Openings from Level 1

- Remove windows
- Partial demolition of wall
- Rework slab and paving

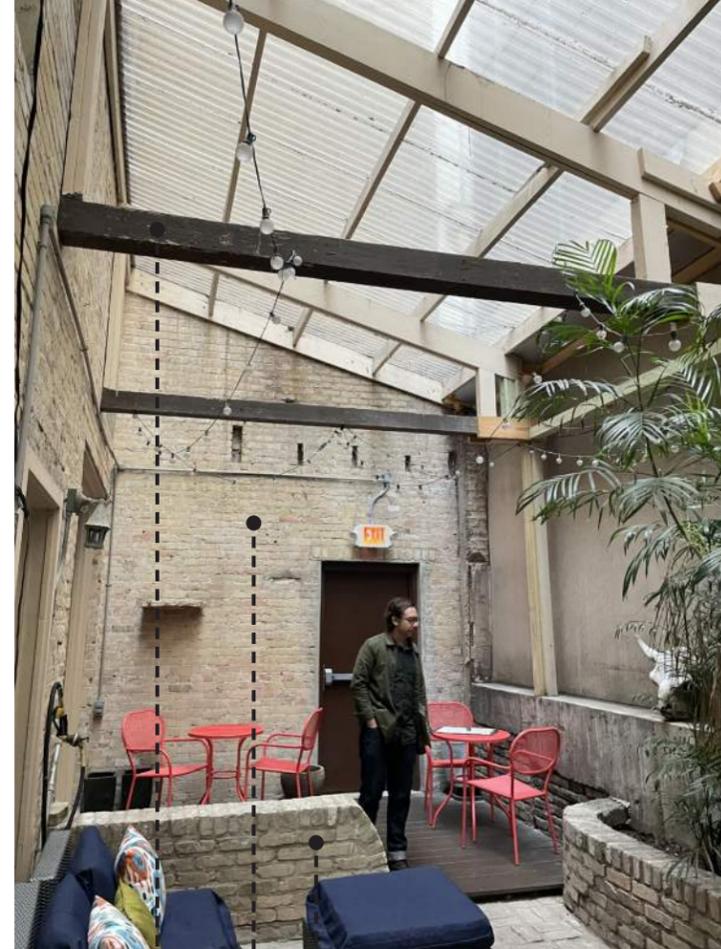
Exit Access through Courtyard

- Demolish half-walls
- Partial demolition of wall
- Remove overhead roof and structure

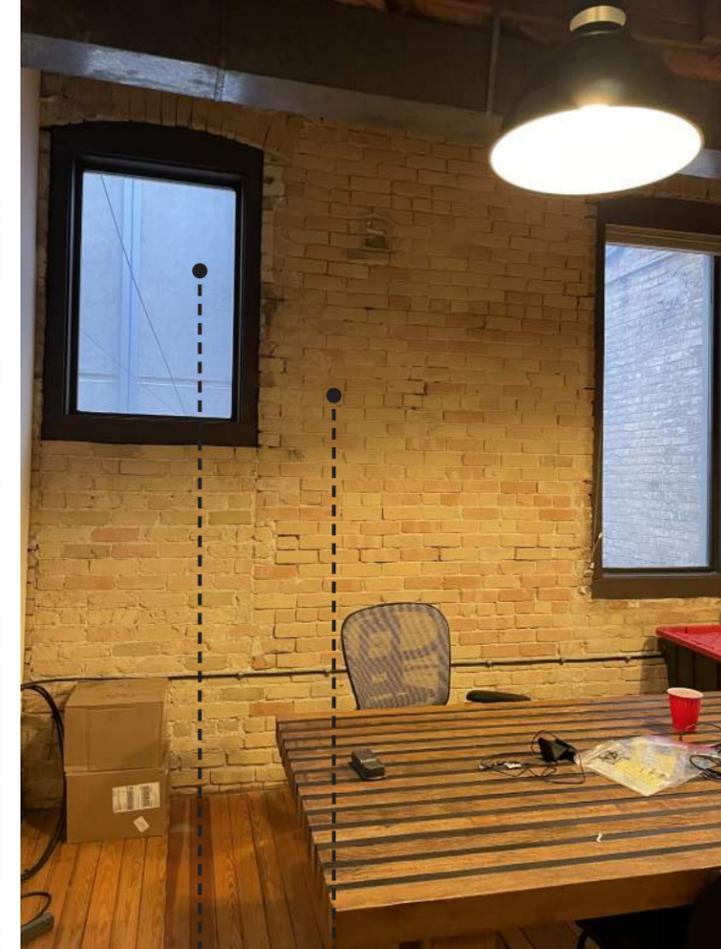
Punched Openings from Level 2 Interior

- Partial demolition of wall
- Remove windows

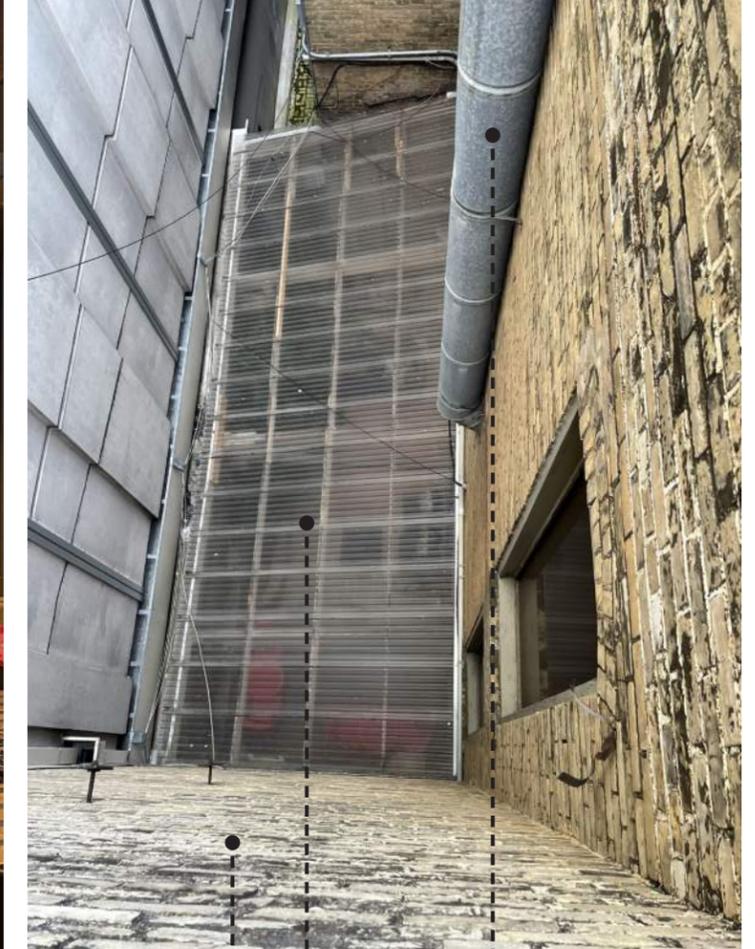
Covered Courtyard from Roof

- Remove HVAC
- Remove roof and structure
- Clean and repair brick as needed

Note: Rear facade is not visible from any public area.
