HEIERMAN - HISTORIC LANDMARK COMMISSION REVIEW

The Heierman Building

115 E. 5th Street
Austin, TX 78701
Travis County

Renovation, Selective Demolition of Non-Historic Elements,
New Construction, and Addition to Existing Structure.

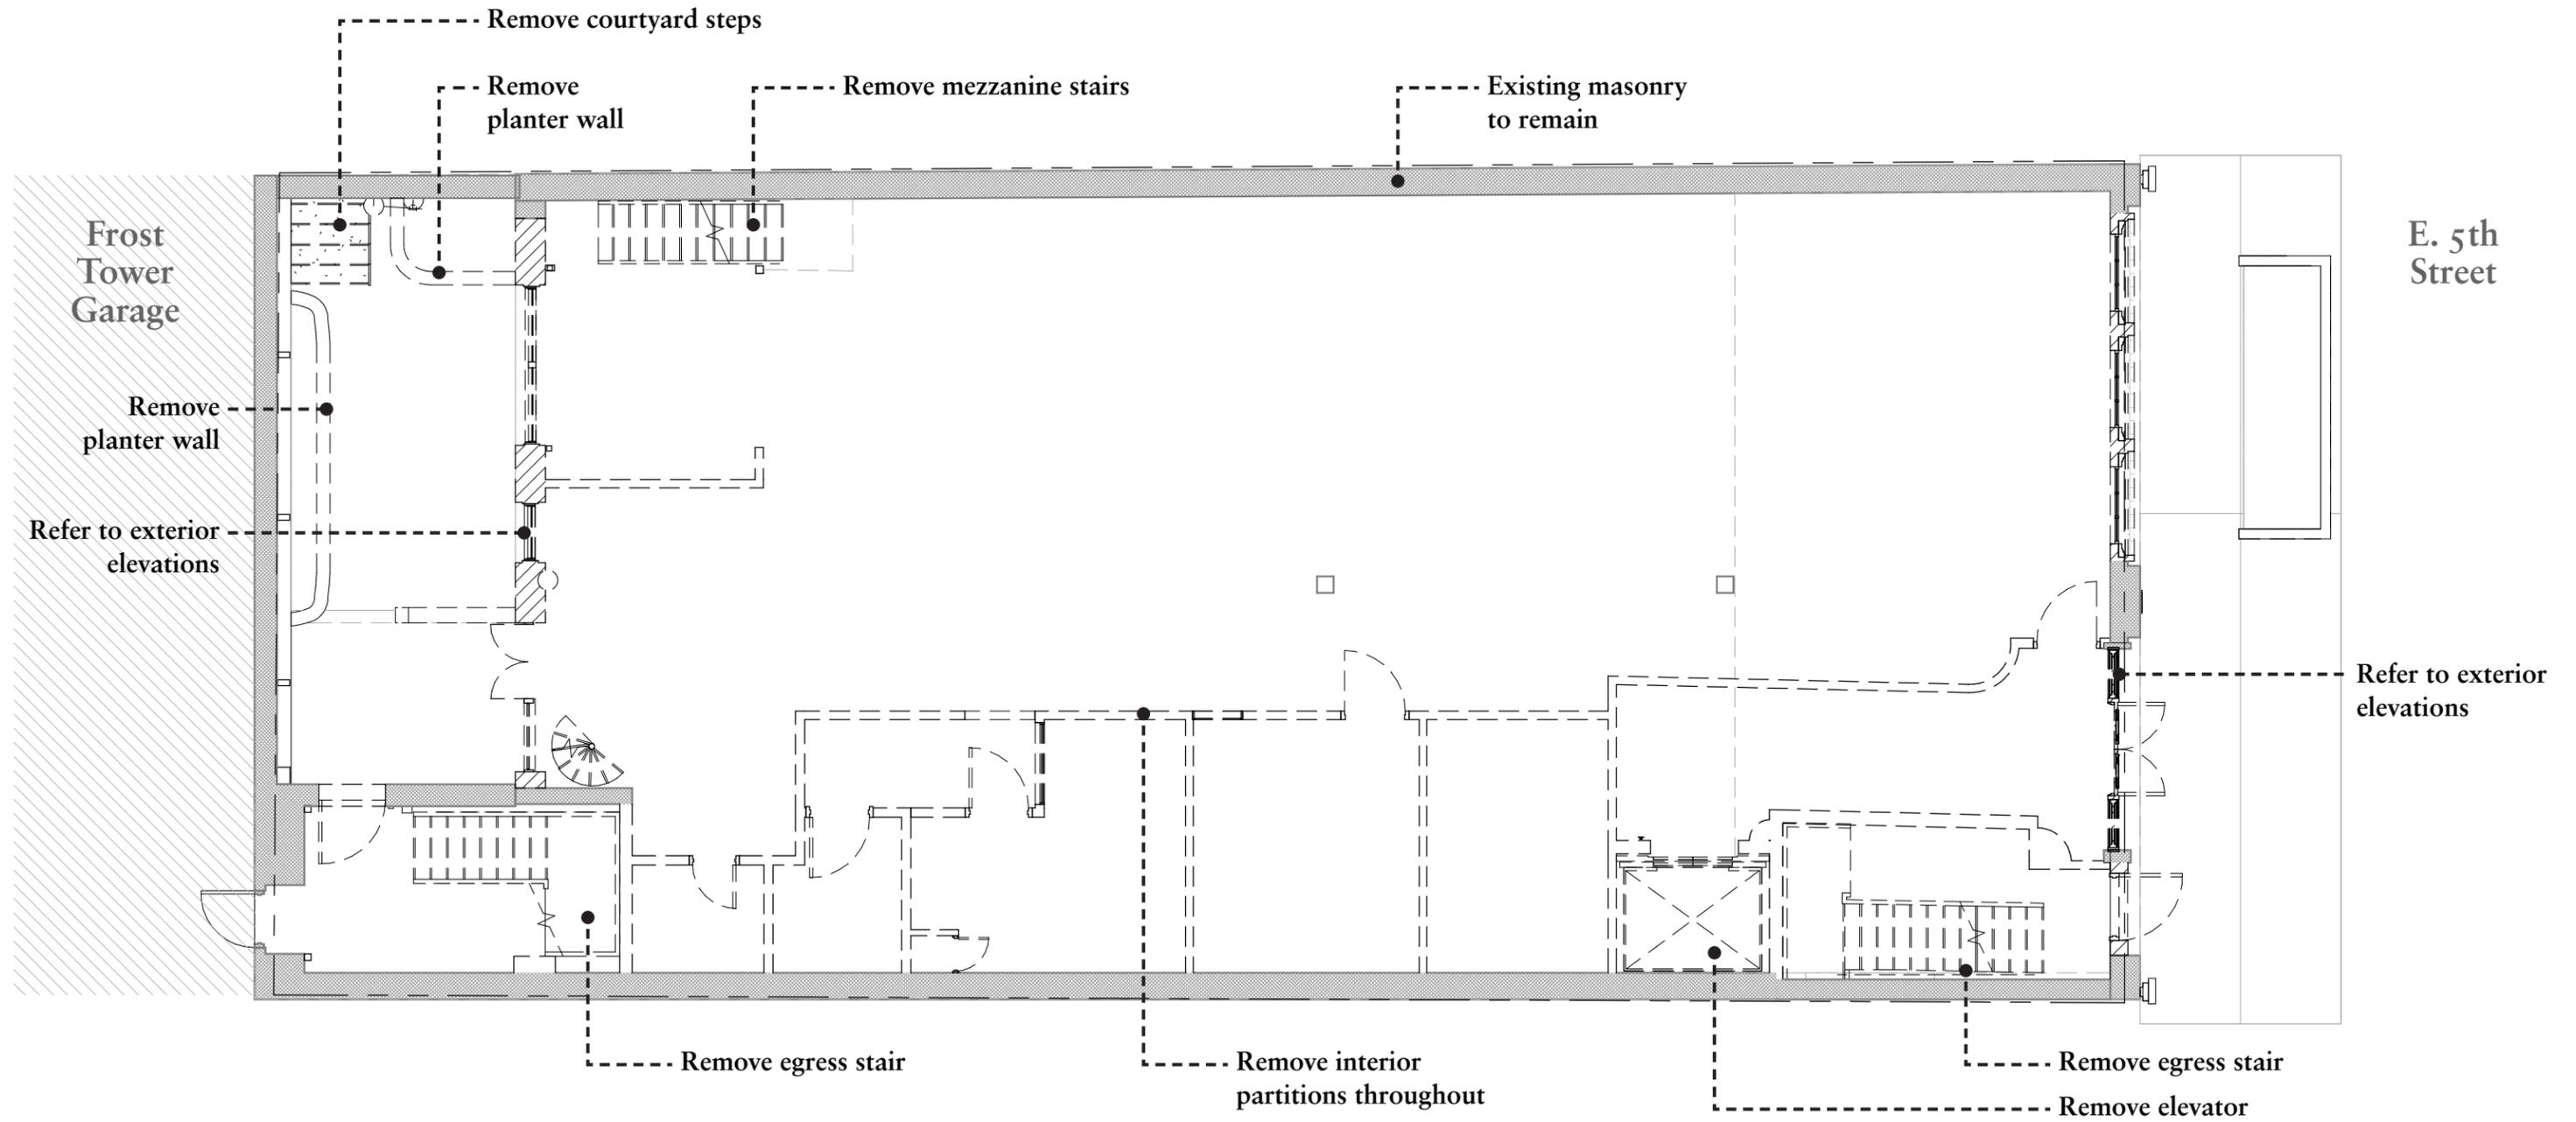
- Existing Wall to Remain
- Historic Wall Demolition
- Modern Wall Demolition

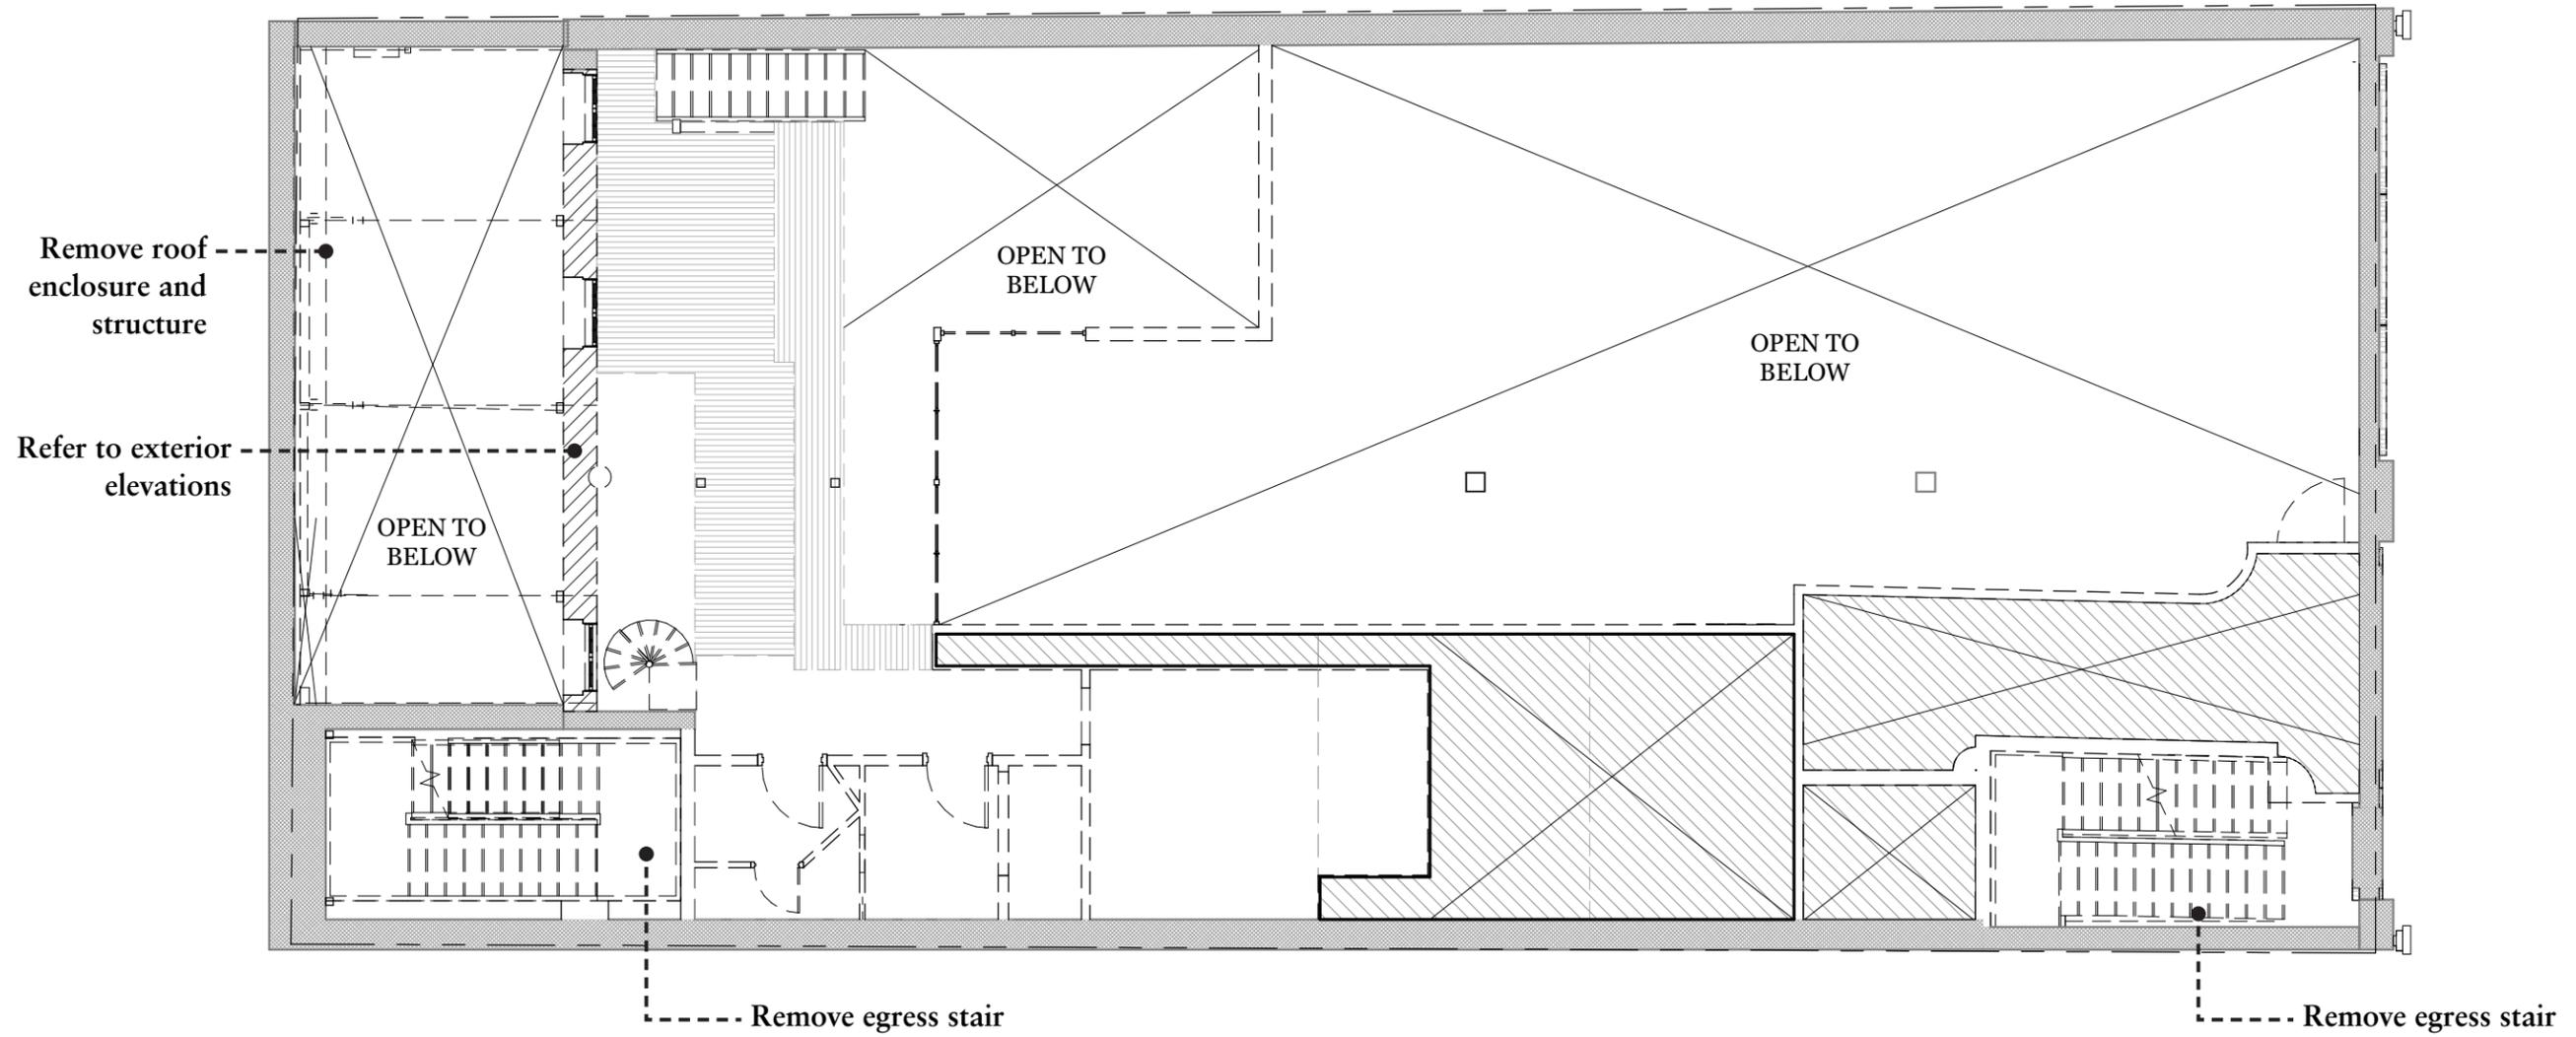
- Existing Wall to Remain
- Historic Wall Demolition
- Modern Wall Demolition

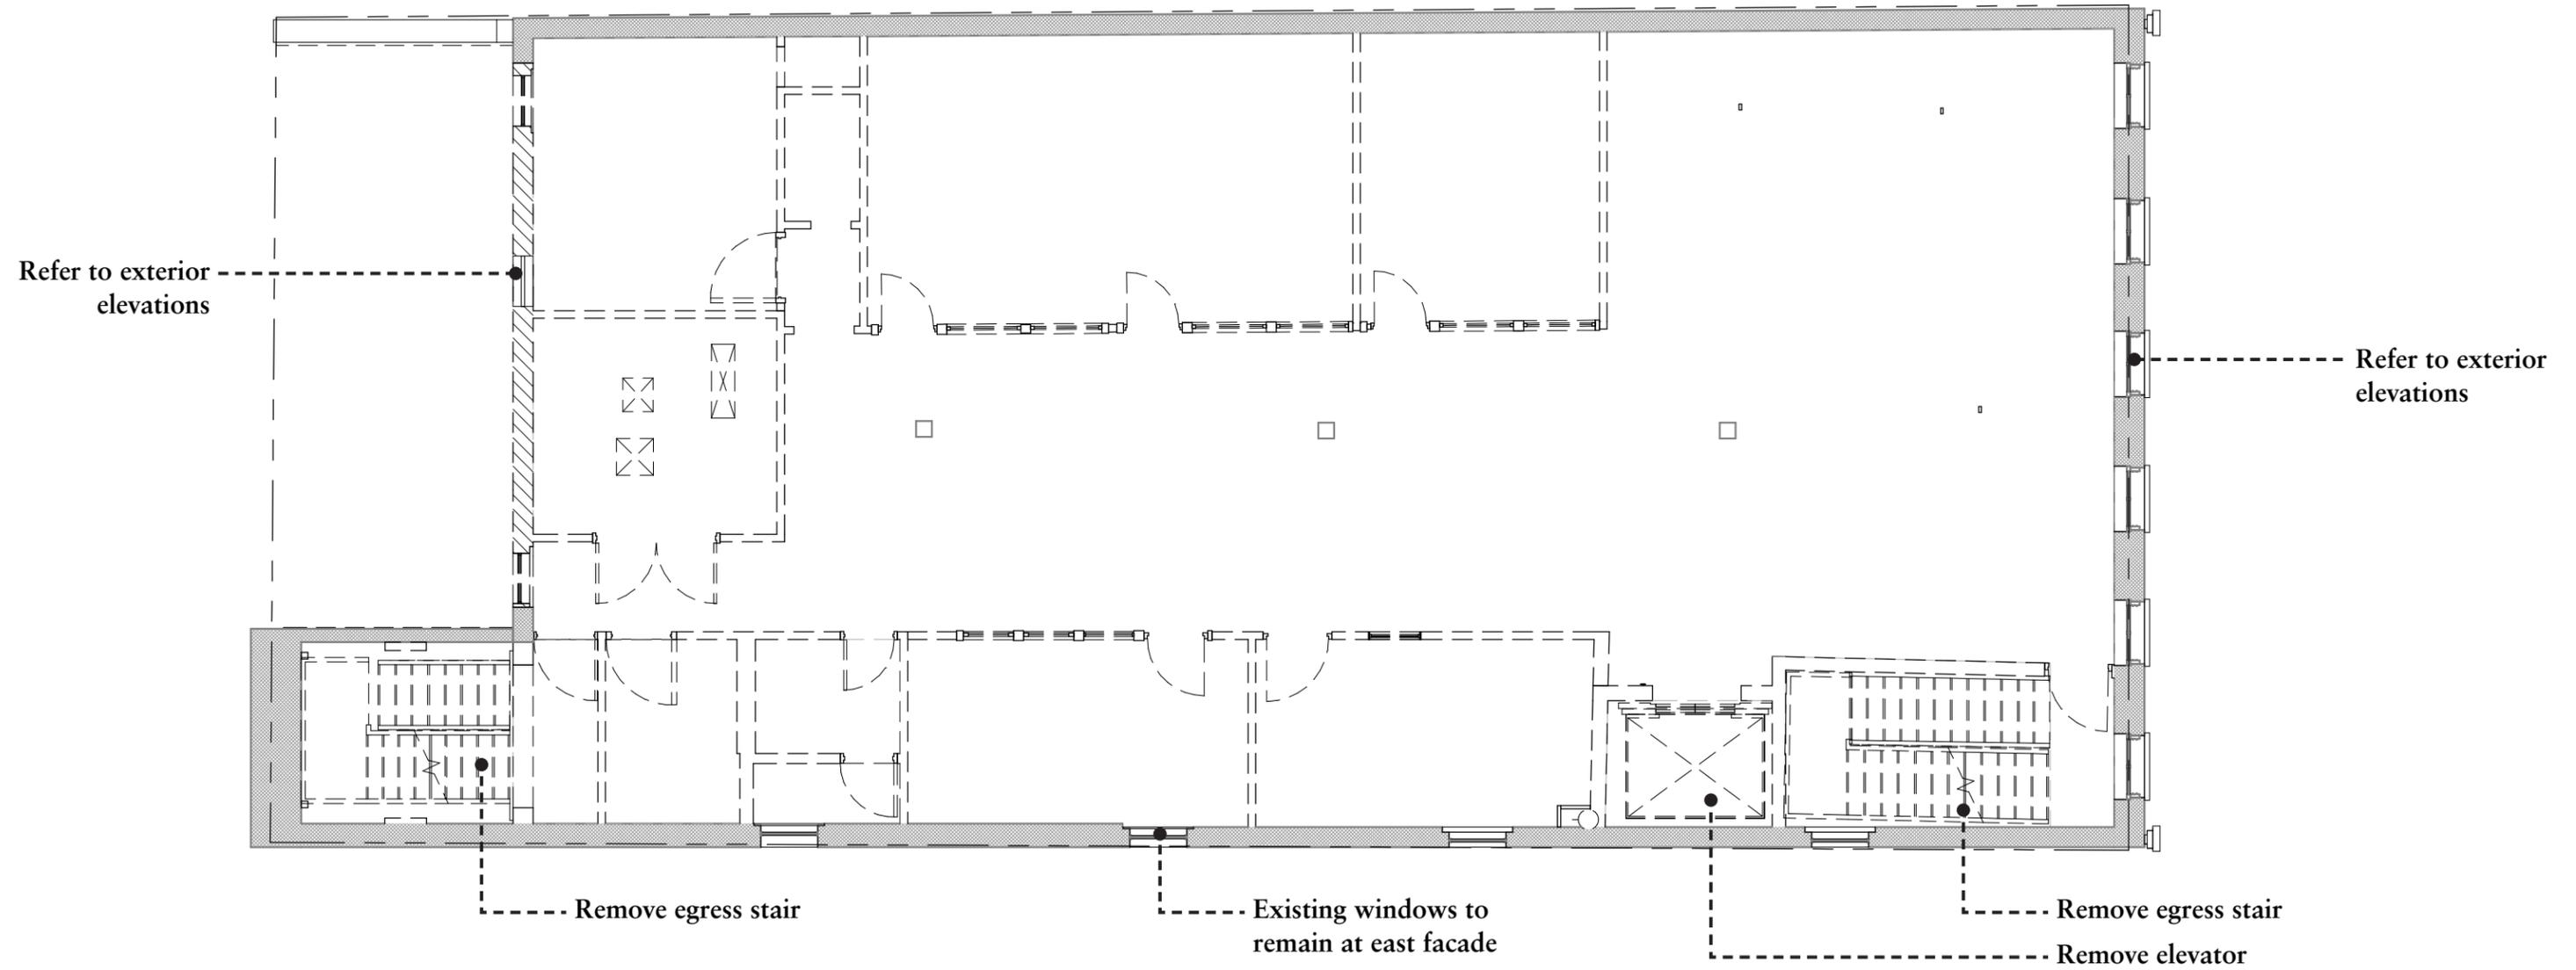
- Existing Wall to Remain
- Historic Wall Demolition
- Modern Wall Demolition

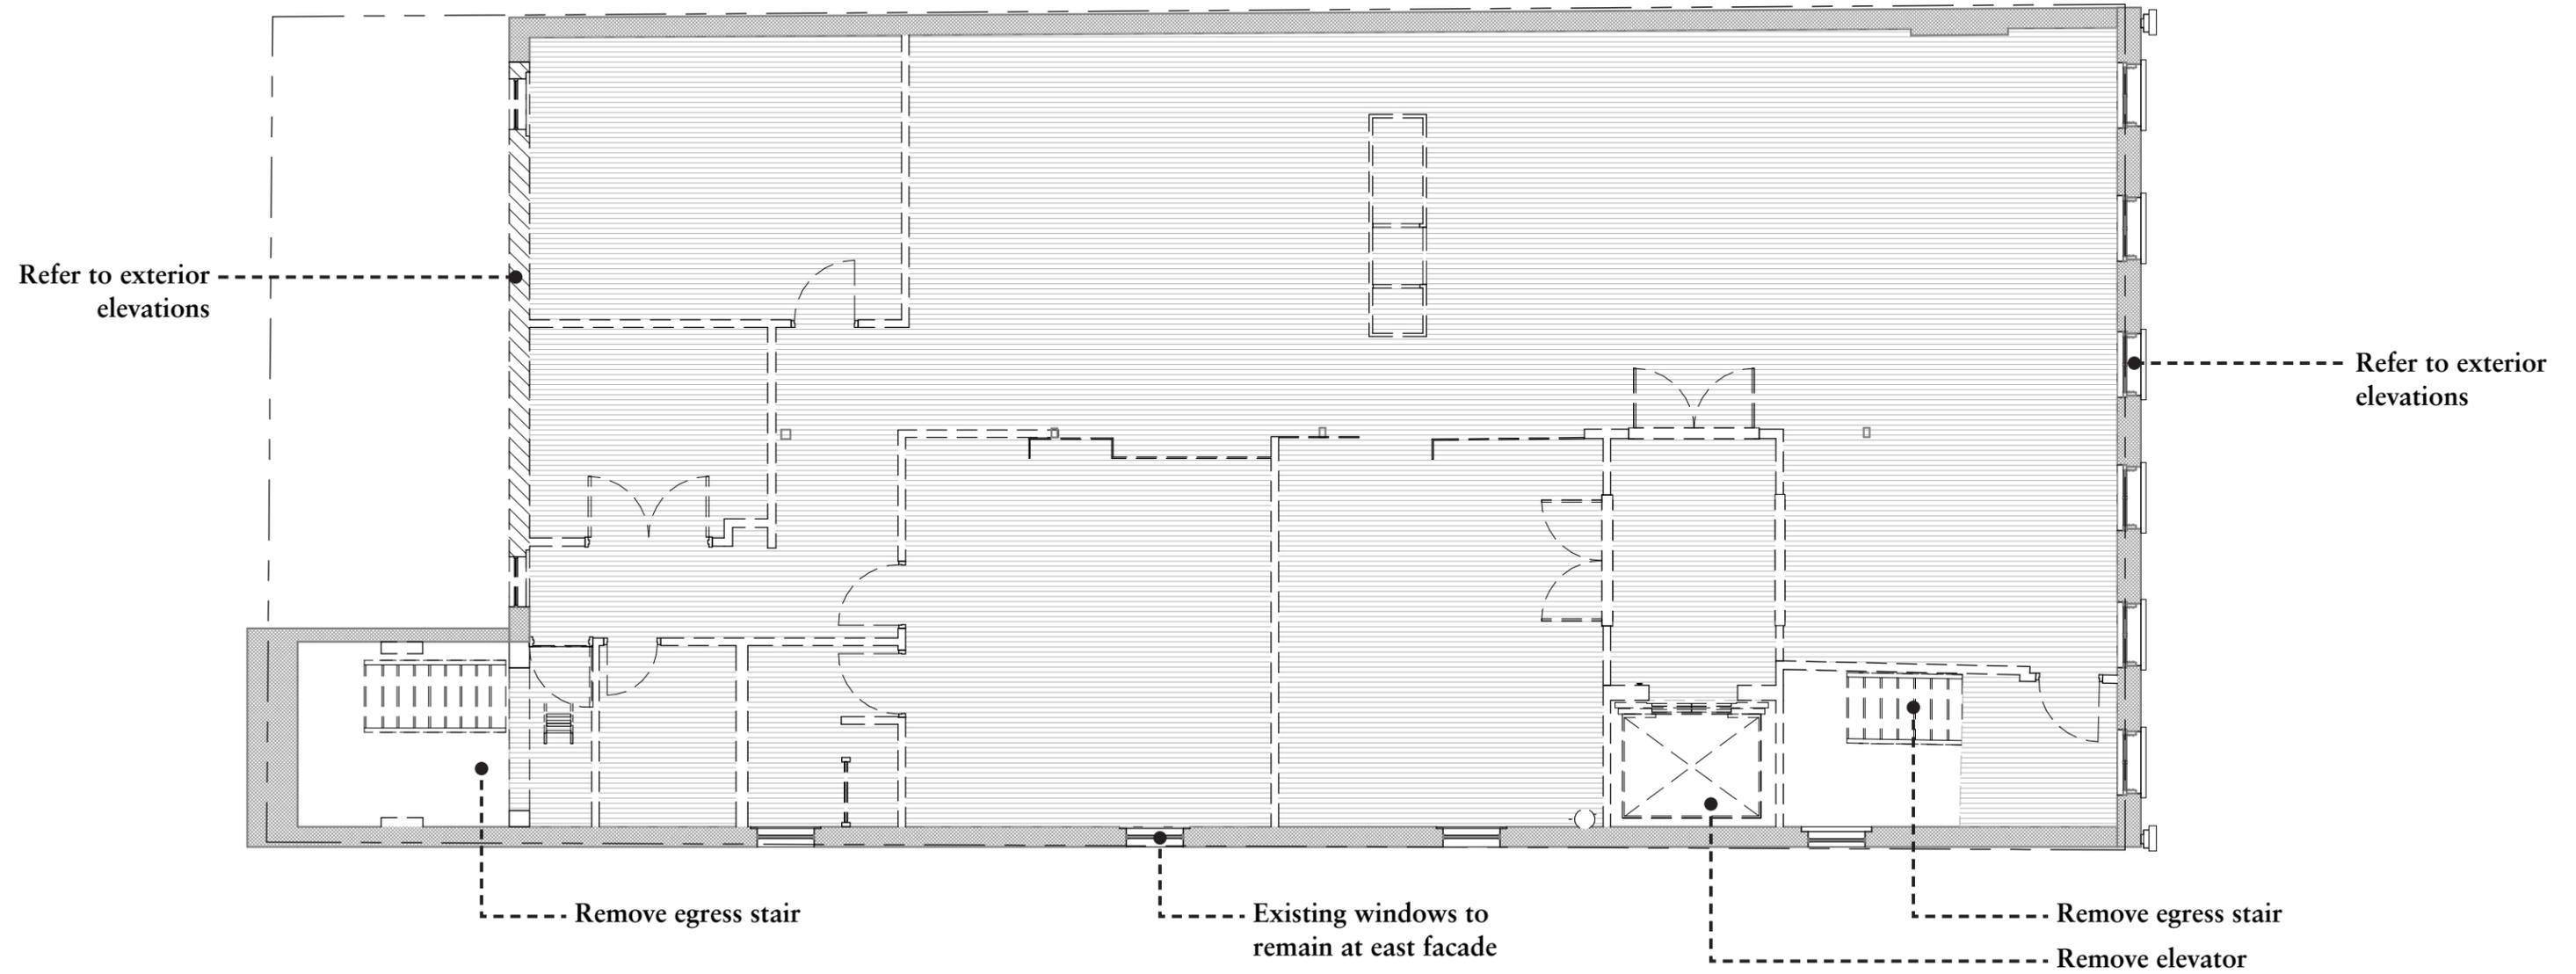
- Existing Wall to Remain
- Historic Wall Demolition
- Modern Wall Demolition

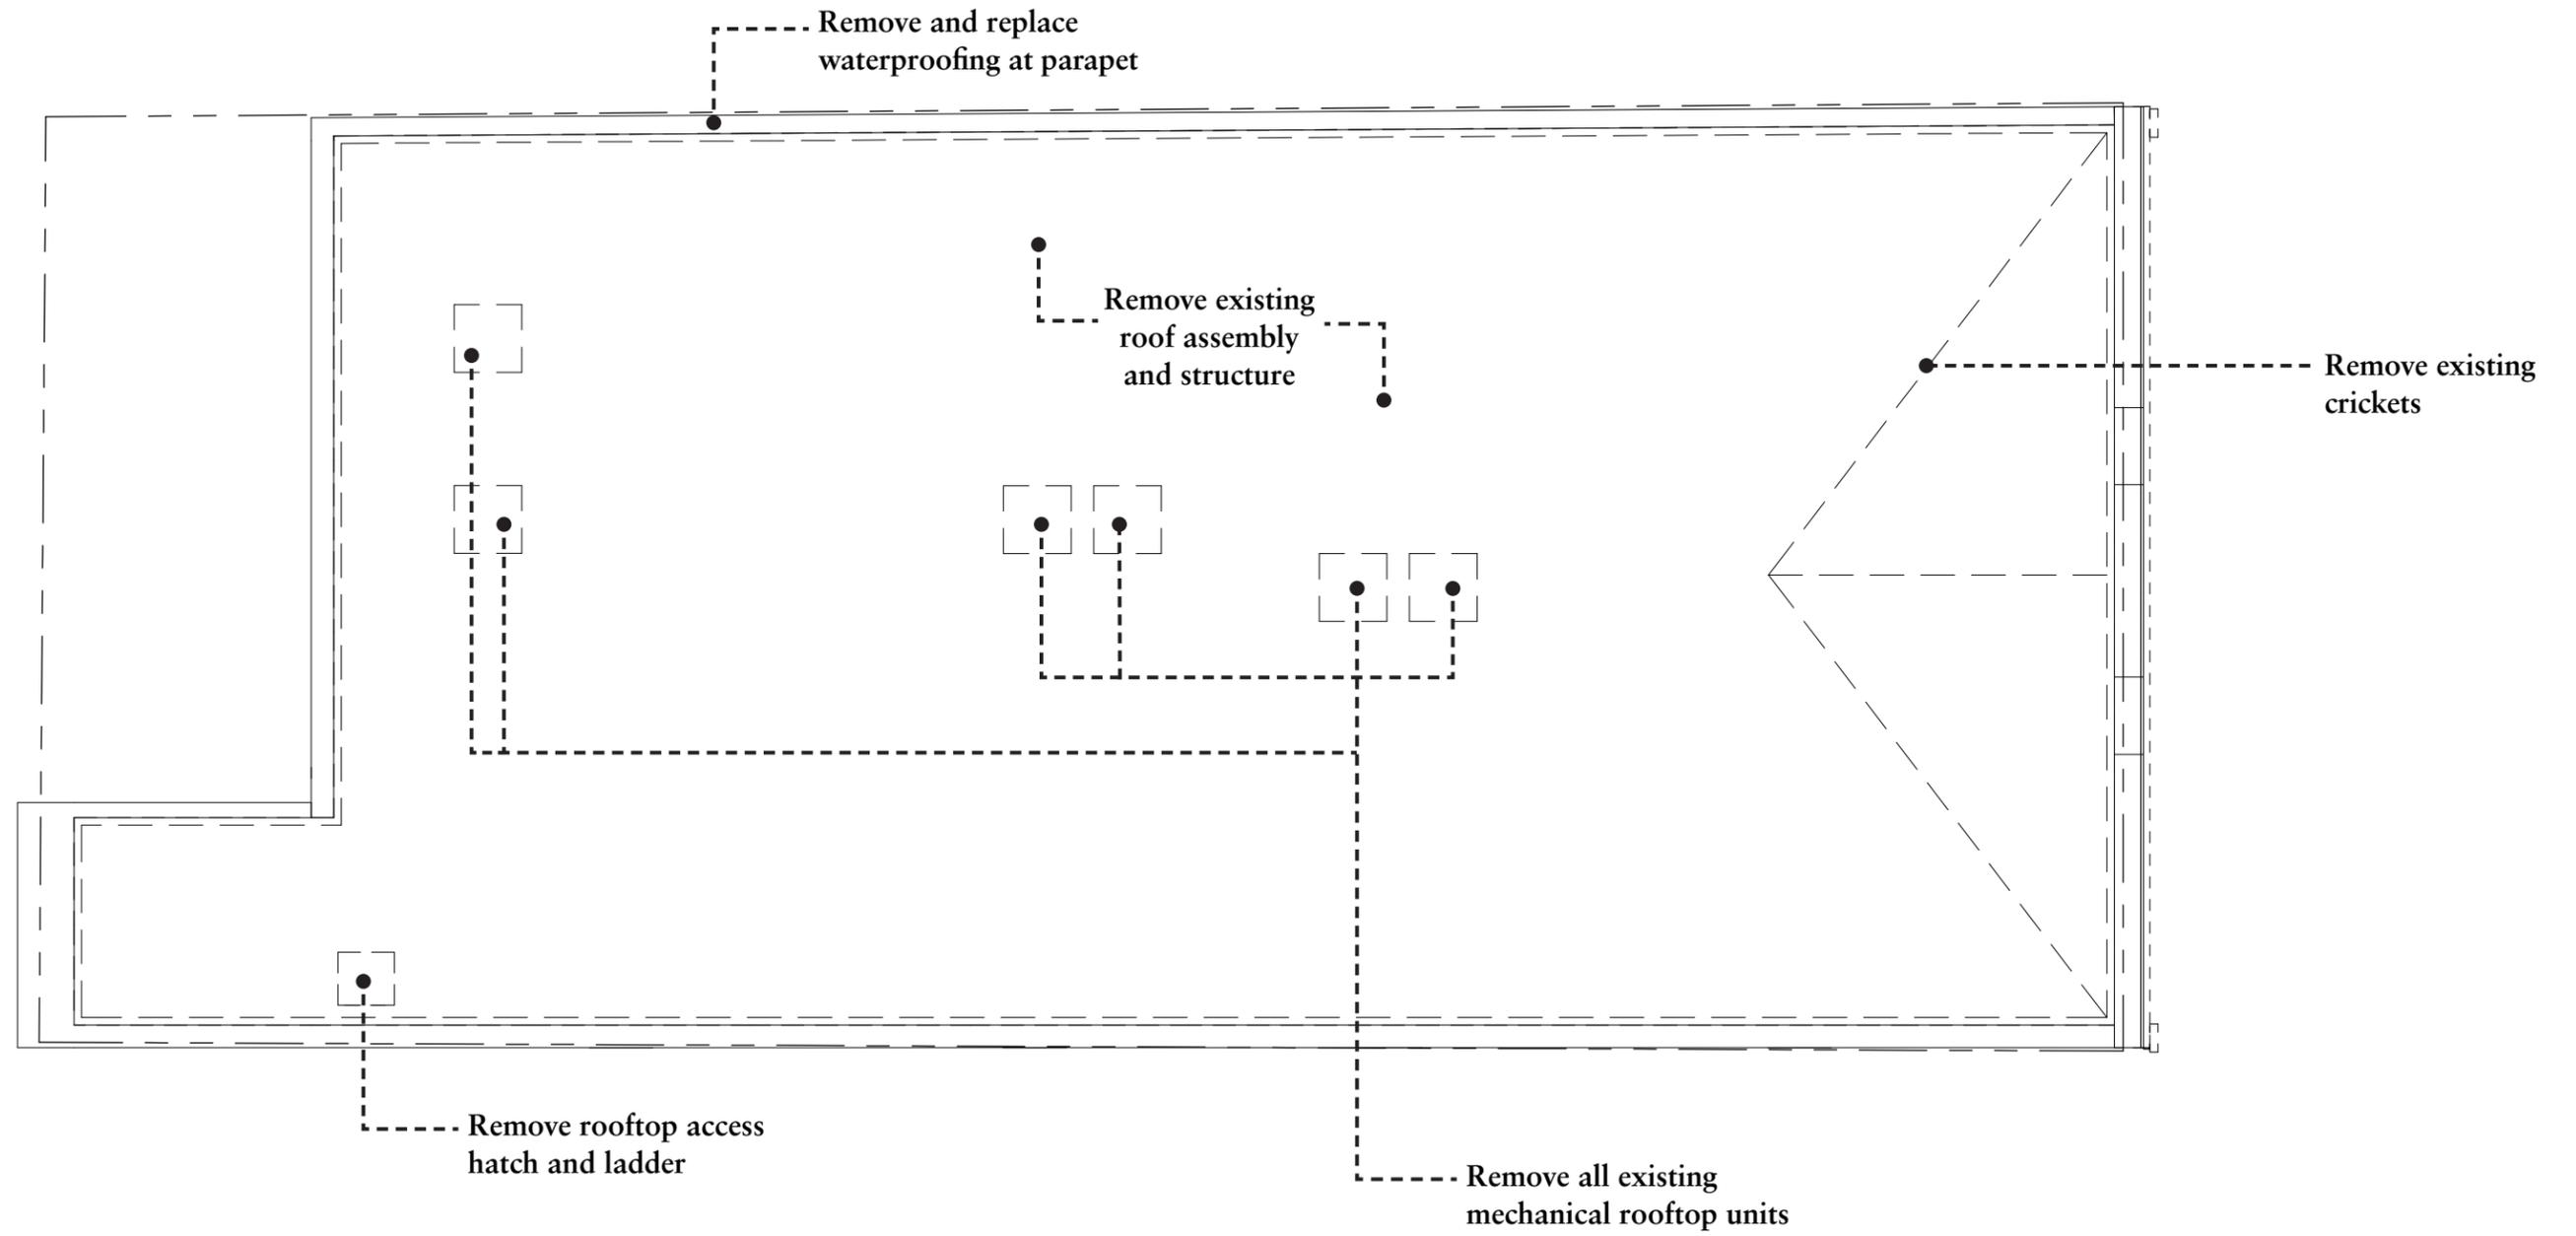
- Existing Wall to Remain
- Historic Wall Demolition
- Modern Wall Demolition
