Subject: **Tree Removal Plan**
Hornsby Bend Biosolids Management Plant Drying Ponds 1E, 1W, & 2
2210 South FM 973
Austin, Texas 78725
Baer Engineering Document No. 142069-8i.012

Tree Removal Plan

Hornsby Bend Biosolids Management Plant

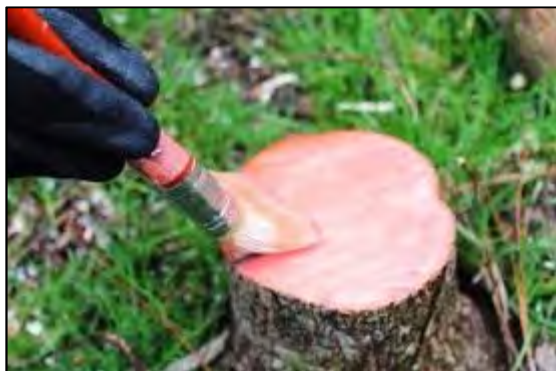
Figure 1. Example of applying glyphosate to a fresh cut stump with paint brush.

Leaving a stump from a live tree is not ideal because the stump will likely re-sprout. Within five minutes of the final flush cut, glyphosate will be brushed, with a disposable paint brush, onto the top of the stump, as depicted in **Figure 1**. The herbicide will be applied by a licensed applicator. The contractor will follow the manufacturer's instructions on applying the proper concentration of the herbicide. The minimum amount of glyphosate should be used to completely cover the top of the stump. Care should be taken to treat only the target stump. The herbicide should not affect the surrounding vegetation or water.

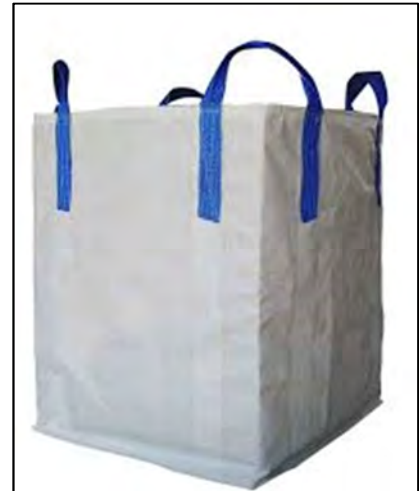
Figure 2. Example of FIBC.

A temporary dewatering plan will be required for those root systems near the water table. Sufficient size and capacity of the dewatering system is necessary to lower and maintain the water table and to allow material to be excavated in a reasonably dry condition. Dewatering will be accomplished through the use of cofferdams, or equivalent. An example is the use of flexible intermediate bulk containers (FIBC), or bulk bags. An FIBC is depicted in **Figure 2**. If this method is selected, bags will be filled with clean gravel or sand and positioned to form a cofferdam that isolates the work area. Once the FIBC are in place, a pump will be used to dewater the area inside the cofferdam. Polyethylene tarps may be required inside the cofferdam to further seal the work area.

The dewatering system will be operated continuously until repair of the berm is completed. The water removed from the excavation should be disposed of in such a manner as will not endanger portions of work under construction. We suggest pumping the water back into the evaporation pond. Once the stump and roots have been excavated and the berm has been repaired, the FIBC or bulk bags should be removed. Their contents should be disposed of properly.

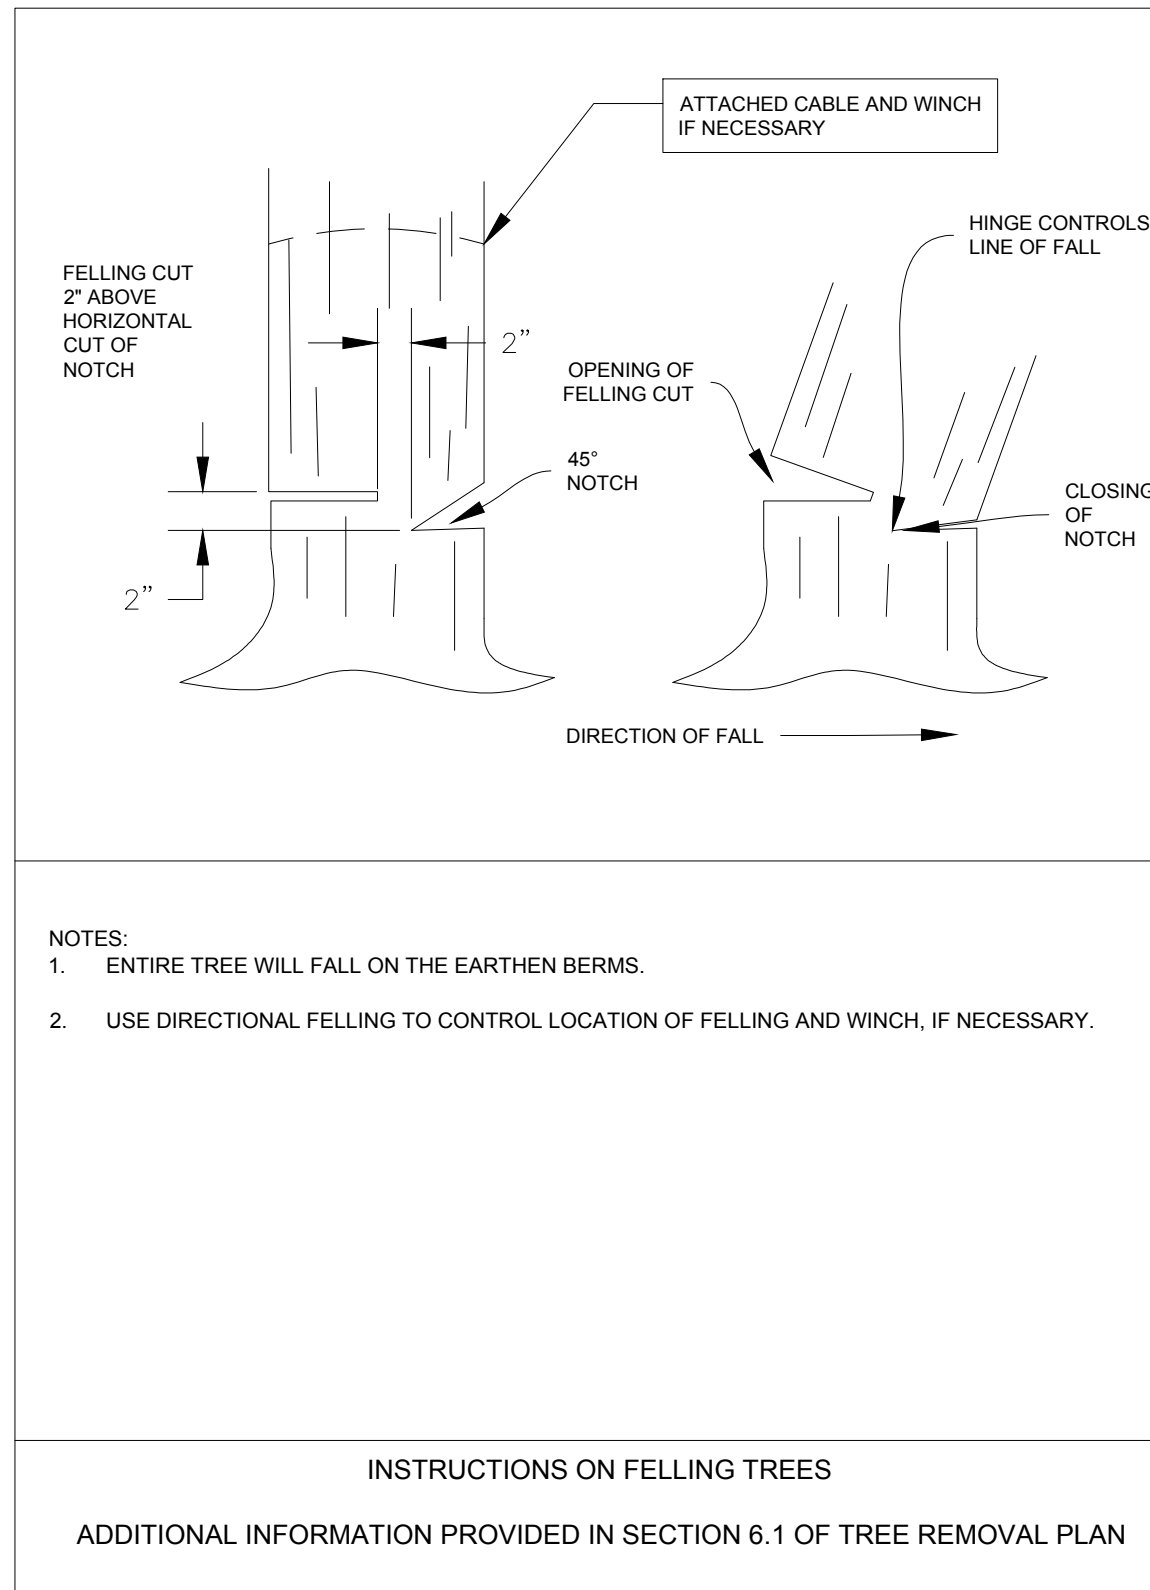
INSTRUCTIONS ON FELLING TREES
 ADDITIONAL INFORMATION PROVIDED IN SECTION 6.1 OF TREE REMOVAL PLAN

- NOTES:
1. ENTIRE TREE WILL FALL ON THE EARTHEN BERMS.
 2. USE DIRECTIONAL FELLING TO CONTROL LOCATION OF FELLING AND WINCH, IF NECESSARY.

Eighty dead trees and stumps were tagged for removal. Standing dead trees will be cut to approximately 2 feet above ground level. The trees need to fall onto the berm of the ponds and not into the water. Felling trees in the water could damage the liner of the ponds and result in water quality violations. The remaining stump and root system will either be excavated using hand tools or painted with polyurethane to slow the decaying process. Root systems that are located in close proximity to the water level of the ponds will require a dewatering plan. If water is encountered during excavation, a dewatering plan will need to be implemented before continuing excavation. A layer of bentonite clay will be placed in the excavation and native soil free of debris will fill the remaining excavation. The following steps provide supplemental information to the detail sheets that are included in the tree removal plan set.

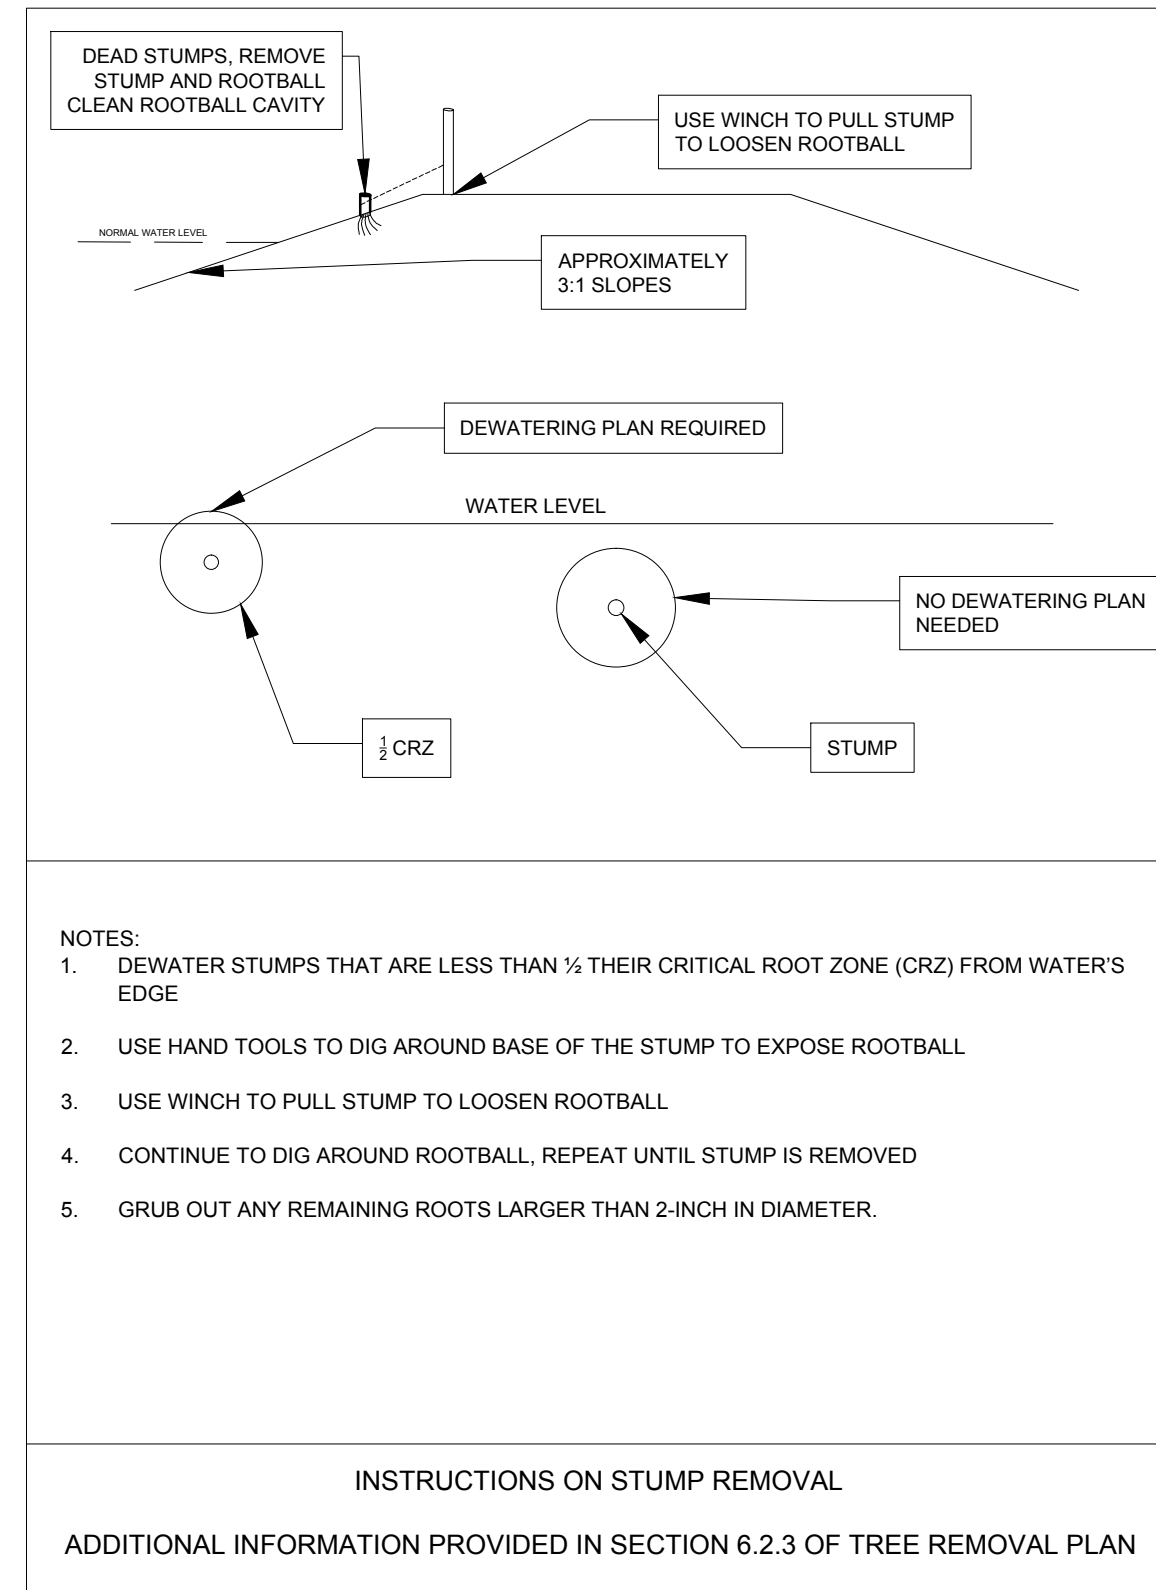
INSTRUCTIONS ON STUMP REMOVAL
 ADDITIONAL INFORMATION PROVIDED IN SECTION 6.2.3 OF TREE REMOVAL PLAN

- NOTES:
1. DEWATER STUMPS THAT ARE LESS THAN 1/2 THEIR CRITICAL ROOT ZONE (CRZ) FROM WATER'S EDGE
 2. USE HAND TOOLS TO DIG AROUND BASE OF THE STUMP TO EXPOSE ROOTBALL
 3. USE WINCH TO PULL STUMP TO LOOSEN ROOTBALL
 4. CONTINUE TO DIG AROUND ROOTBALL, REPEAT UNTIL STUMP IS REMOVED
 5. GRUB OUT ANY REMAINING ROOTS LARGER THAN 2-INCH IN DIAMETER.

The decaying roots of woody species can create channels into the evaporation pond berms comprising the berm's integrity. Hand tools only will be used to dig around the base of the stump exposing the root ball. The stump and root ball should be pulled using a winch to loosen

the root ball. Continue to use hand tools to grub around the base of the stump and pull with a winch until the stump and root ball are removed. Once the stump is removed, grub out any remaining roots larger than 2 inches in diameter. If water or saturated soil is encountered during excavations, cut exposed roots and begin berm repair.

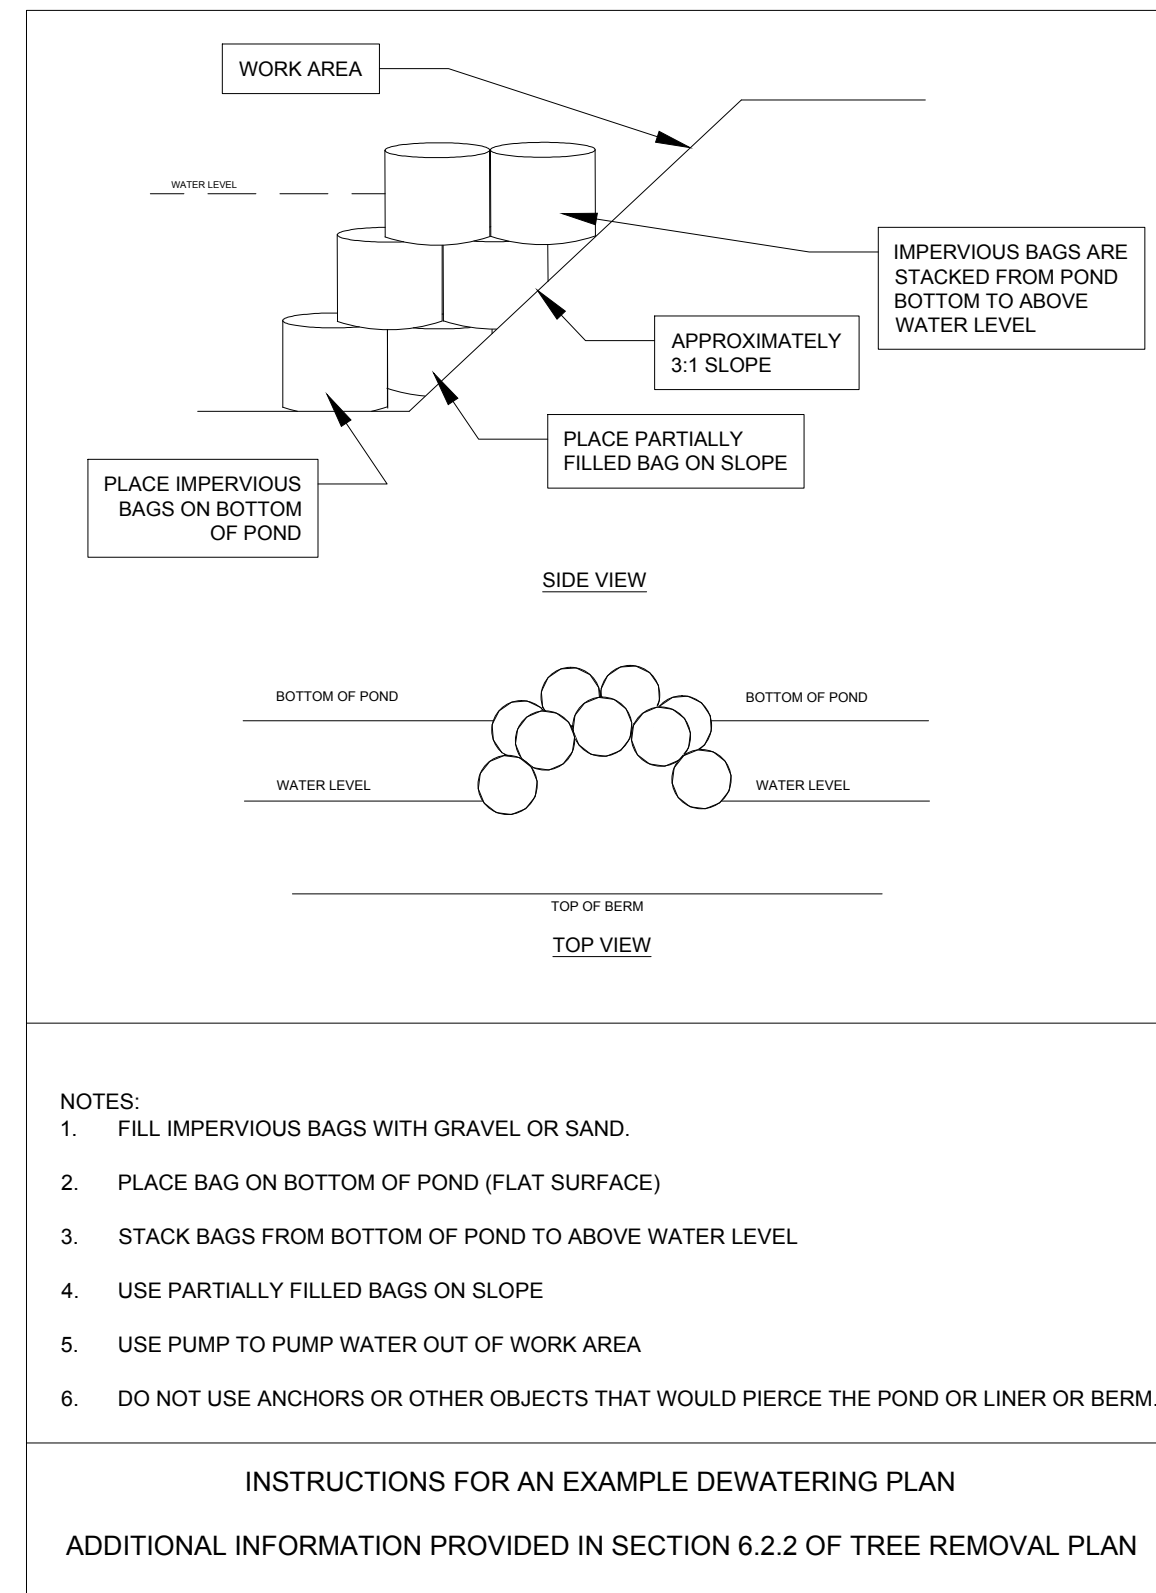
INSTRUCTIONS FOR AN EXAMPLE DEWATERING PLAN
 ADDITIONAL INFORMATION PROVIDED IN SECTION 6.2.2 OF TREE REMOVAL PLAN

- NOTES:
1. FILL IMPERVIOUS BAGS WITH GRAVEL OR SAND.
 2. PLACE BAG ON BOTTOM OF POND (FLAT SURFACE)
 3. STACK BAGS FROM BOTTOM OF POND TO ABOVE WATER LEVEL
 4. USE PARTIALLY FILLED BAGS ON SLOPE
 5. USE PUMP TO PUMP WATER OUT OF WORK AREA
 6. DO NOT USE ANCHORS OR OTHER OBJECTS THAT WOULD PIERCE THE POND OR LINER OR BERM.
