# Lower Buttermilk Branch Stream Restoration

**PUBLIC MEETING**

**July 25, 2024**

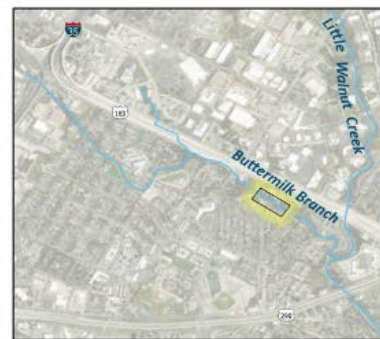
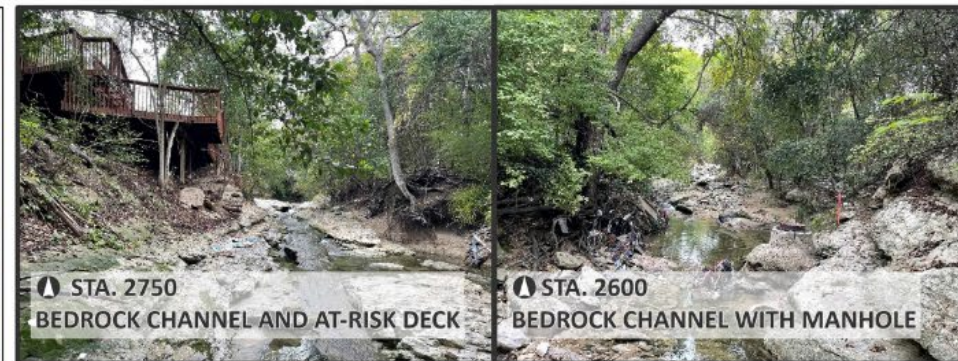
AERIAL IMAGERY FROM 2018, DOWNLOADED FROM THE CITY OF AUSTIN. HILLSHADE BASED ON 2017 LIDAR DOWNLOADED FROM USGS QPR. UTILITIES PROVIDED BY CAROLLO

- MANHOLES
- SANITARY SEWER
- STORMWATER OUTFALL
- STORM DRAIN
- EXISTING BANK ARMORING
- PARCEL BOUNDARY
- EASEMENT BOUNDARY
- EROSION SITE
- CREEK ALIGNMENT
- CROSS-SECTION
- CEF - SPRING
- CEF - ROCK OUTCROP
- CEF - RESOURCE BUFFER
- HERITAGE TREE
- Ordinary High Water
- PREVIOUSLY IDENTIFIED EROSION SITE STATUS
  - ACTIVE
  - PLANNING
  - REPAIRED

- Geomorphic Assessment
  - Identified 14 active erosion sites (A through N)
- Erosion Site Screening and Project Prioritization (4 Steps)
  - Data compilation
  - Site screening
  - Site prioritization
  - Project site recommendations

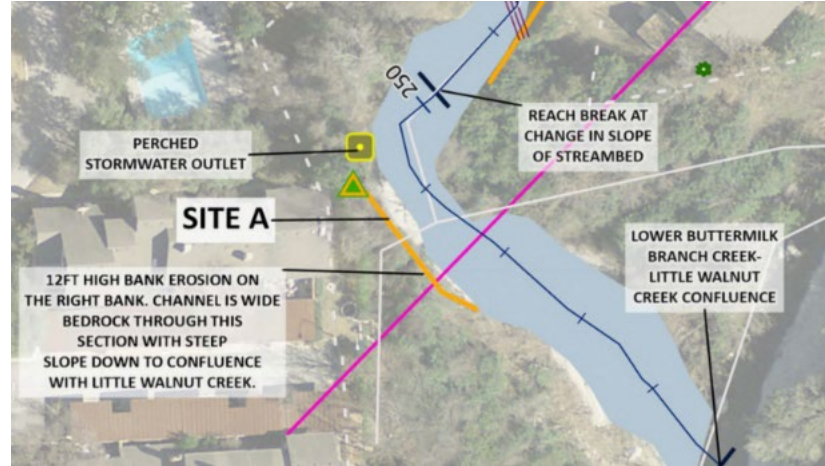
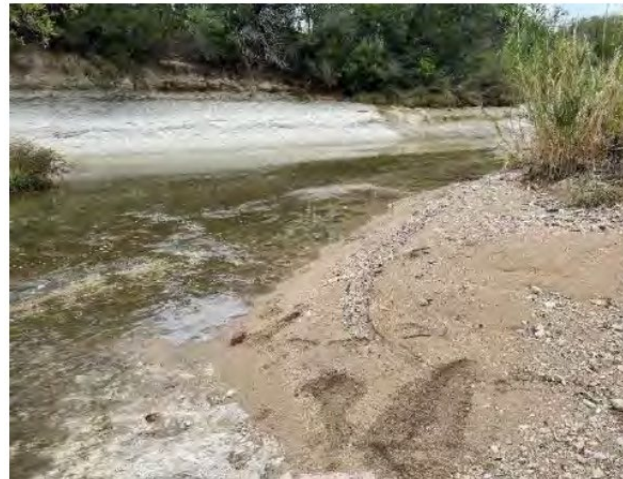
- 12 ft high, steep bank erosion threatens adjacent building
- Proposed improvements are within existing drainage easement
- ± 200 linear feet of improvements
- Existing stormwater outlet near improvements to be modified
- No Critical Environmental Features (CEFs) or heritage trees identified within the immediate vicinity

*Site A (bank in the background)*

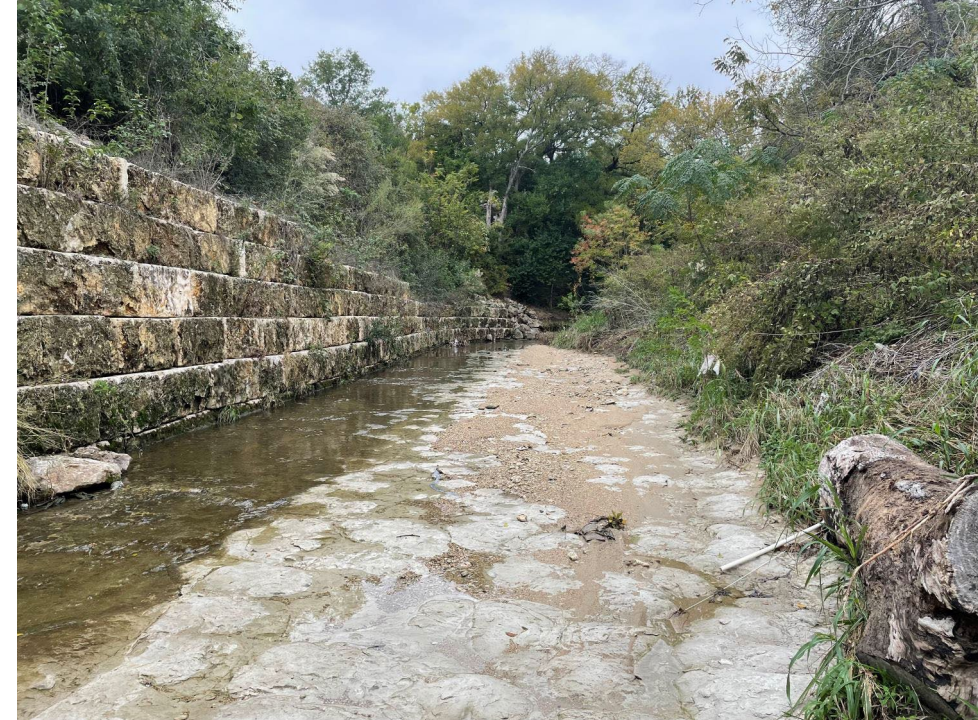
- **Description:**
  - Drilled shaft wall, with H-pile and concrete lagging
  - Limestone facing options
  - Top of wall to extend at least 0.5 ft above the 100-yr storm water surface elevation (WSEL)
  - Opposite bank grading
  - 3:1, vegetated shelf to existing grade
- **Estimated Costs ~ \$2,100,000**

*Similar project completed in 2017*

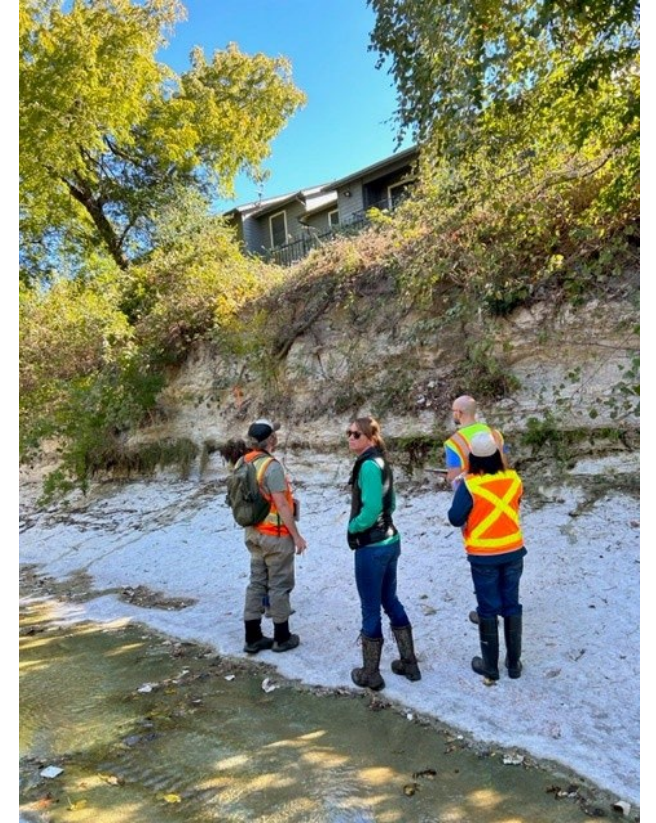
- Scour upstream and downstream of existing bank armoring
- Additional easement may be required
- Nearby CEFs include seeps and a rock outcrop, just upstream of site
- Improvements to be extended between both sites B & C
- $\pm$  530 linear feet of improvements (Sites B and C combined)

*Typical segment of Sites B and C*

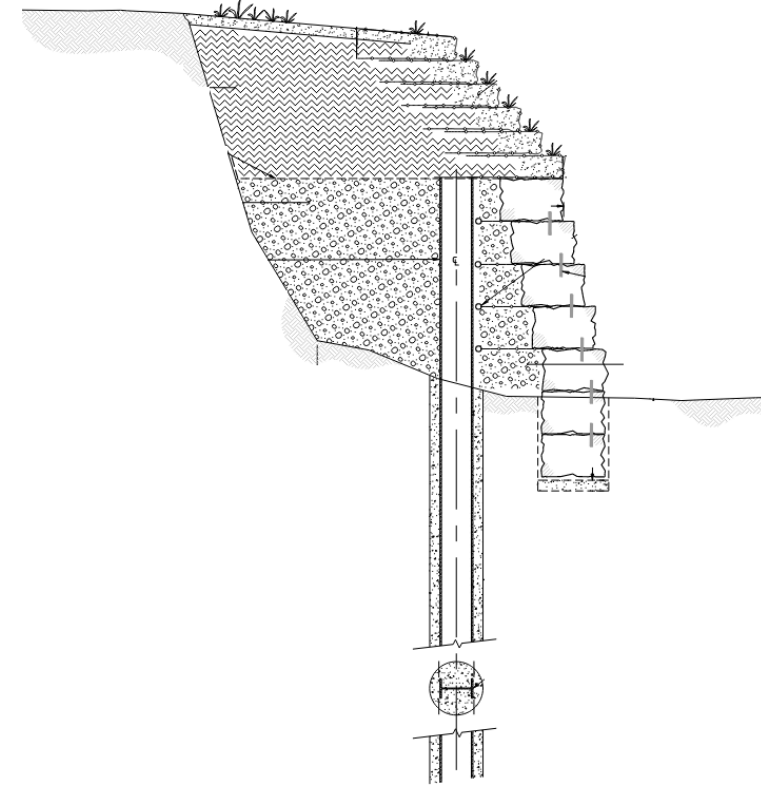
- **Description:**
  - Drilled shaft wall, with H-pile and concrete lagging
  - Limestone facing options
  - Top of wall to extend at least 0.5 ft above the 10-yr storm water surface elevation
  - Opposite bank grading
  - 3:1, vegetated shelf to existing grade
- **Estimated Costs (Sites B & C combined) ~ \$3,800,000**

*Schematic of Drilled Shaft Wall*

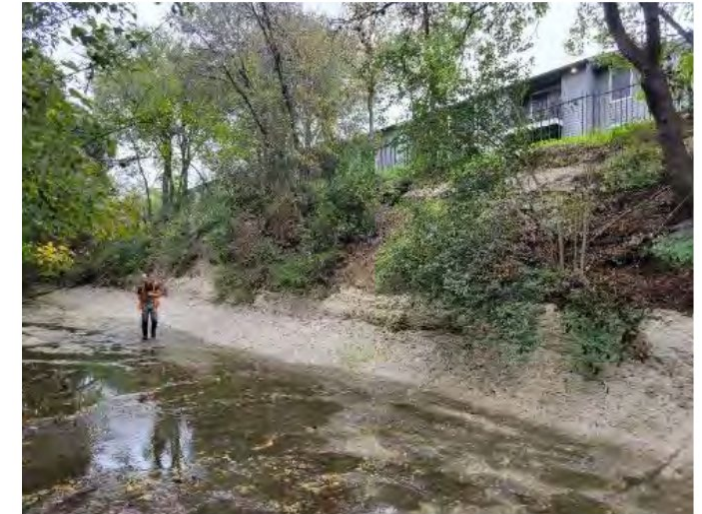
- 20 ft high bank erosion threatens nearby apartment buildings
- Improvements likely to be situated within an existing easement
- Nearby CEF includes rock outcrop extending along the site
- 1 nearby heritage tree threatened with construction
- ± 200 linear feet of improvements

*Site E Typical Conditions*

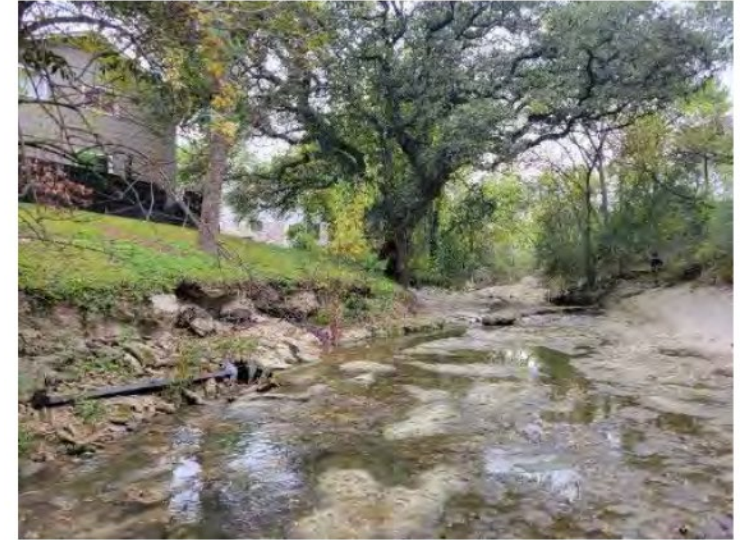
- 12 ft high bank erosion threatens a private yard and residential building
- Proposed improvements are likely to be situated within an existing easement
- Site falls within 150 ft of a rock outcrop;
- 1 nearby heritage tree not likely to be threatened by improvements
- ± 135 linear feet of improvements

*Site F Typical Conditions*

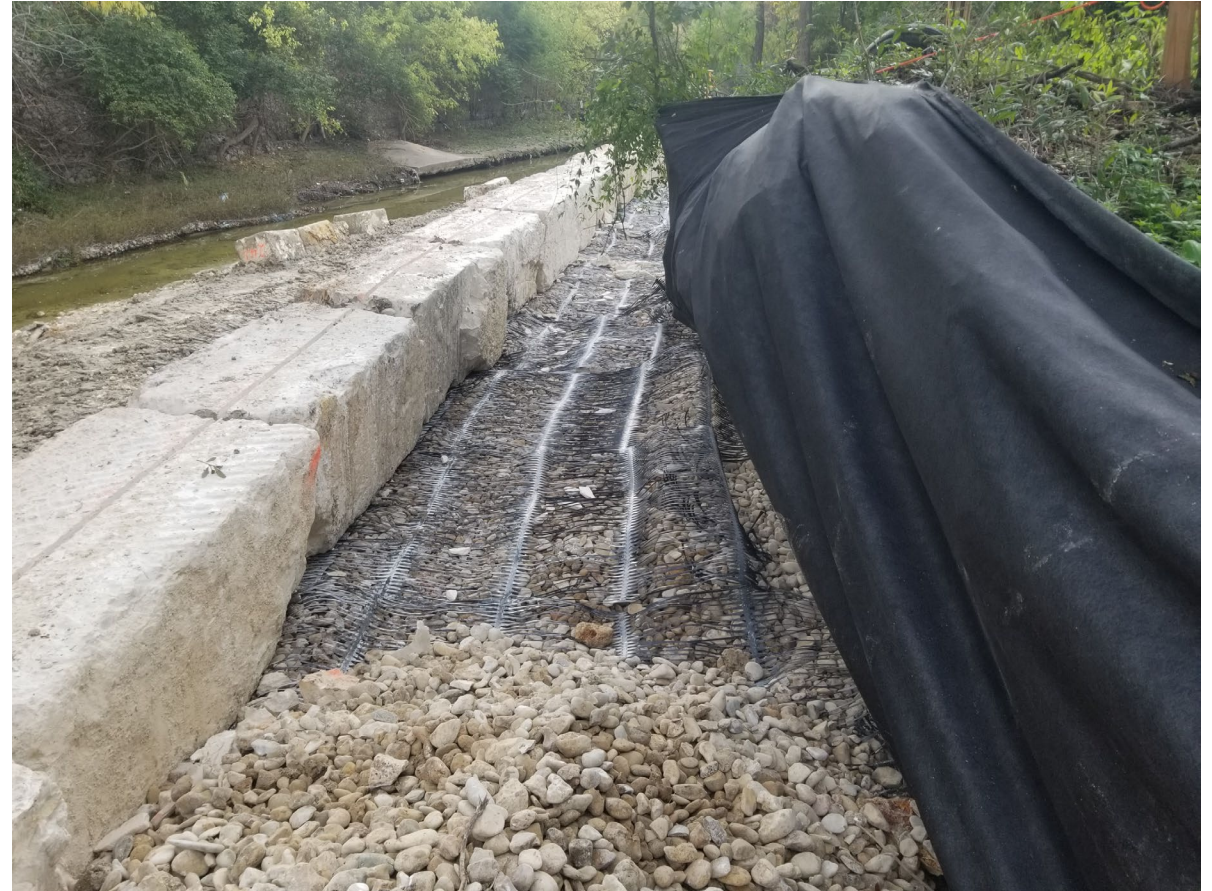
- **Description:**
  - Stacked limestone block with geogrid.
  - 3:1, vegetated shelf to existing grade.
- **Estimated Costs ~ \$1,400,000**

*Example of MSE Block Wall*

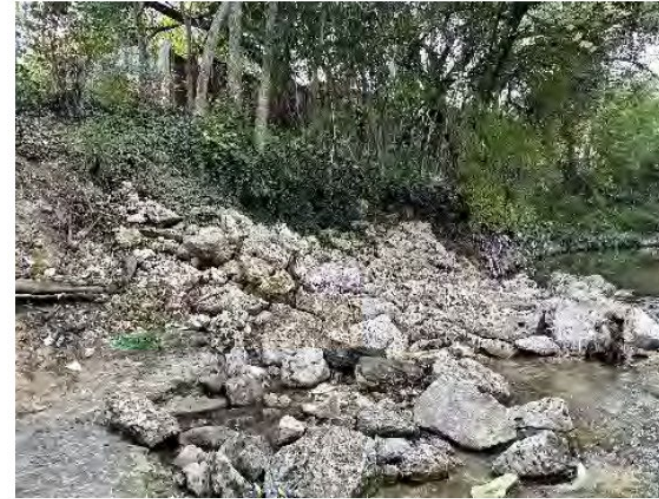
## Site I

- 6 ft high bank erosion threatens yard
- Proposed improvements will likely extend beyond the existing easement
- Additional easement may be required
- Nearby fault according to state-sponsored mapping system
- Site I falls within 150 ft of a rock outcrop
- 4 nearby heritage trees. It's likely some of these will be removed for construction
- $\pm 110$  linear feet

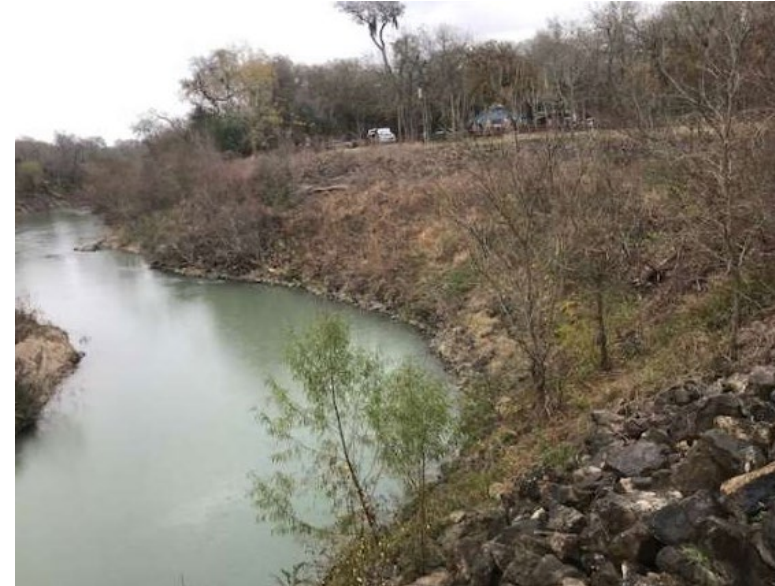
- **Description:**
  - Riprap installed at a 2:1 slope
  - Riprap filled with topsoil and vegetated
- **Estimated Costs ~ \$1,000,000**

*Example of Vegetated Riprap*
