GROUNDS OVERVIEW

BARTON SPRINGS POOL Master Plan

MASTER PLAN Grounds Overview

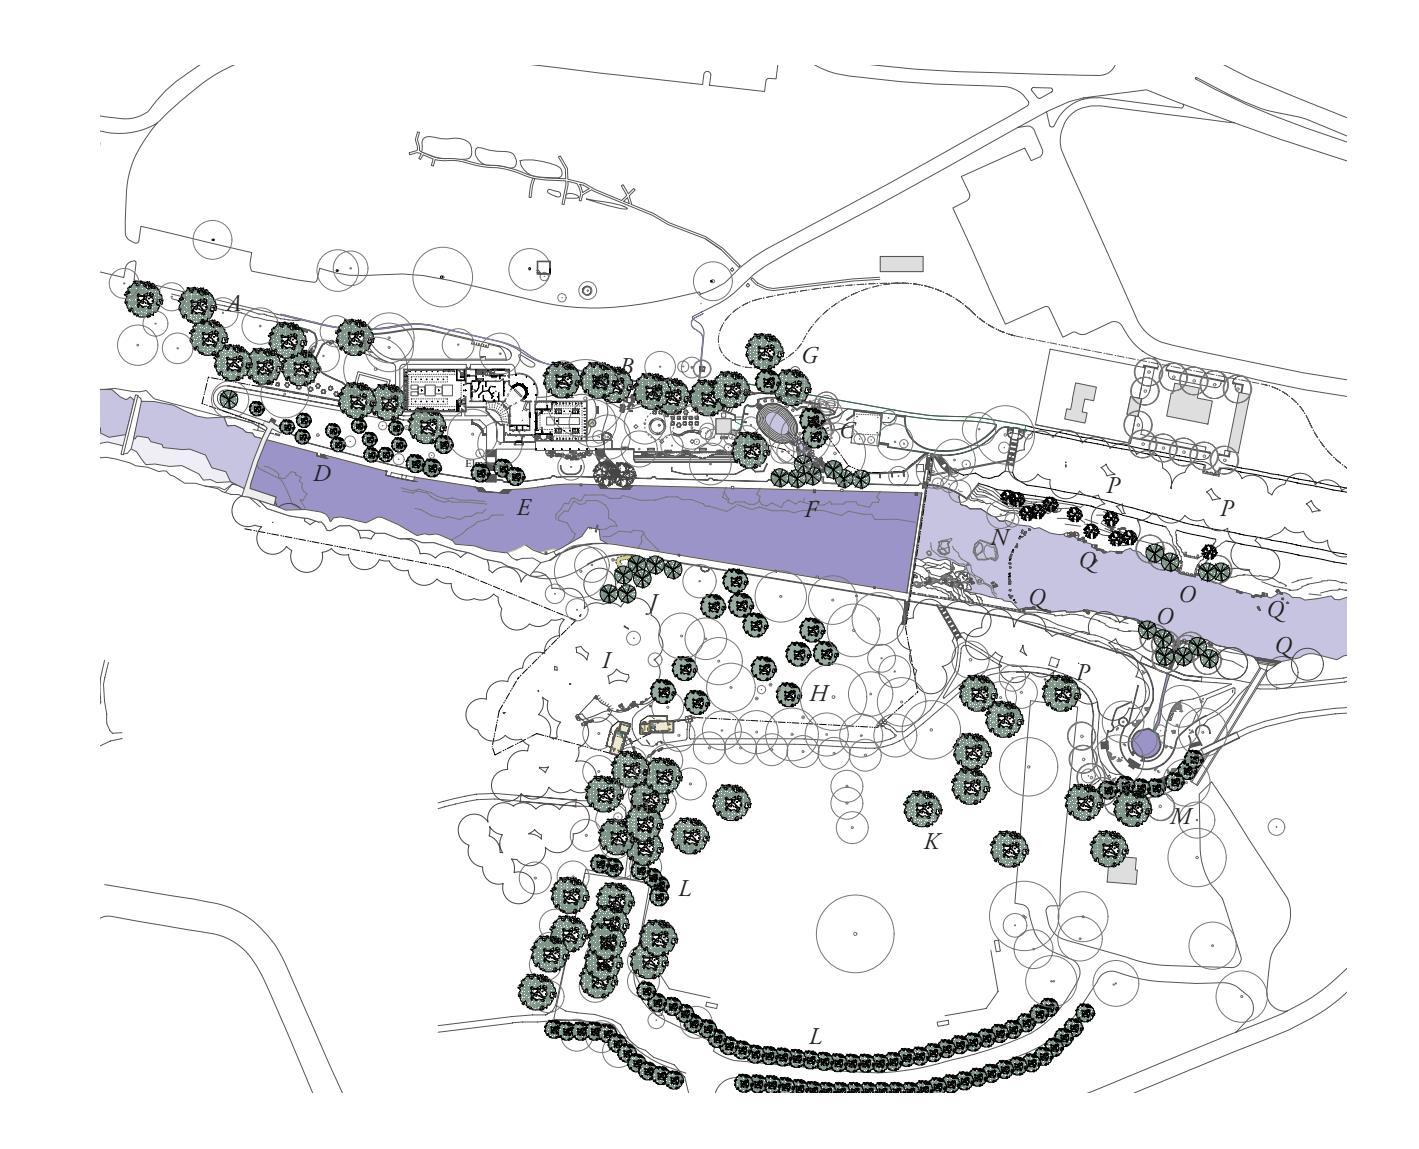
Proposed Trees

- A. Cedar Elm, Texas Red Oak, River Walnut, Texas Ash.
- B. Live Oaks.
- C. River Walnut, Cedar Elm and Bald Cypress.
- D. Big Tooth Maple, Texas Red Oak, Cedar Elm.
- E. Cedar Elm, Chinquapin Oak, Texas Ash.
- F. Bald Cypress.
- G. Cedar Elm, Big Tooth Maple, Texas Red Oak
- H. Chinquapin Oak, Bur Oak,
- I. Rusty Blackhaw Virburnum, Eves Necklace, Escarpment Black Cherry.
- J. Bald Cypress.
- K. Bur Oaks and Chinquapin Oak.
- L. Cedar Elm, Monterrey Oak, Texas Ash.
- M. Chinquapin Oak.
- N. Bald Cypress.
- O. Bald Cypress.
- P. Mexican Sycamore, Cedar Elm, Western Soapberry, Texas Ash. Mexican Plum, Texas Redbud, Yaupon Holly, Eve's Necklace.
- Q. Mexican Sycamore, Bald Cypress, Cedar Elm, Western Soapberry, Texas Ash. Mexican Plum, Texas Redbud and Eves Necklace.

An important goal of this plan is to diversify the tree canopy in the Barton Springs area, by planting a wider variety of native trees. All trees planted should be well adapted, long lived native trees, that would naturally be found in similar environments in the Texas Hill Country. It's important that native trees be planted in the springs area both because they are best adapted to survive in our climate and conditions through the years, and also because they are reminders of the unique beauty of our Hill Country springs. It's important that the native trees selected be long lived, because the expense, both financial and emotional, of coping with the decline of large trees in public places should be avoided where

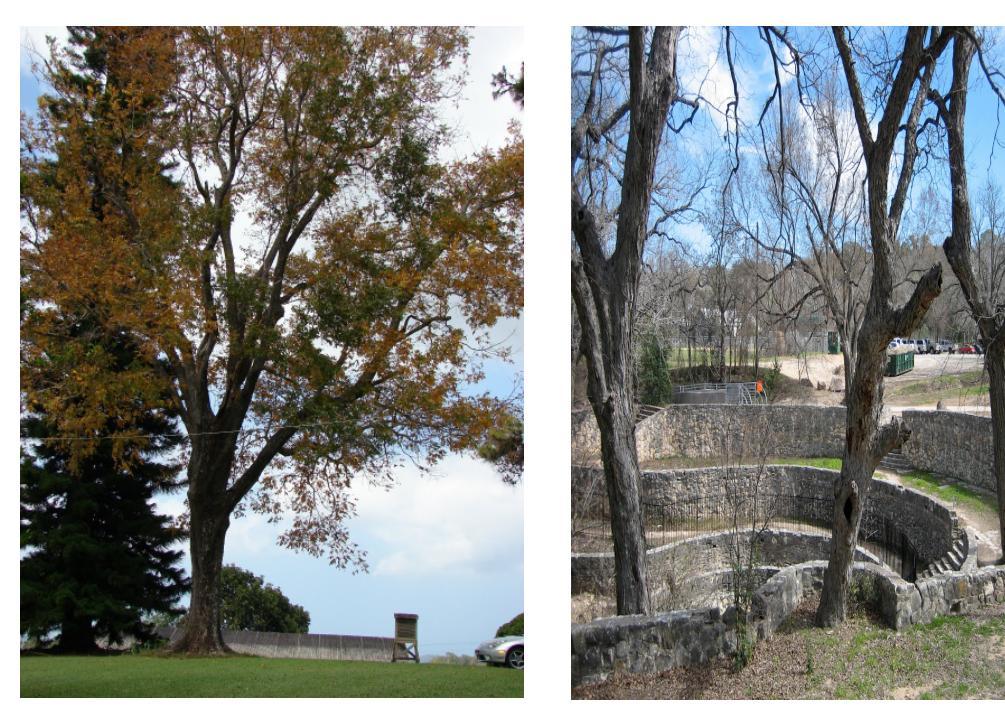
that makes the flaws of this beautiful native tree potentially devastating for the tree canopy around Barton Springs. (Left) Photo: Forest and Kim Starr Damaged and deteriorating pecans around the Sunken Garden.

poor form. (Right)

75% of the trees in the Barton Springs area are pecans, and

Note the broken and missing limbs, the cavities and the generally

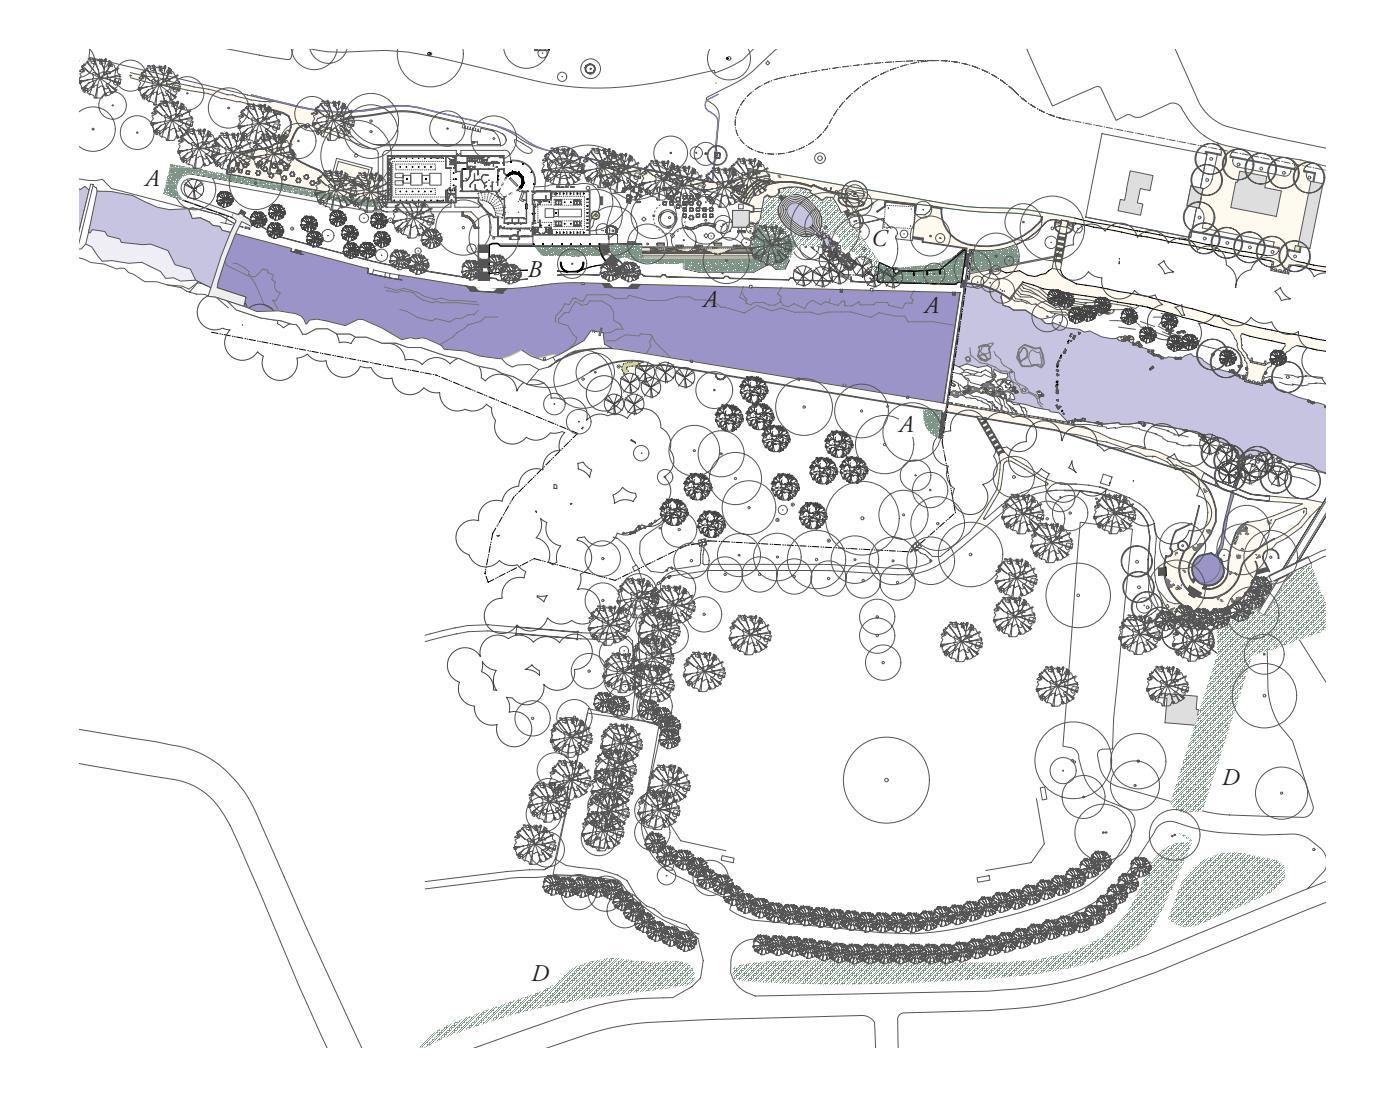
Lawn and Groundcover

- A. Native and Naturalized Shrubs, Grasses and Perennials.
- B. Boulder Garden.
- C. Lush waterside "riparian" plantings, such as river ferns, horsetail, columbine and inland sea oats.
- D. Native bank stabilizing vegetation.

Replace areas of lawn that are difficult to maintain and are not used with naturalizing planting beds. With the exception of the "Boulder Garden", which is a longer-term recommendation, all of the proposed naturalizing planting beds should be considered a short-term recommendation. Their design and installation should be coordinated with the design and installation of the new irrigation system.

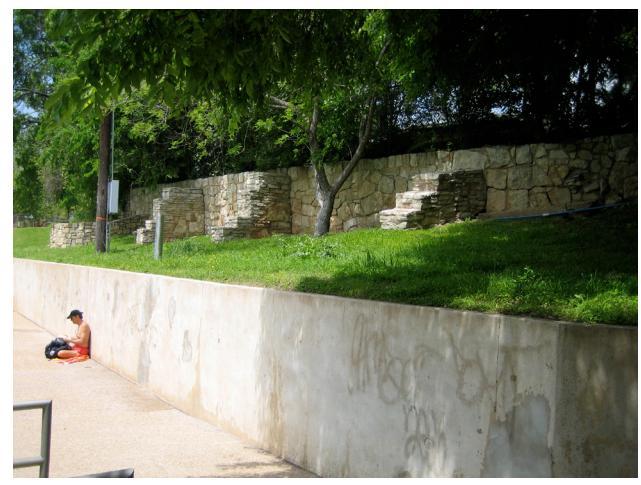
An area of difficult-to-mow St. Augustine grass. Replace with attractive, low-water-use native Texas plantings.

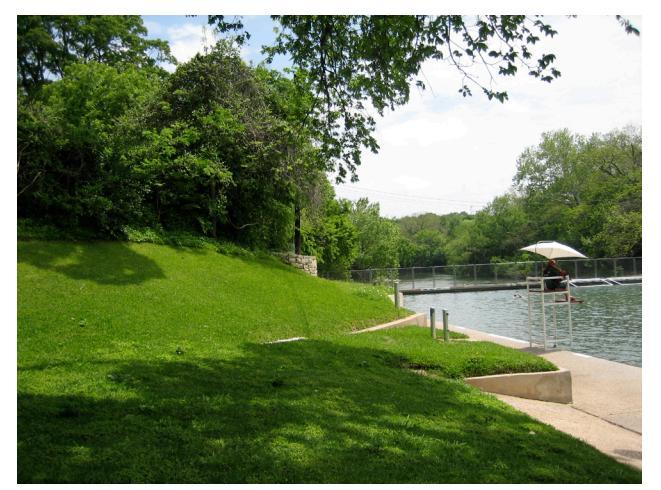
St. Augustine is a non-native turf grass that thrives in shade and requires irrigation to survive. In the sun, it requires substantial irrigation: in the shade, less so. All the St. Augustine slopes around the Pool have functioning, effective irrigation systems. If the irrigation systems were turned off and the St. Augustine not watered, it would weaken and eventually die, even in the shade. In spite of its water use, it is the only lawn that will thrive in shade in Austin.

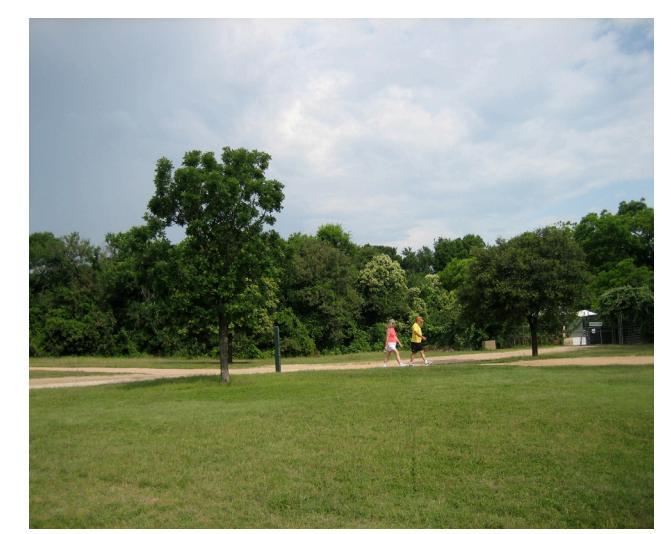
The unirrigated, largely Bermuda grass lawn outside the South Entry. It is comparatively lush in wet years (like the year when this picture was taken), but will be brown in drier summers. It will not, however, tolerate shade.

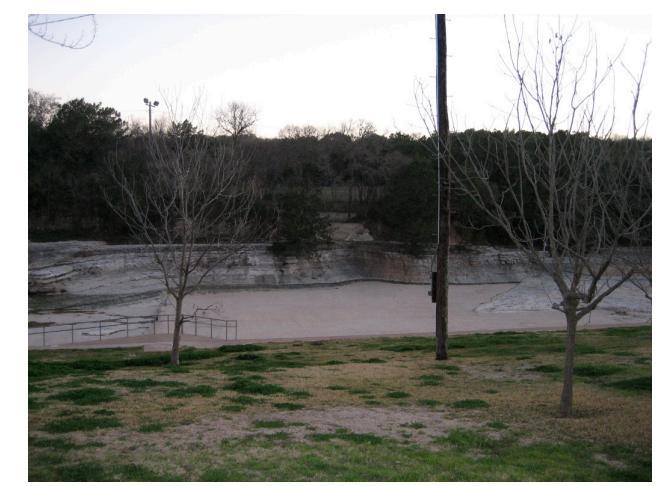
Newly planted trees benefit from separate irrigation from that provided by lawn sprinklers. New trees require irrigation for at least two years to become established.

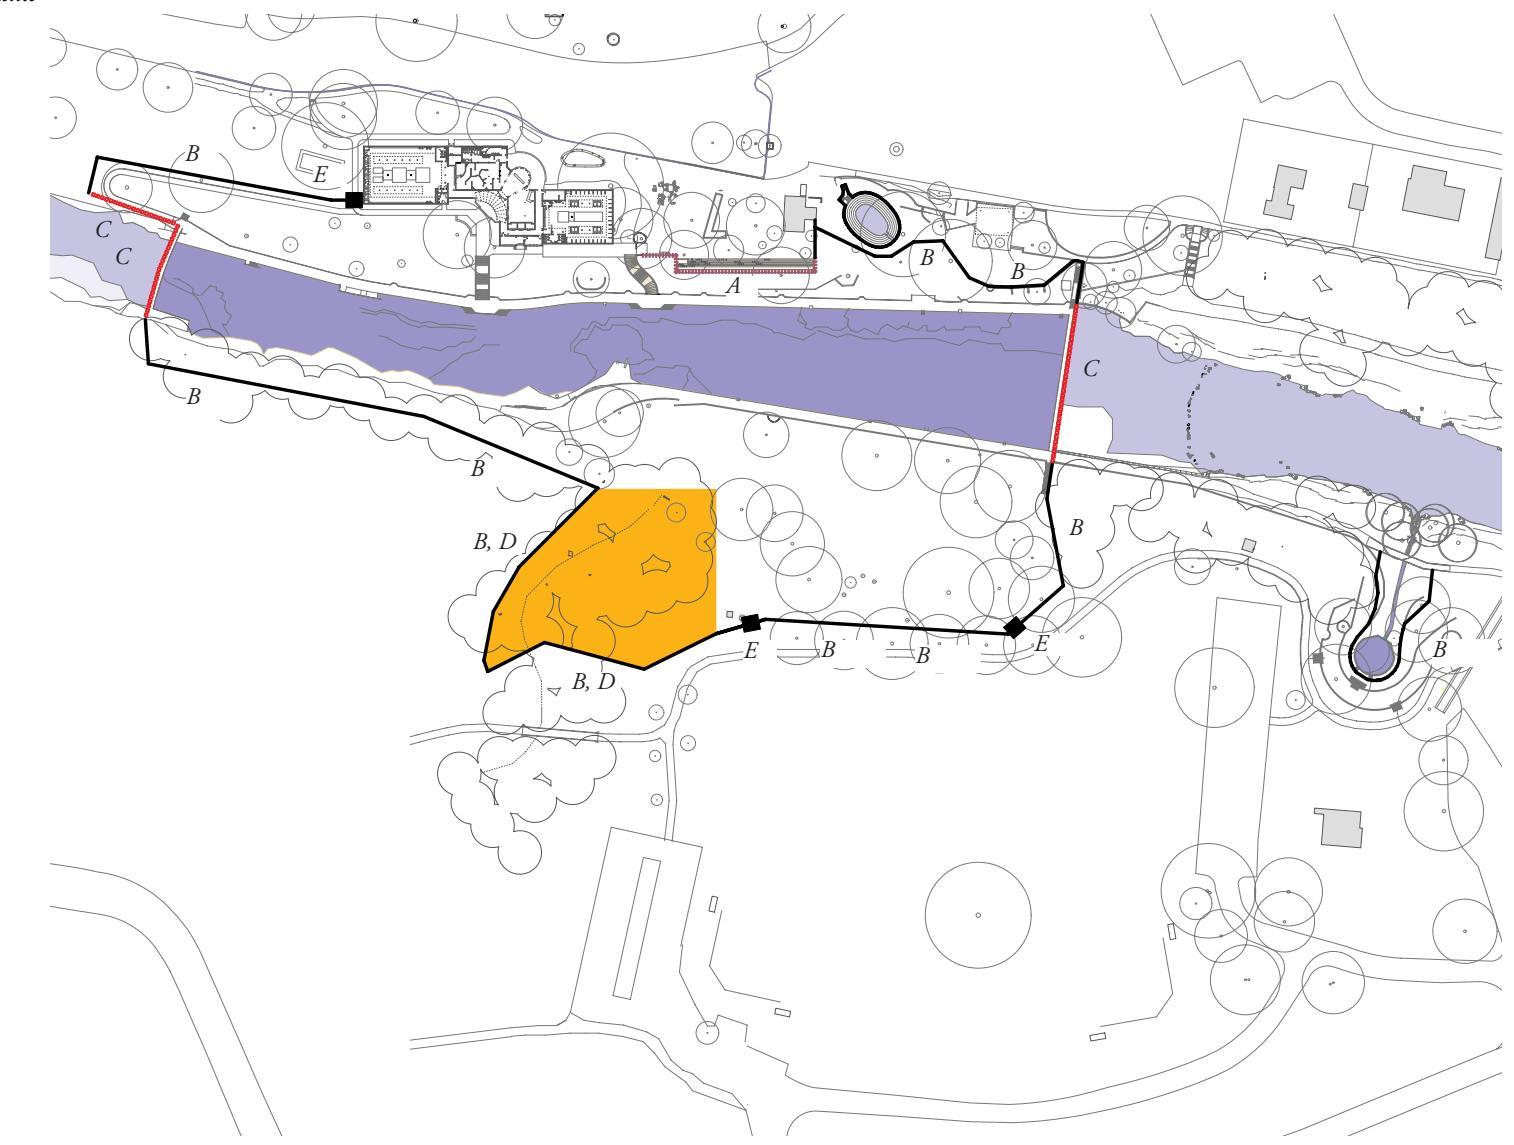
Fences

- A. "Art" Fence
- B. Decorative Wire Mesh Fence
- C. Powder-Coated Chain Link Fence
- D. Fence relocated at South Woods
- E. Accessible Turnstile

The goal of the master plan for fencing is to create a hierarchy of different, complementary fence types, with all fences being less subject to vandalism and easily maintainable.

The first fence type is a fence custom designed and built by an artist, for the very visible overlook at the Tree Court. There are several beautiful iron fences in the Zilker Park / Lady Bird Lake area, designed and built by local metal artists. It is expected that this fence would run from the existing turnstile exit from the Pool to the reconfigured concession stand.

The second fence type, and by far the predominating fence type, is recommended to be a decorative wire mesh fencing. This type of fencing is panels of wire of specified thicknesses, welded together in a grid pattern, mounted on steel posts. This kind of fencing offers the transparency of chainlink, in a stronger, more attractive fence that is still affordable. The thickness of the wire for these fence panels is identified as the wire gauge: the smaller the gauge, the thicker and therefore stronger the wire. Either 4 or 6 gauge wire is appropriate for wire fence panels. This is equivalent to 5 or 4.5mm thickness. Chain link fence fabric is generally substantially thinner than that, and therefore easier to cut. With wire panels, it is important that the panels be set level, even on sloping ground, with the result that the fence appears to stair-step down the slope. Trying to slope the fence panels requires extensive cutting of the fence, compromises the galvanizing of the fence wire and appears awkward. It is therefore recommended that the bottom of the fence panels be buried as required to accommodate sloping ground. Matching steel posts are part of wire fence systems, with brackets that allow fences to installed in straight runs or turn varying degrees of corners. Matching pedestrian and vehicular gates are also part of wire panel systems. Wire panel fences are generally available galvanized, and often with powdercoated finishes. While powdercoating can be a durable finish, it is not as durable as an uncoated galvanized finish. A wire panel fence that meets these requirements is available from Deacero, Inc. (1 800 DEACERO).

The final fence type is for the removable fence panels on the dam. Currently, these panels are galvanized pipe with chainlink. This combination meets the requirement for fairly light panels that can be removed quickly when needed, and are inexpensive to replace when they get damaged. While these panels serve their purpose, they are not very attractive and are in the line of one of the iconic views in Austin: from the Pool down the creek, toward down-

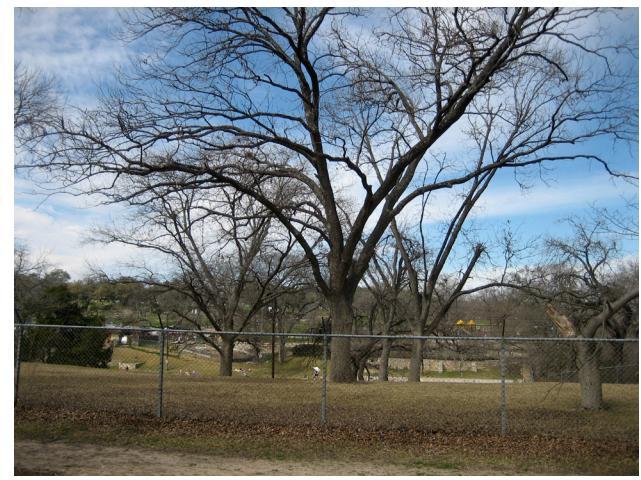
Barbed wire on top of chainlink fence. Staff reports that fences are frequently cut, requiring an ongoing repair effort.

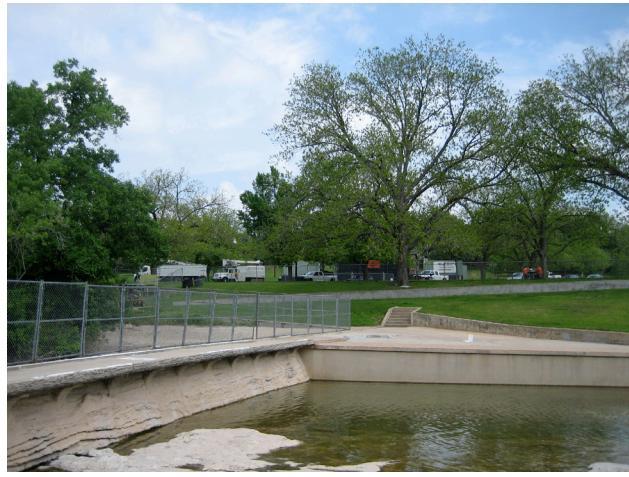
The fencing at the dams must be easy to remove, durable, and inexpensive to replace when it gets damaged.

town, as well as upstream at the upper dam. Making these panels of black powdercoated chainlink fabric, rather than galvanized fabric, would make them less visible. While, as mentioned above, powdercoating does not last as long as unfinished chainlink, these panels are subject to flooding and hard use, and a powdercoated finish is therefore likely to last longer than the panels themselves.

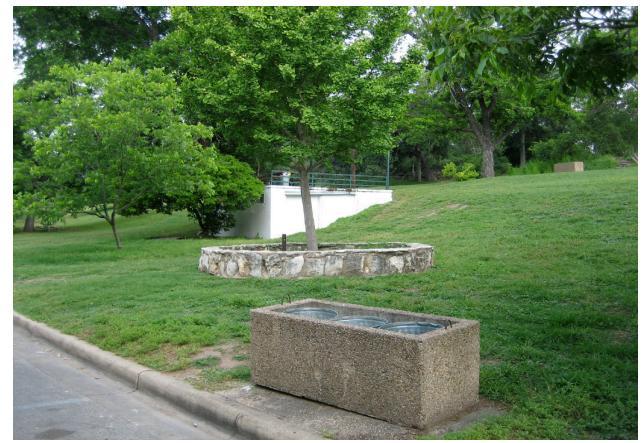
The 'trash coffin' in use throughout the park system. Recycling containers could be added as one of the containers.

The advantage of the coffin system is that the concrete trash coffins are indestructible. Many have been in place for more than twenty years. Their exposed aggregate finish does not make a good surface for graffiti. The galvanized cans inside are durable, cheap and easy to replace. A disadvantage of the coffin system is that the top is open, and the lids for the galvanized cans are often missing,, with the result that the trash is contained but visible.

Because the trash coffins are easy to spot and are already identified as the place for waste, this plan recommends that, for general park use outside the Pool fence and the Tree Court, one of the cans in a two or three can coffin be replaced with a recycling container. Rubbermaid, the manufacturer of the standard blue COA curbside recycling bins, also makes a blue 20 gallon round recycling container, in the 'Brute' series that will fit in the trash coffins. This container is available with a lid with a cutout for cans, bottles and newspapers. Recycling decals can be attached.

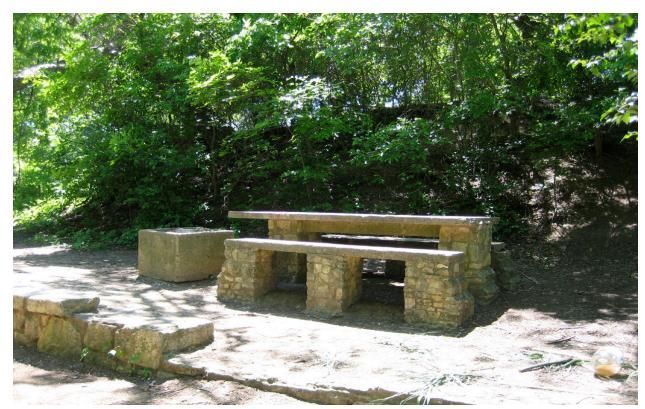
An old stone picnic table that has been modified to be accessible.

There are also several kinds of picnic tables in the park. Permanent, fixed in place tables are mostly older concrete tables on concrete pads. Often these are grouped into a rental picnic area, and occasionally they are individually placed, like the lovely, if eroded, picnic setting above the Hillside Theater. In the Tree Court there are standard vinyl coated picnic tables and also wood tables installed by the concessionaire. While the Sandbox Grove is often used as a group picnic area, we do not recommend that a fixed array of picnic tables be installed there, so that the area can keep its variety of uses, and stay comfortable for individuals to use.

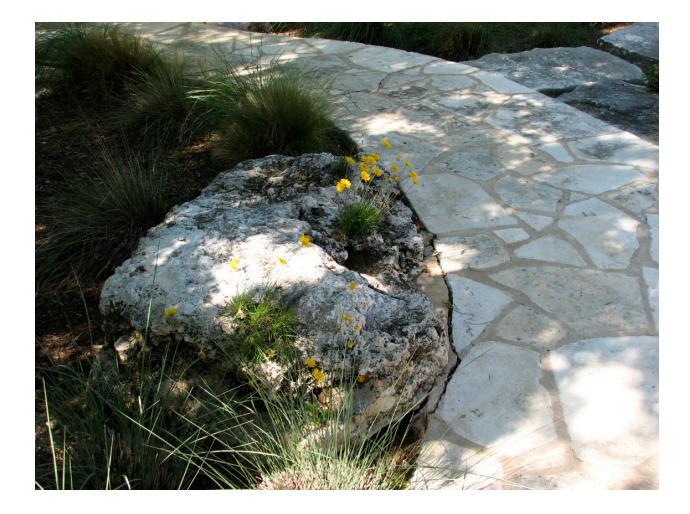
Carefully built stonework, including natural boulders as accents, fits with both the historic and the natural landscapes of Barton Springs.
