# PHASE I ENVIRONMENTAL SITE ASSESSMENT FOR TWO PARCELS OF A PROPERTY LOCATED AT THE CITY OF AUSTIN FM 812 LANDFILL AUSTIN, TX 78719

**WESTON SOLUTIONS, INC.** 2705 Bee Cave Road, Suite 100

March 2013

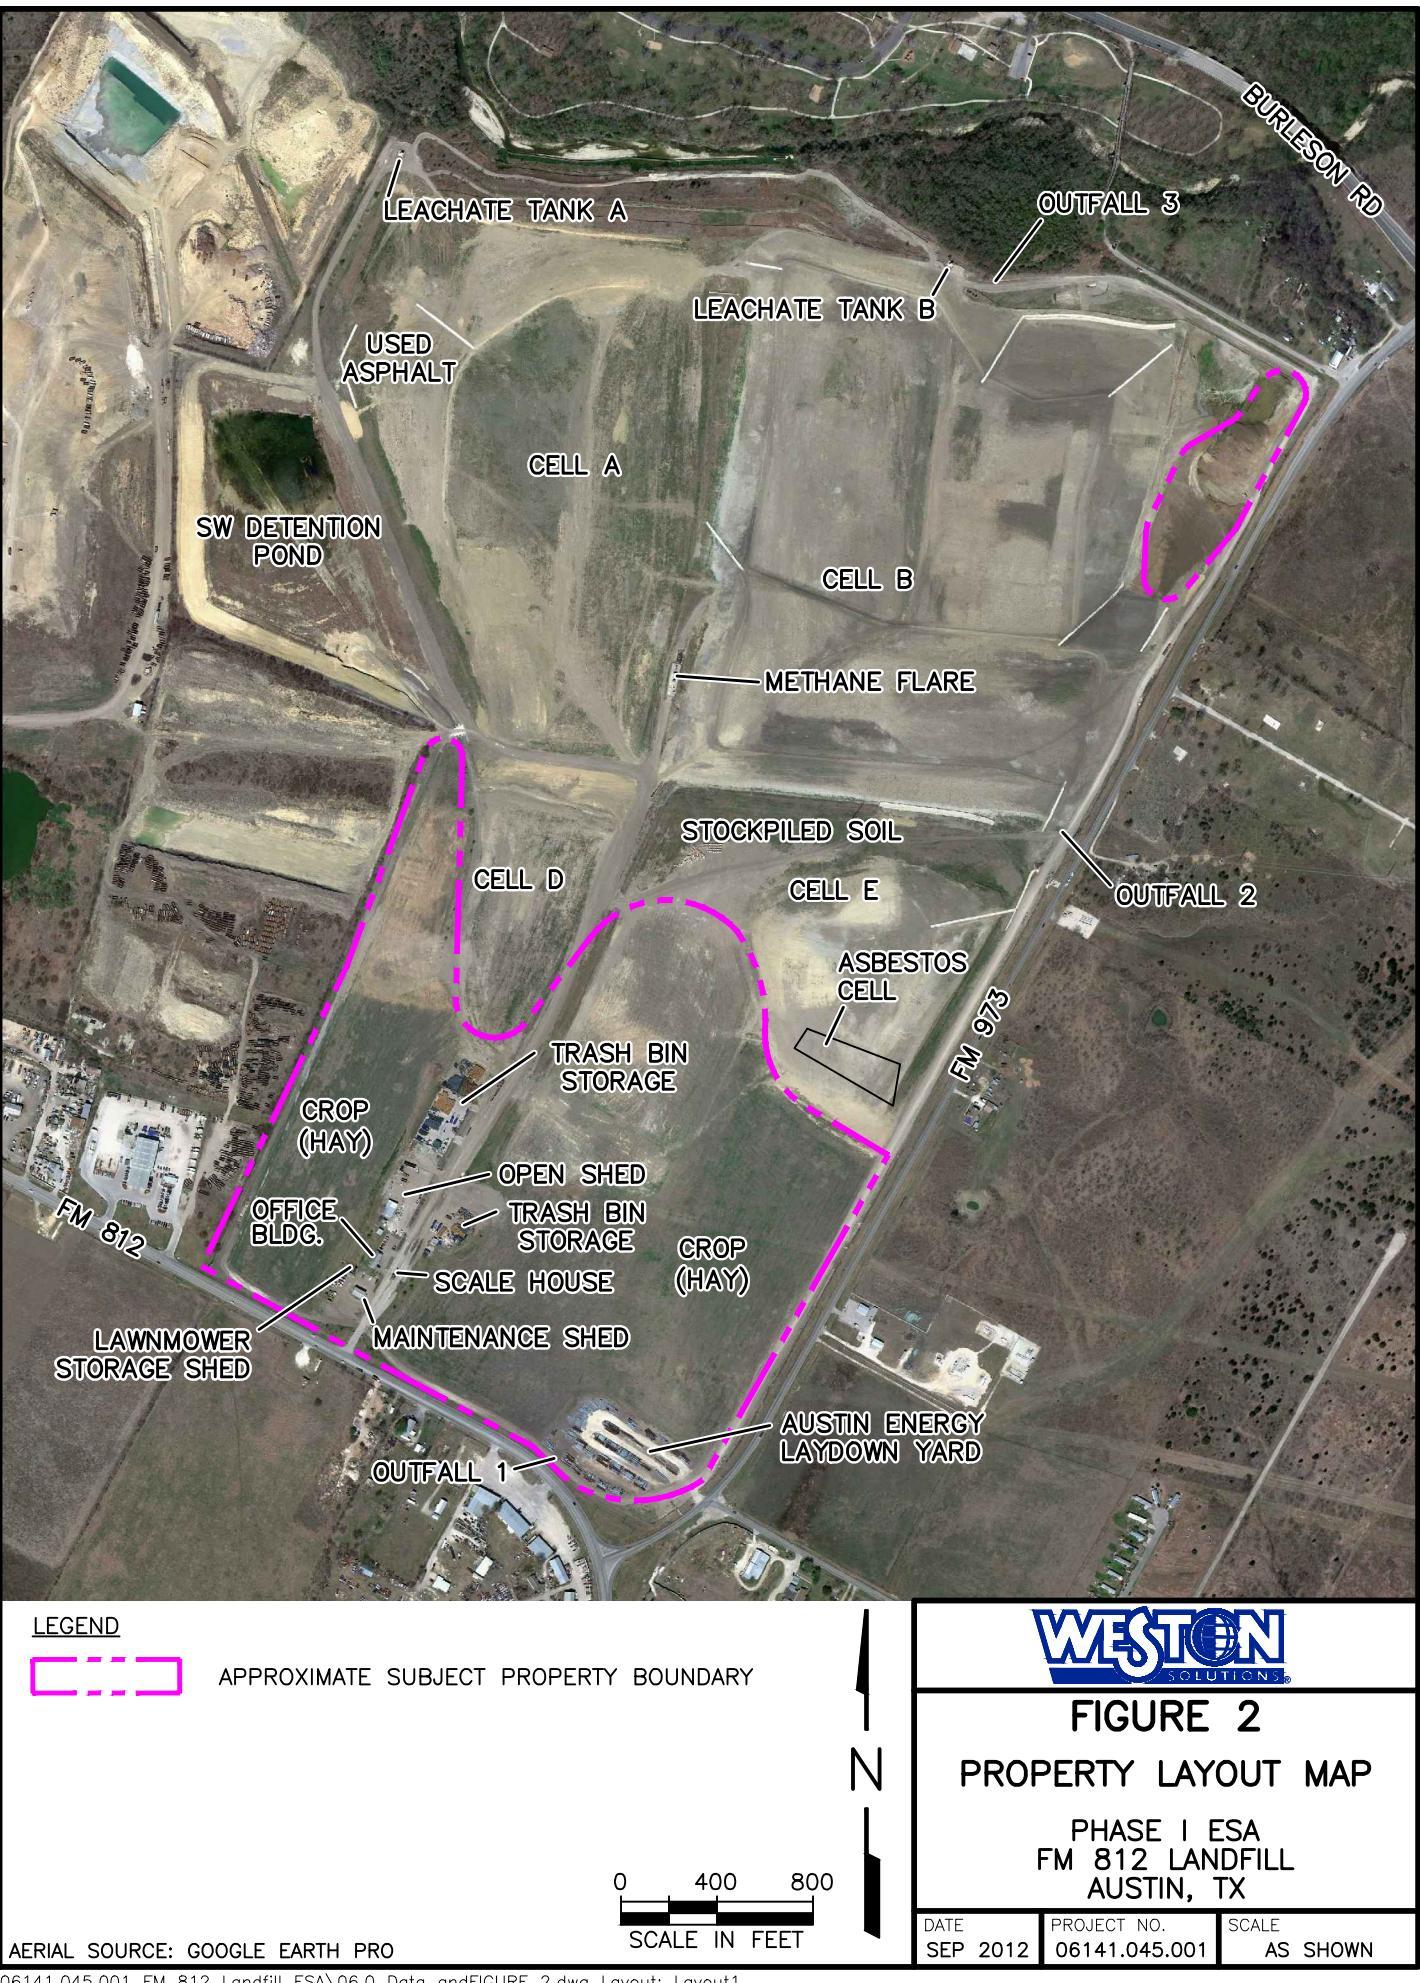
06141.045.001 FM 812 Landfill ESA\06.0 Data andFIGURE 2.dwg Layout: Layout1

Stormwater from the northeastern parcel of the subject property has the potential to flow towards Outfall 3 (Figure 2). According to Mr. Leloux, at the time of the Sept 2012 site visit there was a violation for stormwater Outfall 3 on the northern part of the landfill property. The outfall has been reconstructed to better regulate flow of stormwater into Onion Creek (see Appendix A, photos 13 and 14). The issue was resolved with a letter of no further response required from the TCEO dated 20 December 2012.
Air	No potential sources of air emissions were observed on the two portions of the subject property.
	A permitted methane flare system (TCEQ Permit TH0742G) is located towards the center of the landfill property that is not considered part of the subject property parcels (see Figure 2).
<b>Cooling Towers</b>	No cooling towers were noted during the site reconnaissance.
Solid Wastes	Solid waste generated on the subject property consists of general office waste and is stored in bins by the east side of the office building and transported off-site for disposal. Old tires and air conditioning units were temporarily stored on-site until they could be picked up for recycling, but according to the COA these activities ceased in January of 2013.

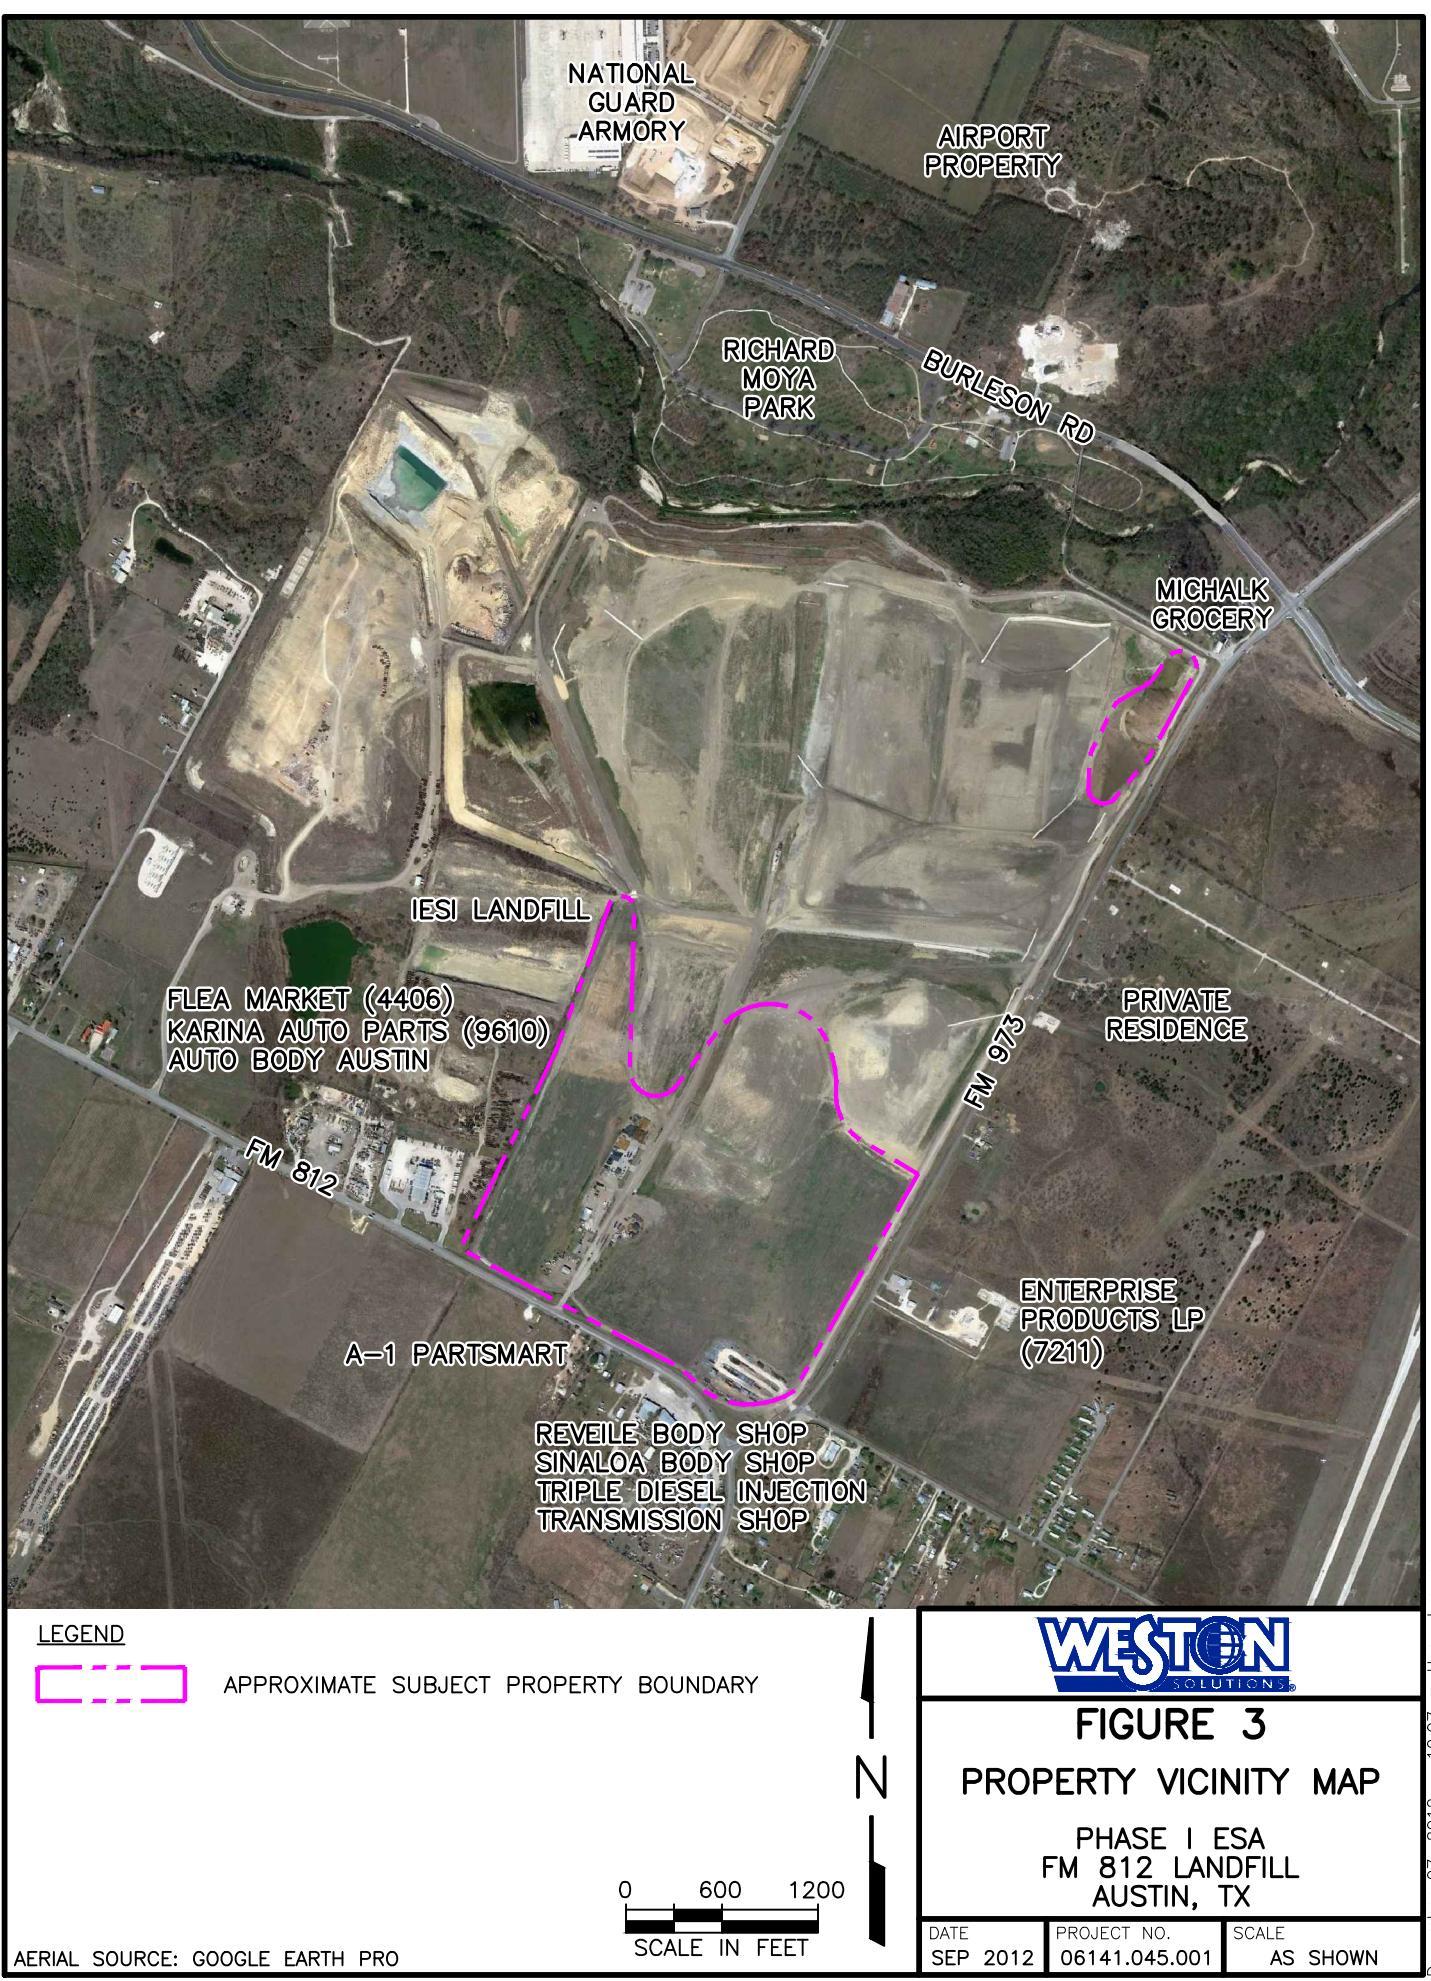
06141.045.001 FM 812 Landfill ESA\06.0 Data and FIGURE 3.dwg Layout: Layout1

Surrounding properties are shown on Figure 3. Site photographs are provided in Appendix A. A summary of the surrounding properties as observed during the 07 September 2012 site reconnaissance is provided in the table on the following page.
