## ZONING CHANGE REVIEW SHEET

CASE NUMBER: C14H-2010-0039

HISTORIC NAME: Bradford-Nohra House

ADDRESS OF PROPOSED ZONING CHANGE: 4213 Avenue G

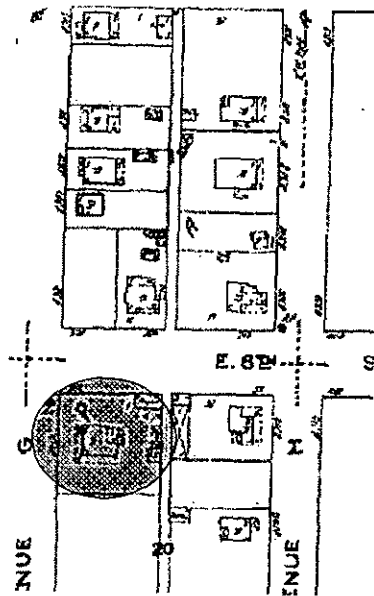
The 1922 Sanborn map shows the house with a two-story wraparound porch as shown in the historic photographs.

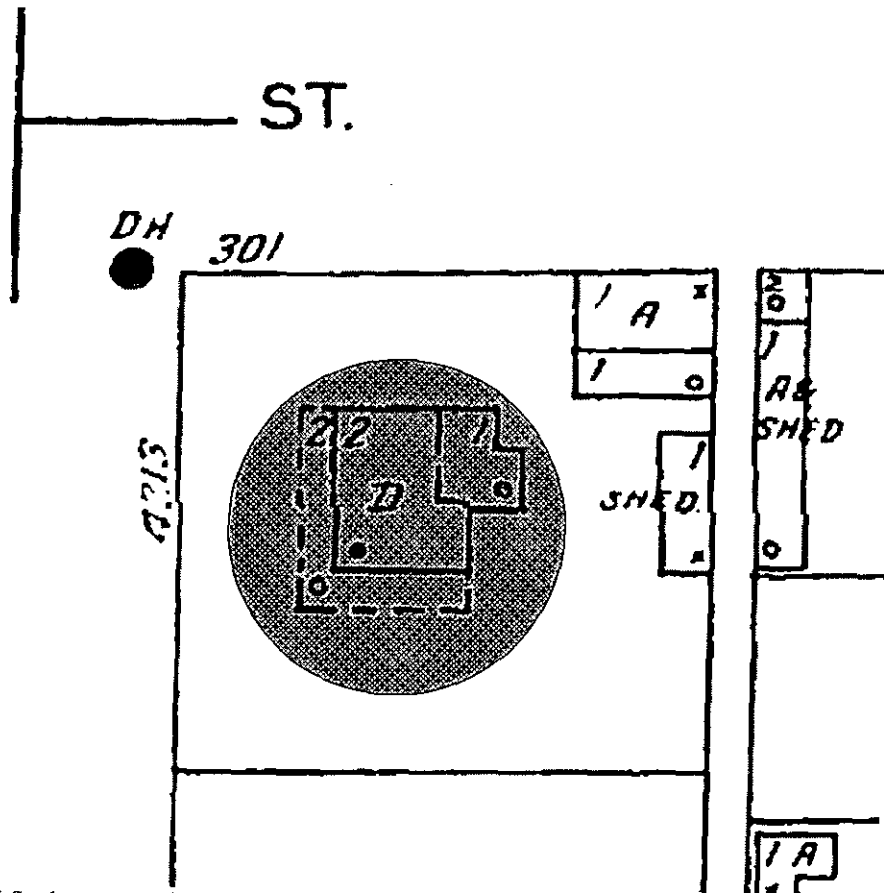
The 1935 Sanborn map shows the two-story wraparound porch and a one-story rear addition.
