HISTORIC LANDMARK COMMISSION JUNE 24, 2013 NATIONAL REGISTER HISTORIC DISTRICT NRD-2013-0047 West Line 507 Oakland Avenue

Demolish a c. 1917 contributing house and garage.

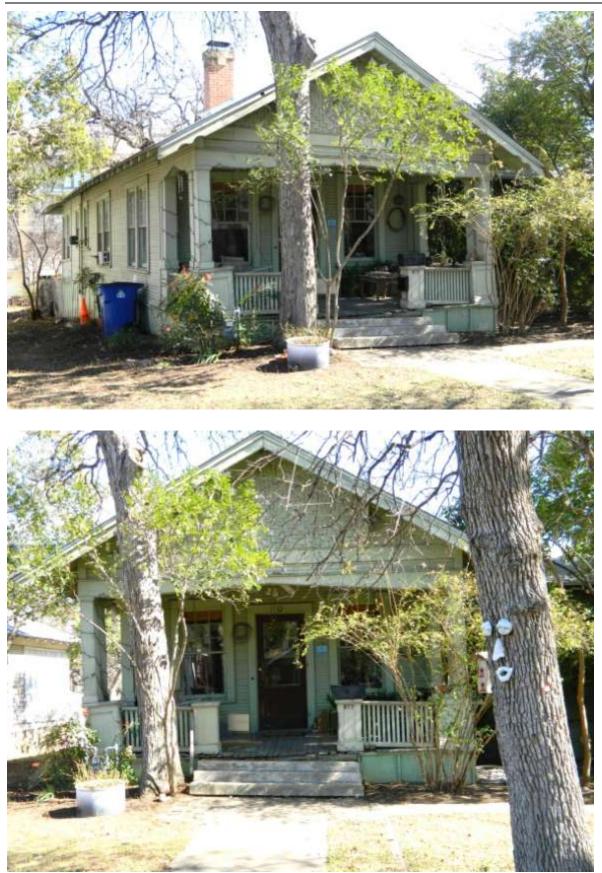
507 Oakland Avenue

The existing c. 1917 house is an approximately 2,000 sq. ft., one-story bungalow form with simple Craftsman features. The front facing gabled main roof, with exposed rafter ends, extends over the offset, projecting front porch, and is supported by double square, wood columns set on wood piers at the corners. The porch also has low piers without columns to either side of the front steps, and a wood railing with square balusters. The cladding includes narrow, horizontal lap siding on the walls and squared, irregular width shingles in the gable end. The verge board on the front gable end and fascia around the porch has decorative shapes. The double-hung, wood windows are 9:1. The additions to the rear-side of the house were constructed prior to 1935, as indicated on Sanborn maps.

The house and garage are good examples of simple Craftsman-style buildings and both retain a high level of historic architectural integrity. Therefore, demolition does not meet the guidelines. Additionally, with nearly all the houses that were present by 1935 still standing and retaining their historic appearance, this block of the West Line National Register District retains a very high level of integrity and would be eligible for Local Historic District zoning. Loss of this house, and the one at 505 Oakland, being located in the middle of the block, would adversely impact this area of the District.

Postpone releasing the permit and encourage the applicant to consider alternatives to demolition.
