HISTORIC LANDMARK COMMISSION SEPTEMBER 9, 2013 NATIONAL REGISTER HISTORIC DISTRICT NRD-2013-0061 Westline 724 Patterson Avenue

Construct an approximately 1,600 sq. ft. addition to a contributing house.

BUTLER RESIDENCE 724 PATTERSON AVE. AUSTIN, TEXAS 78703

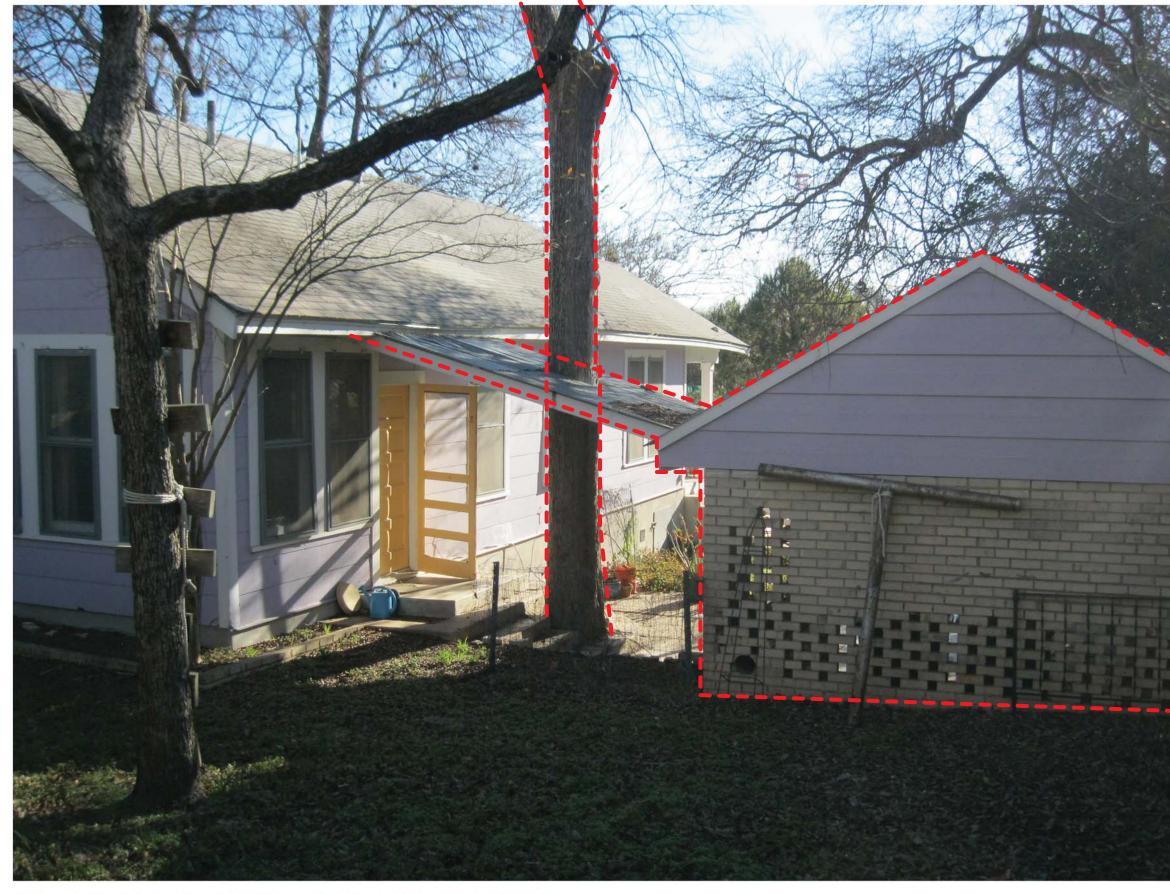
EAST ELEVATION

REMOVAL OF TREE, DEMOLITION OF COVERED WALKWAY, AND CARPORT

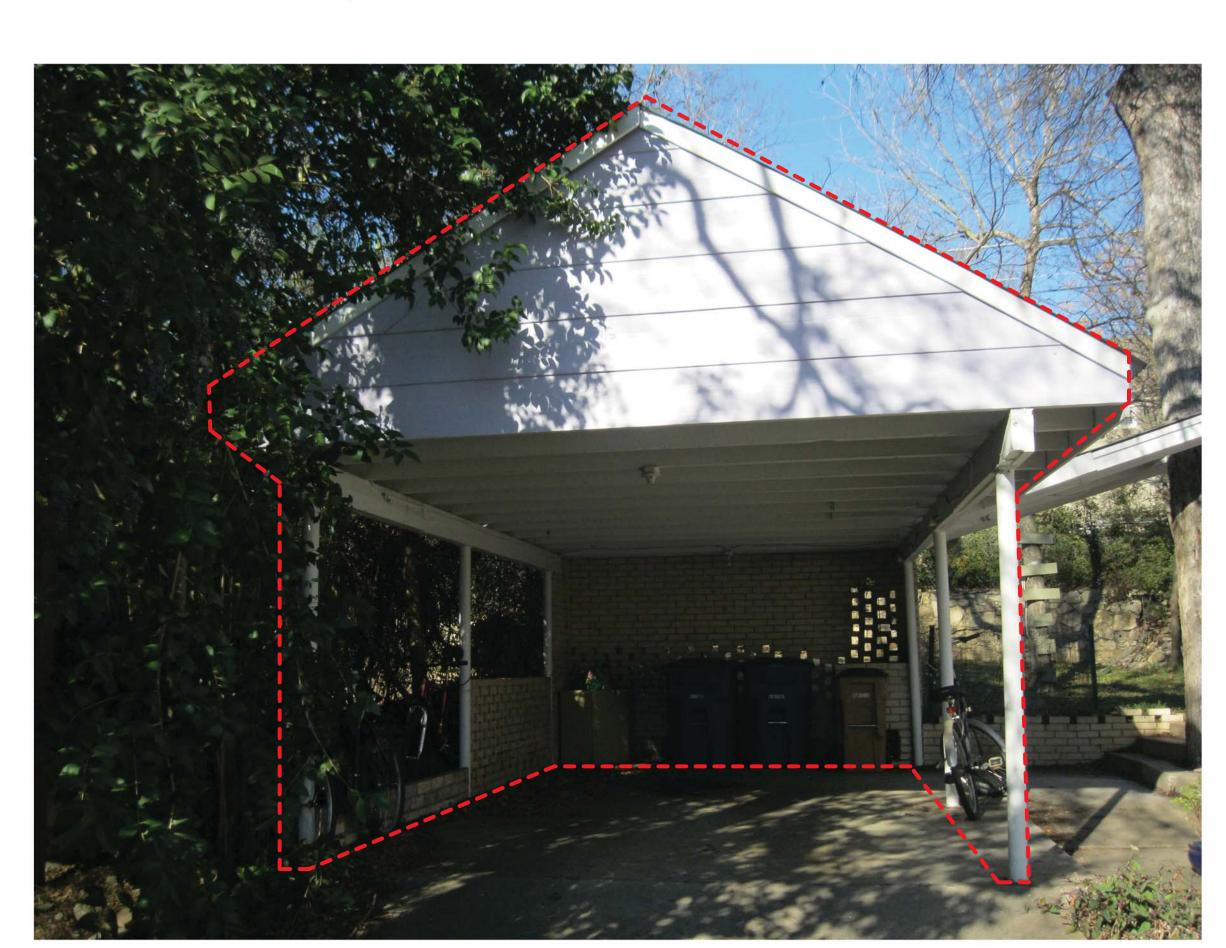
DEMOLITION OF CARPORT

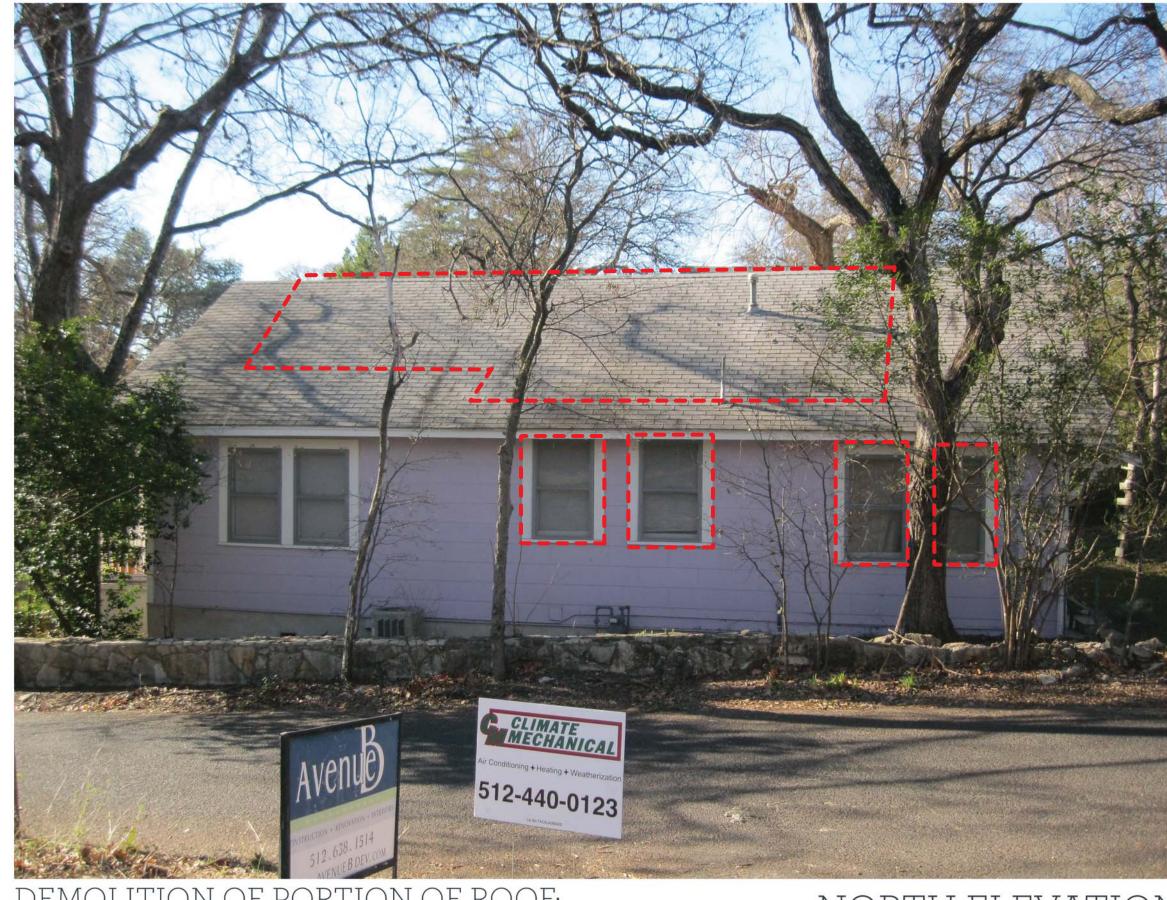
NORTH ELEVATION

DEMOLITION OF PORTION OF ROOF; REMOVAL OF EXISING WINDOWS

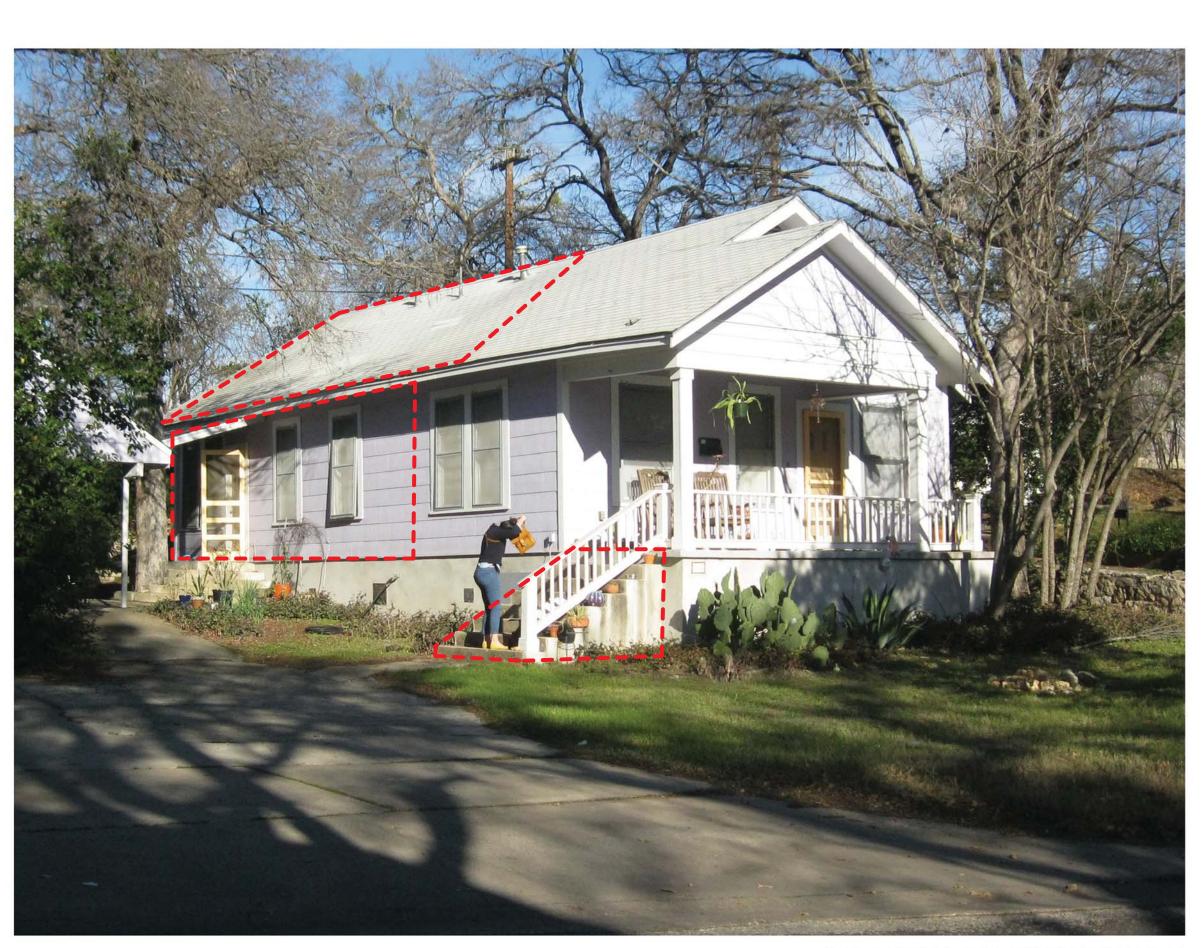
SOUTH ELEVATION

DEMOLITION OF FRONT STEPS TO BE REPLACED WITH WOOD STEPS; DEMOLITION OF PORTION OF ROOF; DEMOLITION OF PORTION OF SOUTH WALL
