**CITY OF AUSTIN**  
**Board of Adjustment/Sign Review Board**  
**Decision Sheet**

**CASE NUMBER:** C15-2014-0065

**ADDRESS:** 5201 TORTUGA TRL

## GEOTECHNICAL INVESTIGATION FOUNDATION RECOMMENDATIONS

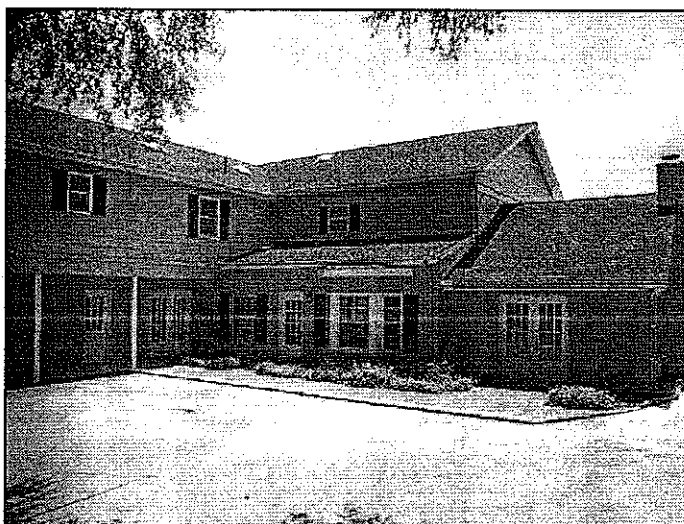
View of electric lines as  
you see them standing  
in courtyard.
