CITY OF AUSTIN
Board of Adjustment/Sign Review Board
Decision Sheet

CASE NUMBER: C15-2014-0065

ADDRESS: 5201 TORTUGA TRL

GEOTECHNICAL INVESTIGATION FOUNDATION RECOMMENDATIONS

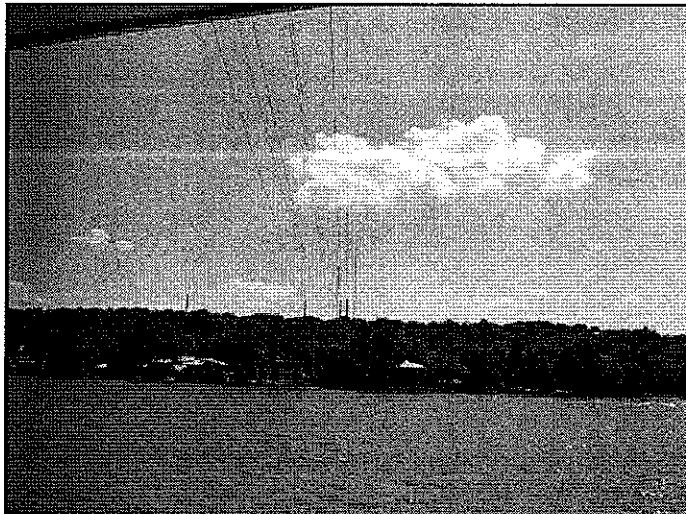
View of electric lines
as you stand on front
porch looking across
the lake.

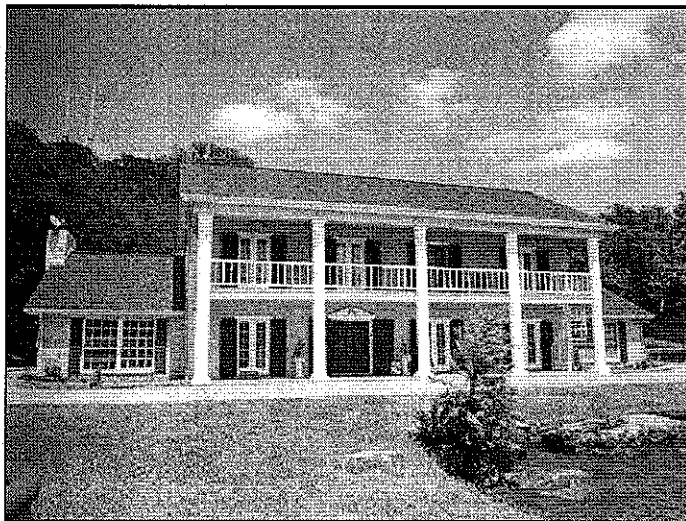
View of electric lines
as you stand in
peninsula and look
back at the home.

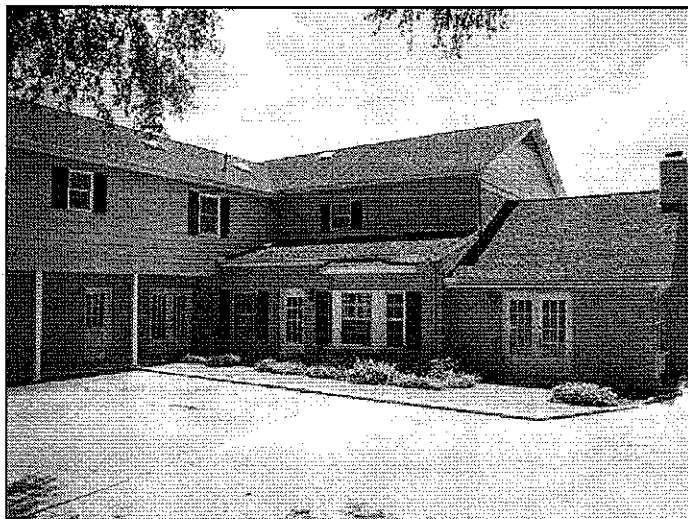
View of electric lines as
you see them standing
in courtyard.

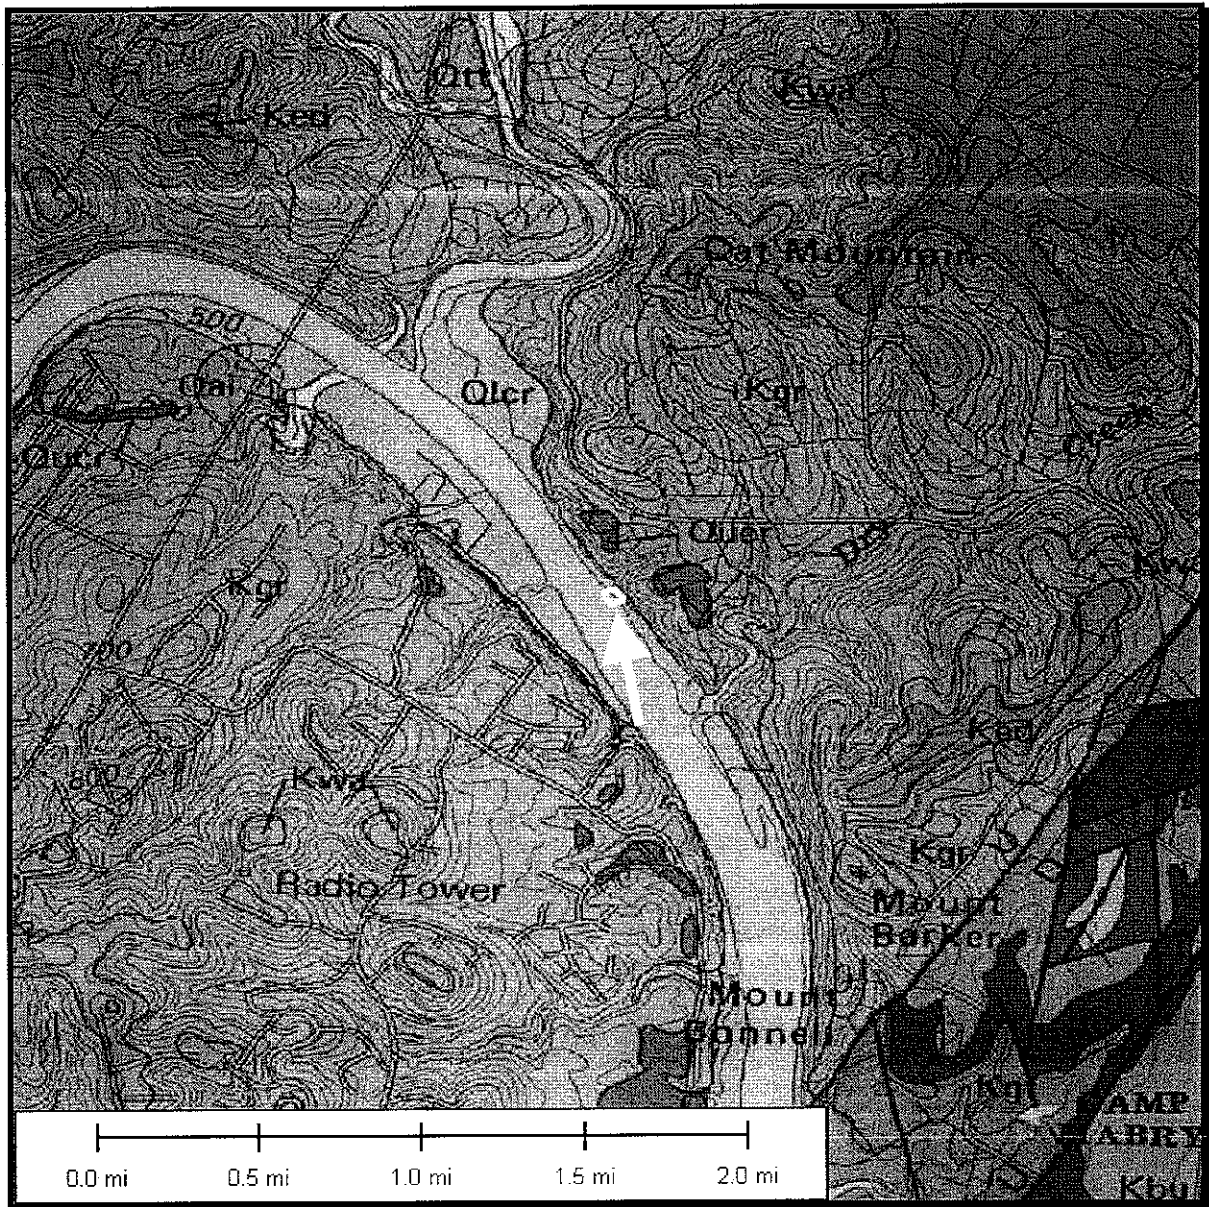
Geologic Setting of Site
Geologic Map of the Austin Area, Texas 1992
 Contour Interval = 20 feet

Approximate location of site in yellow.

The Glen Rose formation is the youngest formation of the Trinity Group from Lower Cretaceous Period and its outcrop forms a narrow prairie in the Austin area from Mt. Bonnell northwest to Burnet. Its outcrop is characterized by steep canyons and terraced or "staircase" topography on hillsides.

The Glen Rose is predominantly a limestone formation, typically consisting of thin to massively bedded, hard limestone strata alternating with clay, argillaceous limestone and thin sandstone strata. The formation was deposited under neritic or near shore conditions and the various strata represent different depositional environments such as mud flats, lagoons, beaches and shallow water reefs. The alternating hard and soft layers cause the characteristic staircase topography of the Glen Rose.

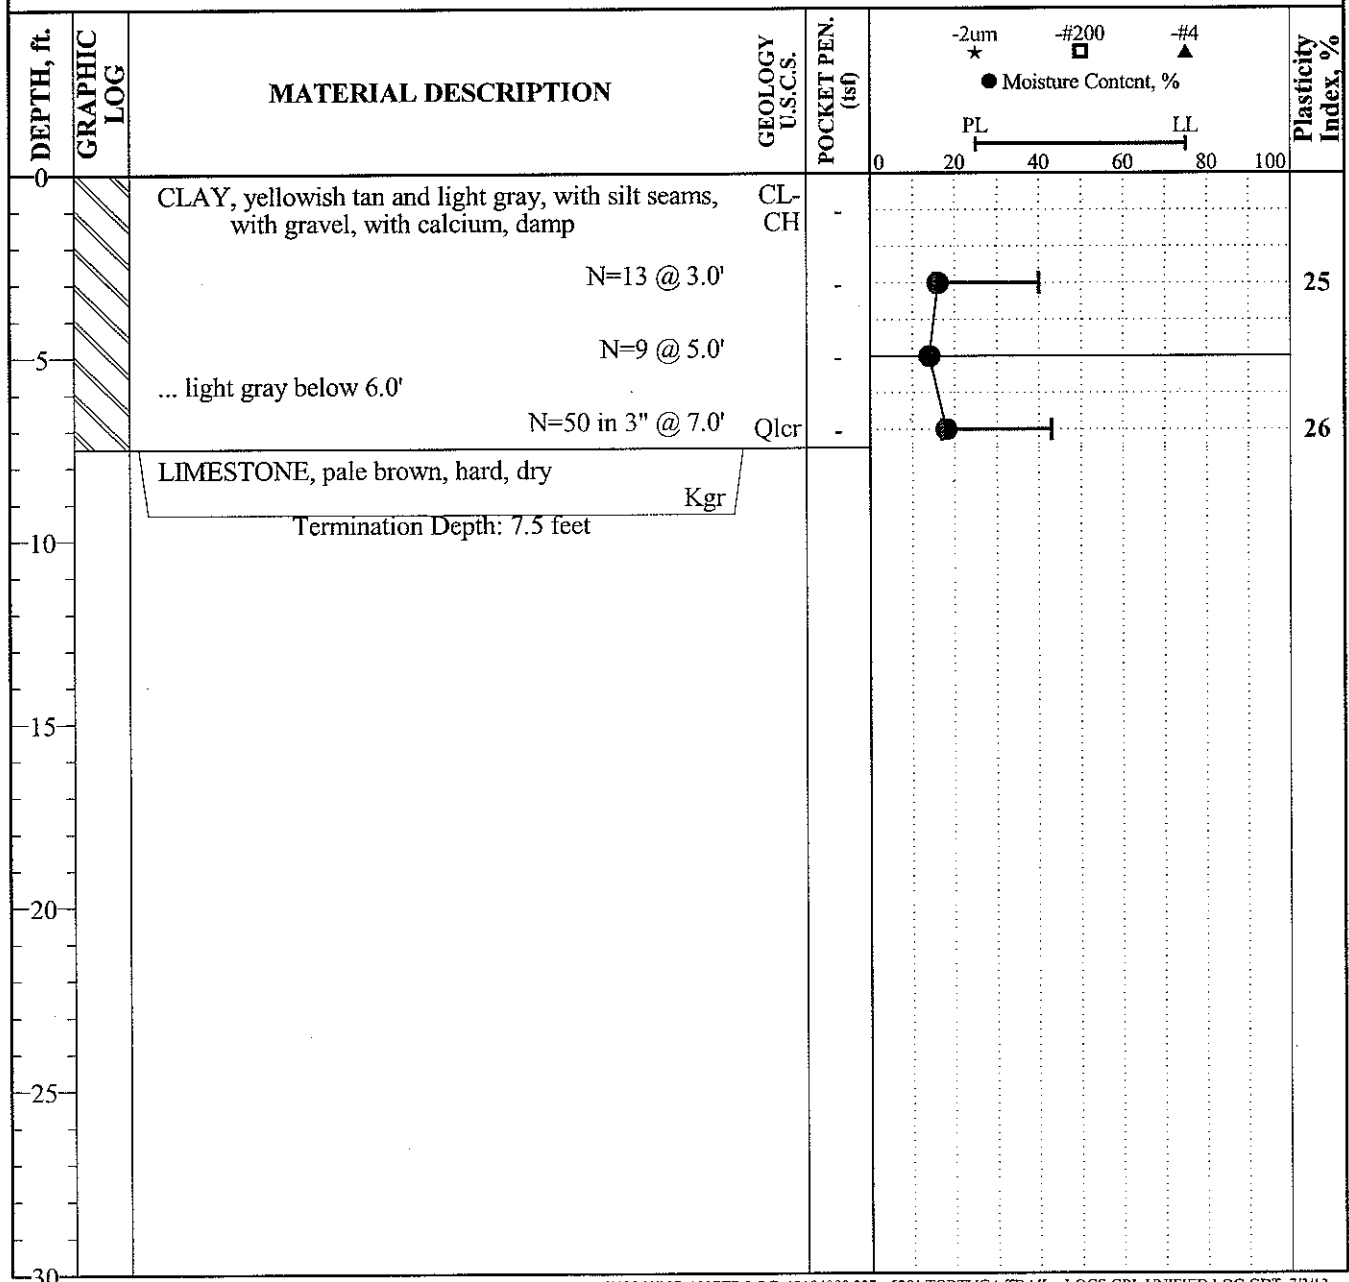
LOG OF BORING

Job Name: 5201 Tortuga Trail
Job Location: Austin, Texas
Engineer's Job #: 13104000.227
Client: Rob and Lama Turner

Seven borings were drilled to various depths spaced at locations as shown on the enclosed Logs of Boring and Plan of Borings using a truck-mounted drilling rig. Water was not introduced into the borings. The field investigation included completing the soil borings, performing field tests, and recovering samples. Representative soil samples were selected for laboratory index tests including Atterberg Limits and moisture content tests. The results of these tests and stratigraphy are presented on the Logs of Boring found in *Appendix A*. A key to the Soil Classification and symbols is located behind the last Log of Boring. See *Appendix B* for details of field and laboratory procedures, as applicable.

The native soil profile identified in the borings consists of an upper layer of yellowish tan and light gray high plasticity clay (CH) that varies in color to light gray and then to brown and is underlain by dark brown and tan moderate plasticity clay (CL/CH). These layers are further underlain by brown high plasticity clay (CH) that varies to moderate plasticity clay (CL/CH). Intact limestone was noted in some of the borings at depth. This soil profile has the potential for volume change with respect to varying moisture contents. This potential is taken into consideration for the foundation recommendations.

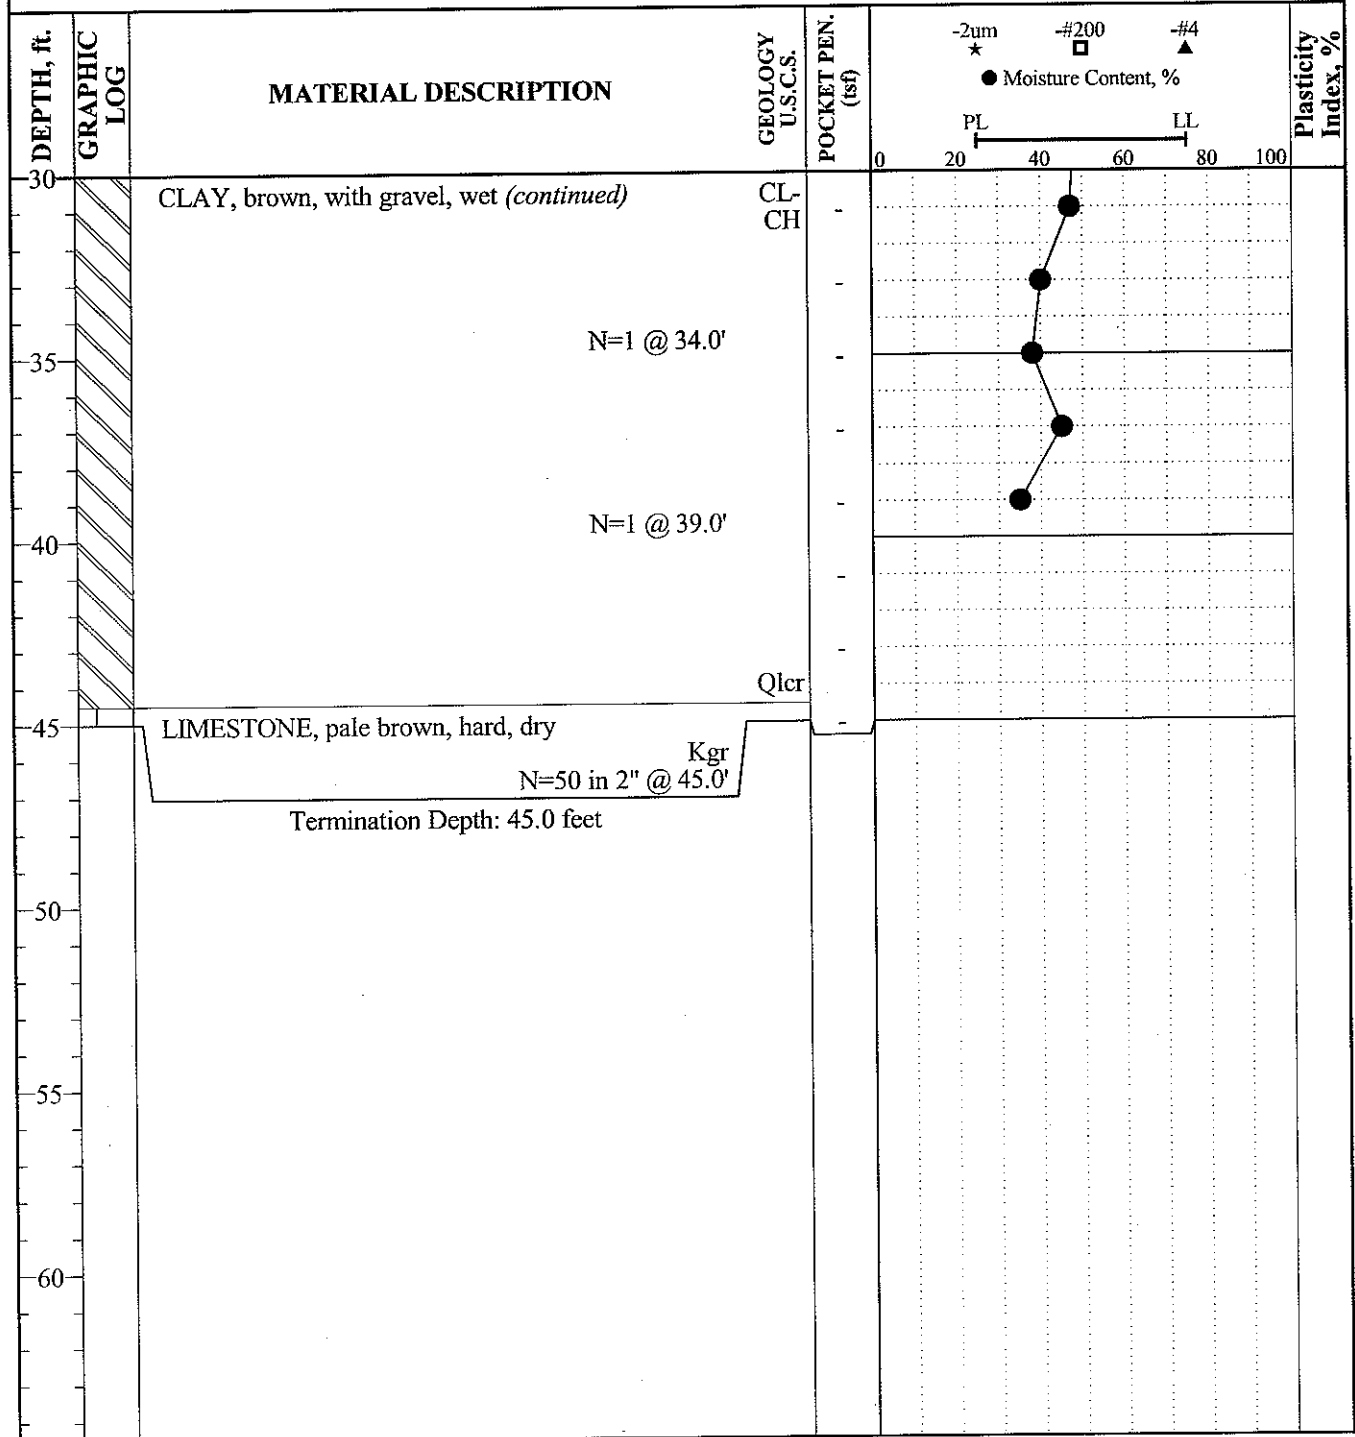
LOG OF BORING

Engineer's Job #: 13104000.227

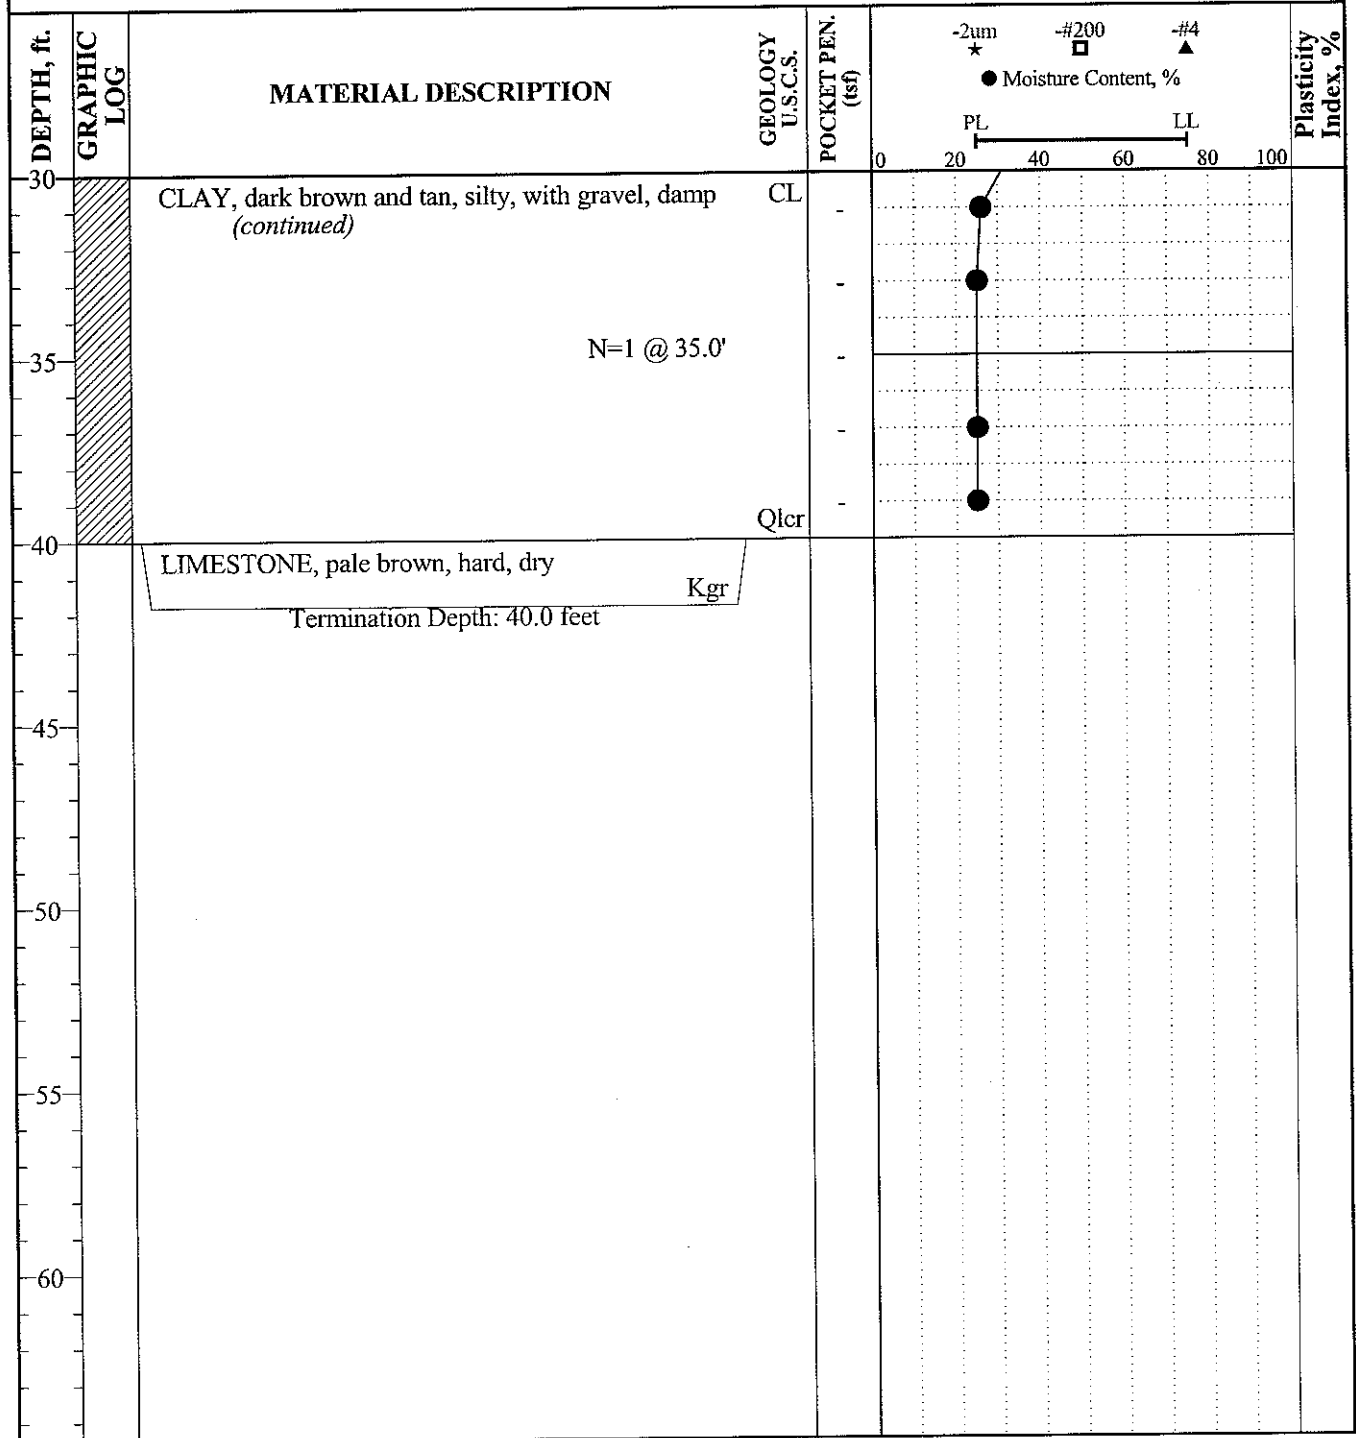
LOG OF BORING

Engineer's Job #: 13104000.227
