Lillie Scott Residence 2100 E. 14th Street Austin, TX 78702

A project for: Newcastle Homes

DRAWING NAME:
FLOOR PLAN &
RENDERING
PROJECT NUMBER:
14-***

DRAWING NAME:
PRESERVATION
DETAILS
PROJECT NUMBER:
14-***
DATE:
07.21.14

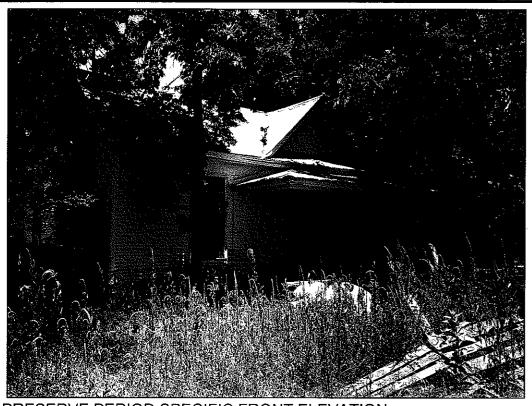
PRESERVE PERIOD SPECIFIC FRONT ELEVATION

NOTE: THIS WORK WILL BE GUIDED BY THE SECRETARY OF INTERIOR STANDARDS FOR PRESERVATION OF HISTORIC BUILDINGS AND STRUCTURES. THE PERIOD SPECIFIC SHINGLE DETAIL ABOVE THE PORCH WILL BE MAINTAINED. WOOD ELEMENTS WILL BE DOCUMENTED, REPAIRED AND REPLACED TO MATCH AT THIS AREA. ADDITIONALLY, DECORATIVE METAL PORCH SUPPORTS THAT ARE FAILING WILL BE REPAIRED AND/OR REPLACED WITH SIMILAR DESIGN ELEMENT.

OBSERVED CONCRETE SPALLING AND SEPARATION OF STRUCTURAL ELEMENTS THIS LOCATION AFFECTING PORCH CANOPY AS WELL AS ENTRY FOR SAFETY. SEMENTS WILL BE REMOVED AND REPLACED WITH DESIGN ELEMENTS. SIMILAR TO EXISTING CHARACTER TO PRESERVE APPEARANCE. EXISTING CONDITIONS OF INTERIOR ARE PROVIDED FOR REFERENCE ONLY.

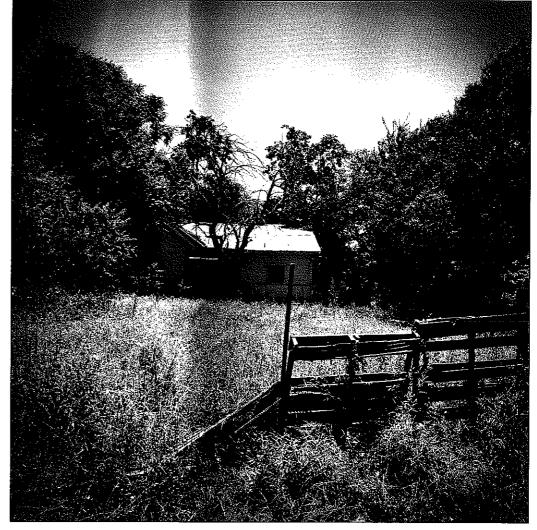
LOCATION OF PROPOSED ADDITION (NORTHEAST CORNER)

NOTE THE NORTHEAST CORNER OF THE EXISTING HOME WILL SERVE AS THE LOCATION FOR THE PROPOSED ADDITION. THIS ALLOWS THE HISTORIC HOME TO MAINTAIN (AND PRESERVE) THE APPEARANCE FROM THE STREET CORNER. THE AREA AT THE REAR OF THE LOT WILL BE THE LOCATION FOR THE PROPOSED SECONDARY DWELLING WITH ALLEY ACCESS. NOTE IMAGE ABOVE IS VIEW FROM ALLEY TOWARD EXISTING
